Geological Engineering Reconnaissance of Damage Caused by the October 15, 2006 Hawaii Earthquakes

Edmund W. Medley, Senior Consultant, Geosyntec Consultants Inc., Oakland, CA, USA, Email: emedley@geosyntec.com

KEYWORDS: Geological Engineering, Hawaii, Earthquake Damage, Rock Mass, Basalts, Rock Block Structures

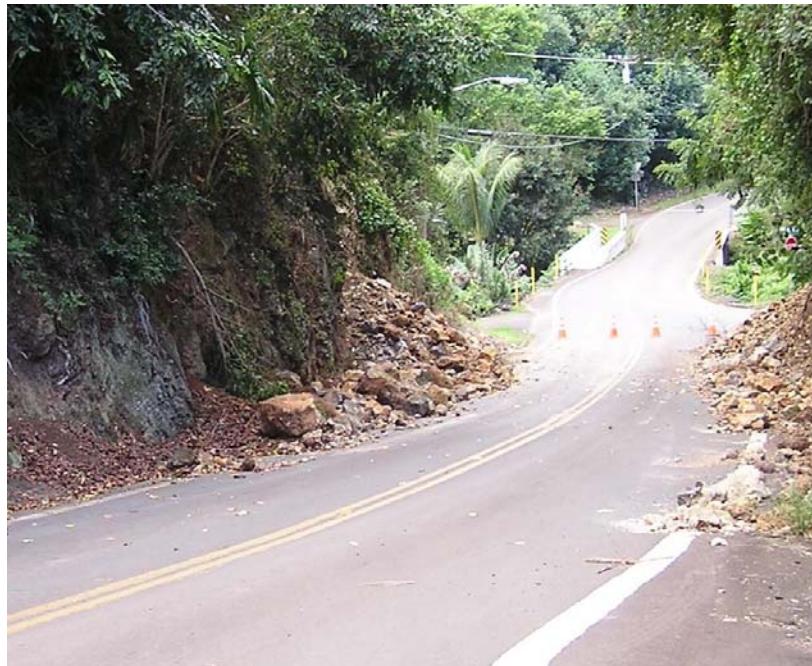
Figure 7. Hwy 270, Station 18, near Kēōkea Bay Beach Park access road. Highway was blocked by rock falls after the earthquakes.

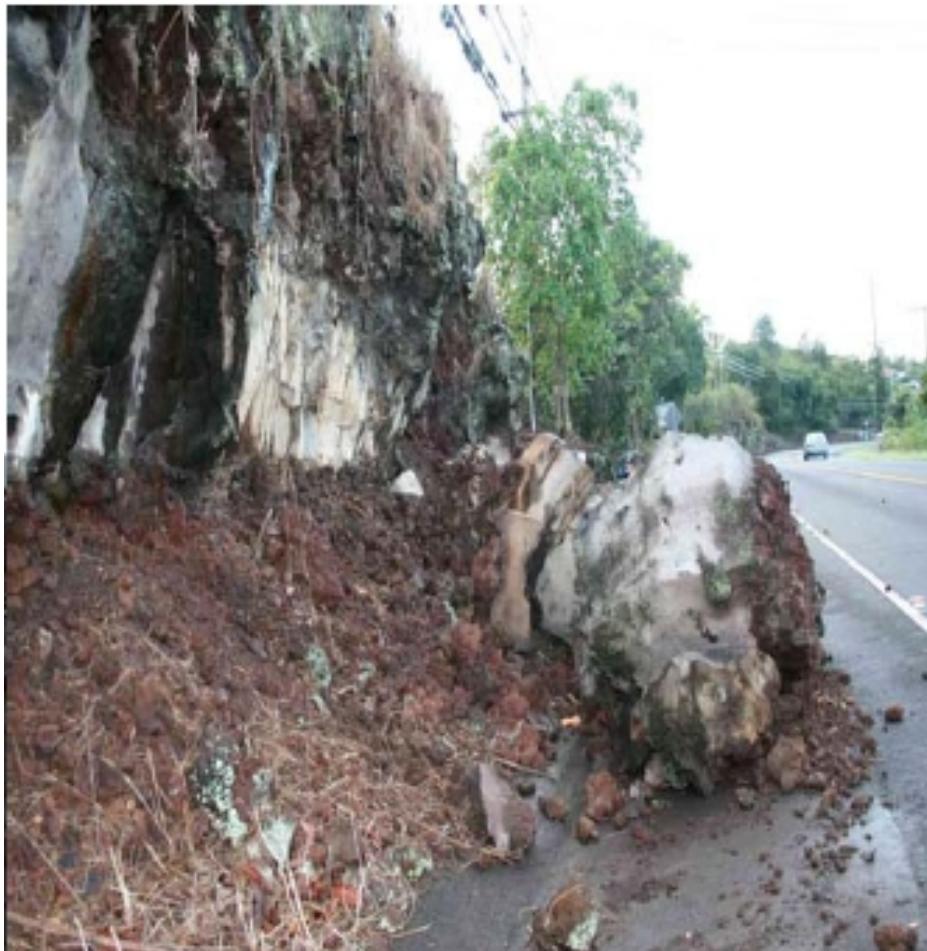
Figure 8. Failed rock cut: massive a'a block undermined by raveled a'a clinker (Chock, 2006; after Robertson et al., 2006).

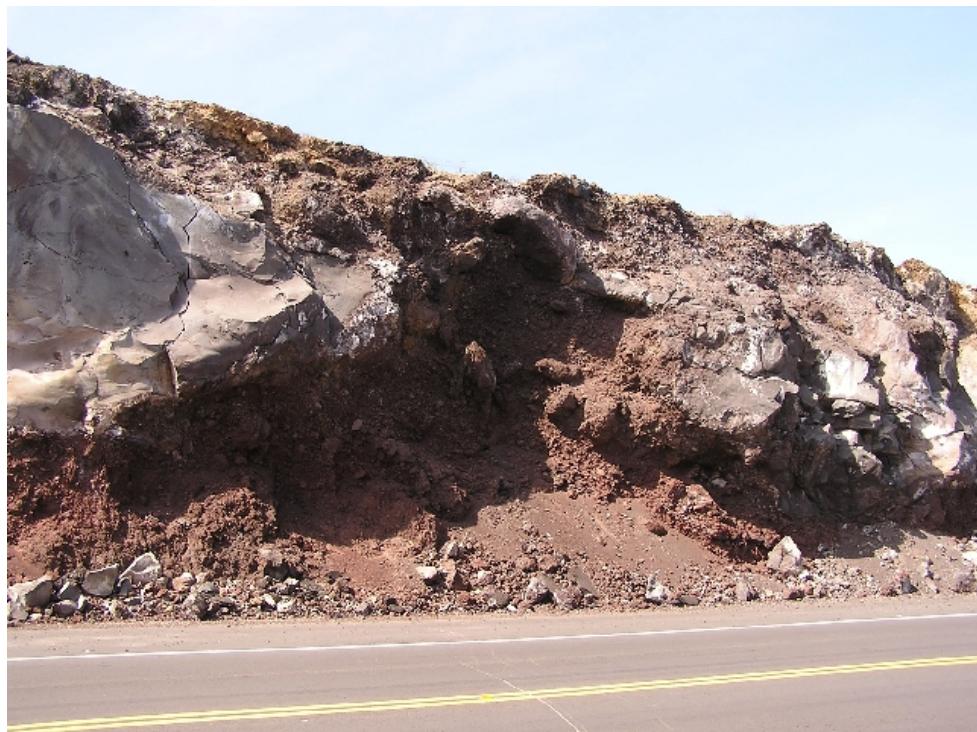
Figure 11. Location 32, Hwy 11. Failure of massive basalt blocks overlying weaker rock (weathered a'a clinker and baked zone).

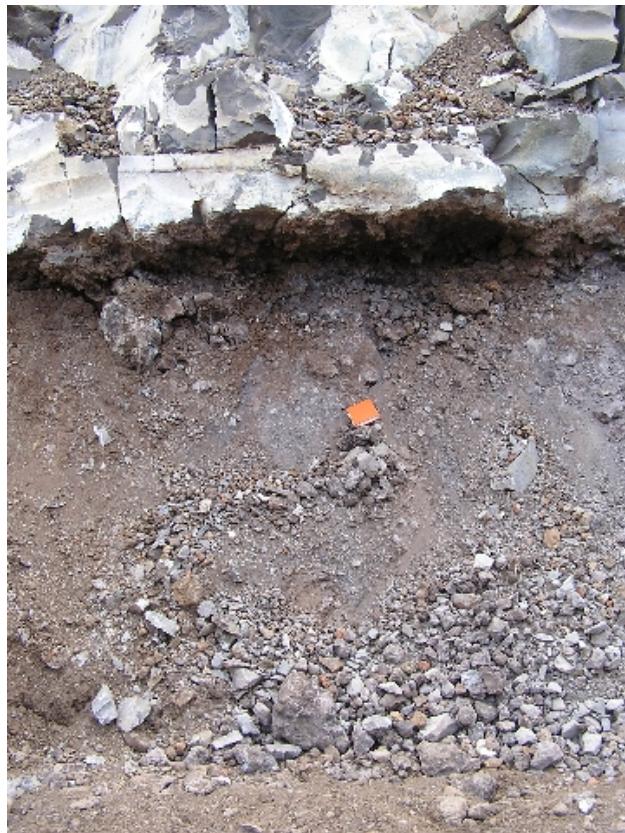
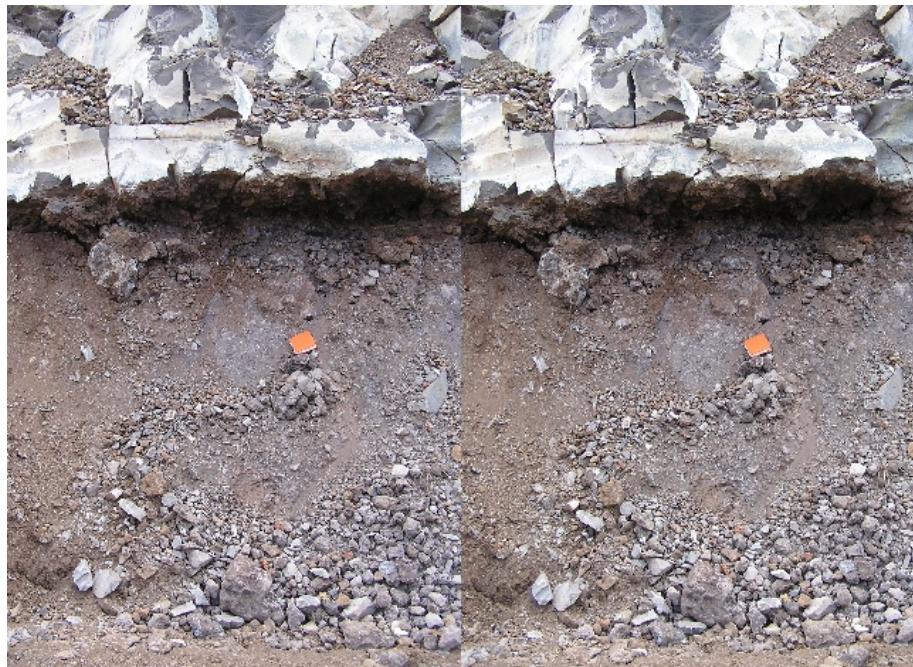
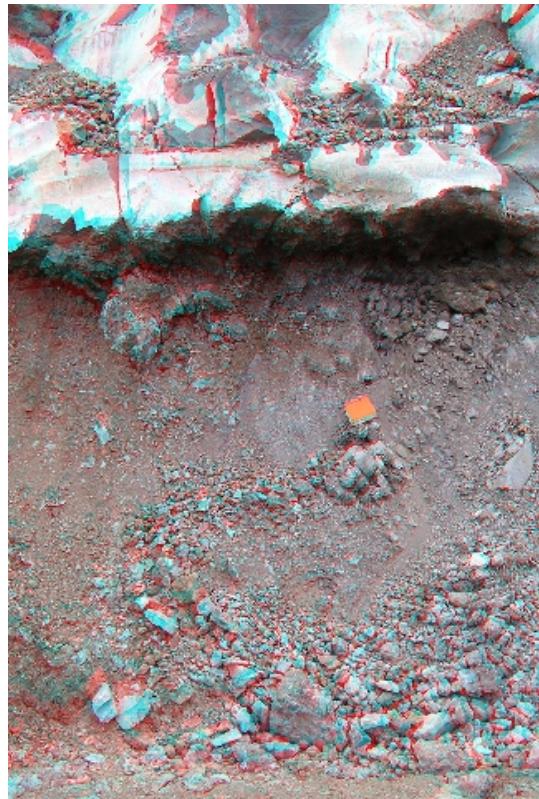
Figure 15. Location 25, Hwy 270 north of Kawaihae. Cantilevered block of massive a'a basalt, undermined by clinker that raveled during the earthquakes. See 3-D stereo images of Figure 16 and Figure 17.

Figure 16. Location 25, Hwy 270 north of Kawaihae. 3-D stereo pair version of Figure 15. Cantilevered block of massive a'a basalt, undermined by clinker that raveled during the earthquakes.

Figure 17. Location 25, Hwy 270 north of Kawaihae. 3-D anaglyph stereo version of Figure 12. Cantilevered block of massive a'a basalt, undermined by clinker that raveled during the earthquakes.

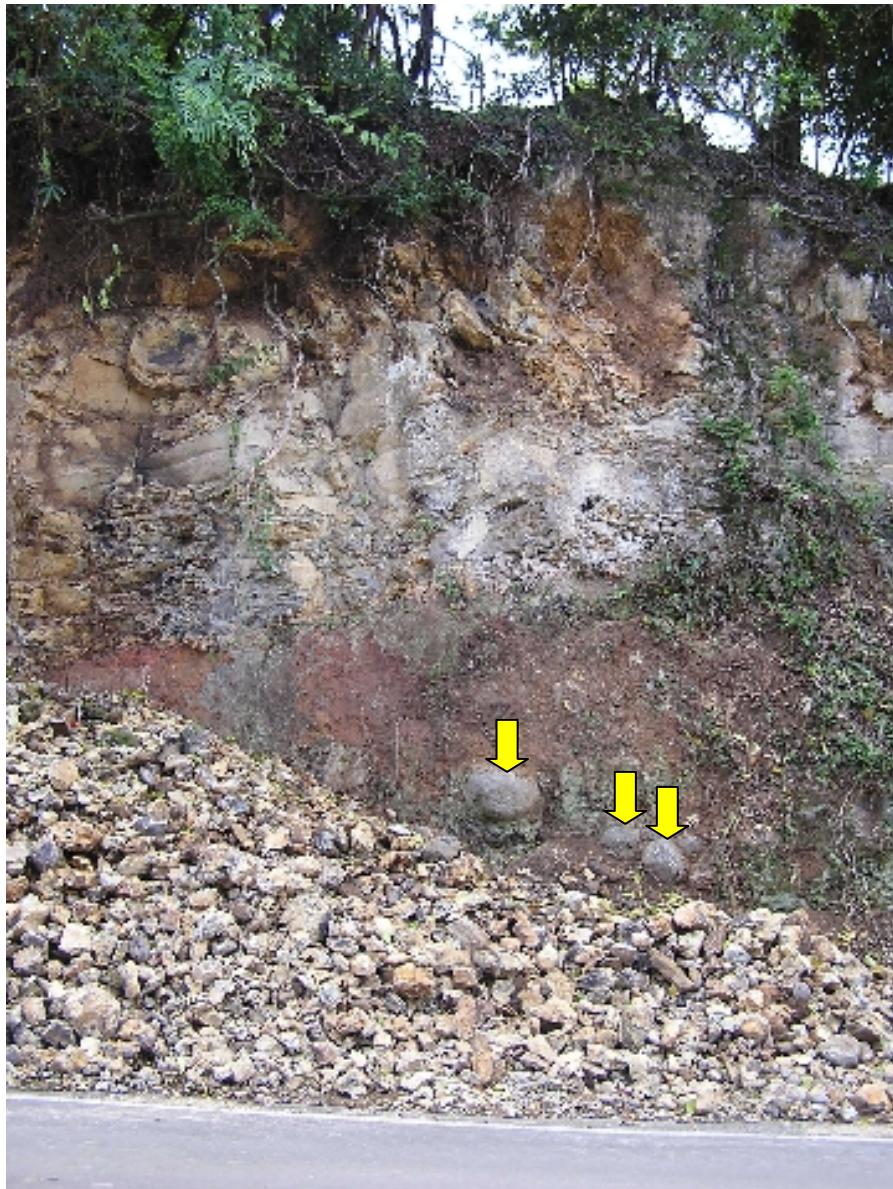
The baked contact between lava flows and pre-existing ground surfaces is often marked by a zone of red soil and highly weathered rock resulting from accelerated weathering. A number of road cut failures were observed where the weaker basal soils failed, undermining the stronger rock above (Figure 11 and Figure 24), in a fashion similar to that above described for a'a/massive basalt sequences.

Figure 24. Location 18, Hwy 270 at Makapala. Failure (pile of rock fragments at front) of stronger rock underlain by baked zone soil, with weathered corestone boulders (arrowed).

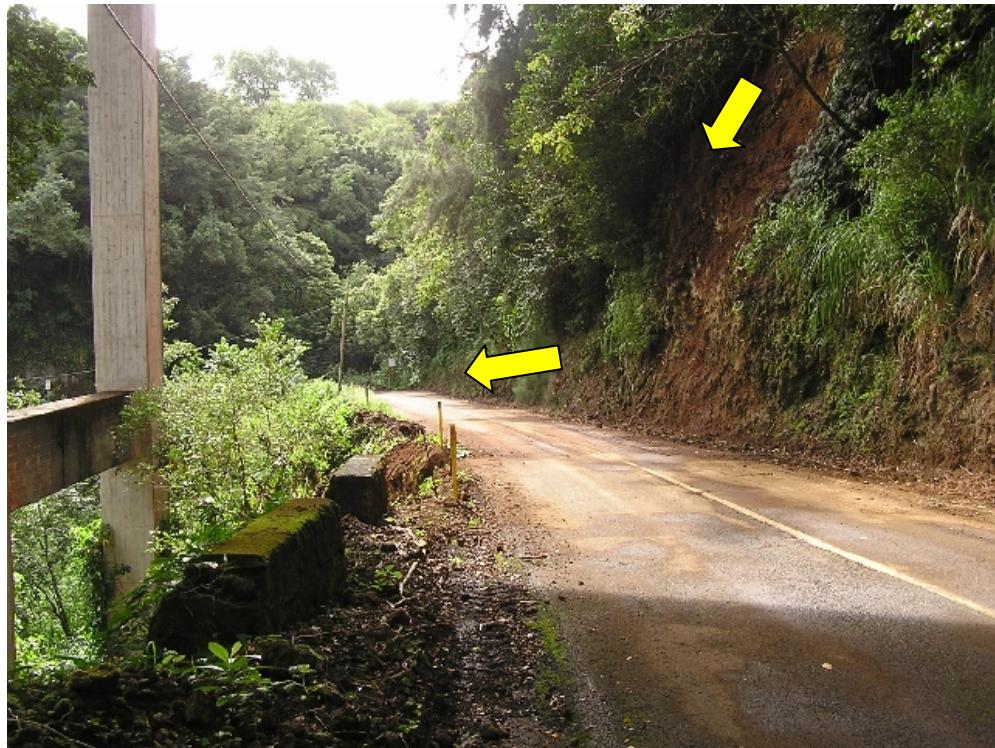
Many small slides of soil were observed during the reconnaissance, although the majority of these were generally of a few cubic meters in volume only. It is unknown what proportions of the observed failures were directly related to the earthquakes; subsequent common, and frequently heavy, tropical rainfall; and, the combination of these factors. Many road cut soil slides were observed to have occurred within larger and older failure features. As indicated above, soil slopes were generally inclined as steeply as rock cuts, greater than 45 degrees (Figure 25).

Figure 25. Location 4, old Hwy 11 near Oōkala, Modern Hwy 11 viaduct above. As evident from red stains in road, soil failed onto and across across Road (arrows) from very steep road cut; typical of many such slides along this road.

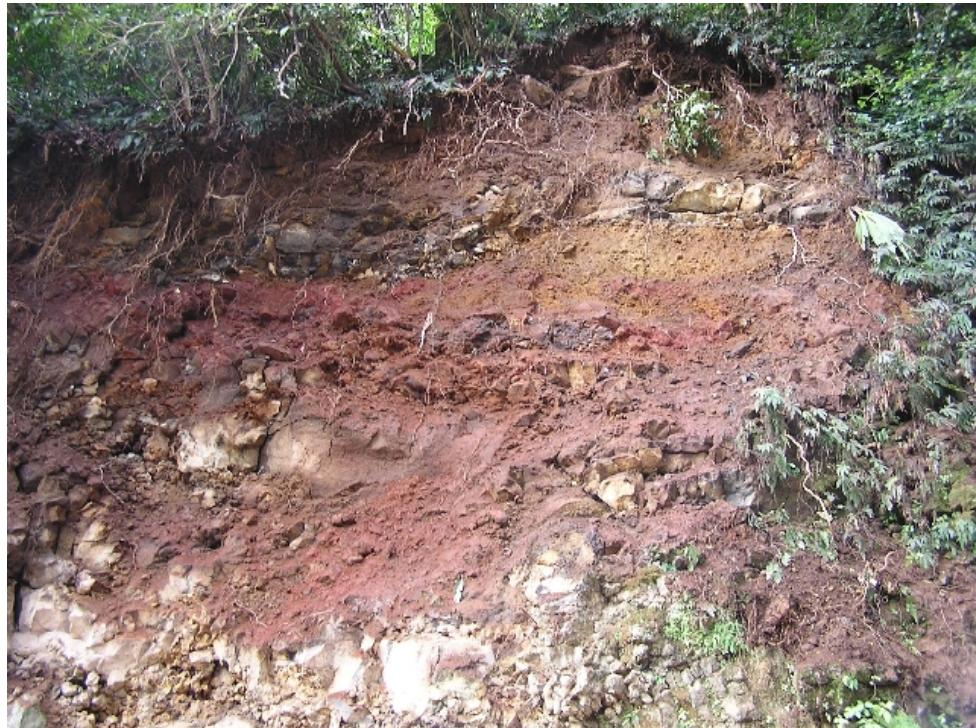
Composite slopes, where soil overlay rock or weathered rock, generally showed failure of the soil only (Figure 26). Where the soil/rock profile varied laterally at road cuts, failures predominated in the soil sections.

Figure 26. Location 4: old Hwy 11 near Oōkala. Failure of soil above rock. Note inclusions of corestone rocks within soil.

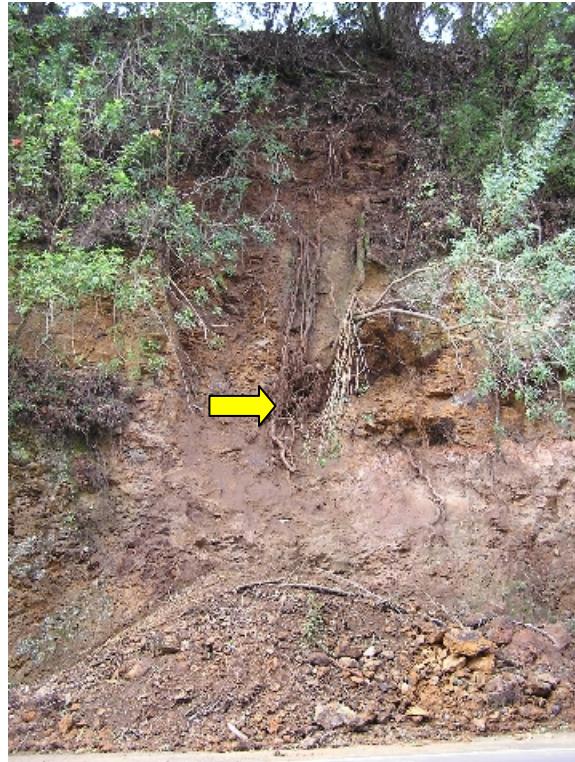
Weathered rock was often found to have failed along fractures occupied by tree roots. Where slopes had been stable long enough for tree roots to take hold in fractures, sections of the slopes peeled off to expose the roots (Figure 27, and Figure

Figure 27. Location 16, Near Kapa'au (Kohala), Hwy 270. Tree roots (arrowed) within relict rock mass fractures degraded the stability of road cuts in soil.

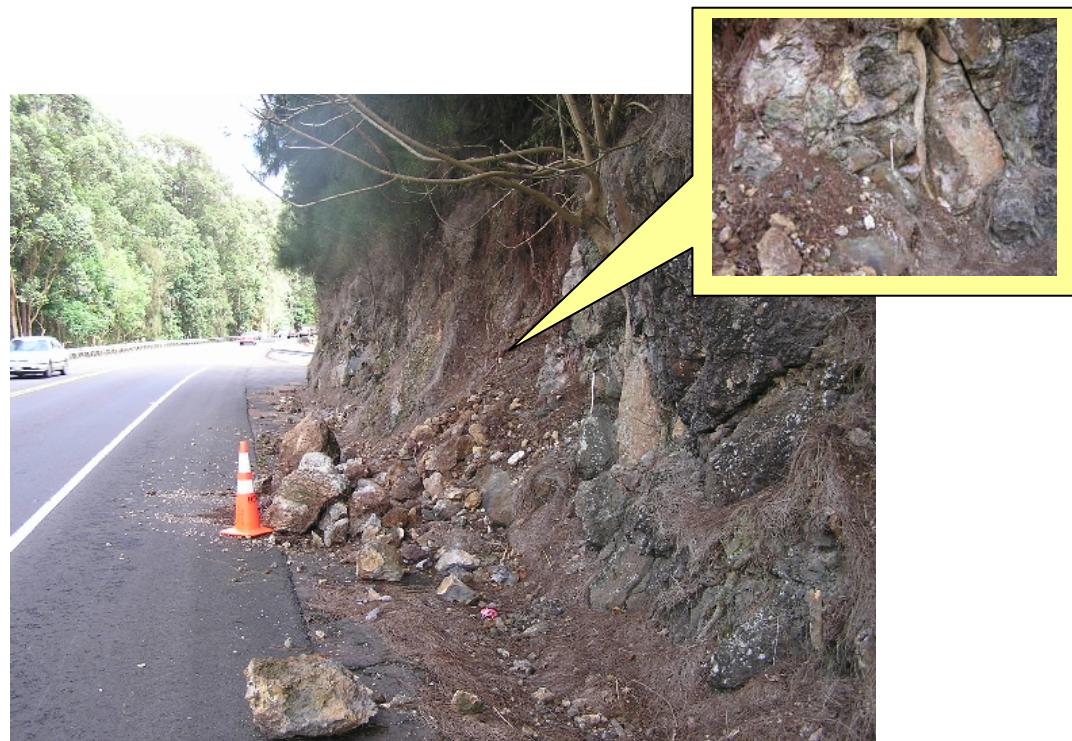
Figure 28. Location 9, Hwy 19 near Honoka'a. Weathered rock. Fractures occupied by tree roots, as shown in insert.

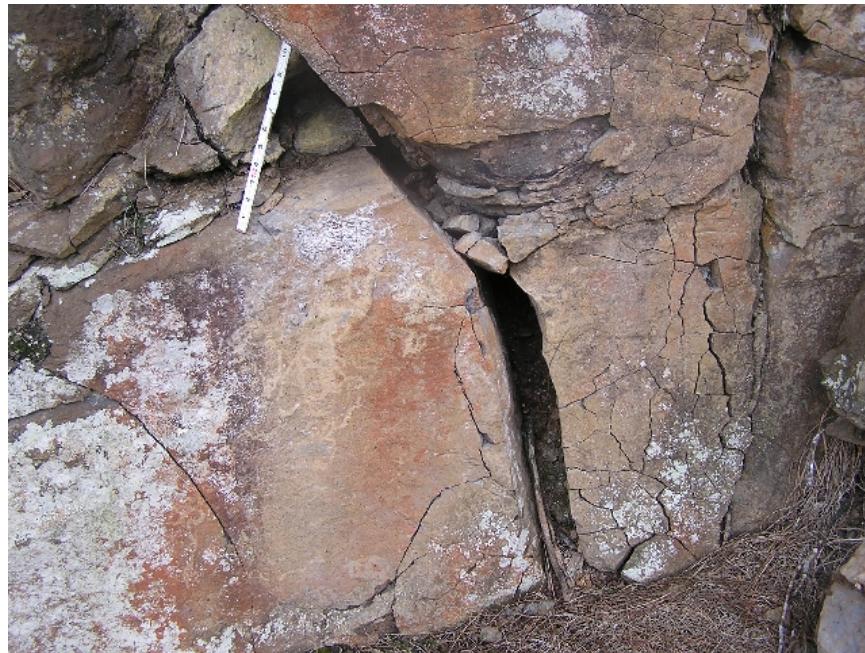
Figure 29. Location 9, Hwy 19 near Honoka'a. Wide fracture likely not caused by earthquake- note debris and tree root.

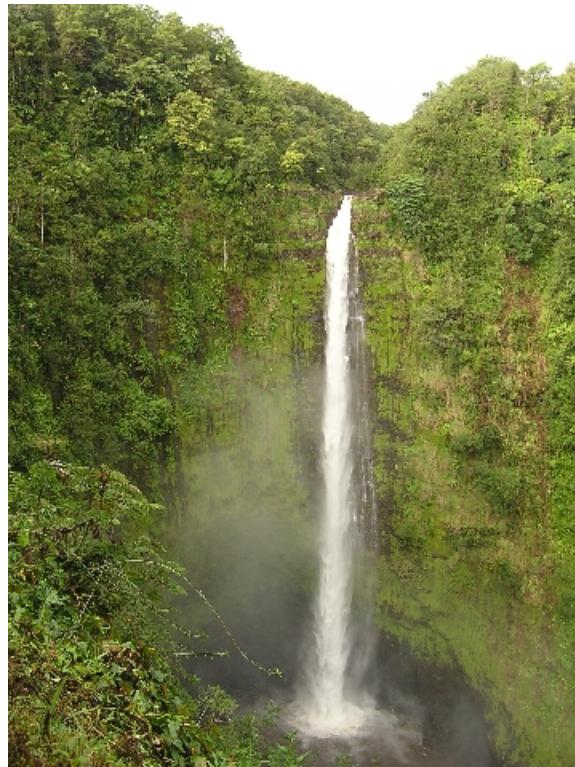
Apparently recent slides were observed on the cliff face of the Akaka Falls (Figure 30). Other earthquake effects at the State Park property were apparently limited to fallen trees and damaged hand railings.

Figure 30. Location 2, Akaka Falls, Hamakua Coast. Scars in the cliff face may not be attributable to the earthquakes.

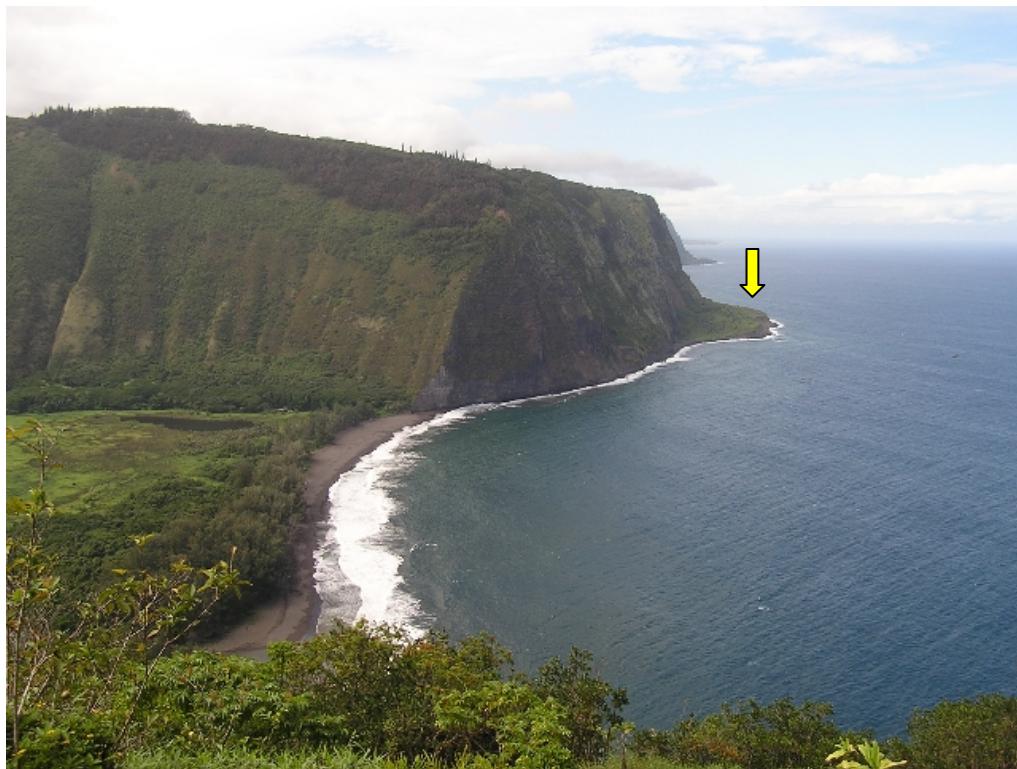
Figure 31. Location 8, Waipi'o Valley cliffs. Debris from an older slide (arrow) intrudes into the sea in the background. Scars in the closer, truncated spur are apparently not a result of the earthquakes since the water is not muddy.

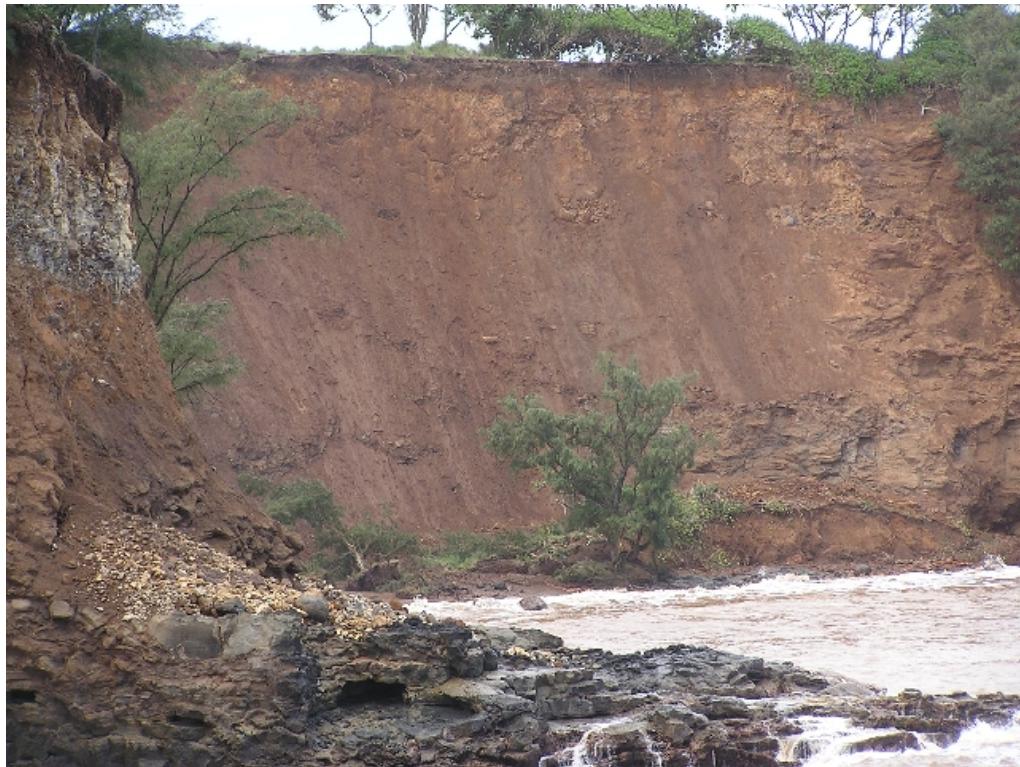
Figure 32. Location 19, Kēōkea Bay. Cliffs failed during the earthquake with displaced trees at base of slope and slide scars.

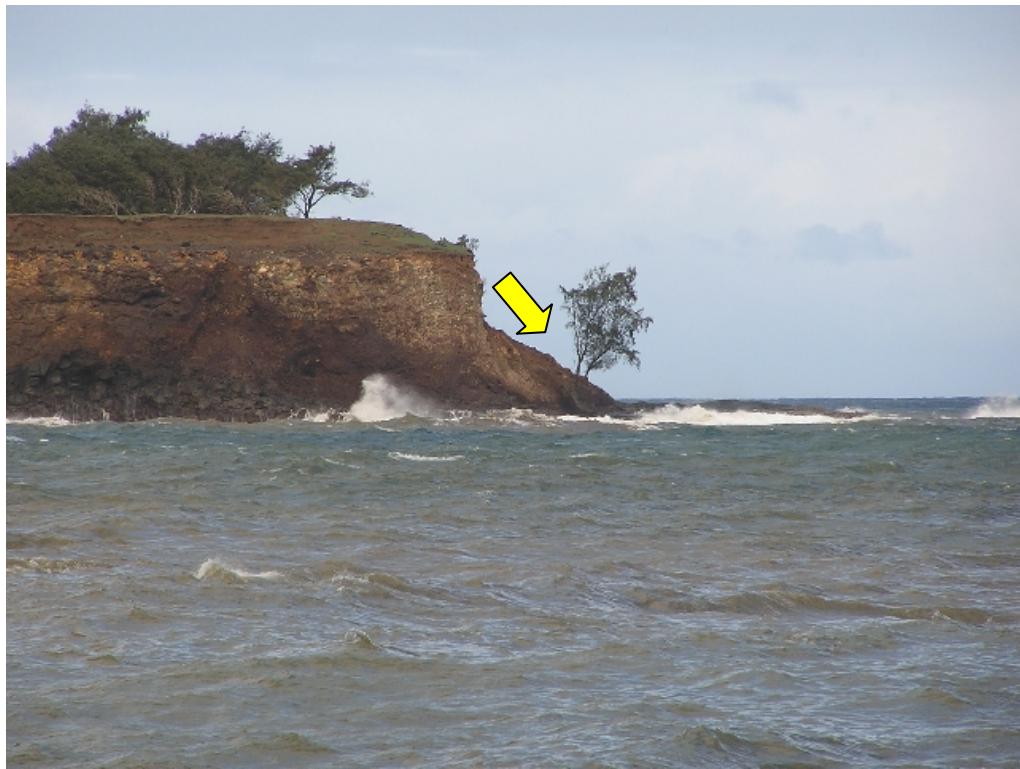
Figure 33. Headland to the northwest of Location 19, Kēōkea Bay. Cliff top slid into the ocean, indicated by the displaced tree and the mostly submerged toe debris.

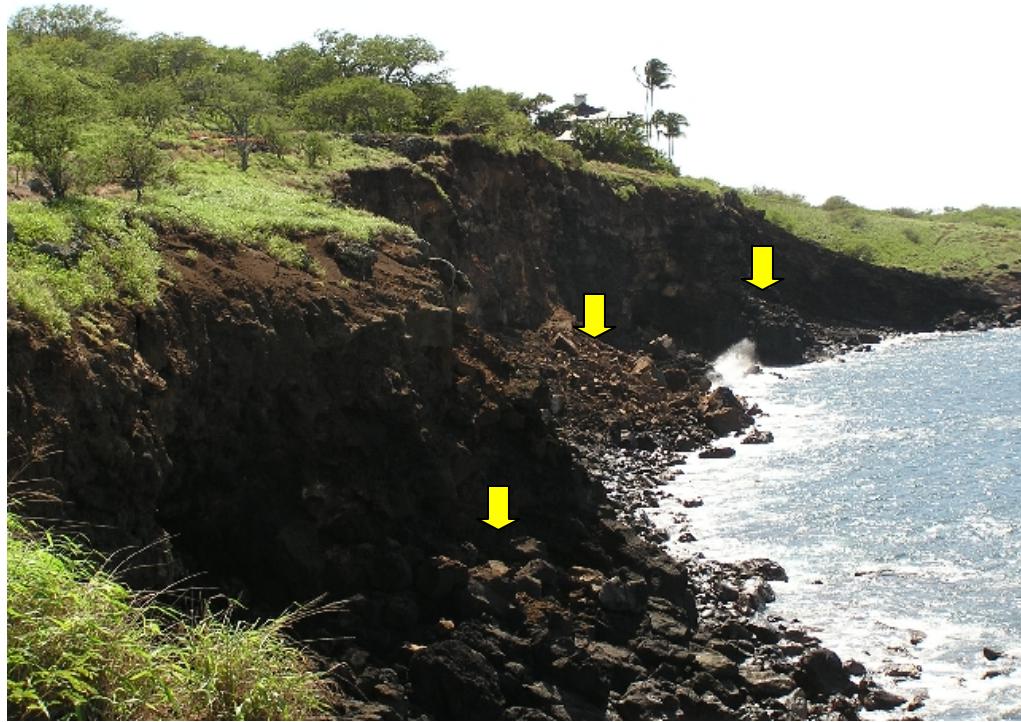
Figure 34. Location 23, failed cliffs (arrowed) south of Honoipu Landing (Ala Kuakini Trail).

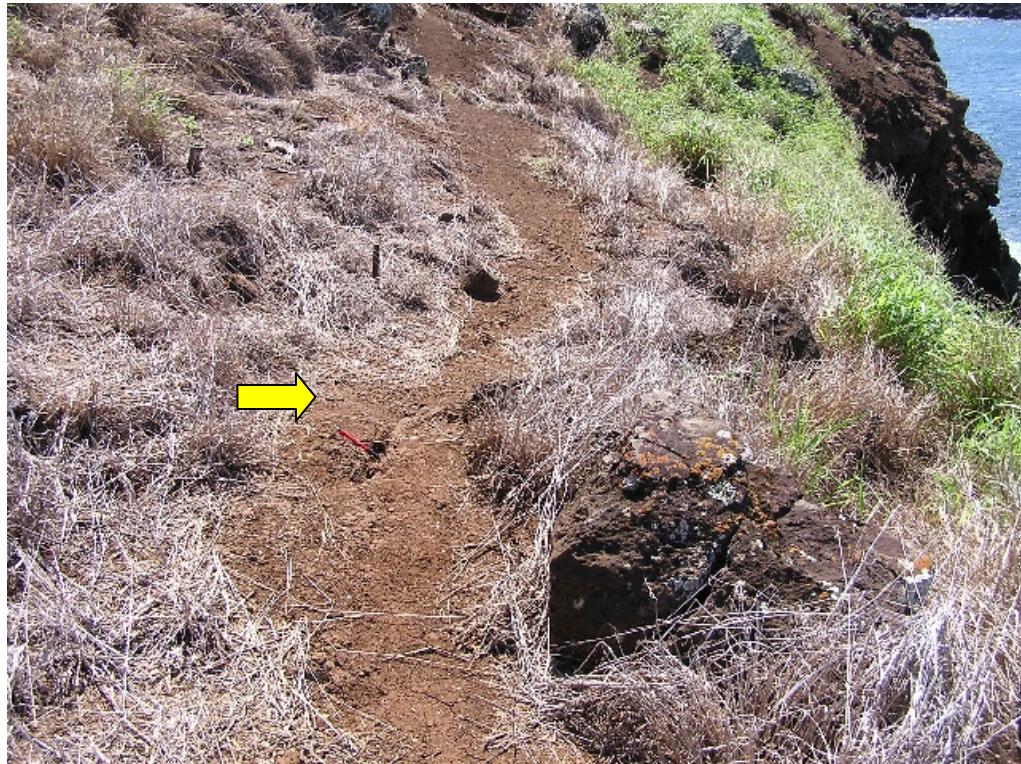
Figure 35. Location 23, Ala Kuakini Trail. Tension cracks behind cliff top (arrowed) in foreground.

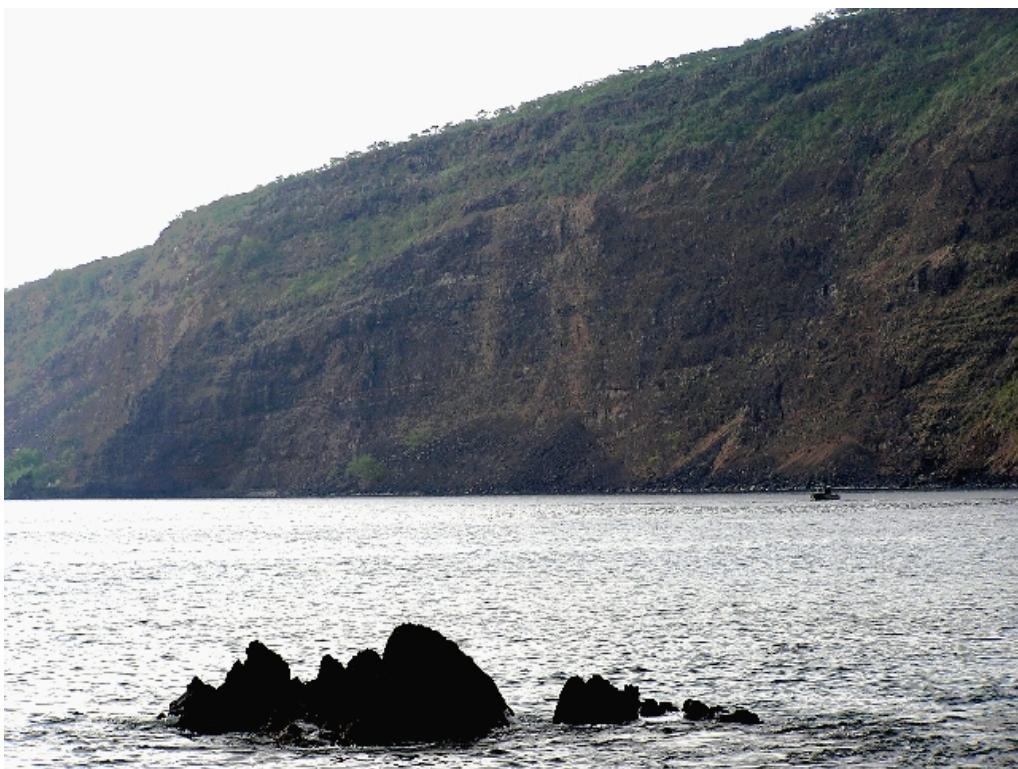
A dramatic earthquake-triggered landslide occurred at Kealakekua Bay (Figure 36), near the Captain Cook Monument, south of Kailua-Kona from the Pali Kapu o Keōua, a fault trace and the head scarp of the Alikā mega-landslide that occurred about 100,000 years ago. The area seaward and landward of the cliffs and shore, including nearby roads and hiking trail, were closed by the State because of unstable ground and the risk of future landslides. Consequently the area was not investigated during the reconnaissance.

Figure 36. Location 36, Napo 'opo 'o, facing the Pali Kapu o Keōua, a fault/mega-landslide scarp.

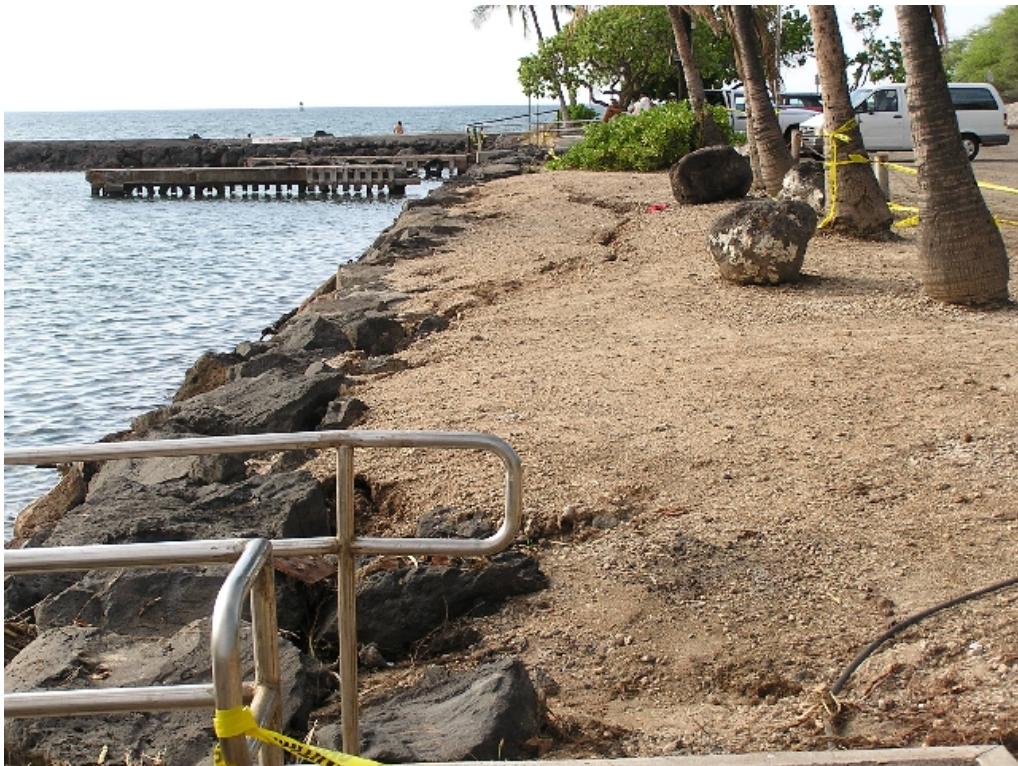
Figure 37. Location 27, Kawaihae Small Boat Harbor, showing arcuate ground crack resulting from lateral spreading.

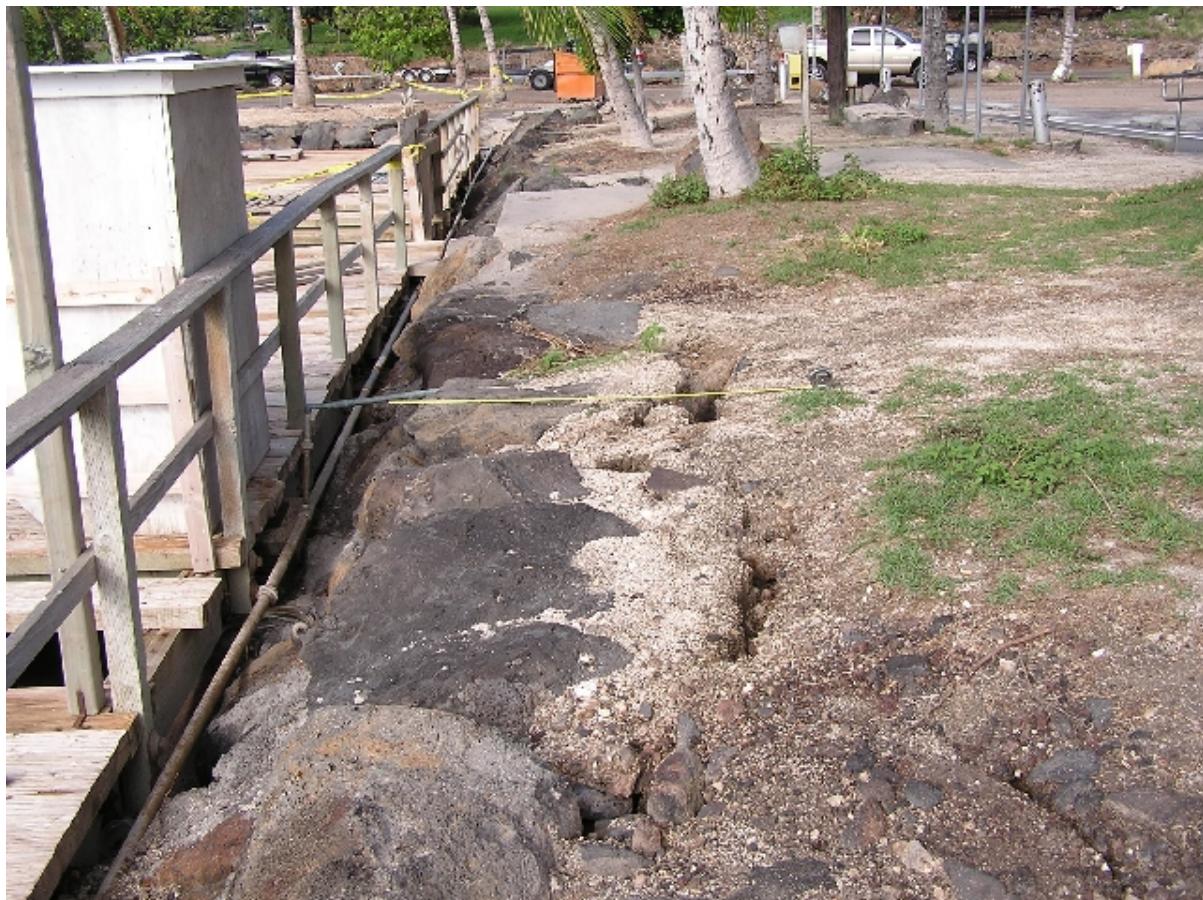
Figure 38. Location 27, Kawaihae Small Boat Harbor. Lateral spreading, and damage to dock. Liquefied sand was ejected from the ground crack (white sand).

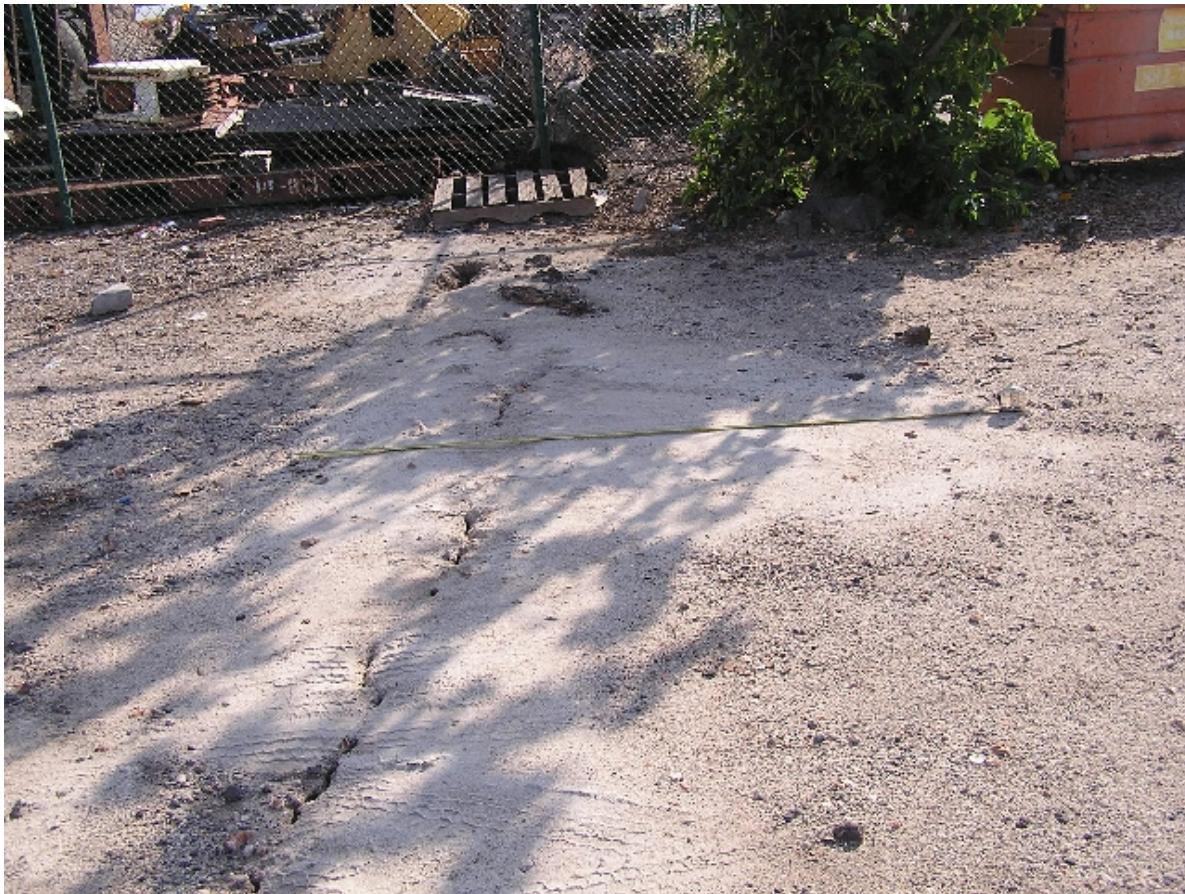
Figure 39. Location 27, Kawaihae Small Boat Harbor parking lot, adjacent boat yard at south side. Liquefied (white) sand was ejected from wide ground crack during the earthquake shaking.

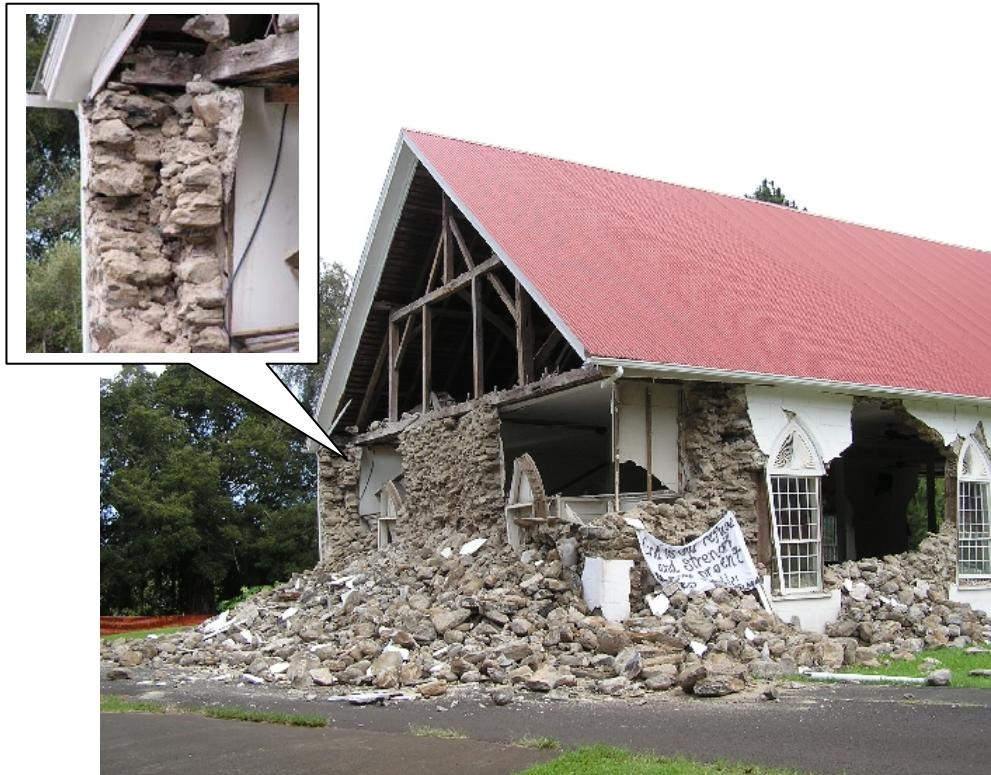
Figure 42. Location 21, Kalāhikiola Congregational Church, Kapa'au. Weakly cemented stacked rock walls (inset) failed dramatically.

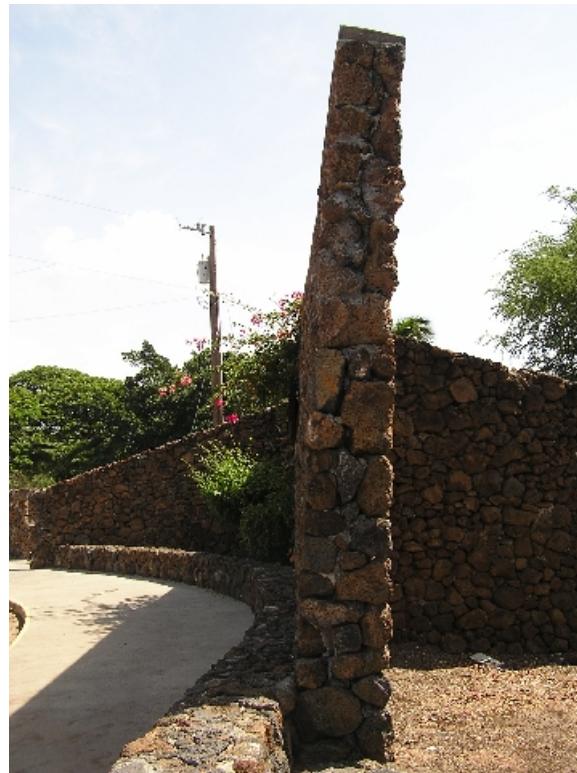
30	Spencer Beach Park, south of Kawaihae	20.0245	-155.8226	Deformed cemented stacked rock block wall	Bent free-standing rock wall; formed from two panels of grouted rock blocks. Bending and block missing near base: evidence of recent EQ damage? No other deformed walls seen, but no other wall are free standing.
31	Mauna Kea Hotel South side	20.0040	-155.8237	Structure damage	Extensive EQ damage at south end of building; hotel subsequently closed. Terrain flat.
32	Hwy 19, Queen Ka'ahumanu Hwy	19.9570	-155.8260	Road cut failure	Cut slopes to 90 degrees. Failures typical of raveling a'a clinker; undermined massive blocks failed into highway
33a	Hulihe'e Palace, Kailua Kona	19.6393	-155.9944	Structure failure	Cracks at exterior; could not access property.
33b	Moku'aikua Church, Kailua- Kona	19.6397	-155.9942	Structural failure of cemented rock walls; and intact stone boundary walls	Cracks at exterior, recently repaired; grouted rock masonry; intact rock boundary walls in Hawaiian rock wall style. Intricate arrangements of blocks of walls provide intimate block-to-block contacts.

Figure 43. Location 30, Spencer Beach Park, south of Kawaihae. Apparent earthquake damage of partially mortared rock wall: wall is bent.

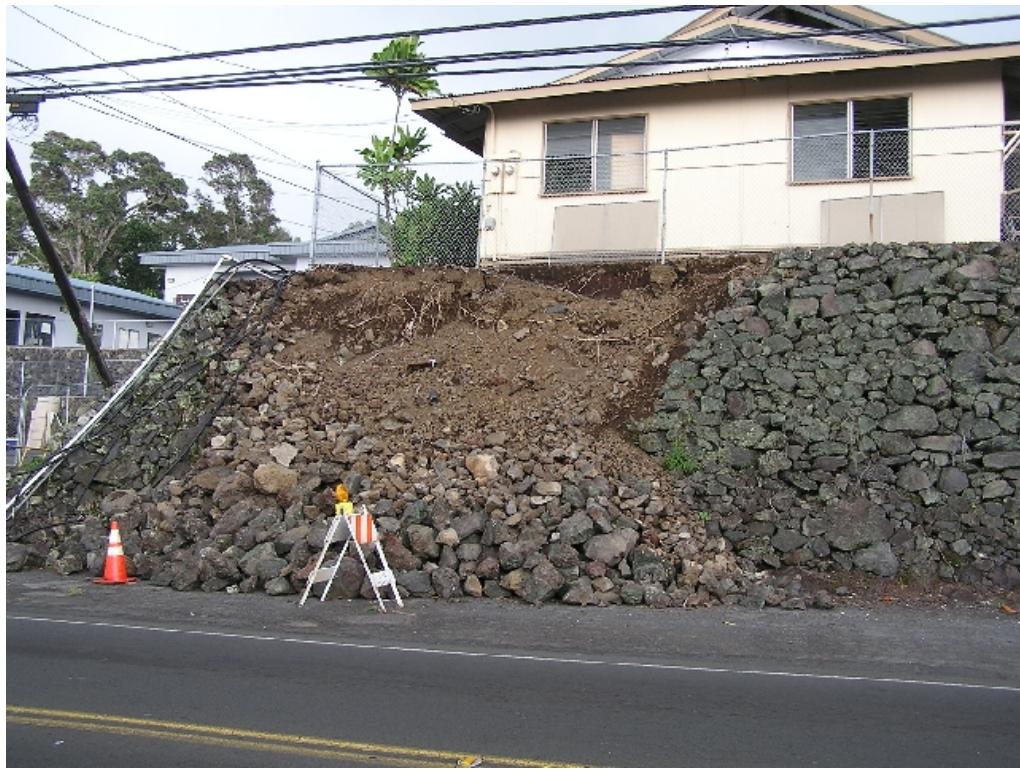
Figure 44. Location 35, Captain Cook. Failed stacked rock retaining wall. 3

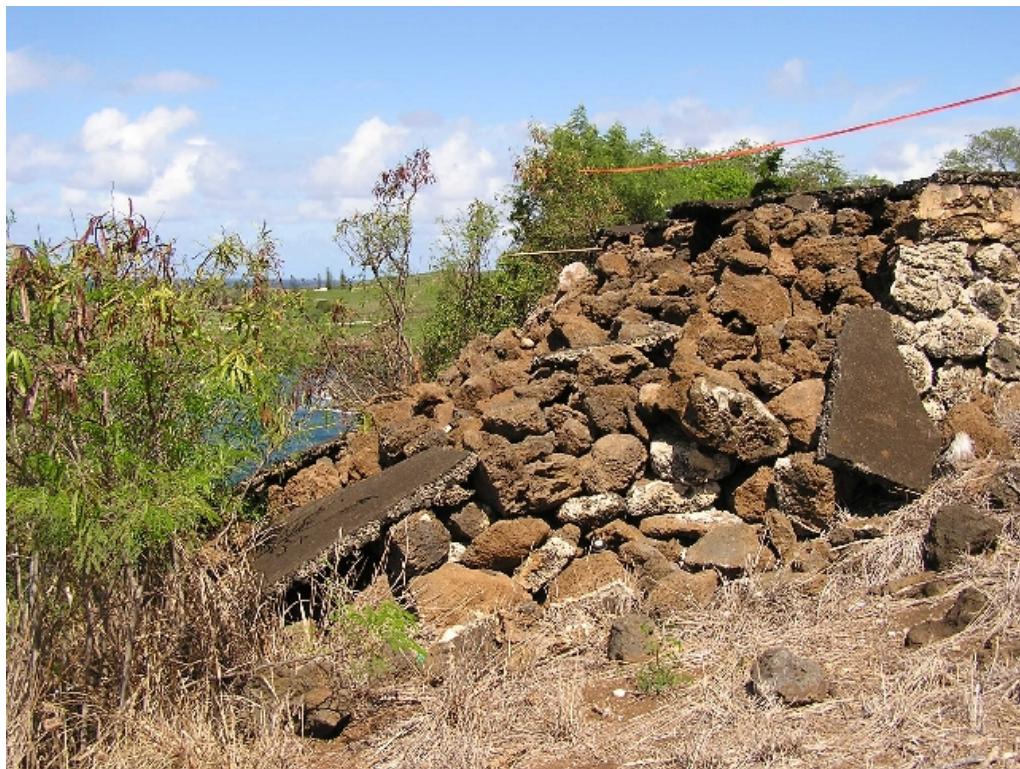
Figure 45. Location 23. Collapse of dry stacked rock wall supporting paved parking area for shoreline access at Puakea Ranch end of trail to Honoipu Landing, due to cliff failures undermining wall foundation.

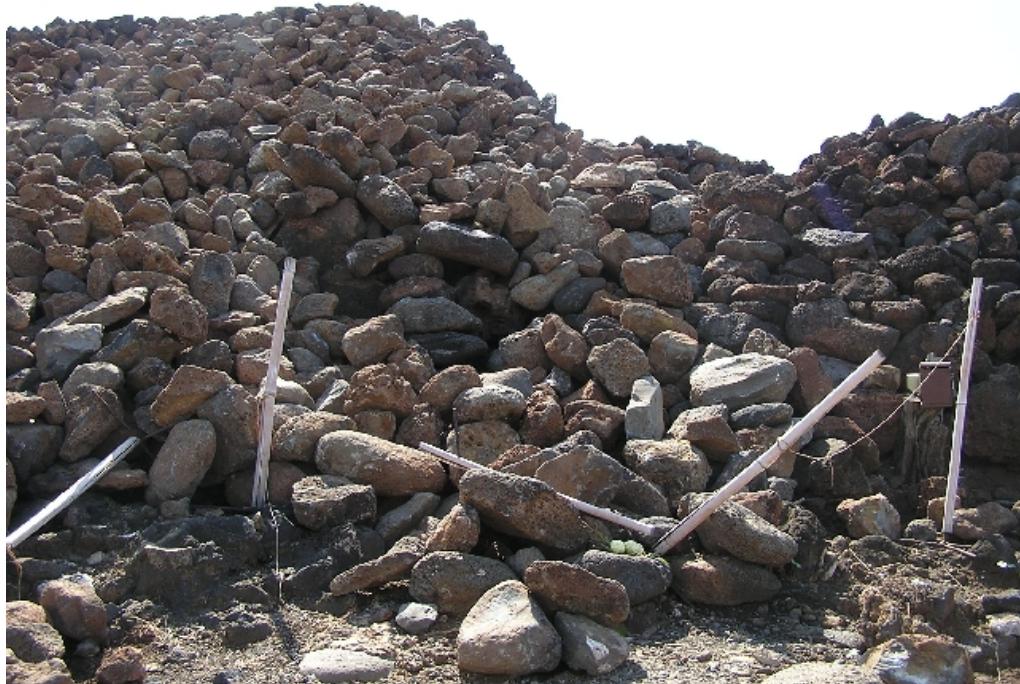
Figure 49. Location 29, Pu'ukoholā heiau, north side: Earthquake caused collapse of access step structure.

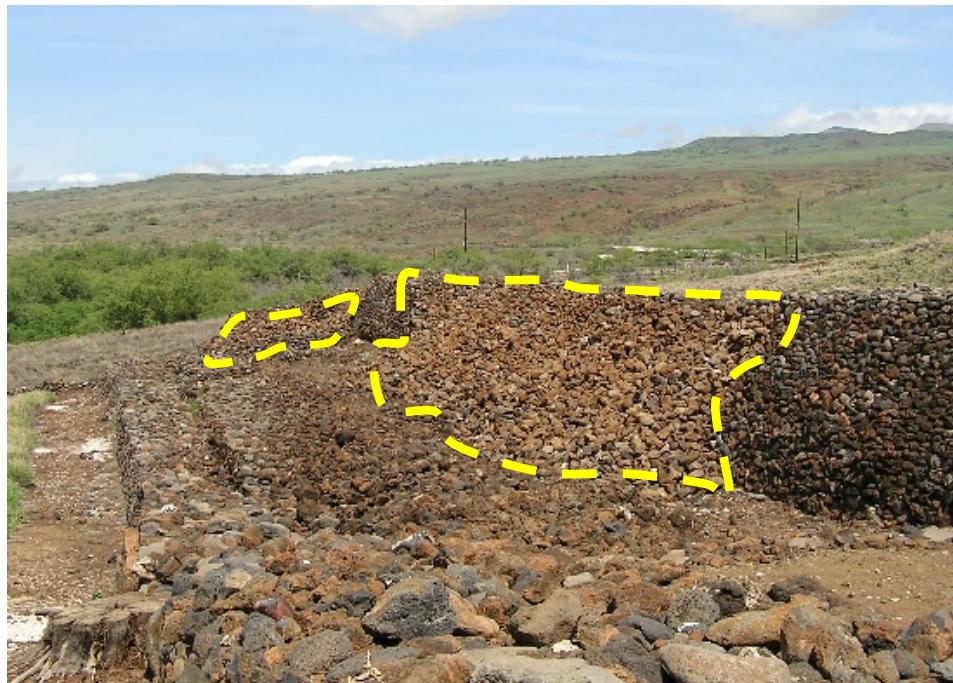
Figure 51. Location 29, Mailekini heiau. Significant raveling and slumping of interior face of the eastern wall (outlined).
