Geological Engineering Reconnaissance of Damage Caused by the October 15, 2006 Hawaii Earthquakes

Edmund W. Medley, Senior Consultant, Geosyntec Consultants Inc., Oakland, CA, USA, Email: emedley@geosyntec.com

KEYWORDS: Geological Engineering, Hawaii, Earthquake Damage, Rock Mass, Basalts, Rock Block Structures

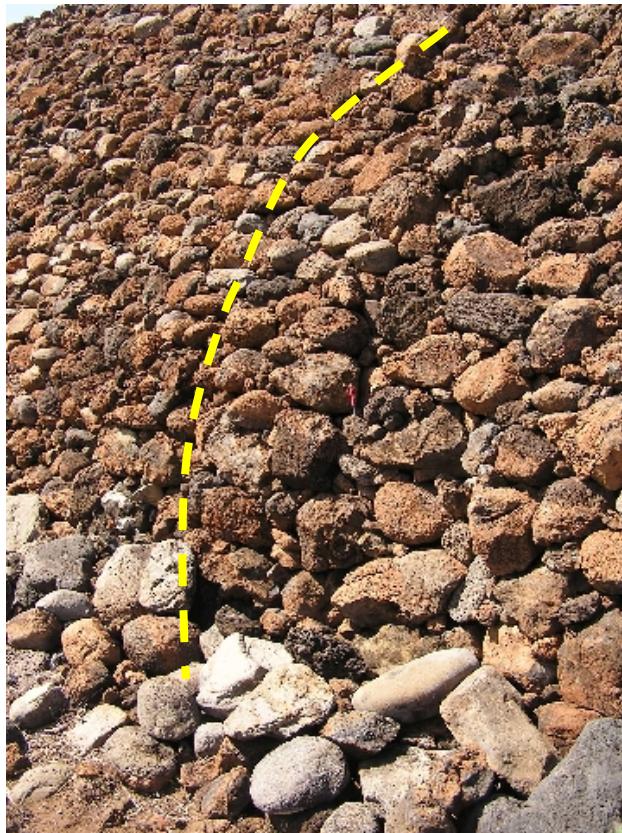
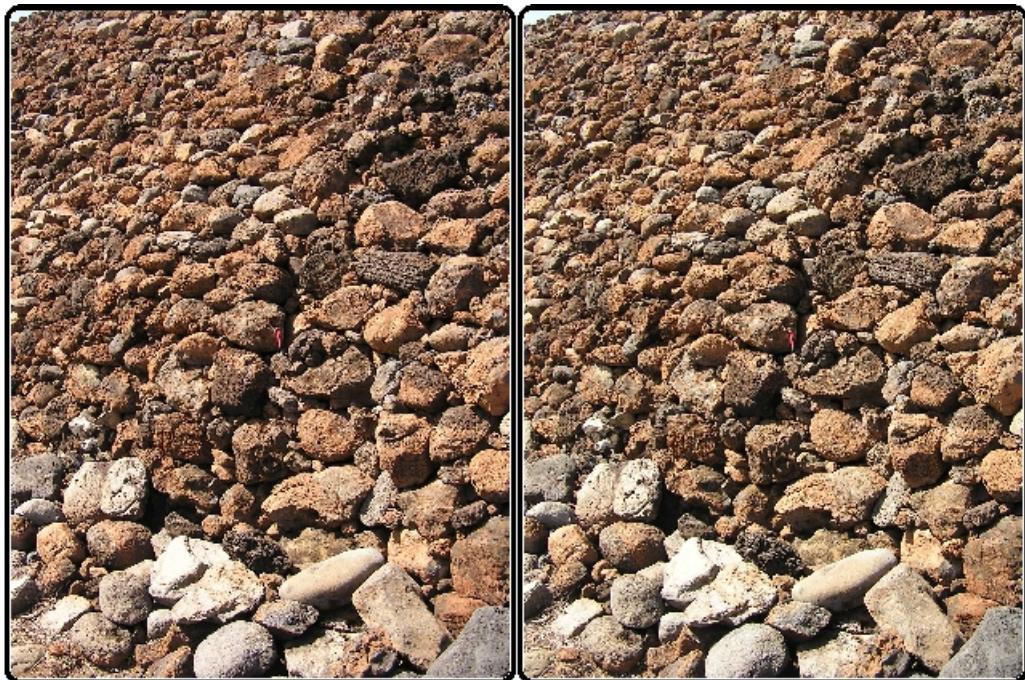
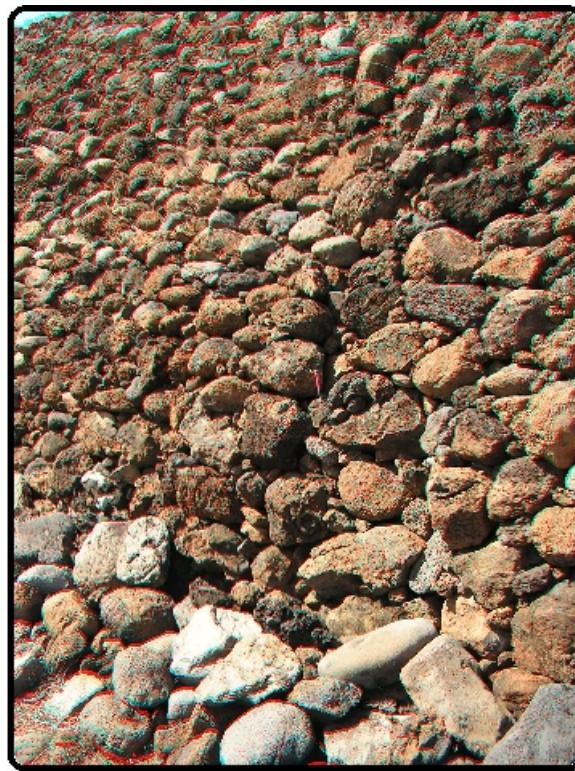
Figure 53. Location 29, NE corner Pu'ukoholā Heiau. Bulging of rock face approaches 90 degree inclination as indicated by yellow line. Bulge is clearly seen in 3-D stereo versions of Figure 54 and Figure 55.

Figure 54. Location 29, bulge at NE corner of Pu'ukoholā heiau. 3-D stereo pair version of Figure 53.

Figure 55. Location 29, bulge at NE corner of Pu'ukoholā heiau.
3-D anaglyph stereo version of Figure 53.

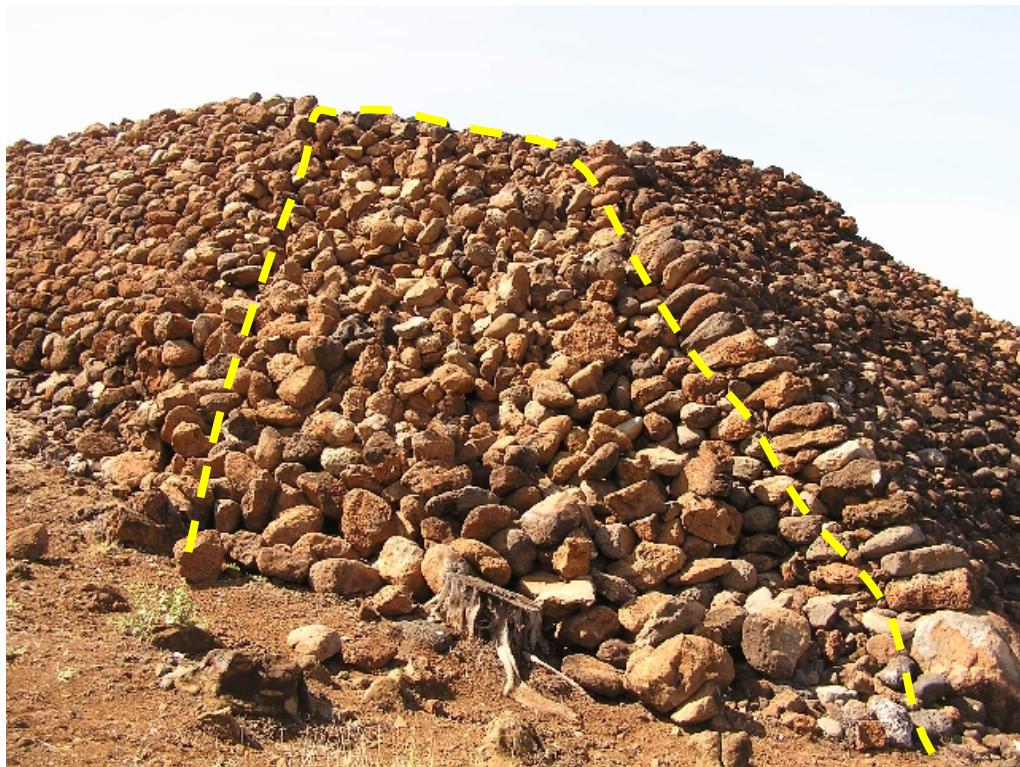
Figure 56. Location 29, Pu'ukoholā heiau, northeast corner. Dashed lines indicate boundary of ravel zone.

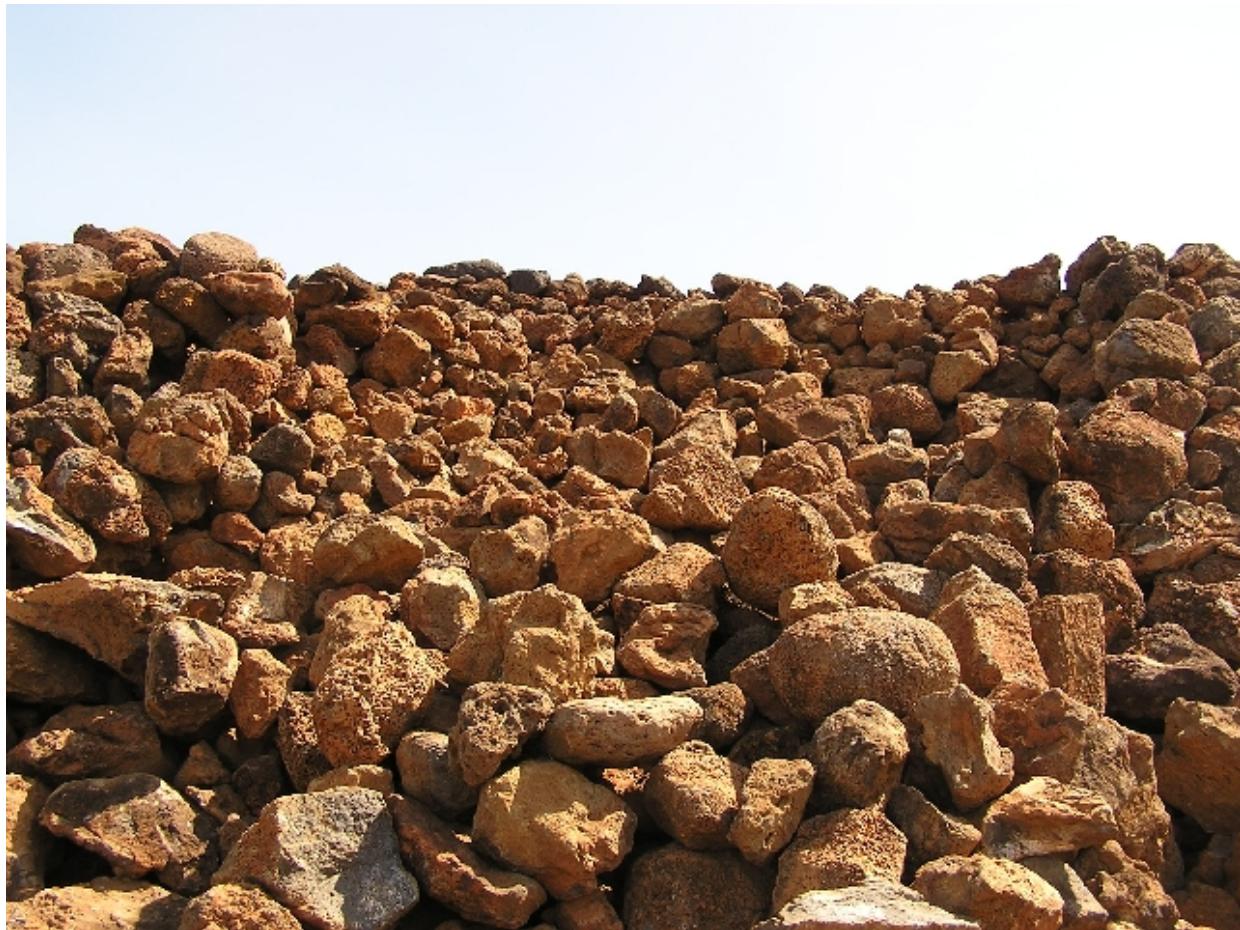
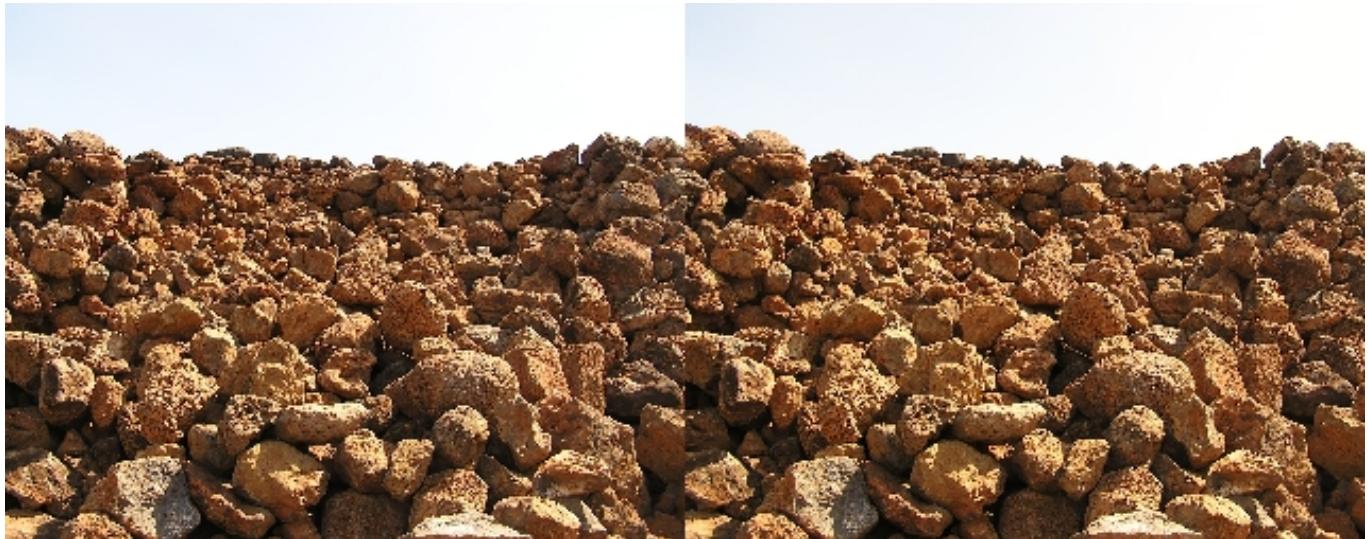
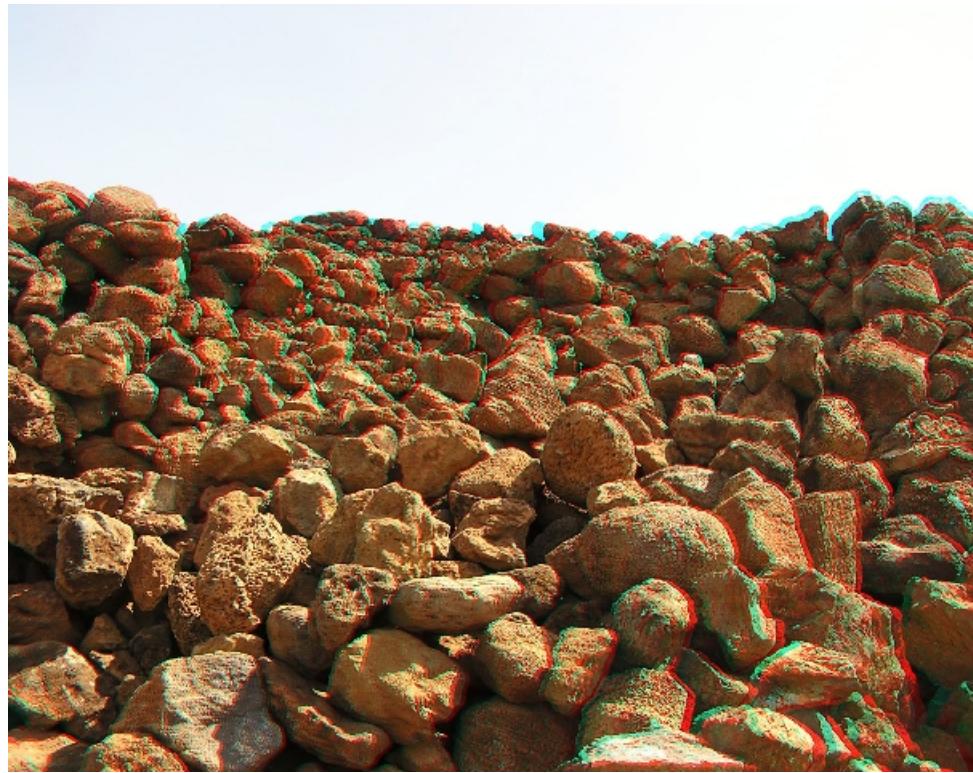
*Figure 57. Location 29, slump failure in high rock wall of Pu'ukoholā heiau, west side.
See 3-D stereo images of Figure 58 and Figure 59.*

*Figure 58. Location 29, slump failure in high rock wall of Pu'ukoholā heiau, west side.
Stereo pair 3-D version of Figure 57.*

Figure 59. Location 29, slump failure in high rock wall of Pu'ukoholā heiau, west side.
3-D anaglyph stereo version of Figure 57.

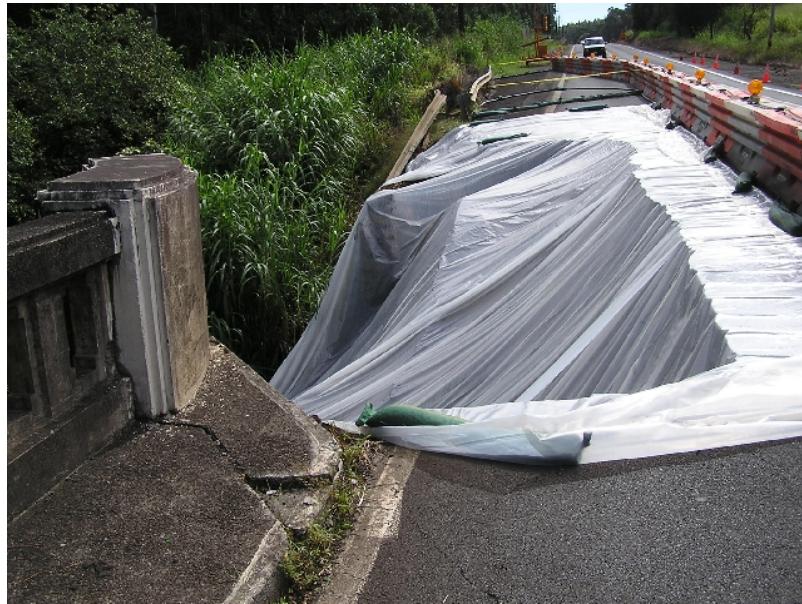
*Figure 61. Location 6, Mile Post 35, Hwy 11 near Pa'auilo.
Failure of fill at east side of southern approach to bridge.*

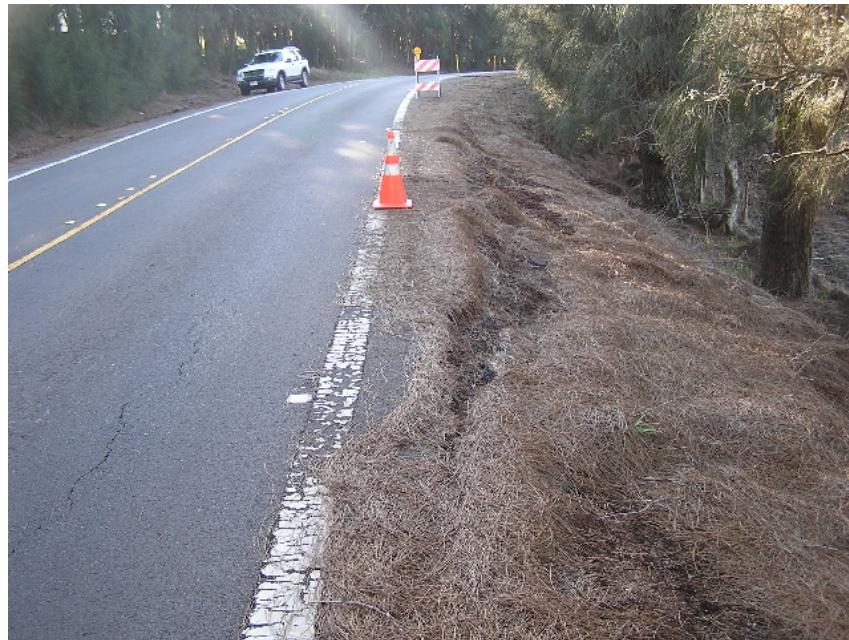
Figure 62. Location 15, north of Mile Post 9.4 Hwy 250. Slump failure of embankment on down slope side of road.

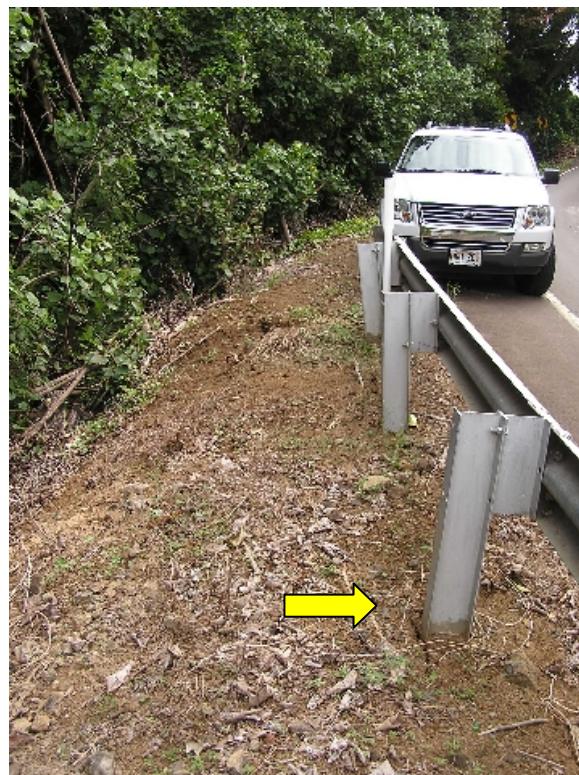
3. At the crest of a steep embankment near Makapala on Hwy 270 (location 18), tension cracks and a head scarp about 0.3 m high were observed (Figure 63). The high embankment was on the down slope side of the road, and had side slopes of greater than 45 degrees.

Figure 63. Location 18, Hwy 270 near Makapala, down slope side. Arrow indicates tension cracks and short head scarp 30 cm high at crest of steep and high fill slope.

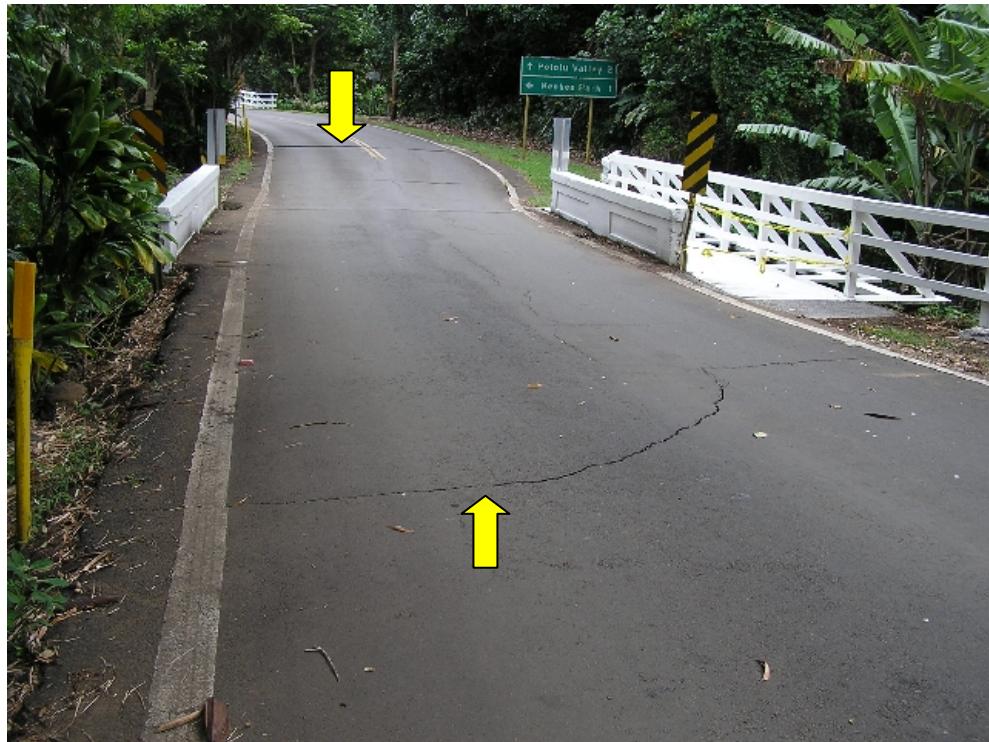
Figure 64. Location 20, bridge at approximately Mile Post 28, Hwy 270.
Asphalt pavement cracked at approximately the cut/fill transitions of underlying subgrade.

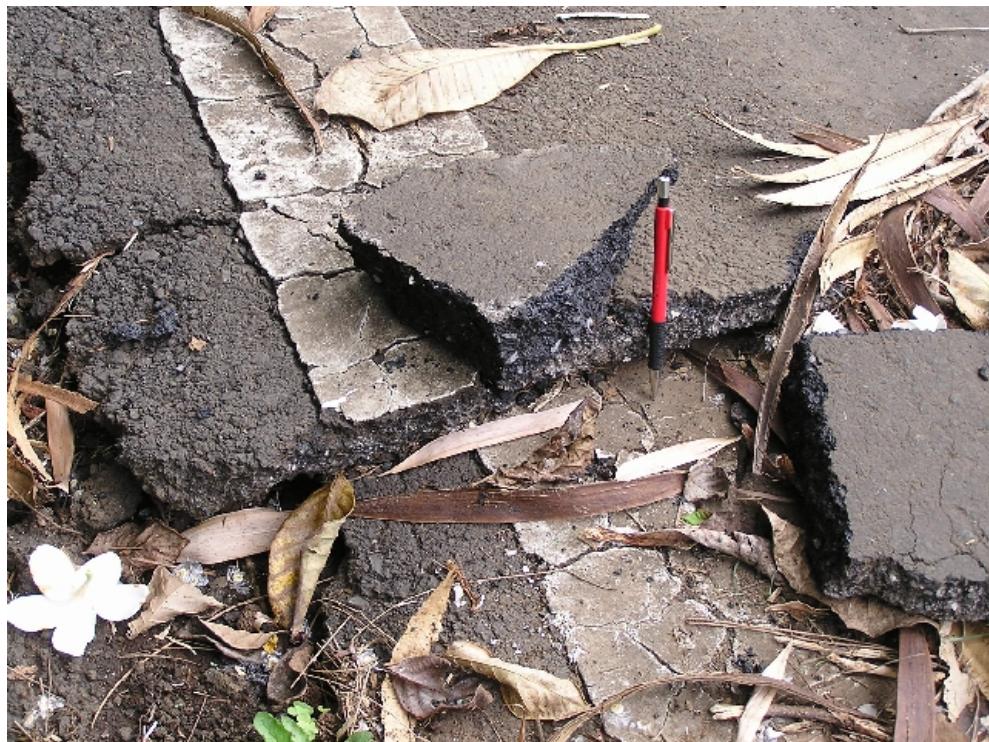
Figure 65. Location 20, bridge at approximately Mile Post 28, Hwy 270.
Thrusting of asphalt concrete pavement.

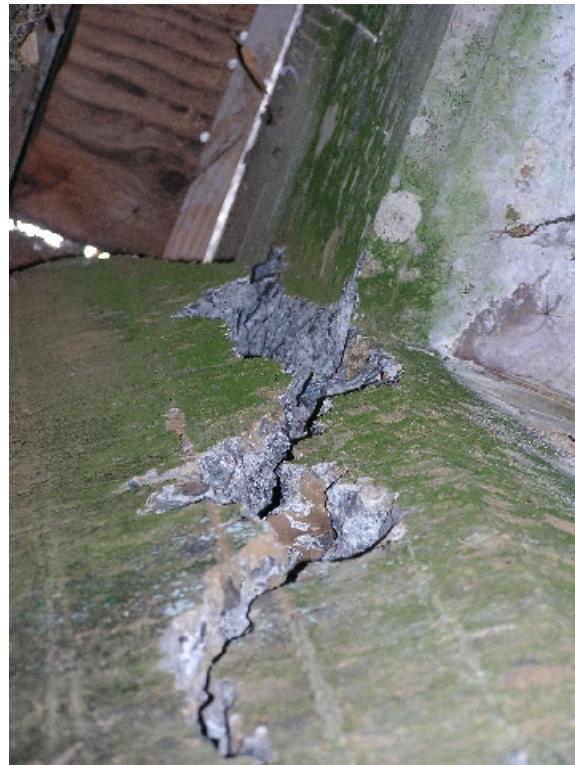
Figure 66. Location 20, bridge at approximately Mile Post 28, Hwy 270. At SW corner of bridge, looking upward at wooden plank sidewalk above. Fresh spalling of bridge abutment headwall at old, pre-existing cracks.

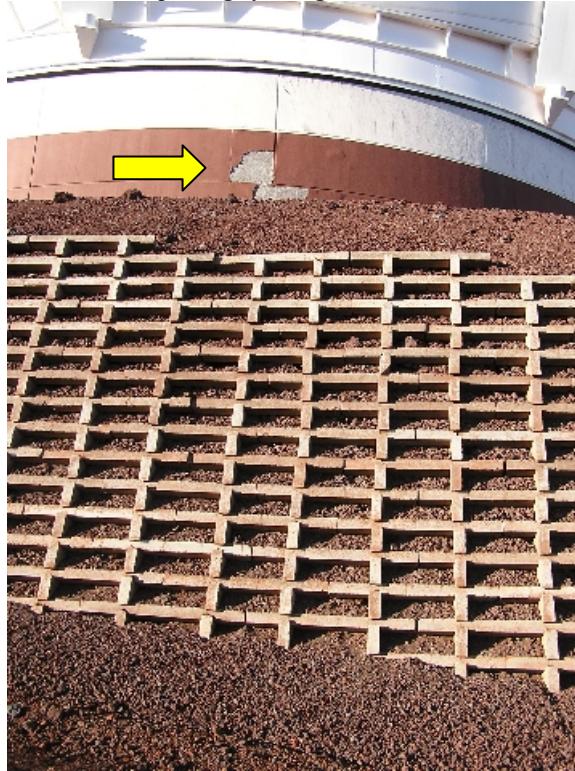
Figure 67. Location 28, Keck Observatory, Mauna Kea summit. No apparent distress to high embankment beside the observatory. Spalled stucco evident at two places on the exterior wall of the building (one arrowed).
