Rockfall and Subsidence on Mumbai-Pune Expressway

Reference: Kumar, K., Prasad, P.S., Mathur, S., Kimothi, S., (2010). Rockfall and Subsidence on Mumbai -Pune Expressway. *International Journal of Geoengineering Case Histories*, <http://casehistories.geoengineer.org>, Vol. 2, Issue 1, p.24-39. doi: 10.4417/IJGCH-02-01-02.

investigations carried out to assess the probable causes and the remedial measures recommended in order to control the rockfall and subsidence at km 41 on the Mumbai-Pune Expressway.

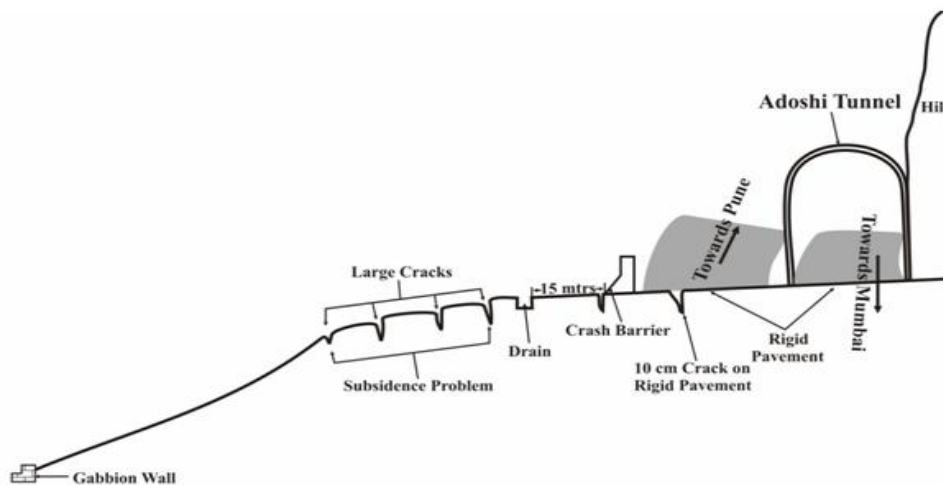
The subsidence portion (Figure 1) is located at km 41 on the downhill side of the expressway, adjacent to Adoshi tunnel (which extends for 500 m along the expressway). Figure 10 shows the schematic diagram of the subsidence problem on the expressway. The annual rainfall in this area is 200–300 cm, and the present drainage measures are not sufficient to drain this amount of water effectively. During the rainy season, water causes significant damage to this road at four locations in the form of a waterfall. One is in the curved portion, the second one is in between the curve and entrance of the tunnel, the third one is above the tunnel and the fourth one is after the tunnel exit. Pipe culverts were provided to help drain out the water on this stretch of the road, but the gradient of these culverts is not proper. However, it was observed that the internal diameter of the pipes varies from 1 to 1.2 m. In the pipe culvert, two pipe sections 1.0 m in internal diameter are provided, and the remaining pipes are 1.20 m in internal diameter. Two 1.0 m diameter pipe sections are installed in between the 1.20 m pipe sections. The joint between the 1.0 m diameter pipe and the 1.2 m diameter pipe is not proper, and the gap between the two pipes is 30 cm (Figure 11). Remaining pipes are also not joined properly. During periods of heavy rain, water seeps through the joints and saturates the surrounding soil mass, thereby causing cracking between lanes (i.e., flexible and rigid pavement). The runoff from the pipe culvert and cross drains is draining directly onto the embankment surface (Figure 12). The rainwater scours the embankment soil, thereby causing the instability of the embankment. After the exit of the Adoshi tunnel, the gradient of the drain is not proper. As a result, water may stagnate and seep into the pavement through the existing weep holes. The rigid pavement (on the outermost side lane) subsided by 5 to 6 cm, and subsidence also has occurred in between the joint of fast track lane (middle lane) and the truck lane. The average width of a crack is 5 cm and the average length of a crack is 85 m (Figure 13). The surface between the crash barrier and the rigid portion has been paved with bitumen. The flexible portion or shoulder (bituminous surface) has separated from the rigid pavement; the depth of the crack is 50 cm (Figure 14).

Figure 10. Schematic diagram showing subsidence problem on the Mumbai-Pune expressway.
