Quarry-Induced Slope Instability at a Broadcasting Transmission Plant near Valcava, Lombardia, Italy

Monica Barbero, Assistant professor, Politecnico di Torino (Torino, Italy); email: monica.barbero@polito.it
Fabrizio Barpi, Assistant professor, Politecnico di Torino (Torino, Italy); email: fabrizio.barpi@polito.it

ABSTRACT: Since 2006, a broadcasting tower and ancillary buildings on the top of a hill adjacent to a large, active limestone quarry, in northern Italy near the village of Valcava, has been heavily damaged by ground deformation due to slope instability. In 2005, the quarry began to work the slope toward the broadcasting plant, releasing bedding planes that affected the tower site: a number of fractures occurred in the warehouse and in the ground around it, that grew particularly during significant rainfalls. In October 2006 a landslide occurred in the quarry area, close to the broadcasting site. In order to understand what induced the fracture process in the buildings and define a support system to stabilize the broadcasting site, a detailed geotechnical survey and a number of numerical slope stability analyses were carried out. One of the main goals of the paper is to

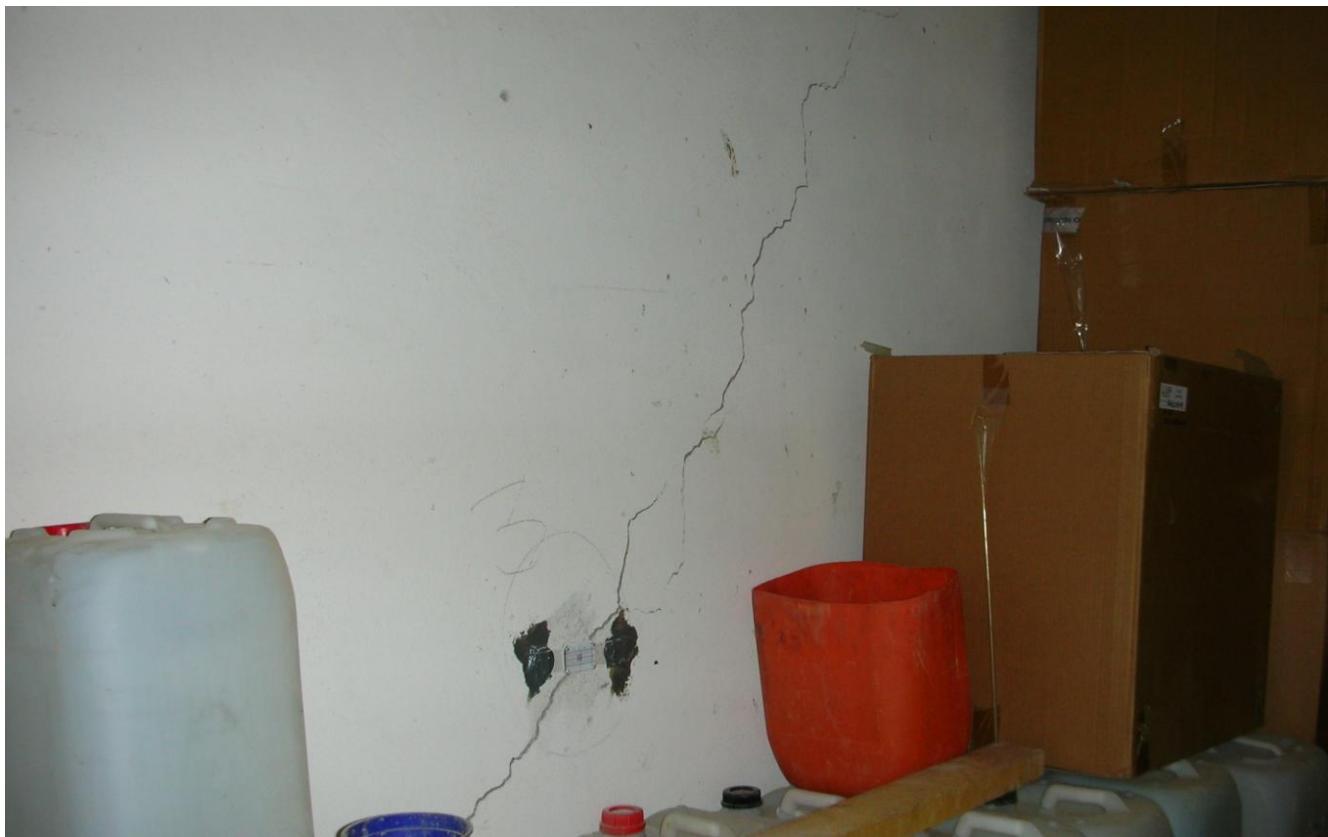
In 2005, quarry operations initiated at the slope toward the broadcasting tower. In May 2006, tension cracks developed in the ground at the top of the hill and many cracks appeared in the walls and floor of the building (Figures 2 and 3). The cracks were parallel to the slope face, suggesting a downward movement of the slope. In October 2006, after two days of medium-high intensity rains, a landslide with a volume of about 27000 m³ occurred in the pit (Figure 4 and 5) at a distance of about 45 m below the warehouse area (Figure 6) and the cracks in the warehouse and in the ground increased, the latter reaching openings of some centimeters. The intense rains of the winter 2006 quickened instability phenomena (Barbero et al., 2008).

Figure 2. Wall damage inside the warehouse.

As crack opening and spreading are important signs of the instability evolution, crack gauges were placed across the larger cracks observed in the warehouse and a continuous monitoring of lengths and openings was performed. Unfortunately, no measurements are available for the cracks that appeared outside the warehouse (tension cracks in Figure 6). The cracks in the warehouse appeared to become more frequent toward the slope in the landslide direction, suggesting that the down slope movement of the rock mass affects the foundation of the warehouse.

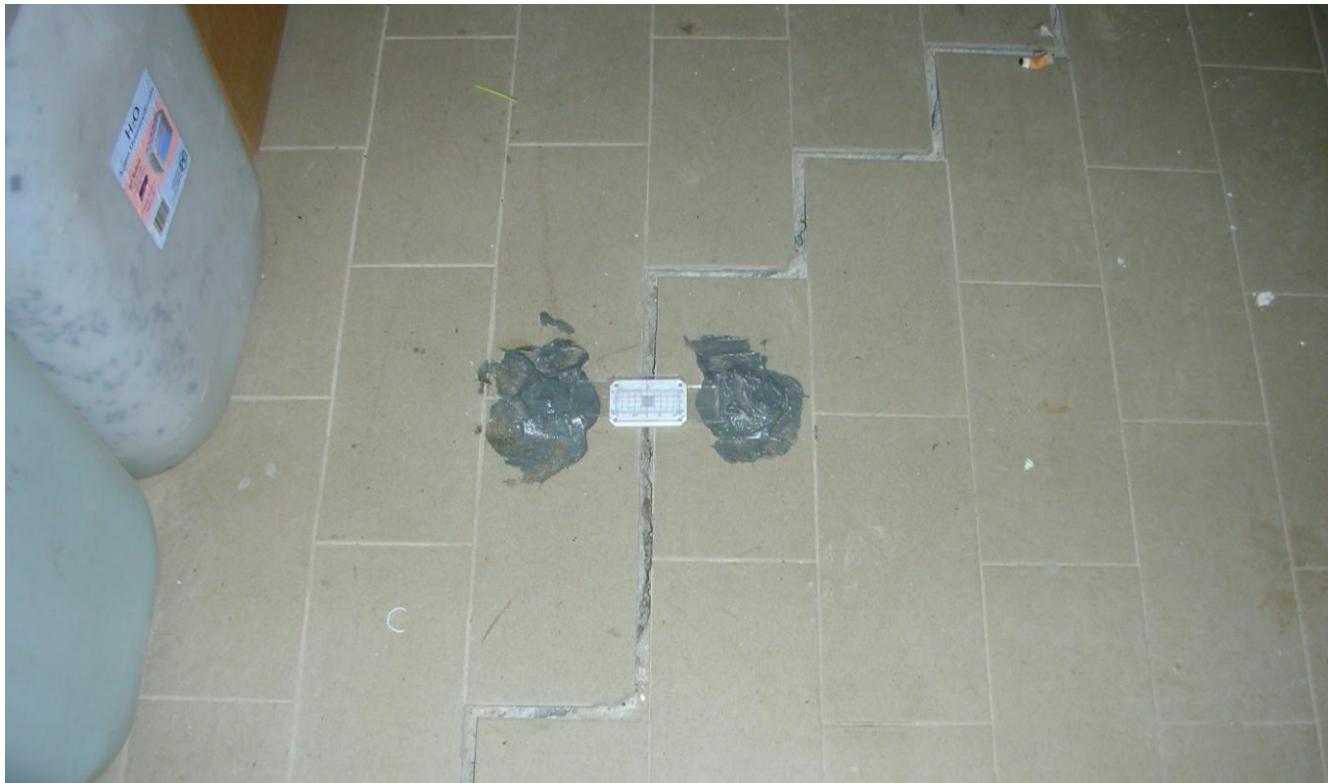
Figure 3. Floor damage inside the warehouse.

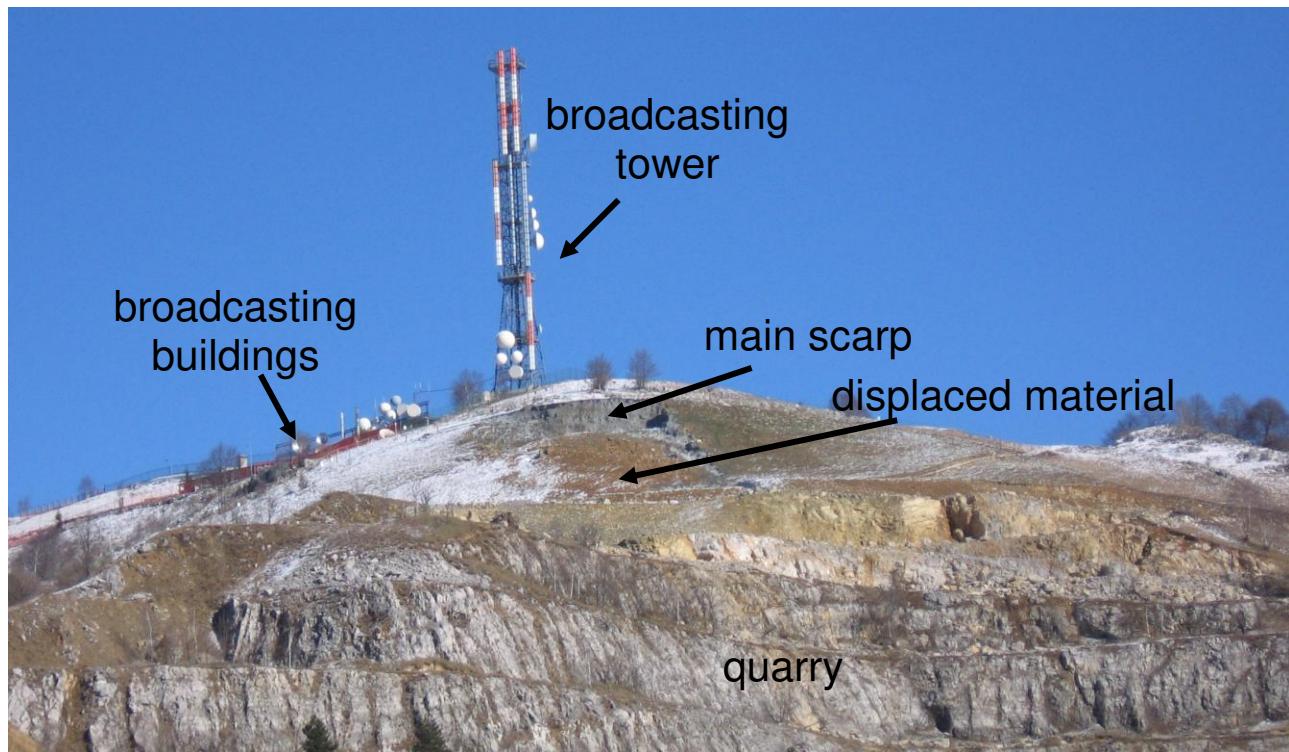
Figure 4. The landslide in the pit area.

3. Fault A marks the eastern boundary of the landslide in the pit area. This involves a 30 m slope height and has a crown length of about 35 m;
4. In the west side of the edge and in the toe of the landslide, many opened cracks were observed, suggesting that the instability phenomenon is not completed yet and potential landslide progression toward the plant is possible;

5. After the event, the landslide was entirely covered by a layer of sprayed-on concrete. In the edge of the landslide, many tension cracks developed with openings of a few centimeters in width. These confirmed that the slope is still moving.

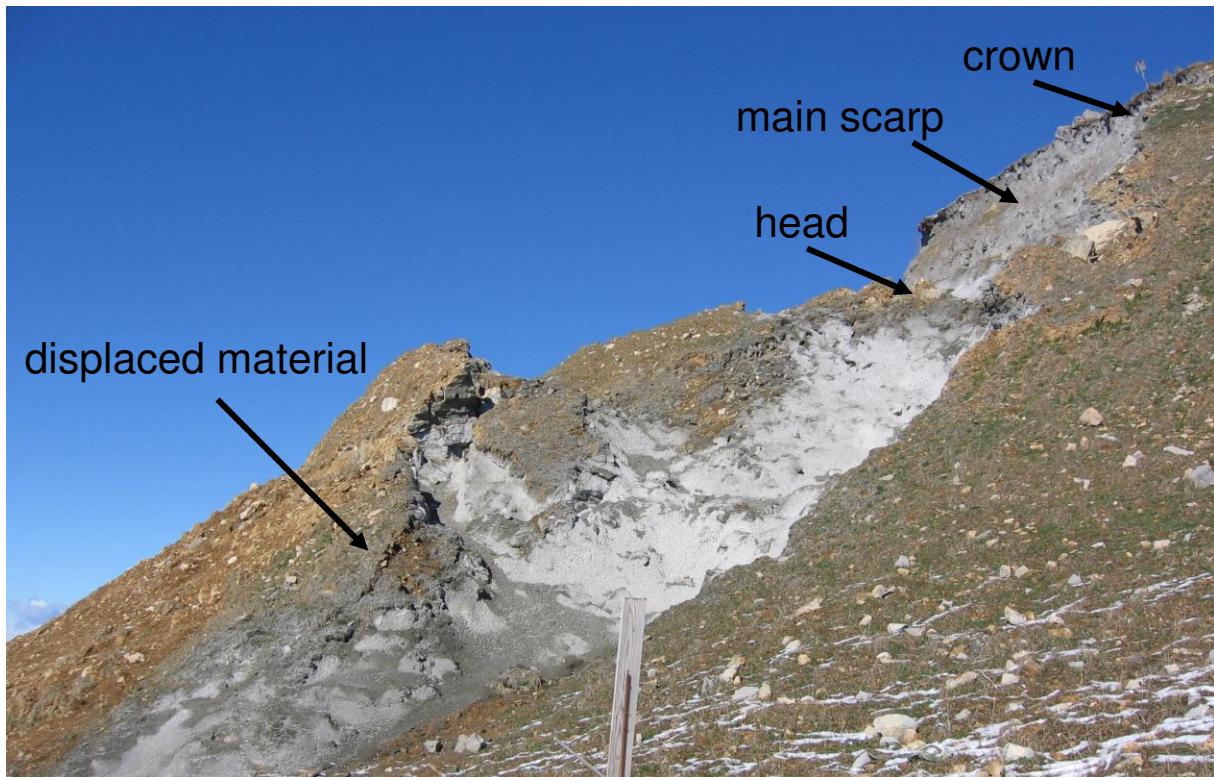
Figure 5. Top of the landslide.

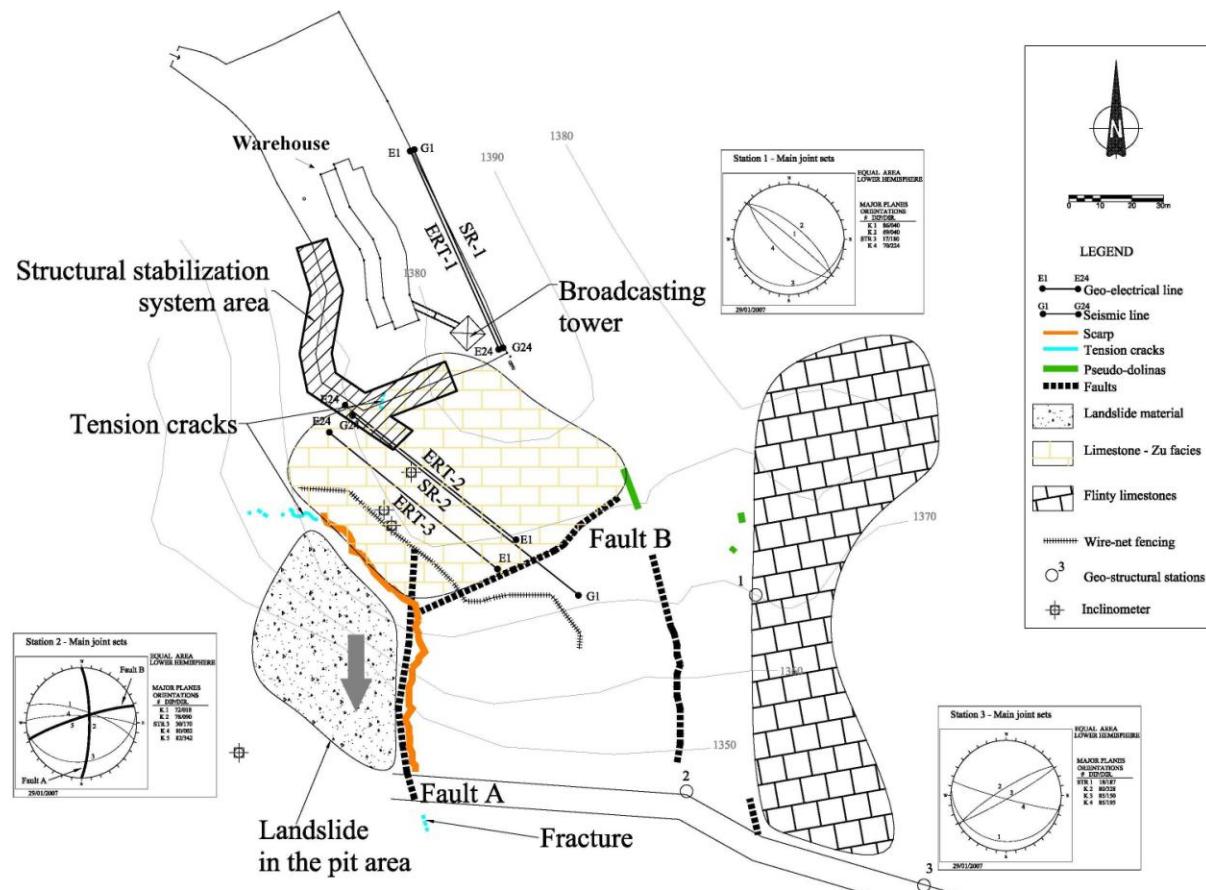
1. Two limestone facies characterized the slope: the Zu limestone and the Sedrina limestone. The geological boundary has tectonic origin and is represented by fault B, in Figure 6. The landslide occurred in the Zu limestone facies, where the presence of marly and argillitic layers facilitated the sliding along the bedding planes;

2. A second fault is present in the slope area (fault A in Figure 6) which intersects the fault B causing strong cataclasism in both facies, with a remarkable reduction of the rock mass quality;

The geological-geostructural survey was performed in three structural stations (shown in Figure 6). Four main discontinuities sets were found to characterize the rock mass (stereographic projections in Figure 6): 10°-15° down slope dipping bedding planes, two sub-vertical sets that can be potential tension cracks and a set parallel to fault B.

Figure 6. Map of the unstable area and results of the geotechnical survey.

The results of the field surveys have shown that many natural weakness elements affect the site. Fault A marks the east boundary of the landslide. Its intersection with fault B (Figures 6 and 7) induces heavy fracturing in the limestone to significant depths contributing to the instability of the area. The downslope dipping bedding planes predispose the slope to sliding and the two sub-vertical sets of discontinuities can become preferential paths for water percolation.

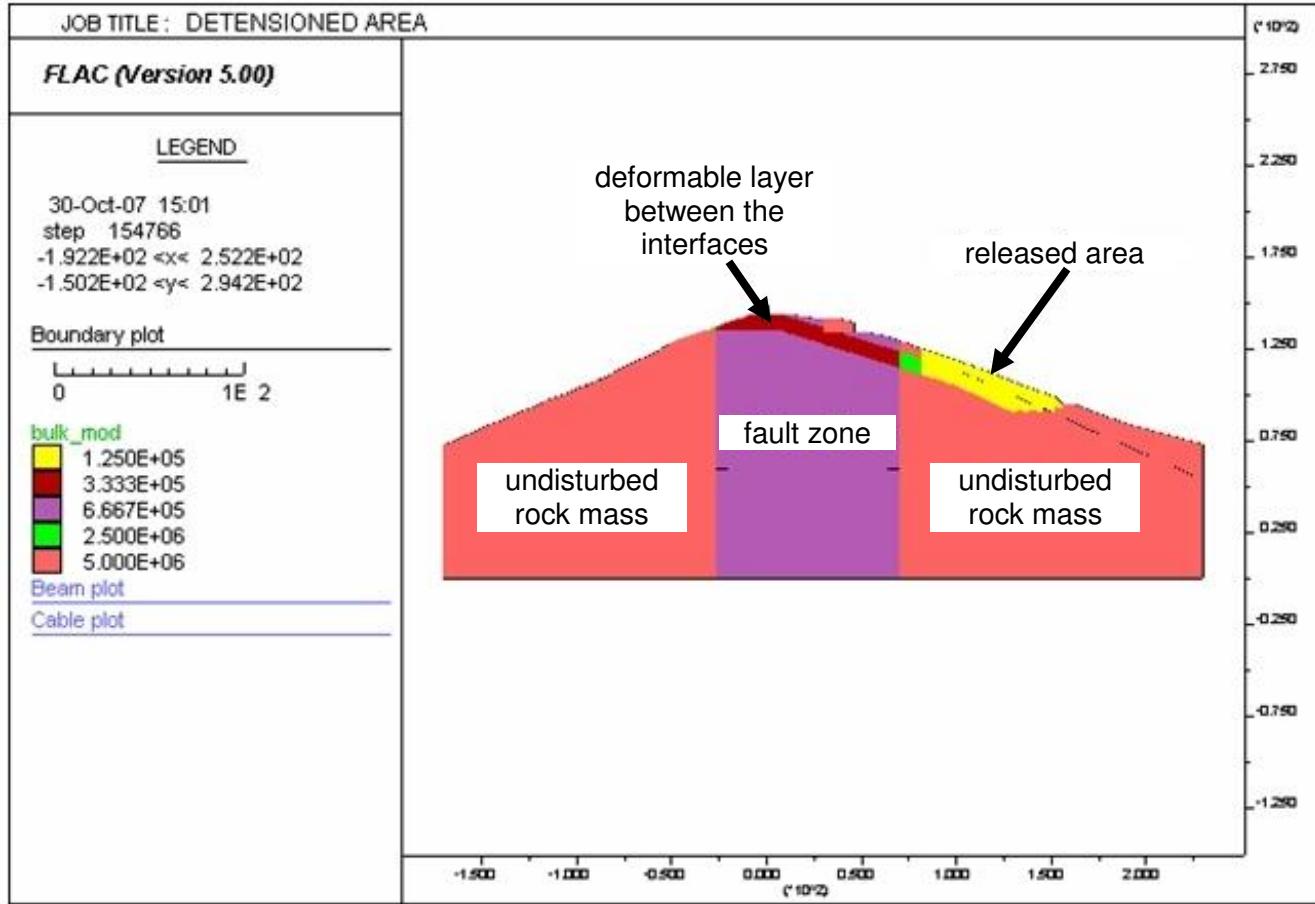
The slope behavior after the landslide in the pit area was simulated. It was assumed that the landslide induced a stress release in the slope beside it, between 1345 m and 1375 m above sea level with down slope displacements. For this purpose, a 20 m thick layer of the rock mass (equal to the estimated depth of the landslide) has been relieved between 1345 m and 1375 m above sea level. In order to simulate the progressive failure along the critical layer, the deformability and strength properties of the corresponding elements were progressively reduced (Table 6 and Figure 12).

The results show an important displacement increase in the upper part of the slope. The displacements in the warehouse area are appreciable only in the case of water table at 5 m from the level of site (Figure 13). A wide area in the disturbed rock mass reaches the plastic boundary for every hydraulic scenarios. From this, it is possible to reconstruct the slope's stress-strain history. The cuts in the pit area induced a progressive instability in the area immediately below the broadcasting plant, with downwards displacements that started in the pit cut and spread towards the warehouse. The landslide in the pit area quickened the instability phenomenon that worsened with heavy rain falls, leading to considerable displacements in the warehouse area.

Figure 12. Model with released area to simulate the landslide in the pit (FLAC).

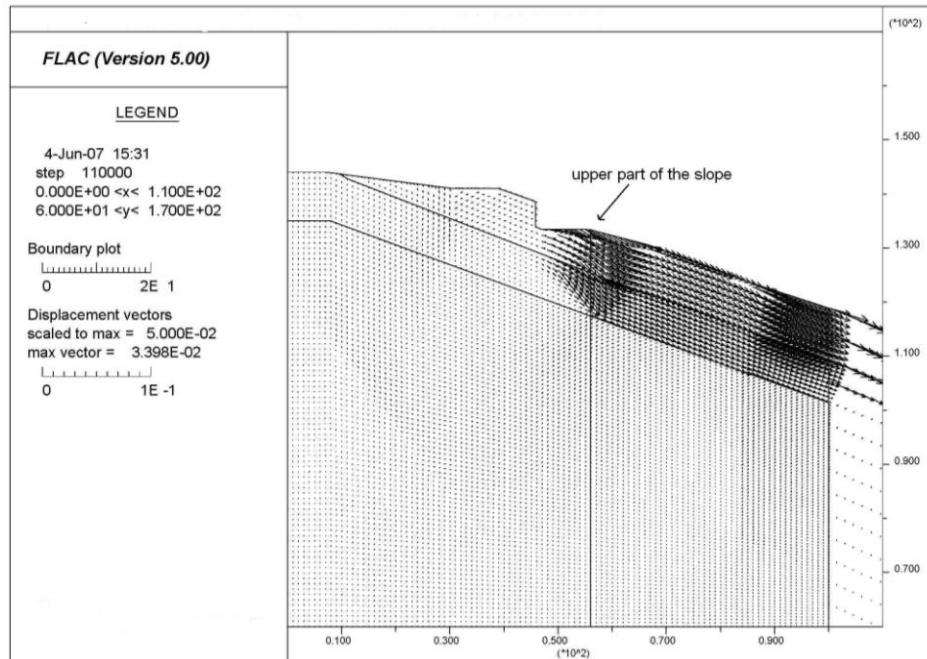
Figure 13. Numerical results: displacements in the upper part of the slope.

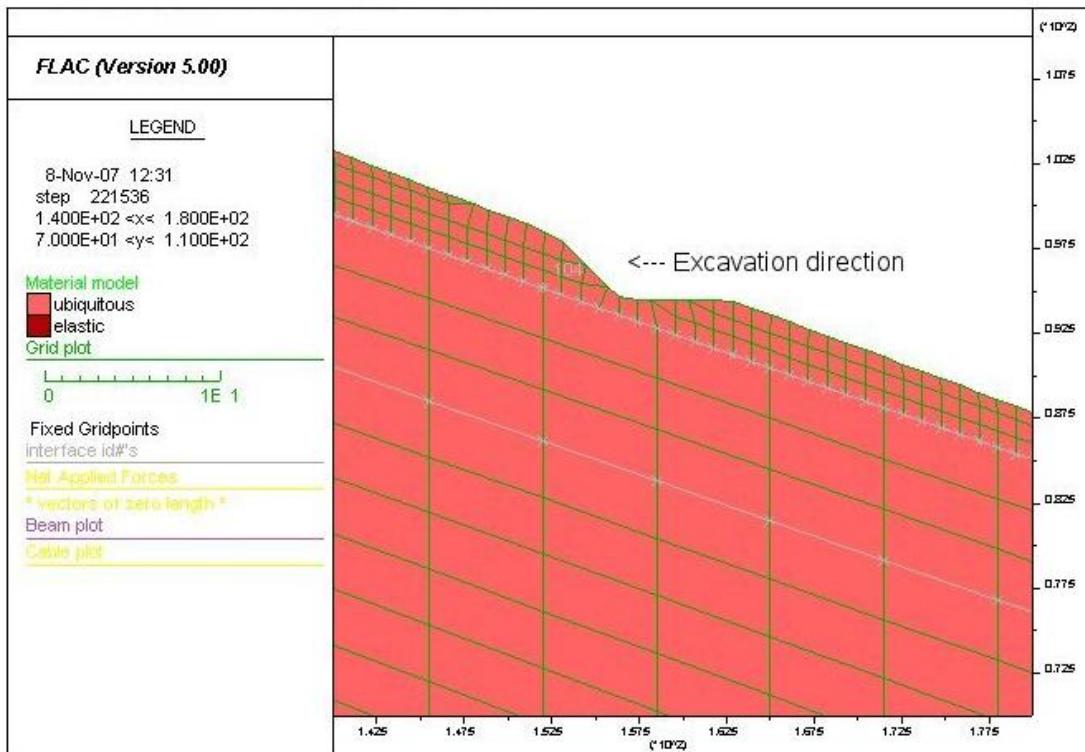
The obtained results pointed out that, with the extension of the pit area, the displacements in the upper part of the slope increase. Close to the warehouse they become in the order of a few centimeters. In particular, the displacements become considerable when the excavation involves the deformable layer.

The results allow to assert that a progression of the mining activity toward the broadcasting plant would induce its instability. For this reason, it can be considered as a triggering cause of the slope movement. As such, it should not to be authorized.

Figure 14. Model for the progression of the mining activities analysis.

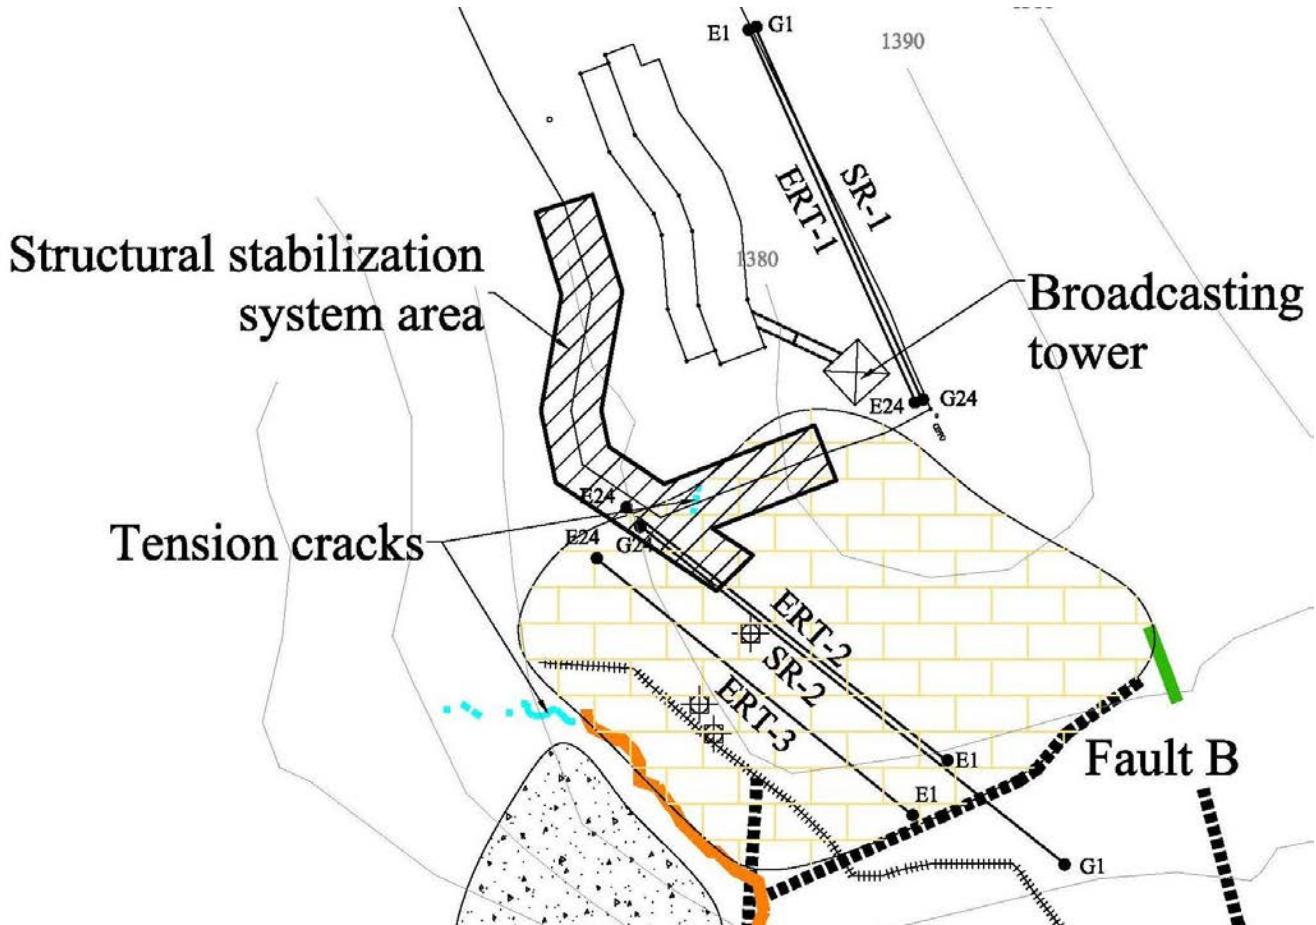
Figure 15. Map of the site with the location of the stabilization system.

1. sealing the cracks with mortar or resins at the top of the slope to reduce infiltration of water ;
2. turfing of the critical area of the slope, between 1345 m and 1375 m;
3. installation of sub-horizontal drains (microfissured PVC pipes), starting from the foot of the landslide in the pit area, so that residual water inside the slope is drained;
4. interception of runoff in the southern area of the site and channeling it to the slope at the back of the plant, where there is no apparent instability problem;
5. continuous monitoring by inclinometer and crack gauges in the warehouse area.

In order to confine the strain effects of the stress release induced by the landslide, the broadcasting site has to be isolated from the unstable slope. For this purpose, a structural stabilization system in the warehouse square was suggested (Figure

15 and 17). It was conceived to be a bulkhead consisting of 27 m long micropiles reinforced with steel pipes, 139.7 mm of diameter and 10 mm thick. The micropiles are connected at their head level by a reinforced concrete beam. The bulkhead extends as shown in Figure 15 and is anchored in the head to the undamaged rock mass by means of 28 m long four strands steel anchors, at center distance of 3 m and with a down dipping of 25°. During the construction of the bulkhead, any karst cavities will be filled.

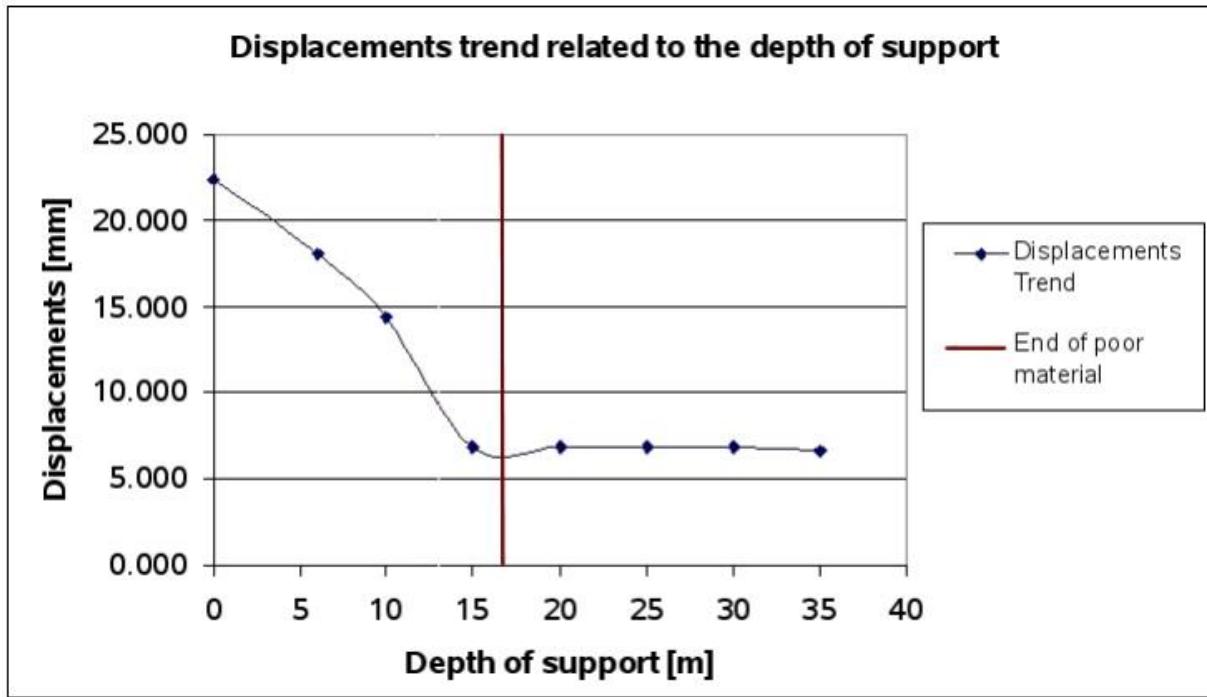
The results (Figure 16) confirm that the minimum length for the micropiles is about 16 m (the depth at which the boundary between the weaker layer and the undisturbed rock mass is located). On the other hand micropile lengths greater than 20 m don't provide further benefit to the plant stability. It is possible to conclude that 27 m is a good estimate of the length for the micropiles.

Figure 16. Model displacements in the area upstream the bulkhead, related to the length of the micropiles (assuming that in-situ bedrock is at 16 m depth).
