Embankment Failure in Residual Soils at Nivsar, Ratnagiri

Reference: Juneja, A., Chatterjee, D., and Kumar, R. (2013). *Embankment Failure in Residual Soils at Nivsar Ratnagiri*. International Journal of Geoengineering Case histories, <http://casehistories.geoengineer.org>, Vol.2, Issue 3, p.229-251. doi: 10.4417/IJGCH-02-03-04

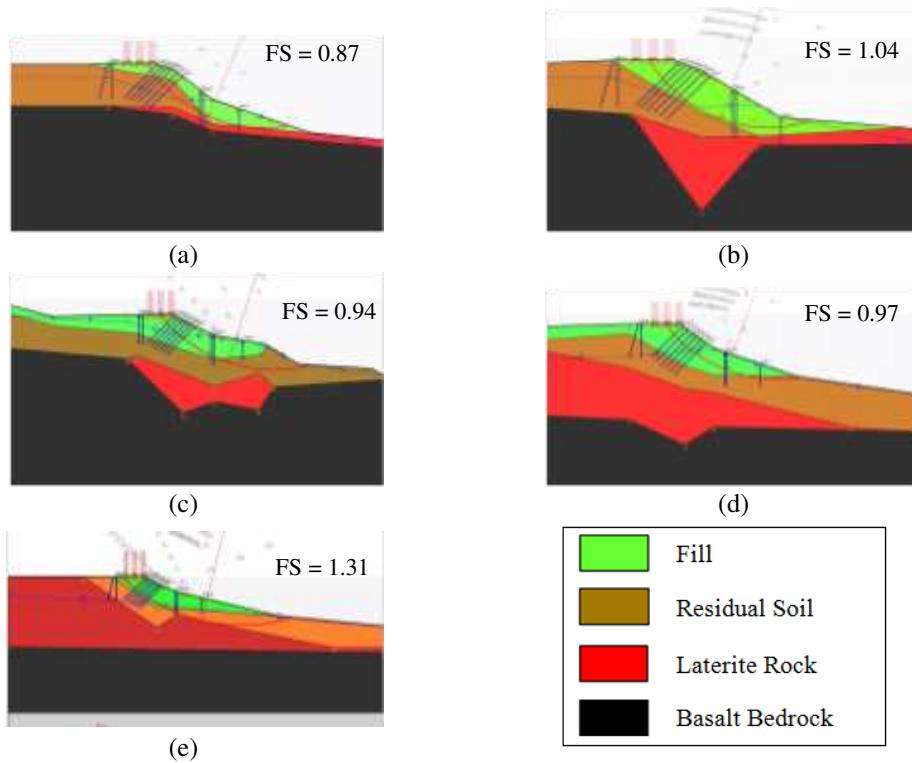
Soil nails and micropiles were installed in November 2005. These reinforcements failed and could not arrest the slope movement during the 2006 monsoon. Subsequently, two new rows of micropiles installed in January 2007 also failed during the 2008 monsoon. It was therefore appropriate to also study the stability of the 2006 and 2008 reinforced slope failures. In this analysis, the location, diameter and spacing of the reinforcement elements were taken from Table 1. Ground conditions and the slope geometry were identical to those used in the previous case. Figures 14a-e and 15a-e show the minimum safety factors and the location of critical circles in sections A-A to E-E for the 2006 and 2008 wet (monsoon) season, respectively. As can be seen, the safety factor is less than one in sections A-A, C-C and D-D for both years, indicating that the soil nails and micropiles installed in November 2005 and January 2007 were indeed inadequate to resist the slope movement. It is also interesting to note from Figures 12a-e and 14a-e to 15a-e that the reinforcement has little influence on the shape and size of the critical slip circle.

Figures 14a-e. Safety factor and critical slip circle during wet season with November 2005 ground improvement scheme for section: (a) A-A; (b) B-B; (c) C-C; (d) D-D; and (e) E-E.

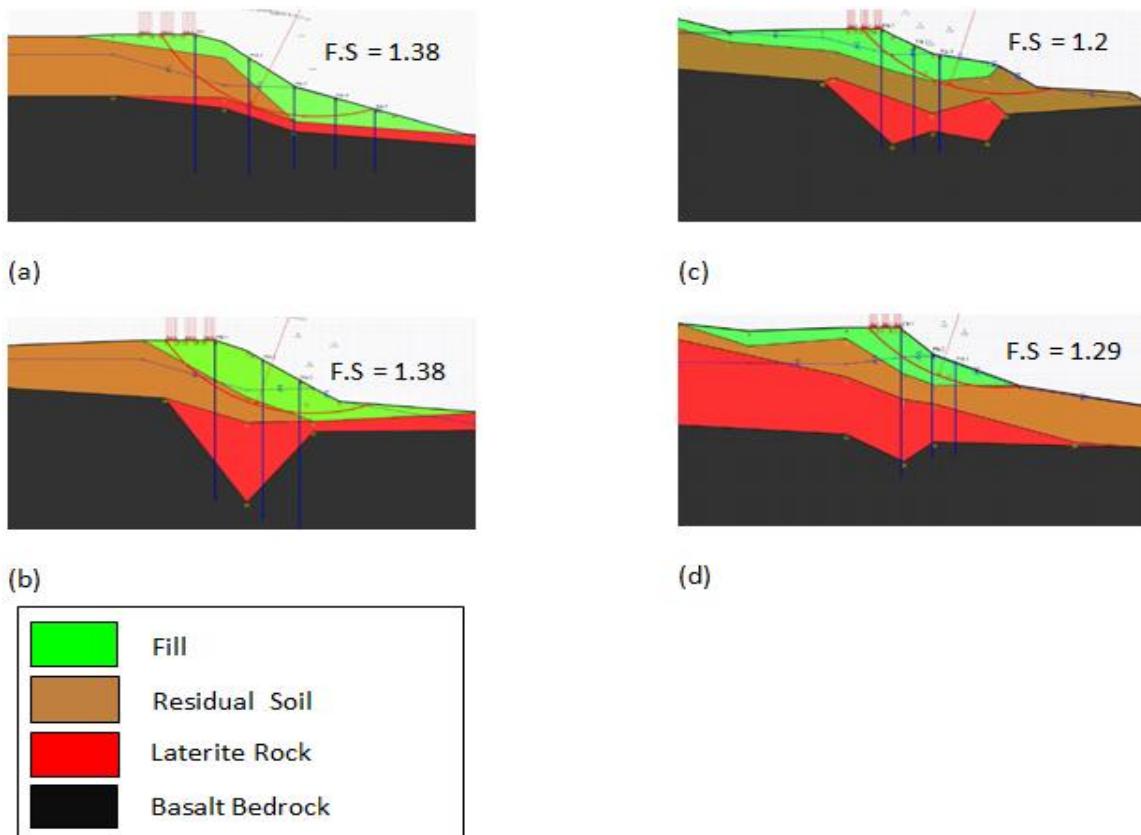
Figures 17a-d. Safety factor during wet season with proposed contiguous bored pile for section: (a) A-A; (b) B-B; (c) C-C; and (d) D-D.

One possible solution to enhance the stability of the slope was with the use of large diameter piles to retain the (failed) soil mass. In this case, safety factors of sections A-A to E-E were also deduced by assuming that the slope was reinforced with single or multiple rows of contiguous bored pile wall constructed parallel to the platform. Figure 16 shows the schematic layout of the proposed bored pile wall. The 1.2m diameter piles terminated below the slightly-to-moderately weathered basalt rock because of which sections B-B and C-C had long piles to provide adequate anchorage (Table 3). Table 9 shows the location and length of the piles used in the analysis. Figures 17a-d show the minimum safety factor and the location of critical circles in sections A-A to D-D for the wet season when the slope is reinforced with contiguous bored pile wall. As can be seen, the minimum safety factor increased up to 1.2 and 1.38 with the use of contiguous bored pile wall.

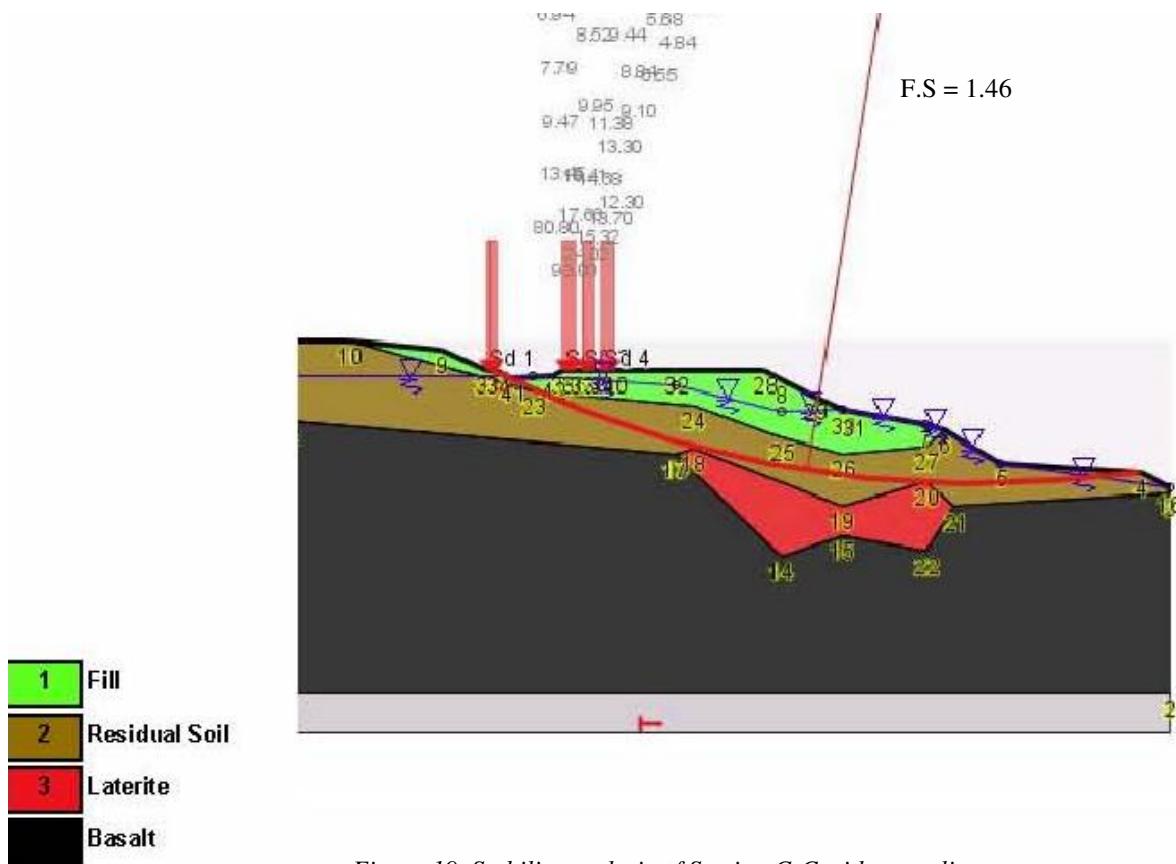
Figure 19. Stability analysis of Section C-C with new alignment.

more than 1.4. The slope was therefore considered to be safe and unlikely to fail under the new loads. This new alignment has been implemented since 2011. It has been constructed at less than 20 percent of the cost incurred to improve the ground. The railways have also removed speed restriction at Nivsar which has resulted in additional savings during the monsoon.

The cost to use the bored pile wall was over 200 million Indian Rupees (US\$ 3.6 million) and appeared to be prohibitive. As an alternative to this design, the old rail alignment was removed and replaced by a new alignment. The new alignment consisted of 3 loop-lines and 1 main-line. Figure 18 shows section C-C along with the location of the new alignment. In this section, the top left side of the hill was slightly levelled to accommodate the main line and the loop lines. Section C-C was chosen because the new alignment was closest to the failure surface at this section. The horizontal distance from the vertex of the failure surface and the 4 lines was 16m, 21.3m, 26.2m and 46.4m, respectively. The stability of the slope was then reinvestigated using the computer program Talren-4 (Terrasol 2005). As in the previous case, all the lines were loaded by 125 kN/m^2 . This assumption was unduly conservative in absence of strict guidelines (RDSO 2003b). Nonetheless, it permitted trains with more overtaking opportunities on the passing-loops. The ground water level was modeled using the highest RL recorded in Table 5. The failure circles are shown in Figure 19. As can be seen, the minimum safety factor is
