Preliminary Field Assessment of Sinkhole Damage in Pokhara, Nepal

ABSTRACT: Since November 2013, numerous sinkholes have been forming in the Armala area of Pokhara Valley, Central Nepal, posing serious threat to local residents. In order to provide measures aimed at reducing sinkhole risk, investigations into the cause and features of the sinkholes are crucial. This paper presents early research results based on two damage surveys conducted in June 2014 and November 2014 in the Armala area. Comparison of photos, taken in the two surveys, clearly indicates not only the formation of new sinkholes, but also the re-activation of filled sinkholes. By means of dynamic cone penetration tests and surface wave method investigations, qualitative characterization of the soil profile was attained, and shallow weak soil layers which are believed to be the location for future sinkholes could be identified. On the basis of the field investigation results, possible sinkhole formation mechanisms are identified for the Armala area. Furthermore, results of a reconnaissance survey conducted in the Armala area in early May 2015 (following the 2015 Gorkha Nepal Earthquake, which occurred on April 25th)

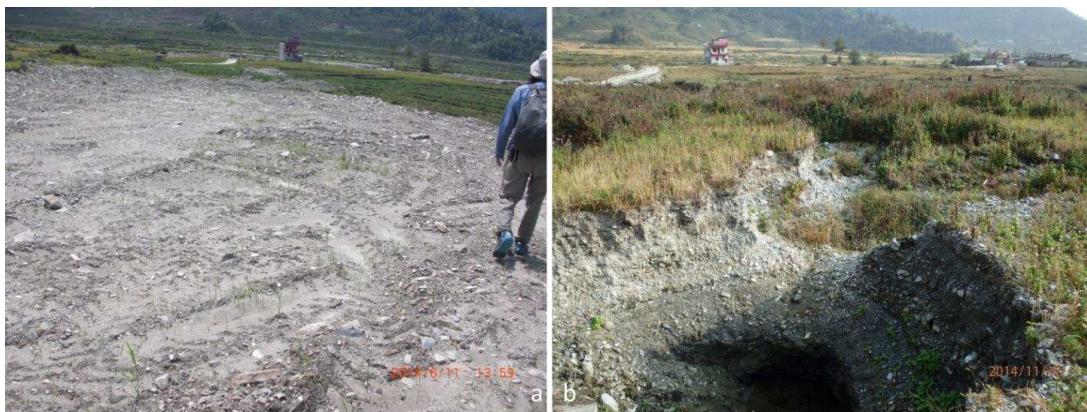
Immediately after the occurrence of the sinkholes, a wide area affected by the cave-in was backfilled by using gravelly soil retrieved from nearby quarries, which is identified by a yellow color filled area in Figure 2. Though, at the time of the first damage survey in June 2014, most of the sinkholes had been fully backfilled (Figure 7a corresponding to photo point 5), the photos taken in November 2014 at the same location clearly show that the backfilling was not an adequate solution as most of the former sinkholes were re-activated (Figure 7b) likely in August 2014 during the peak rainy season in Pokhara Valley.

Figure 7. (a) Sinkholes backfilled area (photo point 5) as seen in June 2014; and (b) Re-activated sinkholes as observed in November 2014.

As mentioned earlier, as an immediate mitigation work, all the old sinkholes were filled by the local government. This practice could disrupt the underground water flow so that ultimately the caving process caused the re-activation of sinkholes. Note that due to loose conditions of backfilled material, it is expected that the development of a re-activated sinkhole is much quicker than that of the original sinkhole where natural compacted soils was gradually eroded by water.

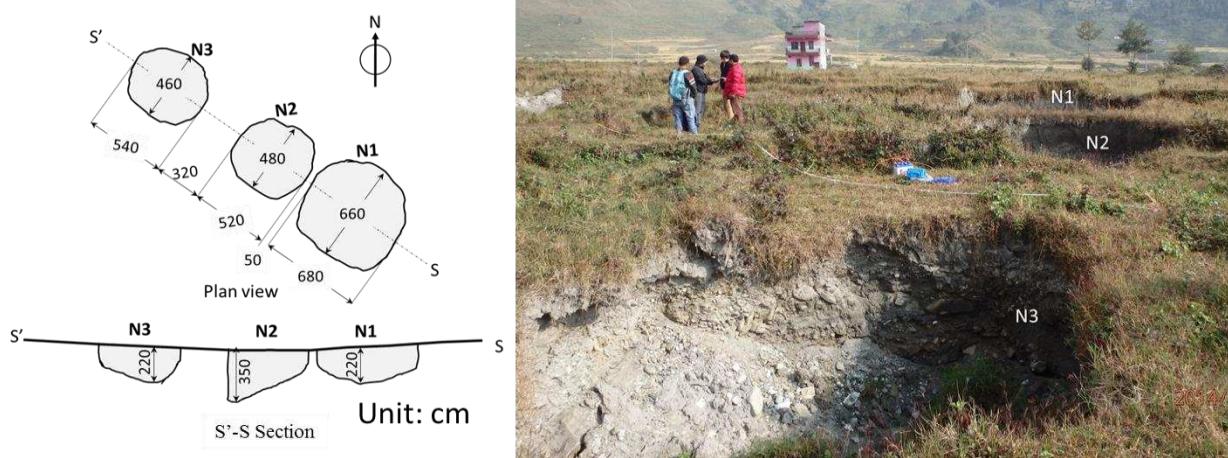
Among many, sinkholes N1, N2 and N3 in the area X shown in Figure 2 were found to be of particular interest. They were developed in a delimited area of approximately $10\text{ m} \times 20\text{ m}$, as shown in the schematic map shown in Figure 8. They have a circular pattern and diameters ranging from 4.6 m (N3) to 6.8 m (N1). Their depth measured at the top of the collapsed soil varied from 2.2 m (N1, N3) to a maximum of 3.5 m (N2). According to witnesses, N1 was the first sinkhole to be formed. A few days later, N2 caved-in and finally N3 developed. This progressive formation of several sinkholes along a straight line (moving along the uphill direction from N1 to N3) may suggest that the collapse of N1 caused the complete disruption of underground water flow. Consequently, water started to erode the soil just adjacent to N1 until a new cave-in (N2) was formed. In a similar way, N3 was later developed. The same pattern of sinkhole formation occurred often since November 2013. Most of the newly developed sinkholes are located on the upstream side of the underground water flow.

Figure 8. Series of sinkholes appeared in the area X in Figure 2 (photo point 6).

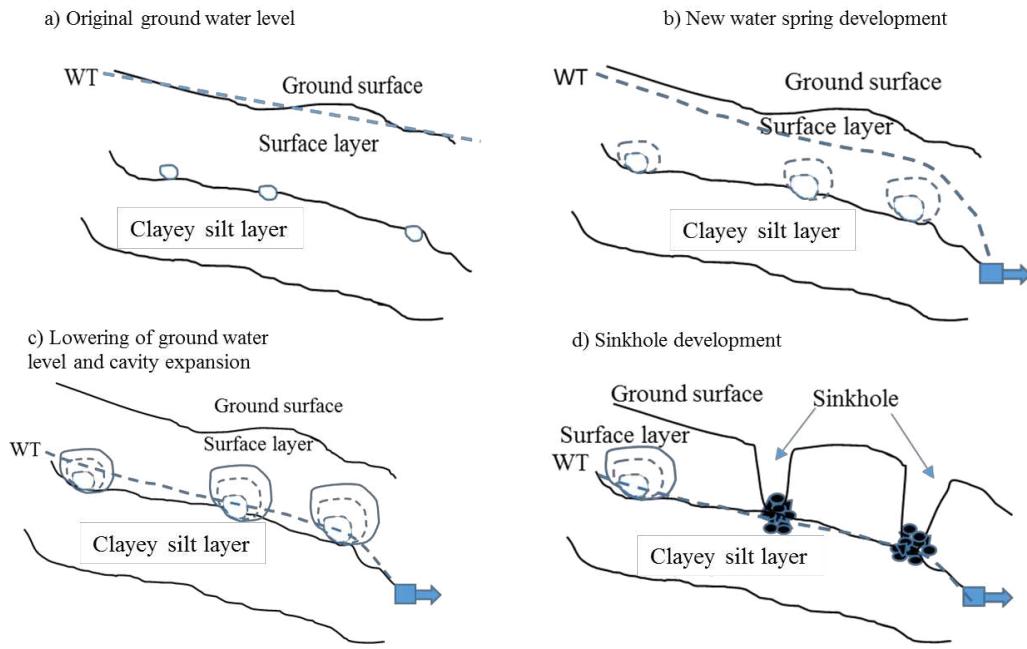
Figure 2) is clear and has no sediments. On the other hand, water samples collected at WS point 1 and 2 shows high turbidity (Figure 17). This indicates that underground water continues to dissolve the silt and there was a continuous caving process till June 2014. As the process continued, the loose, unconsolidated soil and sand above was gradually washed into the cracks and voids. Depending on how thick and strong the top layer was and how close to the surface the void beneath was, the ground was not able to sustain its own weight. Thus, cavities that before were stable, suddenly became unstable and collapsed (Figure 16(d)).

Figure 16. Probable mechanisms of sinkhole observed in the Armala area.

- prevent irrigation;
- using an effective drainage system and diverting surface runoff;
- remediating existing sinkholes and clogging shallow holes;
- identifying cavities in the soil and filling them by grouting;
- improving the ground by compaction or ground injection to increase the strength and bearing capacity of the soils.
