The May 25th 2011 Railroad Embankment Failure in Ann Arbor, Michigan, As a Means for Teaching Geotechnical Engineering

Reference: Zekkos, D., Athanasopoulos-Zekkos, A., Grizi, A., and Greenwood, W. (2016). *The May 25th 2011 Railroad Embankment Failure in Ann Arbor, Michigan, As a Means for Teaching Geotechnical Engineering*. International Journal of Geoengineering Case Histories, Vol.3, Issue 4, p.234-245. doi: 10.4417/IJGCH-03-04-03

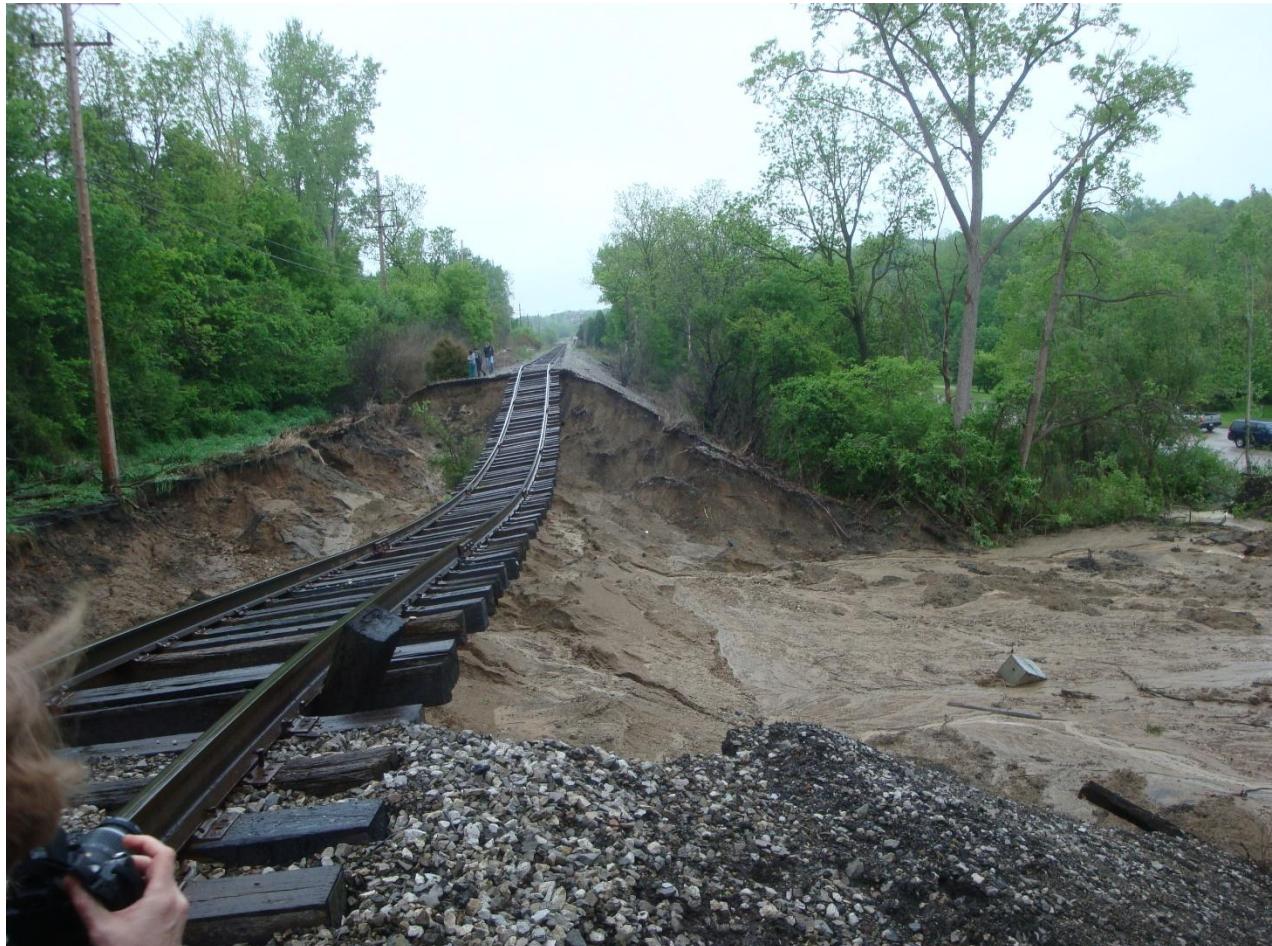
The case history of a railroad embankment failure, shown in Fig. 1, that took place in Ann Arbor, Michigan, on the 25th of May 2011 is presented as a means for teaching fundamental principles of geotechnical engineering. An advantage of this case history as an education tool is that it can be taught at different levels and give the instructor the opportunity to emphasize several different topics in soil mechanics and geotechnical engineering. Additional advantages include the impressive nature of the failure, the detailed characterization using in-situ and laboratory approaches, and the wealth of lessons learned that can be readily understood by students.

Figure 1. View of the railroad embankment failure looking East.

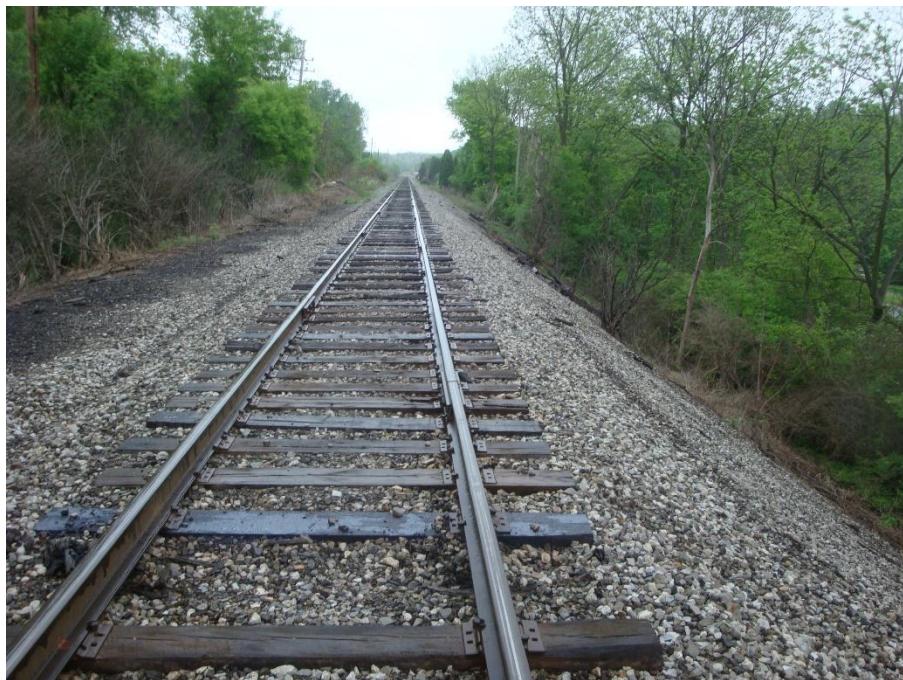
The failure site is located to the north of downtown Ann Arbor in Michigan, USA, as shown in Fig. 2b. The failure took place on the railroad embankment that is heading parallel to Plymouth Rd and adjacent to residential structures. Fig. 3 illustrates an intact portion of the embankment immediately to the East from the failure location. The failure resulted in:

Figure 3. View of intact portion of the embankment immediately to the East of the failure area. One can see that the uphill part of the embankment (left) is supported by natural ground that is at a much higher elevation than the downhill part of the embankment (right).

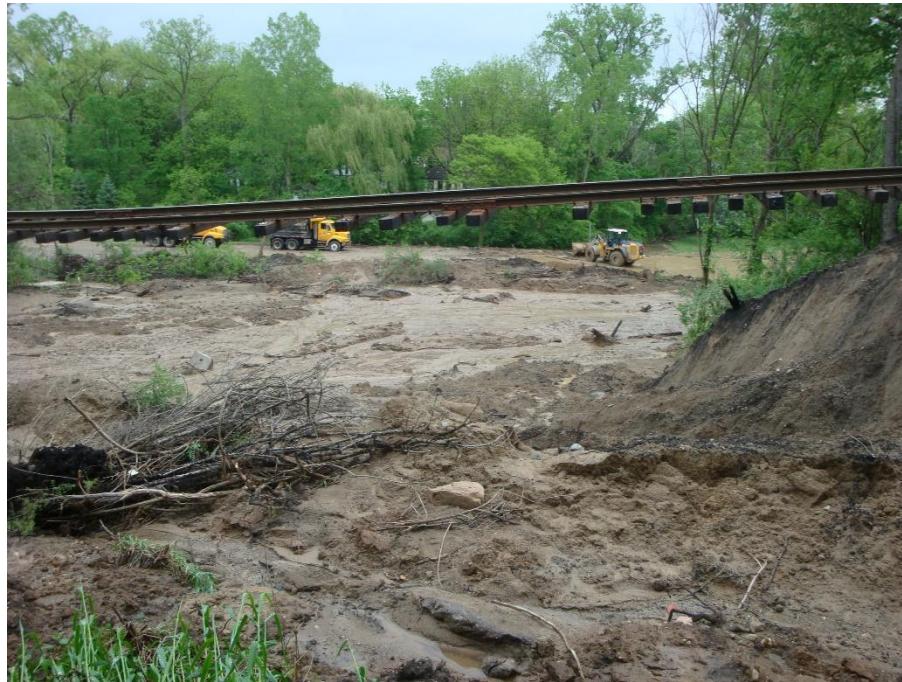
- (a) Shutdown of the railroad for an extended period of time;
- (b) Closure of Plymouth Rd for two days; and
- (c) Flooding and debris deposition on the downslope side of the embankment that damaged a public park southwest of Plymouth Rd and deposited additional sediments in a natural stream, as shown in Fig. 4.

Figure 4. View of the conditions downhill of the failure showing deposition of debris and water. Trucks and dozer are operating on Plymouth Rd. and flooded area further back is a flooded public park.

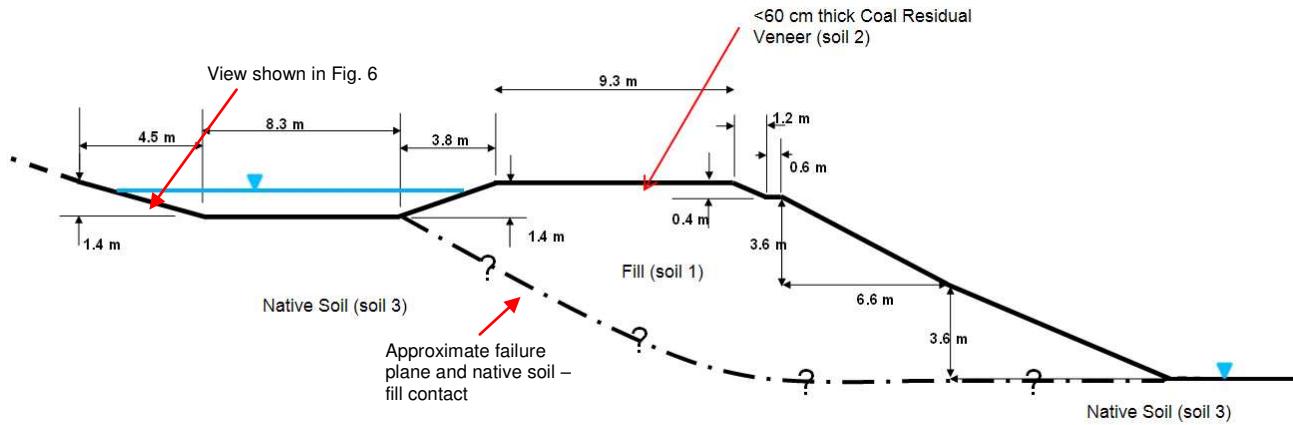
The embankment is constructed partially on a naturally sloping ground and has a total height of 7.6 m as shown in Fig. 5. Its crest, that supports the railroad lines, has a width of 9.3 m. The embankment fill consists of two layers. The main layer (Fill Soil 1) is a silty sand (SM). A surficial layer of very small thickness is also present and consists of coal ash residuals (Soil 2). The natural soil that underlays the embankment is a sandy clay of low plasticity (CL) that geologically is described as very dense glacial deposits (Native Soil-Soil 3).

Figure 5. Cross-section of the railroad embankment at the location of the failure.

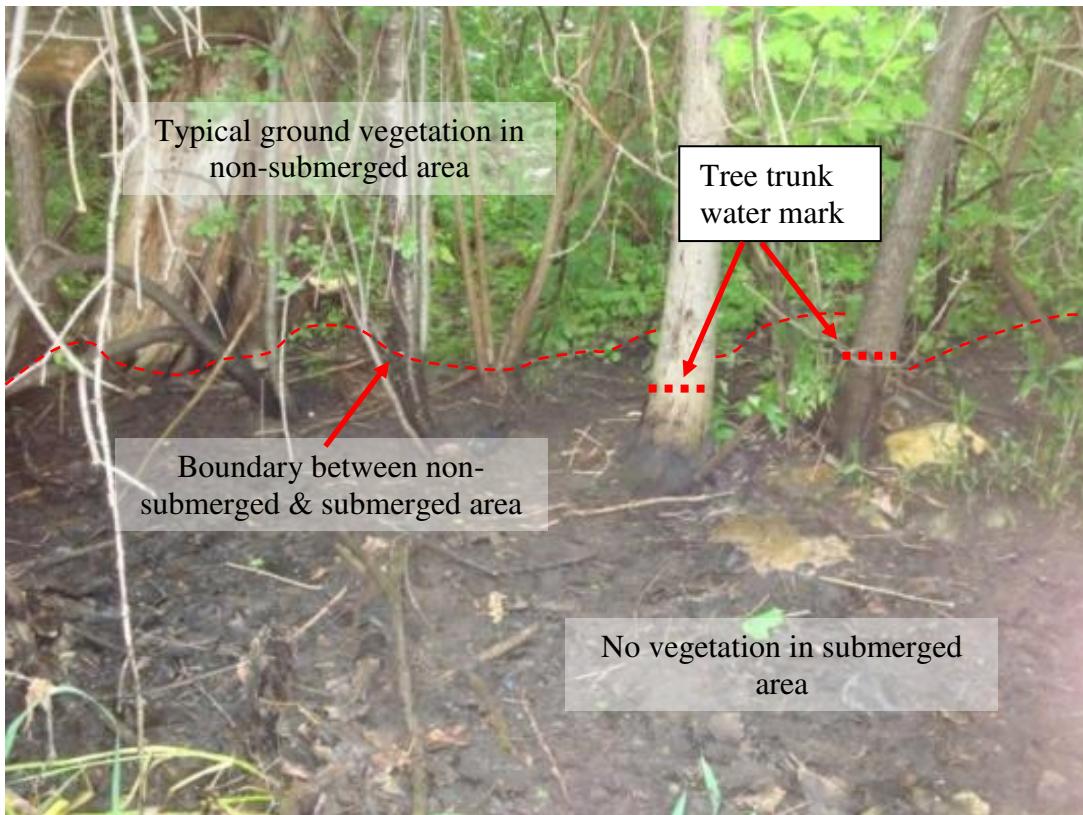
During the site visit, it was observed that the failure location was at a local natural depression that was receiving and accumulating surface water from a wider area. After careful inspection, the authors hypothesized the existence of seasonal ponding water. The surface soil on the uphill side of the embankment was very wet with vegetation that is typical of marshes, such as reeds. Next to the embankment where the water appeared to nearly permanently ponding and below trees there was no vegetation (see web-based supporting information titled “Photos and “Videos”). These conditions were found to be unique compared to other locations along the axis of the embankment. In addition, the level of water could be clearly seen as a watermark on the trunks of trees, as shown in Fig. 6. Based on these observations it was evaluated that the depth of the ponding water could have reached up to 120 cm. Local residents confirmed the existence of ponding water adjacent to the embankment. In fact, it appears that a neighbor used to feed visiting ducks at that location. Retention of ponding water was not part of the original embankment design. It is important to note that ponding water existed for at least some

Figure 6. Area previously covered by ponding water and water mark on tree trunks.

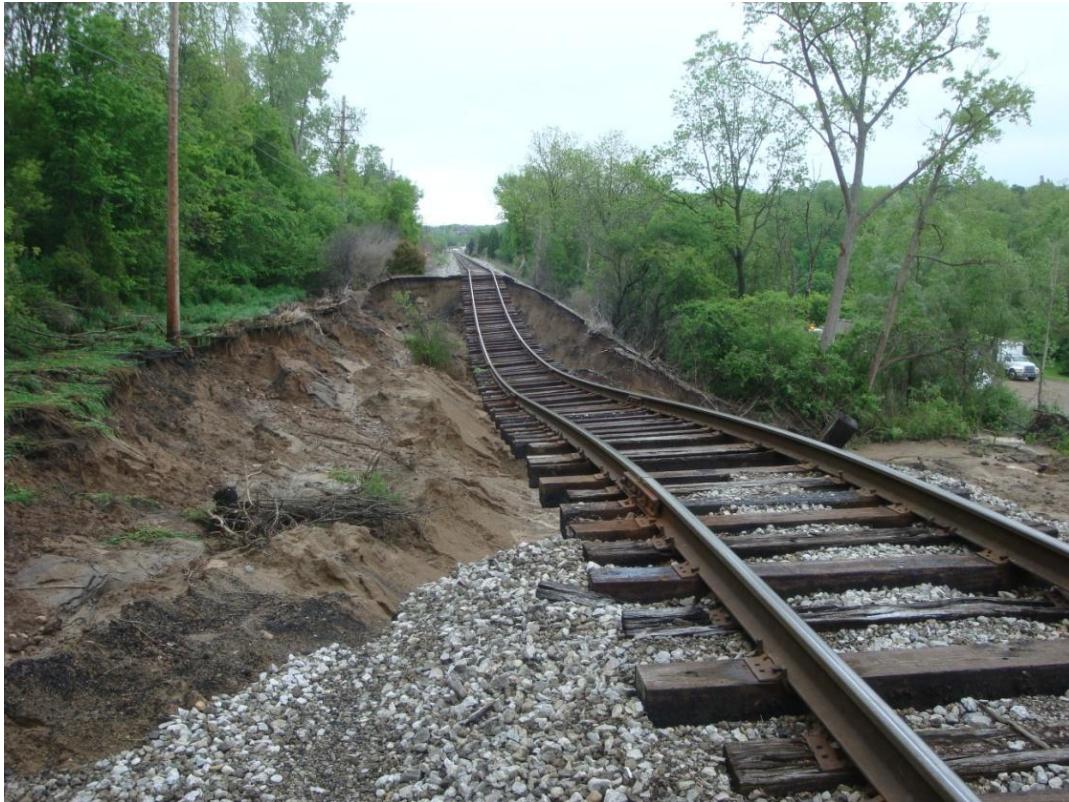
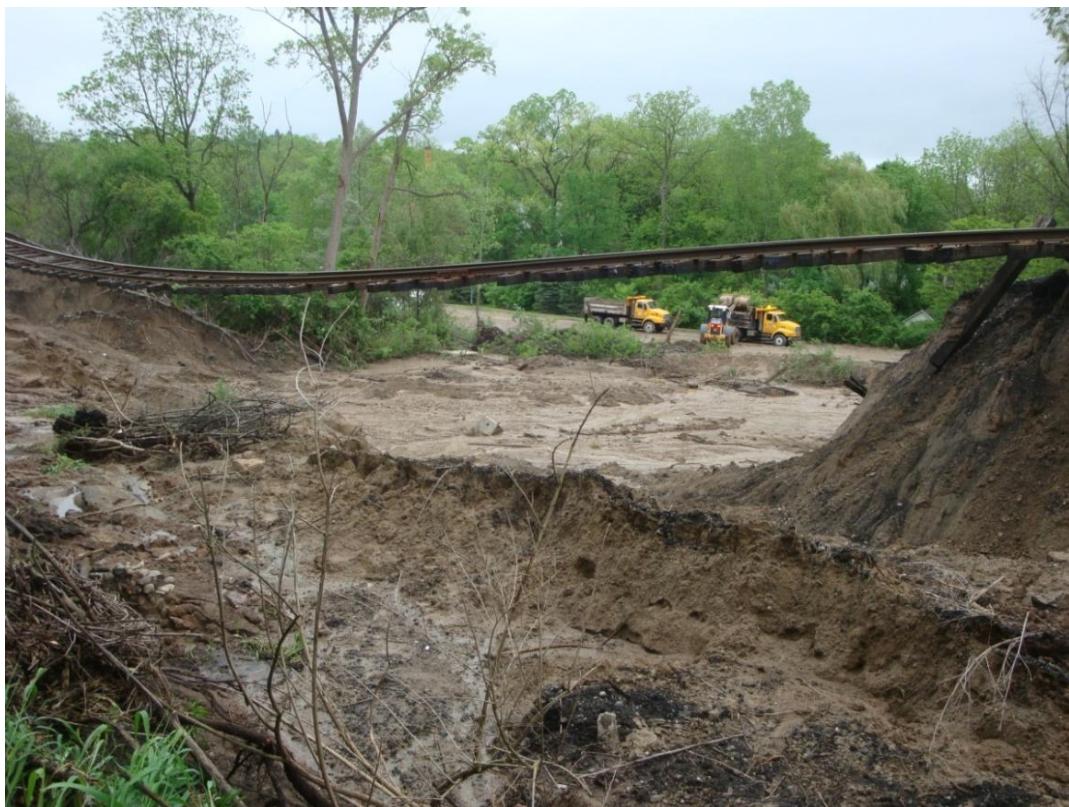
The failure surface appears to engage the entire railroad embankment that is supported on naturally sloping native ground. A 30-m long section of the embankment along the railroad axis slid, and the sliding mass moved a significant distance downslope, removing a number of trees that had grown in the downslope side of the embankment between the railroad embankment and Plymouth Rd. The interpreted failure surface per field observations is shown in Fig. 5 and 7 and is in the vicinity of the contact between the native ground and the embankment fill, but appears to be restricted within the embankment fills and not involve the native soils.

Figure 7. View of the failure along, and perpendicular to, the railroad embankment axis.

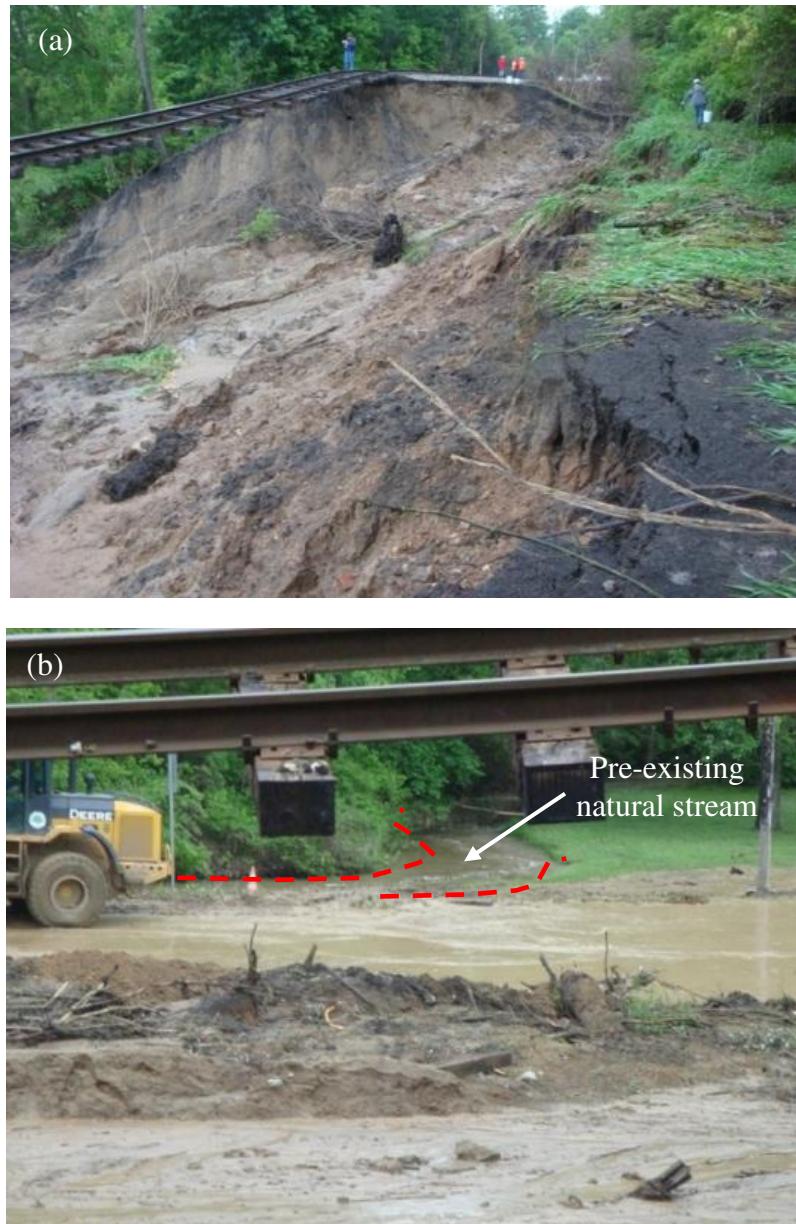
Soil Layer 2: This embankment layer is restricted to the top few cm from the surface and is essentially coal ash residuals that are black in color and can be clearly seen in Fig. 10. The fines are non-plastic and represent only 6.8% of the total mass of the soil, whereas the gravelly size particles are equal to 29.6%. It is classified per USCS as well-graded gravelly sand with silt (SW-SM). This soil layer is not expected to have played a significant role in the failure since it is of very small thickness and restricted at the surface only. Thus, more comprehensive testing to characterize its properties was not conducted.

Figure 10. View of the failure from the crest of the failure surface where (a) the left-in-place embankment is shown; (b) the mass of soil with large amount of water is shown at the toe of the failure reaching the pre-existing natural stream.

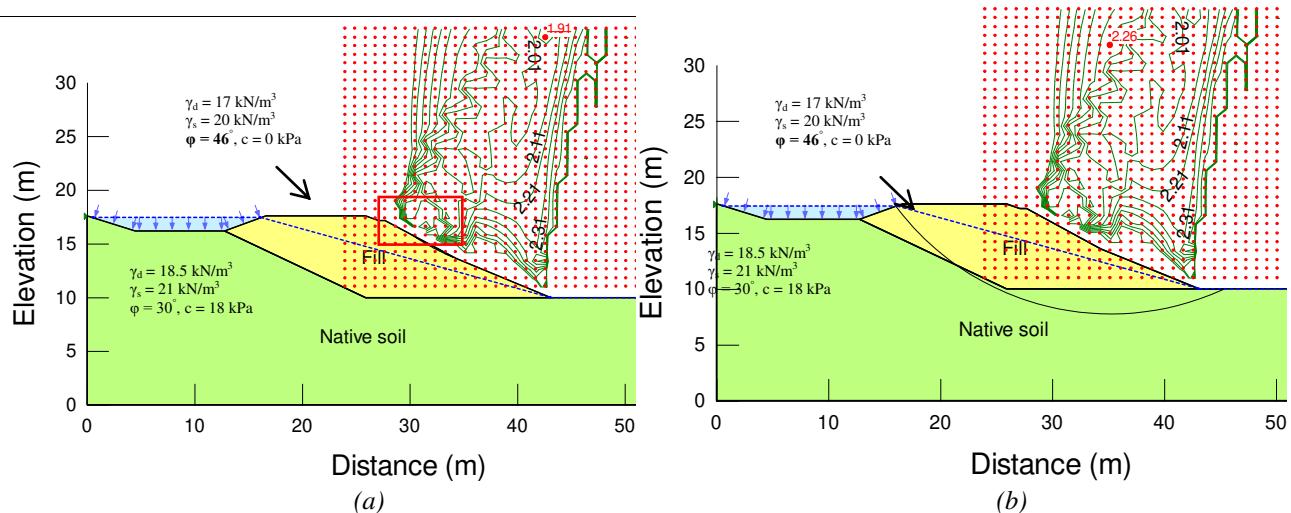
Following site characterization and the assessment of the embankment and failure surface geometry, stability and seepage analyses were conducted using the software programs SEEP/W and SLOPE/W (Geostudio, 2007) and the Spencer method of analysis (Spencer 1967). For stability assessment, parametric analyses were also conducted for reasonable variations of soil properties, as well as variations of the water depth of the ponding water (60 – 120 cm) that is reasonably well documented based on the field observations. These parametric analyses are critical in assessing the impact of uncertainties in the results. The parametric stability analyses indicate that even for the highest ponding water depth, the factor of safety remains significantly higher than one, i.e., it varies between 1.4-1.9 (for friction angles equal to 38° and 46° respectively) for a shallow failure surface that is restricted within the embankment, and is shown in Fig. 11a within the red box. Note that although the failure planes shown are “classic” numerical failure surfaces of purely frictional material with zero cohesion, even for low cohesions of 1-3 kPa, the observation that shallow failure surfaces are most critical remains valid. Higher values of factor of safety that vary between 1.5 and 2.3 were calculated for deeper failure surfaces that intersect the native soil (soil layer 3). Example results of the analyses are presented in Fig. 11.

Figure 11. Indicative results of embankment stability analyses for hydrostatic pore pressures. (a) showing lowest Factor of Safety (FS) of 1.91 for shallow failure planes (in the red box); (b) showing indicative FS of 2.26 for a failure plane that intersects the native soils.

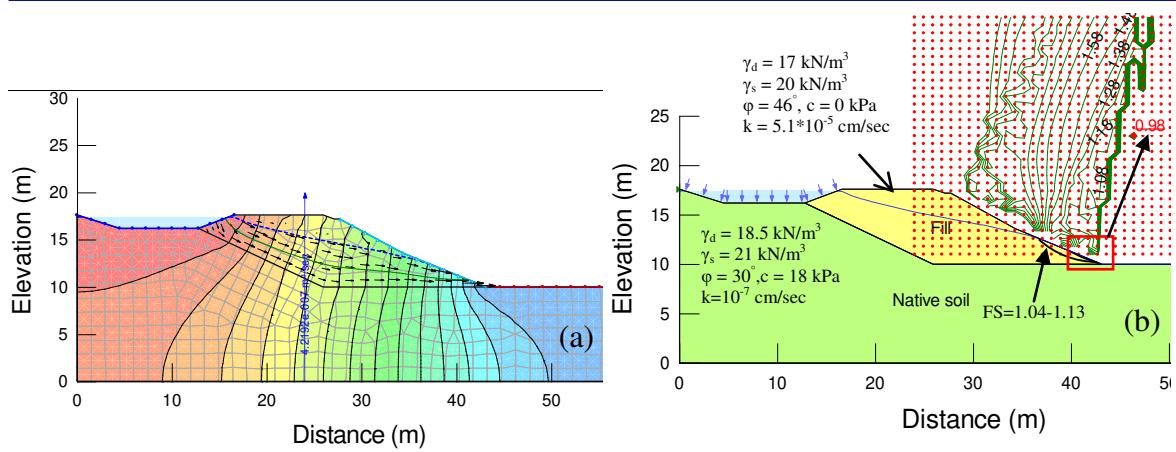
Subsequently, seepage analyses were conducted using the estimated hydraulic conductivities. As described earlier, the natural soil has significantly lower hydraulic conductivity than the embankment soils. Thus, the analyses indicate that when the ponding water depth increases, the exit gradients at the toe of the embankment become high, and vary between 0.48 and 0.78, which are dangerously high and close to critical gradients (~0.9). The stability analyses using the calculated hydraulic pressures, indicate failure of the embankment with factors of safety around one, as shown in Fig. 12. Note that this is not surprising as the seepage analysis gives a more realistic pore pressure profile (Fig. 12a) than that of an arbitrarily assumed piezometric surface (e.g., Fig. 11) with the flow concentrating more on the higher hydraulic conductivity soil. The results, indicate that the failure is caused by the high pore pressures that may even cause piping. The numerical results, are supported by the following interesting field observation: The reeds in the ponding water area adjacent to the embankment were found to be bent sideways and positioned horizontally with a direction that was pointing with great accuracy to the exact location where the ponding water initially drained quickly, as shown in Fig. 12.

Figure 12. Indicative results of combined (a) seepage and (b) stability analyses using seepage analyses results

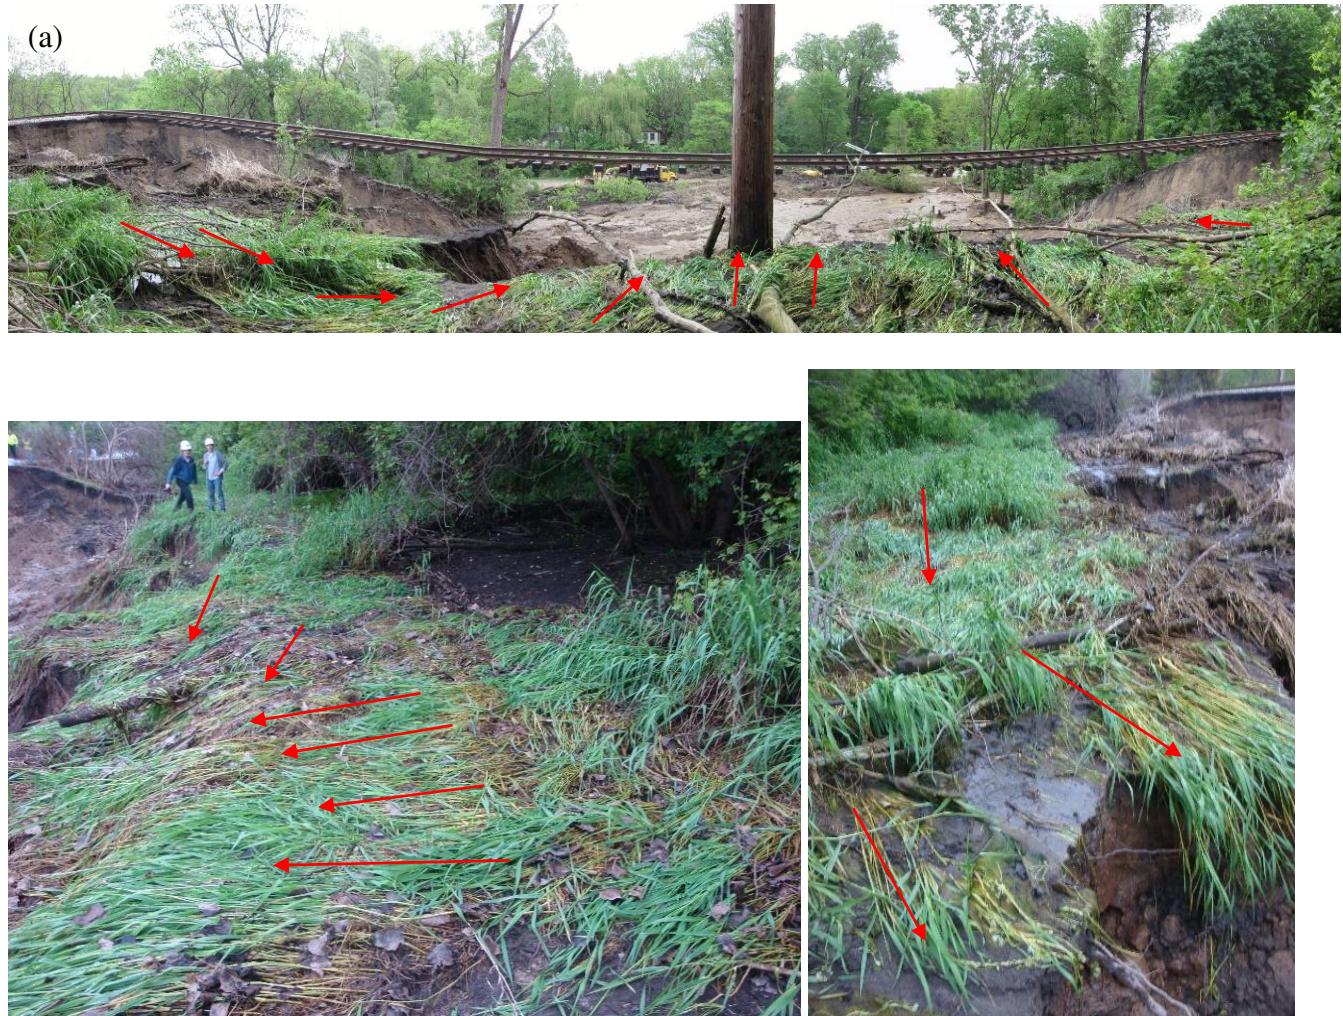
Figure 13. View of the failure and the reeds uphill of the embankment. The arrows are parallel to the direction of the fallen reeds that bent and broke during the abrupt emptying of the ponding water and fell on the ground with their orientation pointing to the initiation point of failure. (Fig. 13a by Karl Jansen, ceephotos.com)
