# A Large Scale Landslide in a Coal Mine in Marly Formations: Evaluation, Analysis and Rehabilitation

**ABSTRACT:** This paper describes a large scale landslide in a coal mine in Servia area in Kozani, Greece, which occurred in February 2011. The landslide, of ~250m width and ~350m length, took place in marly lacustrine sediments. The main factors for the manifestation of the landslide were a temporary interruption of works, the existence of a specific weak surface, the clayey nature and the sensitivity of marl to environmental agents, the action of water and the large slope height. Due to the magnitude and the position of the failure, a geotechnical solution was proposed that involved rearrangement of ground masses. The proposed solution led to successful rehabilitation and unimpeded continuation of the exploitation process.

Reference: Prountzopoulos, G., Fortsakis, P., Marinos, V. and Marinos, P. (2016). *A Large Scale Landslide in a Coal Mine in Marly Formations: Evaluation, Analysis and Rehabilitation*. International Journal of Geoengineering Case Histories, Vol.4, Issue 1, p.29-45. doi: 10.4417/IJGCH-04-01-03

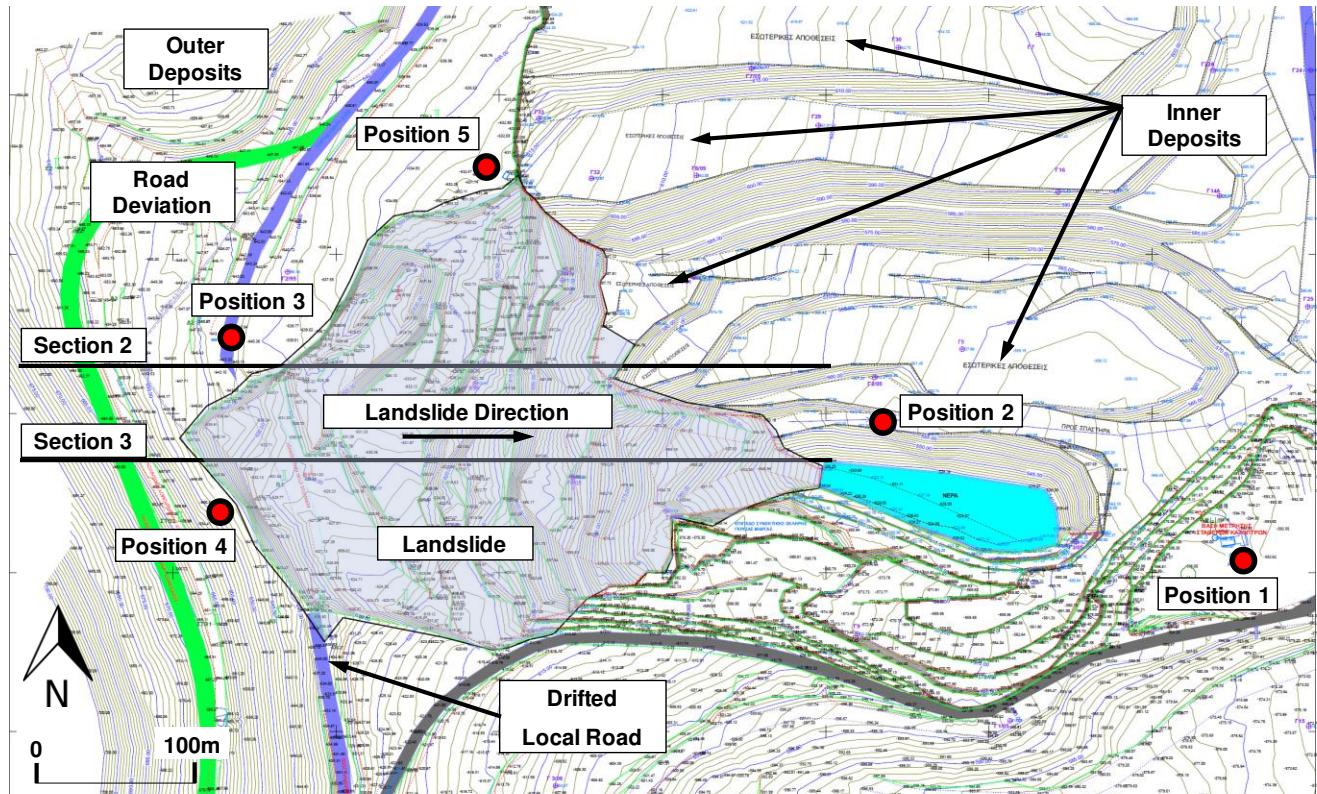
Figure 2 shows a plan view of the landslide area, with demarkation of the main features of the incident, as mentioned or referred to in the present paper. After examination of historical, geometrical and geotechnical data provided by the exploitation contractor, in-situ inspections and evaluation of the available information, it was concluded that the factors that played an important role in the initiation and triggering of sliding movement and the evolution of the landslide were:

Figure 2. Topographic mapping (plan view) of the coal mine after the landslide with demarkation of some key features

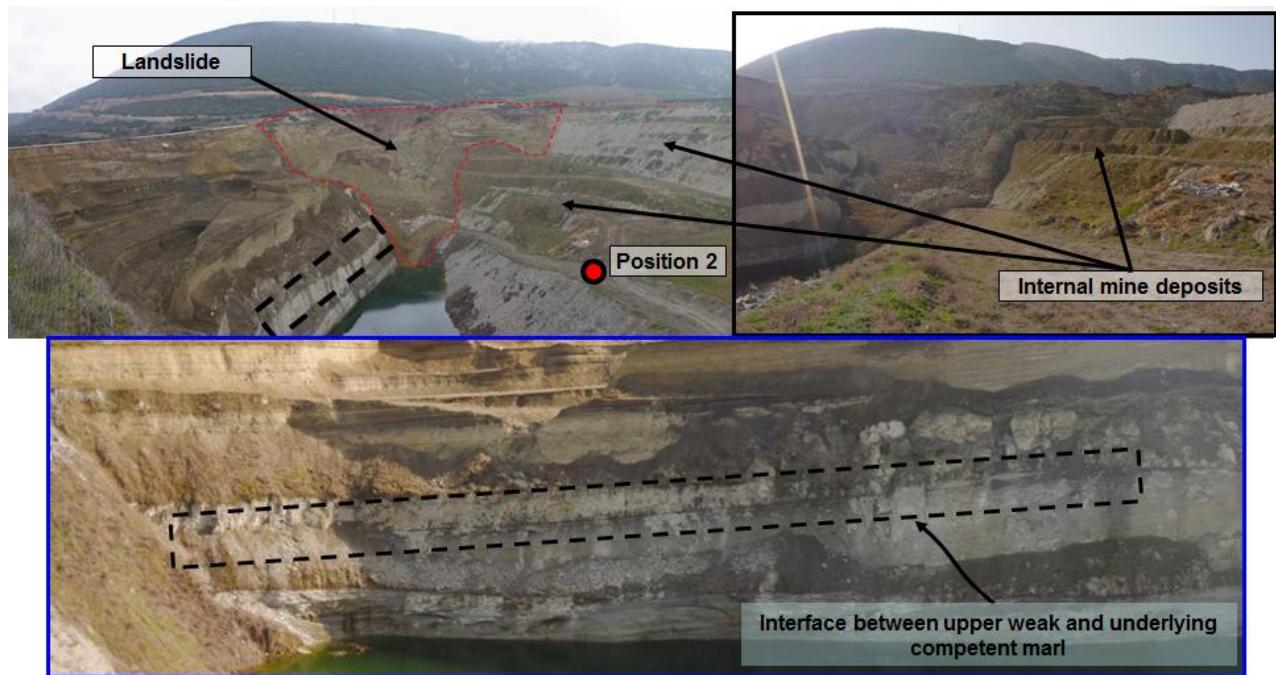
Figure 3 illustrates a general aspect of the landslide from its E and NE side (Positions 1 and 2 in Figure 2) and a view of the contact surface between the weak and the competent marl, which played a major role in the landslide manifestation. Figure 4 illustrates various aspects of the landslide and its main features.

Figure 3. Aspect of the coalmine and the landslide from Position 1 (upper left), the landslide from Position 2 (upper right) and the contact surface between the weak and the competent marl (bottom)

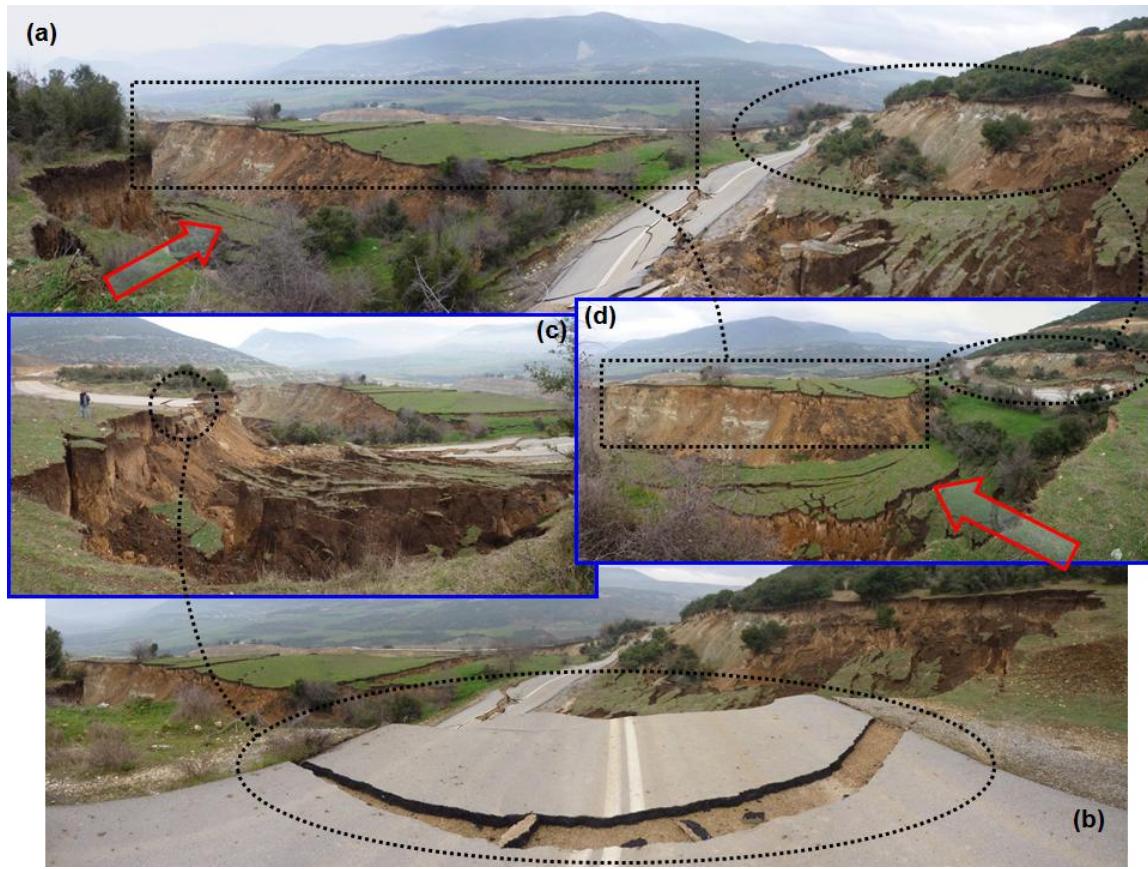
The landslide had a clearly three dimensional character, due to the lateral "constraints" posed by the non-commercial deposits of the mine at its north part and the exploitation limit at its south part. The failure surface at the landslide crest at its NW boundary had a considerable (subvertical) inclination and was steeply dipping towards the weak contact surface between the weathered and the underlying compact marl (Figure 4a left and 4c). On the contrary, at the west boundary of the landslide crest, the failure surface had a milder inclination (Figure 4a and 4b right) and seemed to have travelled a considerable length within the shallower weak marl formation. Within the landslide, large blocks of the marly formation were almost monolithically displaced (see Figure 4a and 4d) with limited cracking and detachments within their mass, giving the impression of a combination of rock slide and typical rotational landslide to the incident.

Figure 4. Aspect of the landslide from Position 3 (a & b), Position 4 (c) and Position 5 (d), the landslide crest (oval shape in a & d), the block that moved almost monolithically downstream (rectangle in a & d) and the mass that sank behind the block (arrow in a & d).

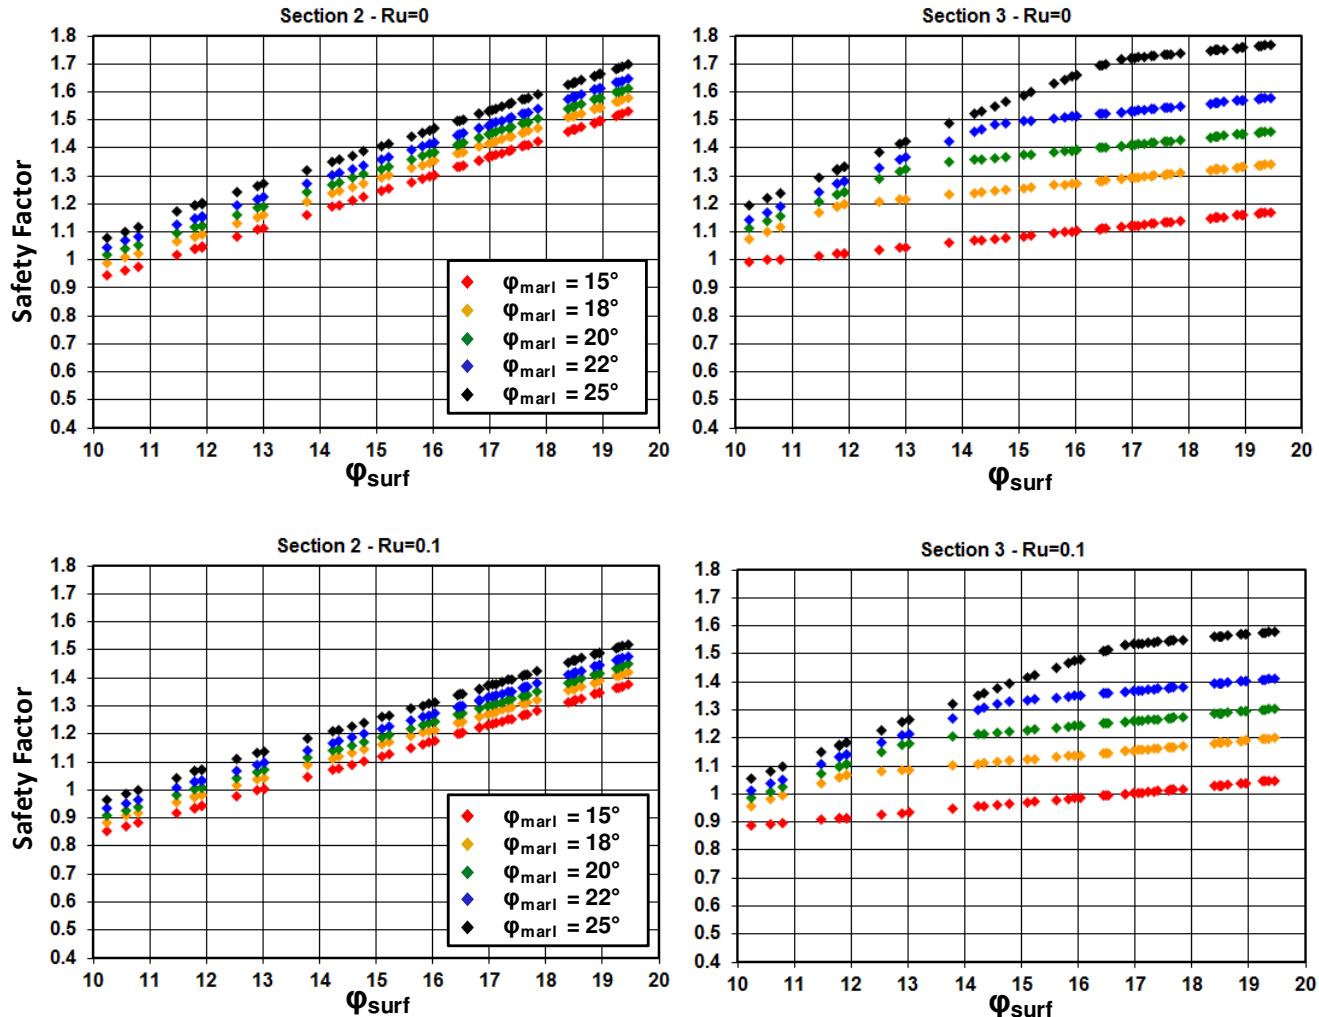
2. Values of the safety factor for values of pore pressure ratio  $R_u=0-0.1$  generally lie above unity for both Sections analyzed (see Figure 6), especially for  $\varphi_{surf} > 13^\circ$  and were therefore excluded. This result was actually anticipated, since water seemed to have had a major role in the landslide triggering.

Figure 6. Variation of safety factor for different values of  $\varphi_{marl}$  and  $\varphi_{surf}$  for  $R_u=0.0$  (up) and  $R_u=0.1$  (down), as computed for Section 2 (left) and Section 3 (right)

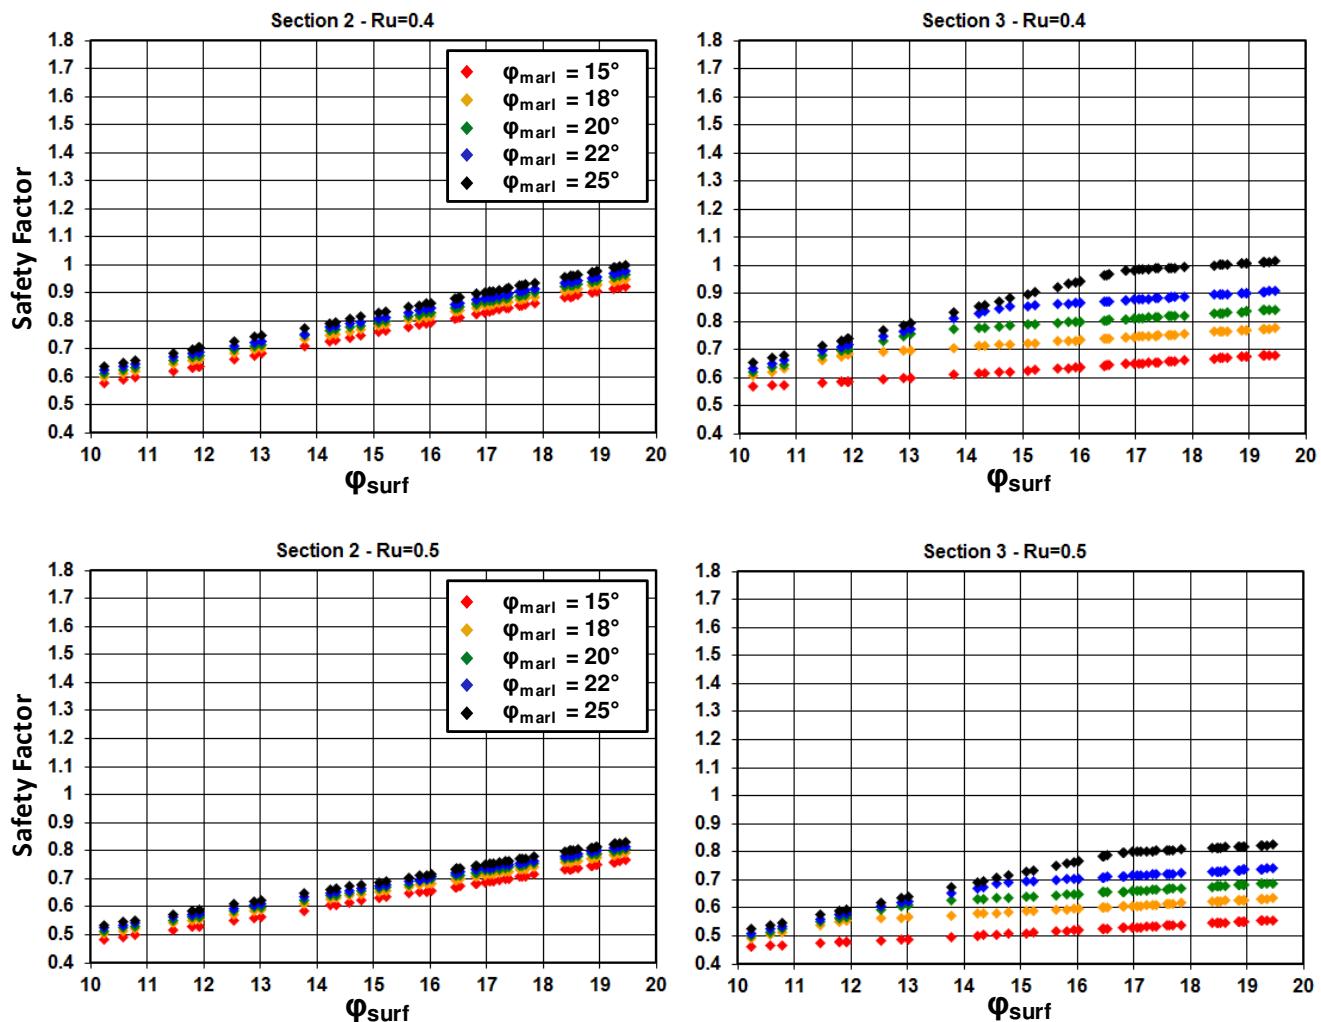
3. Values of the safety factor for values of the pore pressure ratio  $R_u=0.4-0.5$  were generally well below unity for both analysis Sections (see Figure 8), especially for  $\varphi_{surf} < 17^\circ-18^\circ$  and were not considered likely. Values of the safety factor for  $\varphi_{surf} > 18^\circ$ , given the nature of the specific surface and the fact that are assumed to refer to residual strength, were not considered reasonable.

Figure 8. Variation of safety factor for different values of φ<sub>marl</sub> and φ<sub>surf</sub> for R<sub>u</sub>=0.4 (up) and R<sub>u</sub>=0.5 (down), as computed for Section 2 (left) and Section 3 (right)

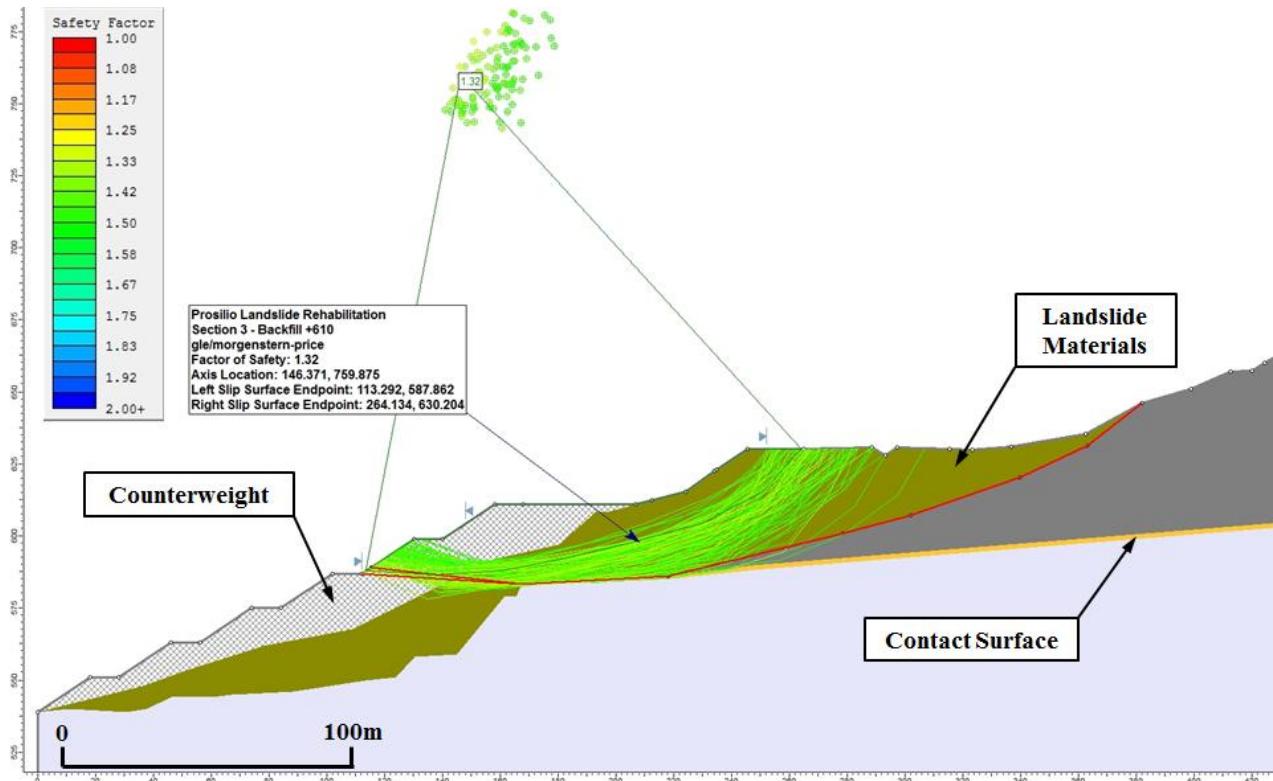
Figure 11. Analysis Results for Section 3 with backfill at the toe up to elevation +610 (F.S. = 1.32)

1. Placement of non commercial deposits at the toe of the landslide up to an elevation approximately 25 m above the contact surface between the upper weak and the underlying competent marl (~+610 m absolute elevation), significantly increased the safety factor. Specifically, considering the envelope of the landslide or surfaces along obvious large scale movements within the total landslide mass as potential failure surfaces, the computed values of the safety factor ranged between 1.52 and 1.63. Assuming that any failure surface within the total landslide envelope was possible (a quite conservative approach, since residual shear strength parameters were assigned in the analysis model) the safety factor ranged between 1.32 and 1.56. These values, even with the second, conservative approach, were considered adequate.

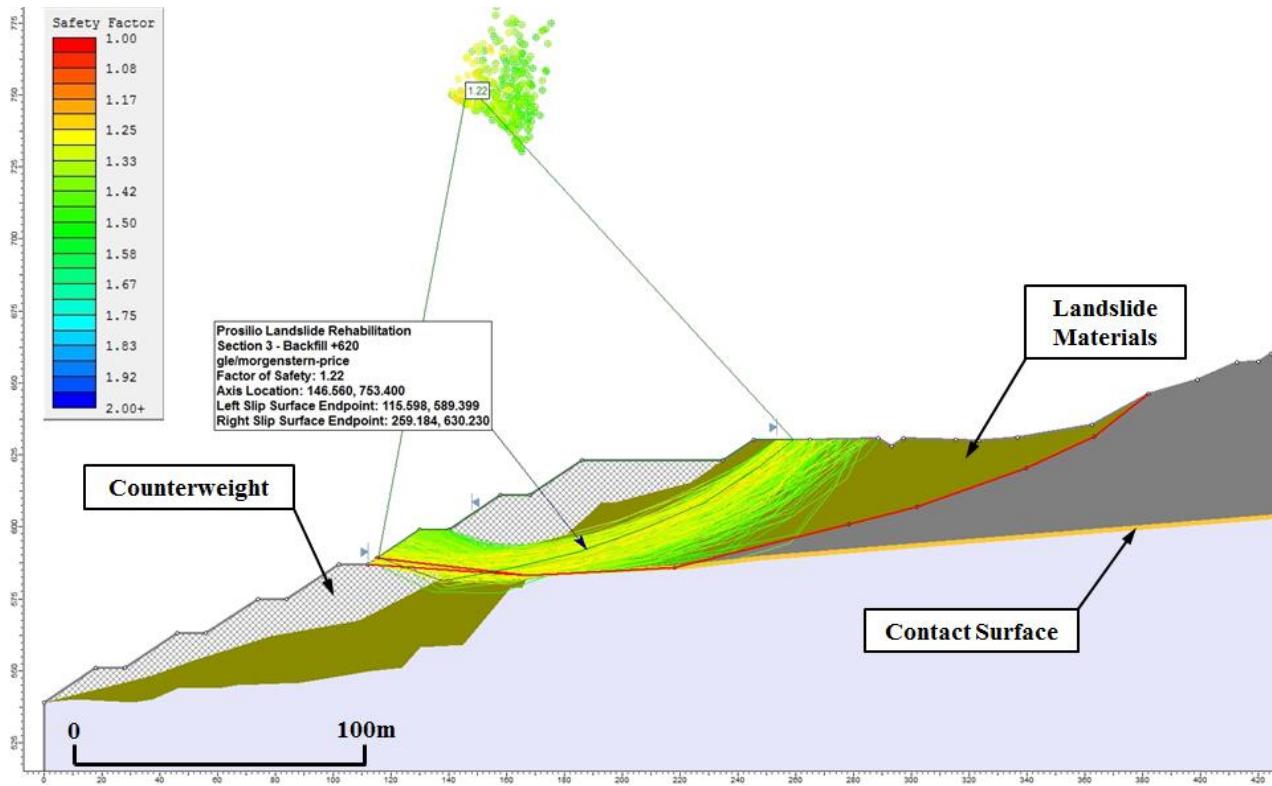
Figure 12. Analysis Results for Section 3 with backfill at the toe up to elevation +620 (F.S. = 1.22)

2. Placement of non commercial deposits at the toe of the landslide up to an elevation approximately 35 m above the contact surface between the upper weak and the underlying competent marl (~+620 m absolute elevation), did not significantly differentiate the safety factor. Specifically, considering the envelope of the landslide or surfaces along obvious large scale movements within the total landslide mass as potential failure surfaces, the computed values of the safety factor ranged between 1.56 and 1.70. Assuming that any failure surface within the total landslide envelope was possible, the safety factor ranged between 1.22 and 1.57. Therefore, it was shown that the additional placement up to the specific level was only to facilitate the landslide removal and exploitation procedures and was not necessary for the stabilization of the landslide. In fact, locally, due to the existing geometry and morphology of the landslide, this additional placement could somehow reduce the available safety factor, as part of the deposits would actually increase the sliding moment for certain potential failure surfaces (pose additional loading to the landslide - see Figure 12 above).

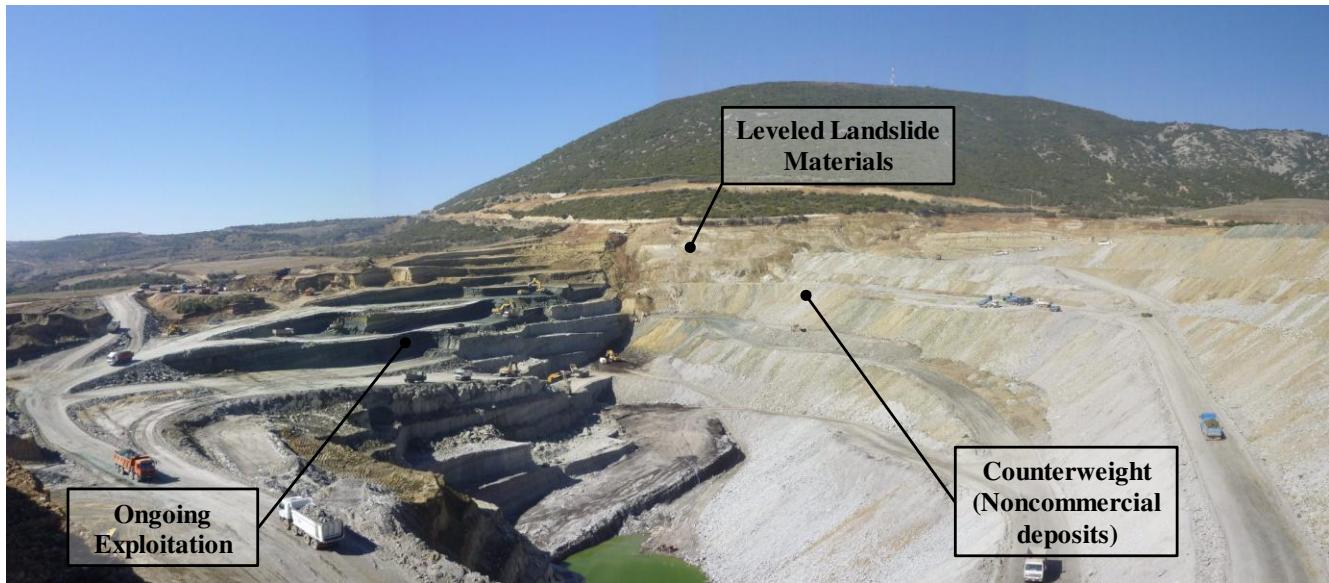
Figure 13. Aspect of the coal mine area after completion of counterweight construction and leveling works (March 2012).

The proposed rehabilitation scheme was successfully applied in order to stabilize the landslide before any intervention to its mass. The operation of the coal mine has continued without significant instability incidents ever since. The following figures show an aerial photo of the coal mine area and an aspect of the same from within the mine area, after completion of landslide counterweight construction and leveling of the landslide materials.

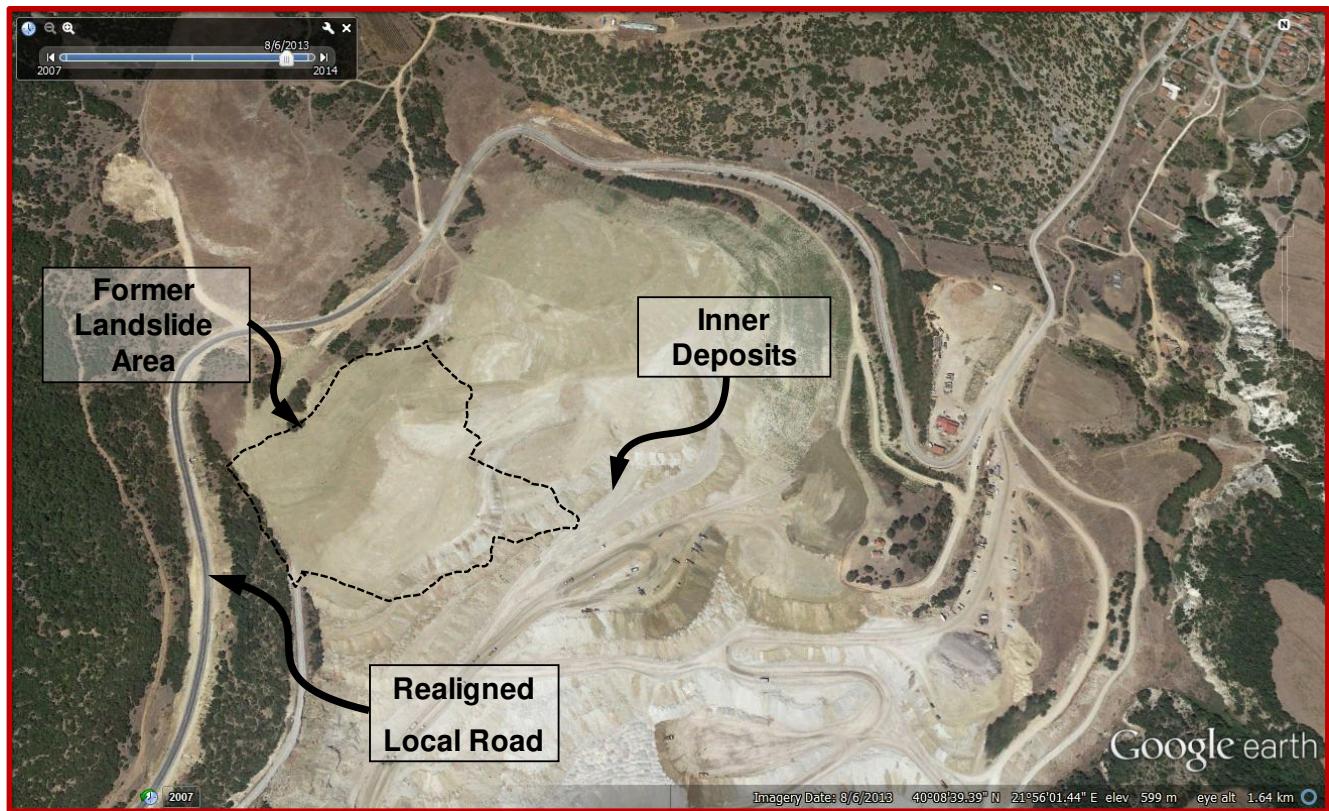
Figure 14. Aerial photo of the coal mine area after completion of counterweight construction and leveling works.
