Remediation of The Pissouri Landslide in Cyprus

Reference: Alexandris, A., Griva, I.K. and Abarioti, M. (2016). *Remediation of The Pissouri Landslide in Cyprus*. International Journal of Geoengineering Case Histories, Vol.4, Issue 1, p.14-28. doi: 10.4417/IJGCH-04-01-02

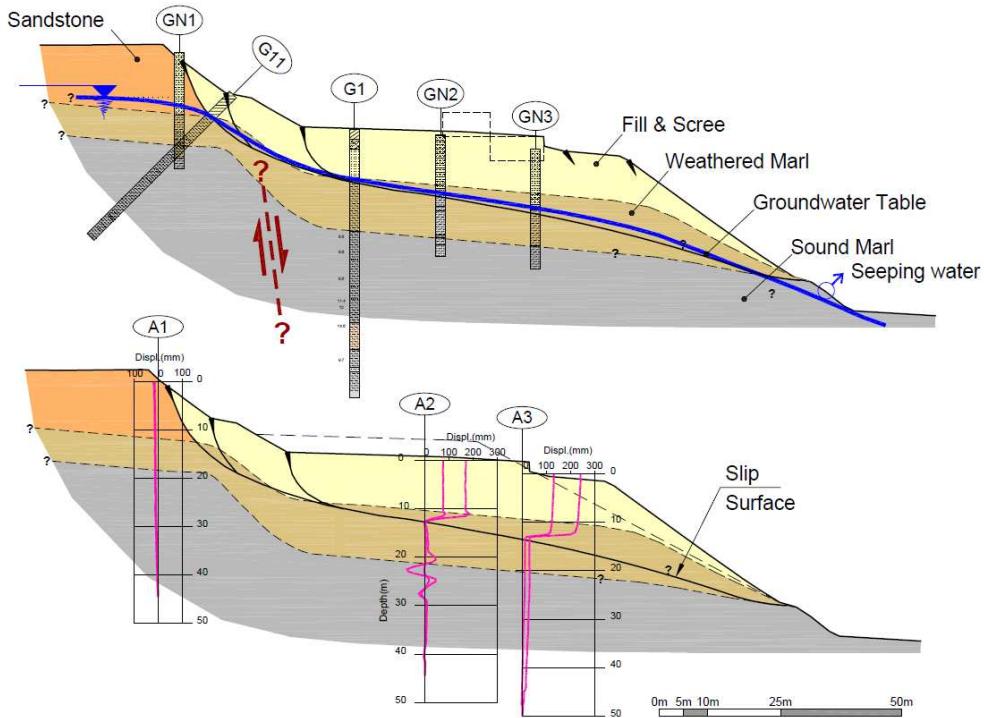
Figure 5. Geotechnical section along the sliding mass. Top: Exploratory boreholes Stratigraphy and ground water table
Bottom: Inclinometer readings and location of slip surface.

The slip surface was located by combining the monitoring data from the two inclinometer tubes (A2 & A3) installed within the sliding mass and the careful mapping of slope breaks and cracks, visible on the ground (in some cases), on the cracked pavement of the distorted road, the houses and the paved ground around them. The third inclinometer tube which had been installed further upslope did not show signs of movement (as shown in figure 5) and allowed the identification of the back scarp of the slide with confidence.

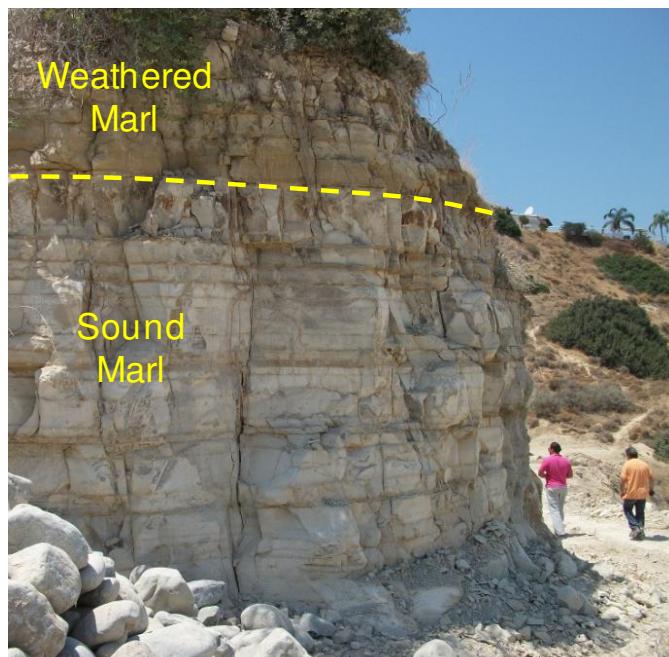
The bedrock is a low strength yellowish calcareous marlstone ($UCS \approx 10$ MPa), fairly undisturbed, but marked by a medium to thick bedding (10 - 100 cm) dipping with a low angle to south-southeast. Stress relief lead to the development of sub-vertical joints and fissures and water circulation gradually resulted to the development of a capping weathered crust. Weathering is associated with oxidization and decalcification of the marlstone, the gradual increase in pore volume (further promoting seepage) and subsequent intact strength degradation to that of a stiff soil. In the landslide site the thickness of the weathered marl crust is 5 to 10 meters and the material was encountered in places disturbed and sheared by the landslide movement. The succession of sound and weathered marl is depicted on the photograph of Figure 6, where the weathered material is noted by the distinct brownish color and its intense fissility. Soil samples obtained from the weathered zone are classified as CH-MH with a plasticity index (PI) ranging from 20% to 35% and clay fraction (CF) between 30% and 60%. Natural water content of the weathered marl does not exceed 30% and the material is generally stiff with SPT values ranging from 25 blows/ft to refusal. Typical classification test results from this zone are also presented in Figure 6.

Figure 6. Left: Typical appearance of the bedded calcareous marl and the overlying weathered crust.
Right: Typical soil classification test results performed on samples retrieved from the weathered marl zone.

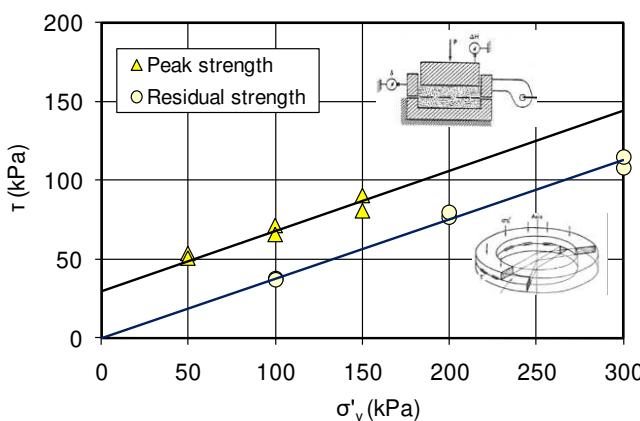
The shear strength parameters of the weathered marl, where the slip surface eventually developed, was investigated in the laboratory by means of a few slow (drained) shear box tests, which averaged to $c' = 30$ kPa and $\phi' = 21^\circ$ as shown in figure 7. Residual shear strength parameters, were obtained from ring shear tests (Broamhead ring shear apparatus) which yielded values of $c_r' = 0$ and $\phi_r' = 21^\circ$. The values of the residual angle of shearing resistance determined directly by the ring shear tests are compared with the dataset presented by Skempton (1985) (Figure 8) and are found to be in the upper bound of the scatter. This is probably due to the fact that the particular ring shear tests were carried out on fairly silty samples (classified as MH) and not on clayey ones.

Figure 7. Shear box and ring shear test results on soil samples from the weathered marl horizon. Peak strength $c' = 30$ kPa, $\phi' = 21^\circ$. Residual strength $c_r' = 0$ kPa $\phi_r' = 21^\circ$.

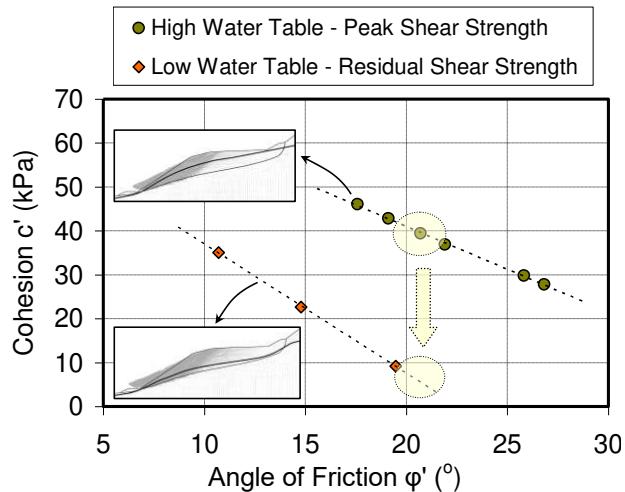
These analyses manifested the fact that an elevated water table can mobilize the weathered marl crust with operational shear strength parameters close to the peak values, as they were determined by the shear box tests performed on the soil samples. They also show that the slide remained mobile after water table lowering, (dry season) if the operational strength values of the weathered marl crust at the failure surface were close to the residual strength values, determined by the ring shear tests. It is concluded that most likely we deal with a new slide, which was brought in the verge of failure due to gradual loading of the upslope area with scree and manmade fill and the gradual progression of the weathering process. The development of high water pressures triggered an already mature slide, which continued to be active even during the dry seasons due to the drop of the shear strength values from peak to residual.

Figure 14. Back analyses results. Estimated mobilized shear strength parameters for a higher and lower water table coincide with the transition of shear strength values from peak to residual.

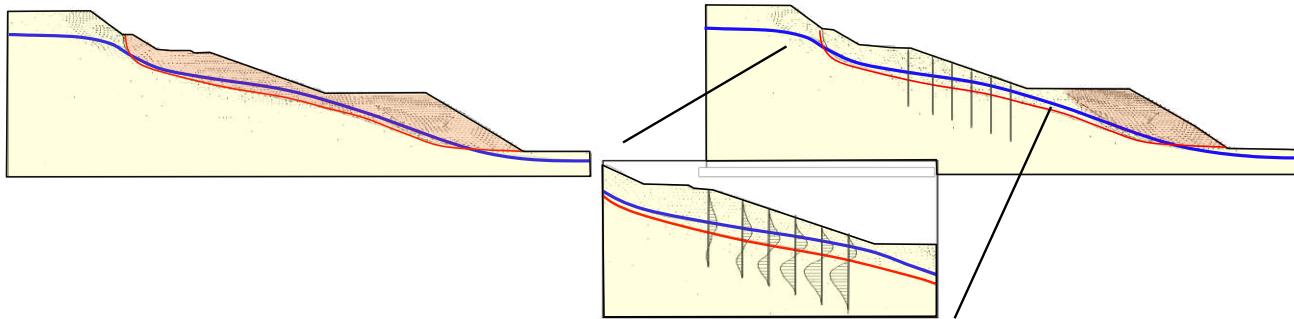
The construction of the toe buttress and the trimming of the upslope area of the landslide, lead to sufficient factors of safety (FOS=1.6) under normal conditions (low water table, static conditions), which though drop to low values with an elevated water table and very low values under seismic conditions. It was also observed that these low factors of safety are associated with mobilization of the entire sliding mass. The dowelling effect of the bored piles isolates and stabilizes the upper part of the sliding mass, while the lower part may remain more critical but still with sufficient FoS. Figure 17 depicts the critical sliding mode with and without the dowelling piles. In this case the raised water table yield a FOS = 1.6 and the seismic analysis a FOS=1.15.

Figure 17. Stability analysis of the remediated slope. Left: Without the stabilization piles the entire sliding mass mobilizes as a single body. Right: With the addition of the piles the toe buttress is more critical.

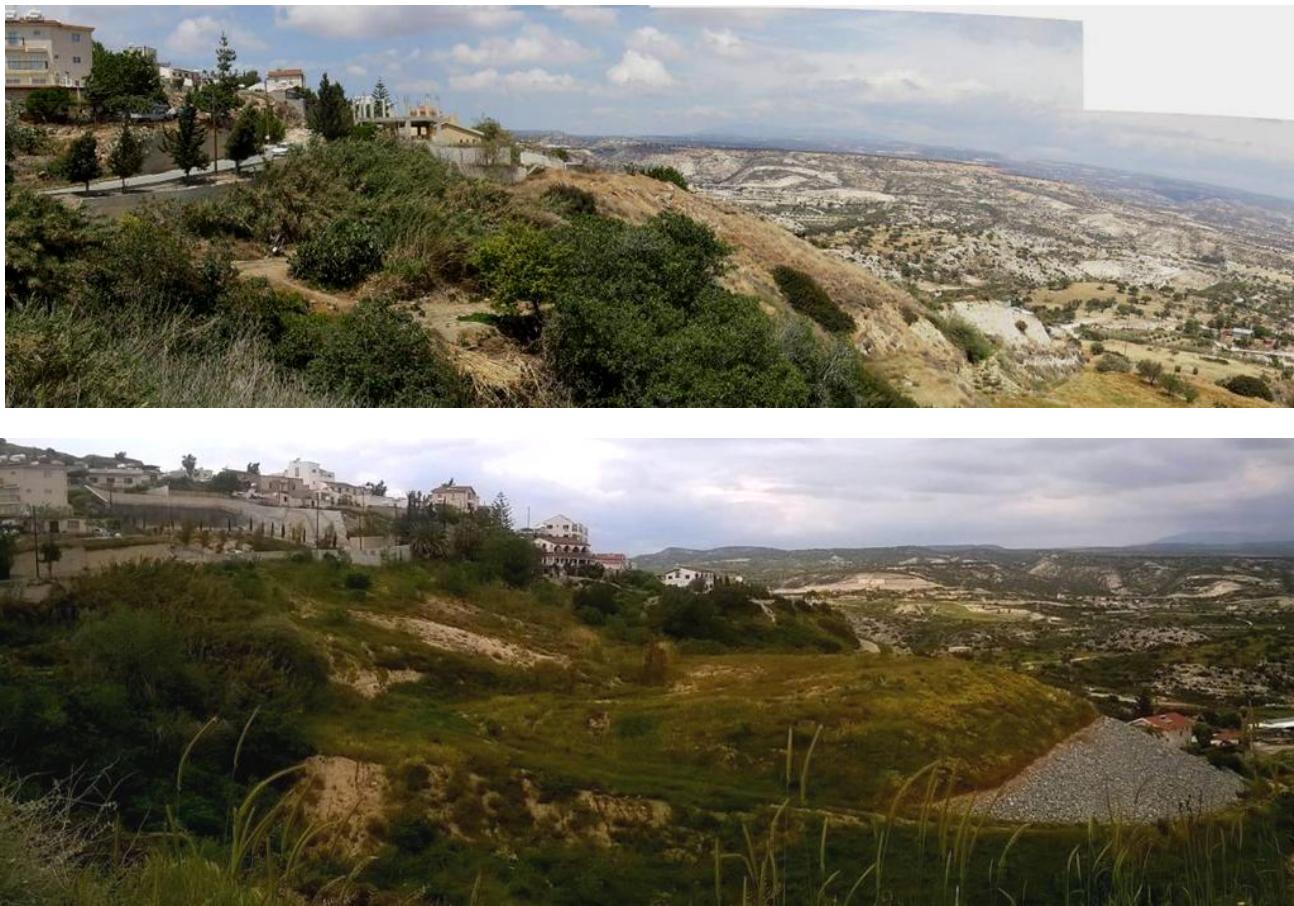
Figure 23. The landslide area before (top) and after (bottom) the stabilization works.
