A High Rock Cut Stabilization in Muscat City, Oman

ABSTRACT: A large road box cut was constructed in hilly terrain of Muscat city, Oman, in an area underlain by the geologically complex Sahtan and Mahil formations comprising of limestone, dolomite, sandstone and siltstone with interbedded soft calcareous mudstone. The rockmass contains a large number of small scale faults, shear zones, minor folds and solution cavities. The maximum height of the cut was 50 m with slope angle of 1V:0.25H, and intermediate benches generally 3 m wide. To control vibrations in the urban neighborhood located nearby and avoid damage to the rockmass, a very cautious and time consuming excavation approach was adopted using rock breakers. The excavation work was completed in 2010. Oman has a hyper-arid environment with scarce rainfall for many months. However, occasionally the area is hit by intense rainstorms. During Cyclone Phet and accompanying rains in June 2010, part of the cut slope failed with a downslope movement of about 800 m³ of massive rock. This necessitated a post-excavation re-evaluation of the cut slope, which culminated in design modifications, and construction of long term slope stabiliza

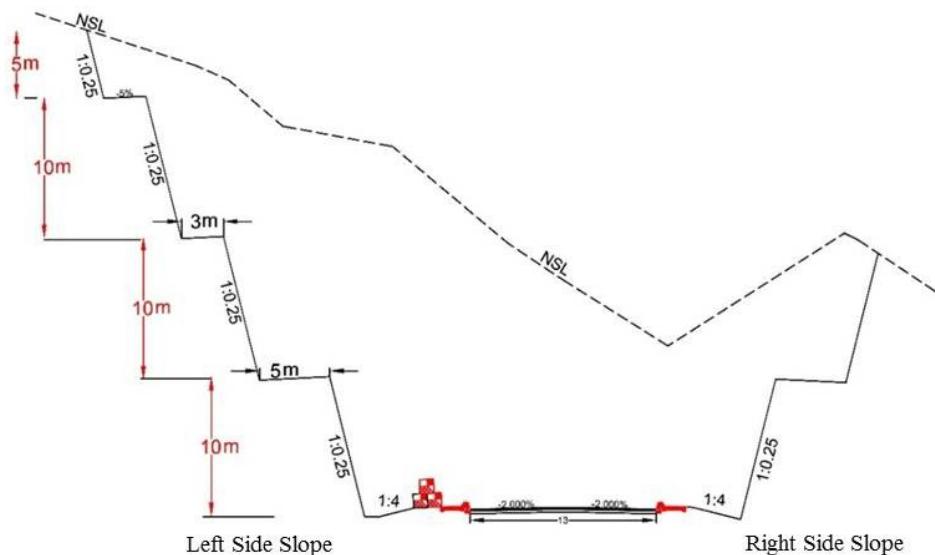
Figure 2. Slope and roadway configuration at station RD 0+420 m in Box Cut#1.

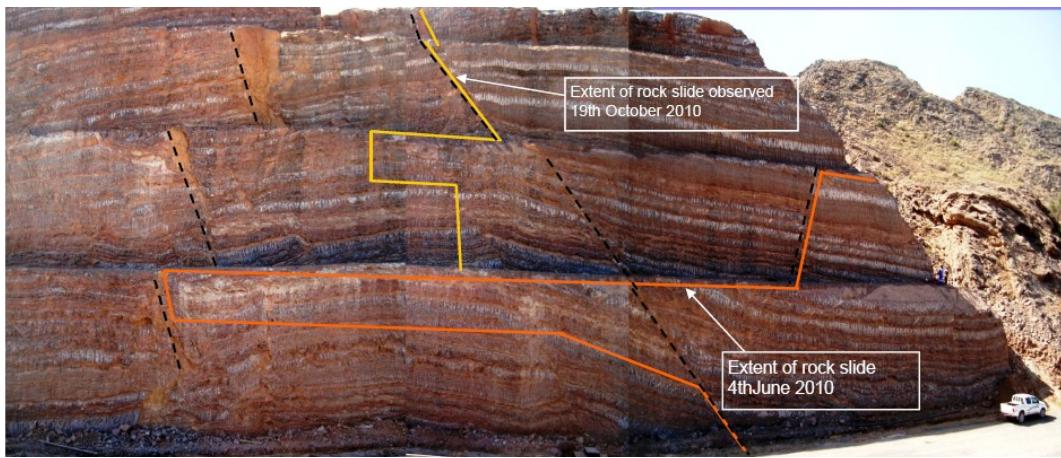
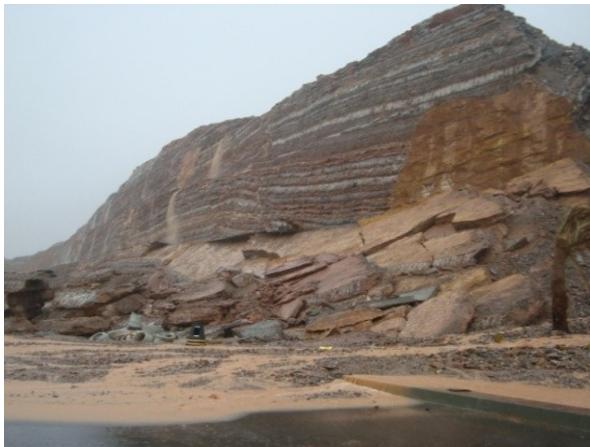
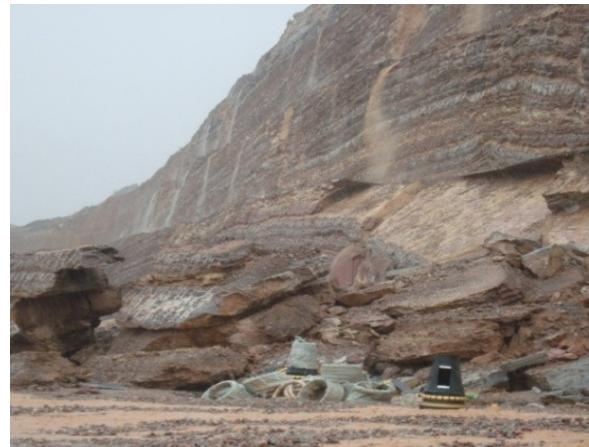
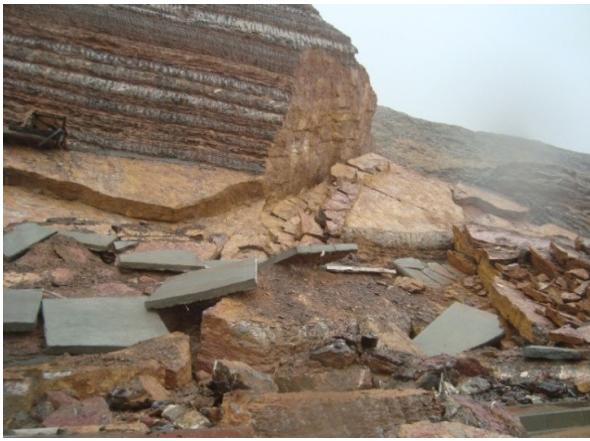
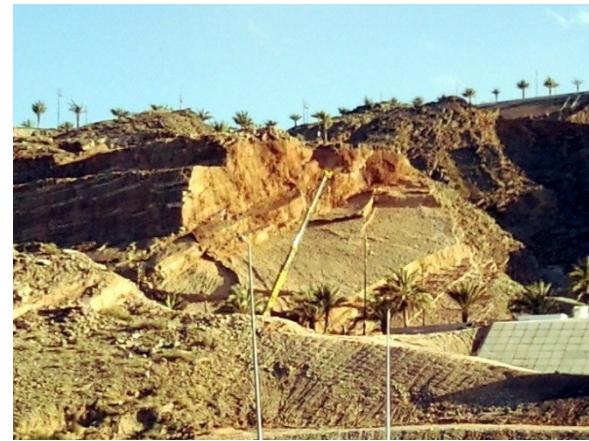
This rainfall caused a rock slide on the left side of the Box Cut # 1, from RD 0+380 m to 0+480 m. This section constituted the farthest edge of the cutting. On this side of Box Cut #1, a small wadi (valley) is located behind the slope. This was used as a channel for diverting the storm water from the catchment areas behind the slope. This wadi has steep gradient and was unlined at the time of slope failure.

Photographs taken just after the rain storm showed that the failure had occurred initially as a single event. Failure occurred along a 40° dipping bed in the lowest slope, which extended to the inner edge of the first berm and a near vertical joint forming the release plane. The photographs taken at that time also showed a large amount of water transported debris coming out from the above mentioned wadi adjacent to the failed area. Water was also noticed cascading over the crest of the main rock cut.

With the passage of time, the extent of the initial failure grew in size as more and more rock mass adjacent to the initial failure area failed progressively. Within a couple of weeks of the initial event, the failure grew to the top of the 35 m high cut, extending about 20 m along the crest and reaching as far as a steep joint with a strike of about 260° (N100 deg W), and dip of more than 70°. The total volume of failure was estimated at 800 m³ (Figure 4).

From site observations, it was concluded that the failure initiated along a laminated bed of argillaceous rock layers, which had the least shearing resistance of all the rock mass at the site. The failure undermined the slopes above it and caused their failure, which progressed in the weeks ahead of the initial event.

The main triggering factor was the increase in water pressure associated with the rainfall event. The Box Cut # 1 slope at the farthest end was exposed to weather on three sides; the front cut face, the edge face and behind in the wadi (valley). It is likely that the water in the wadi overflowed and infiltrated the loose jointed and bedded rock mass. It is also likely that the small solution channels formed conduits for water that entered the formation, contributing to the failure. Although the rock mass appeared visibly stable in the area after a few weeks, there were other bedding / joints in the area that could cause further instability in the future, especially under wet conditions.

Figure 4. Top photo provides an overall view of the slope face prior to sliding and the extent of two episodes of sliding on June 4th and October 11th 2010. The lower frames, except the lower right corner view, show sliding during Cyclone Phet, while the lower right corner view shows the resulting slope face after the final collapse on October 11th 2010. The sliding along the bedding and a vertical joint, a free release plane along the overspilled wadi, is an obvious reason of sliding during cyclone Phet.

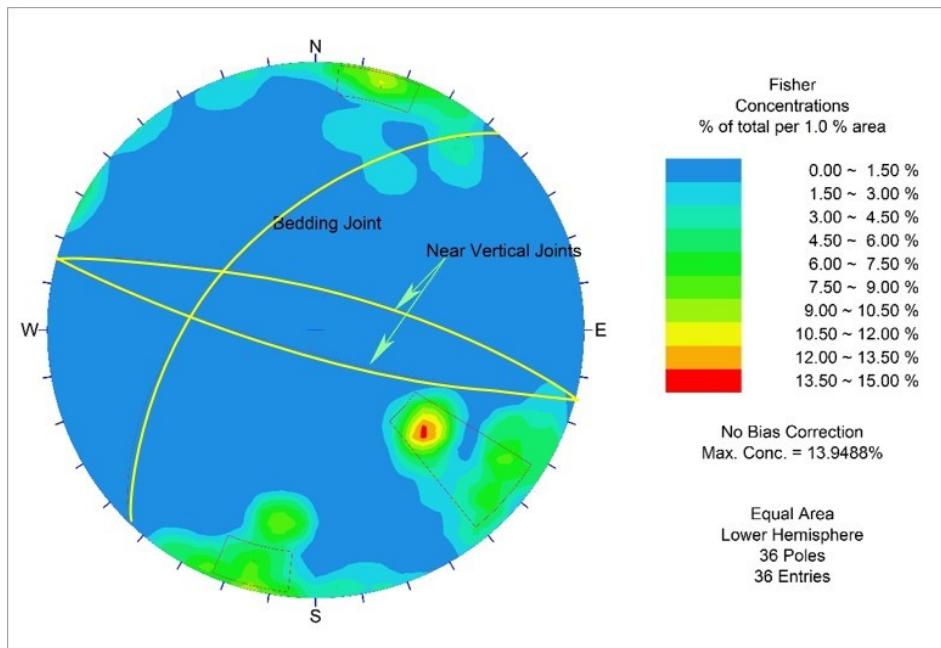
In Box Cut #1, from approximately RD 0+220 to 0+500 m, the interlayering of the beds is quite prominent and dips at 30° to 45° daylighting out of the face and within +/- 20° of the face orientation. In addition to the bedding, there are joints and faults that are steeply dipping at 70° to 90° and strike NE-SW or SSW. These joints have high persistence over all cut benches to the full 40 m height. Some of these features are faulted with noticeable displacements. Figure 5 shows the pole plot of the joints and great circles drawn through the centre of poles concentration by visual examination.

Figure 5. Stereoplot of the discontinuities representing the left slope in Box Cut 1.

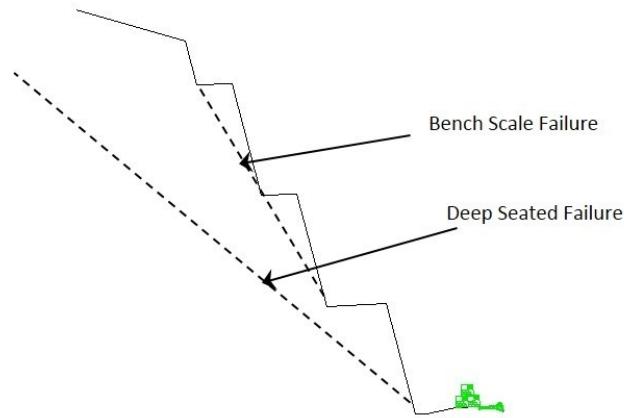
The orientation of bedding planes along various berms showed appreciable variation in the dip inclination. However, previous failures and site observations led to the conclusion that the most likely inclination of the failure plane was 40°. Also smaller scale failures involving one or two benches and larger global scale failures with deep seated planes were both possible. Based on the above, the following expected failure planes were considered in the re-assessment of slope stability:

Figure 8. Illustration of relatively small scale and multiple bench (deep) failure planes assumed in stability analysis of Left Face Slope at Km 0+400 m.

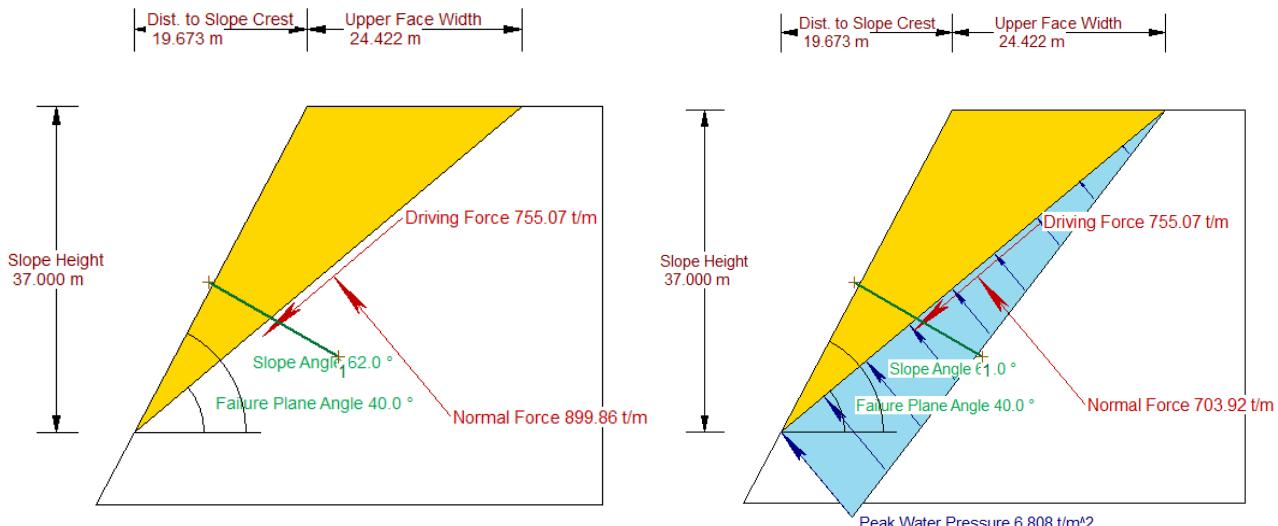
Figure 9. The driving and resisting forces against the calculated FOS 1.12 and 1.01 for dry and wet slope (15 m water head) respectively.

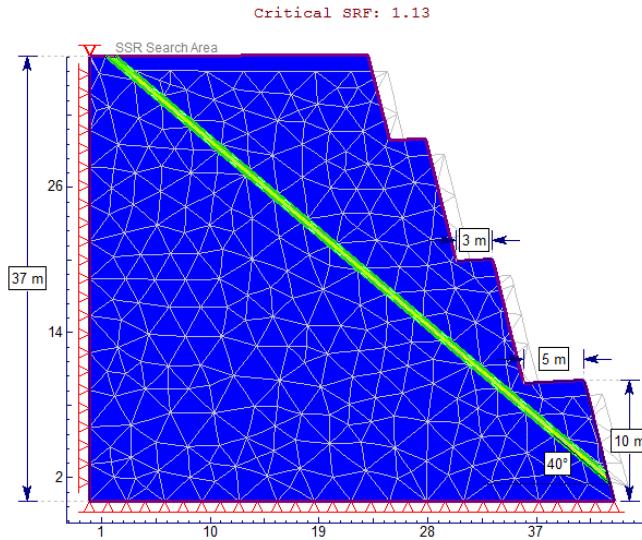
From the table above, it is can be observed that the Factors of Safety from the three approaches used are in general agreement. Figure 10 below shows the exaggerated deformed FE mesh of the upper sliding block for the SRF = 1.2 (In Dry Condition) for which no FEA convergence occurred.

Figure 10. Deformed mesh for the $SRF = 1.2$ (in dry conditions) for which no FEA convergence occurs. The maximum SRF for which the FEA satisfies the state of equilibrium is 1.13.

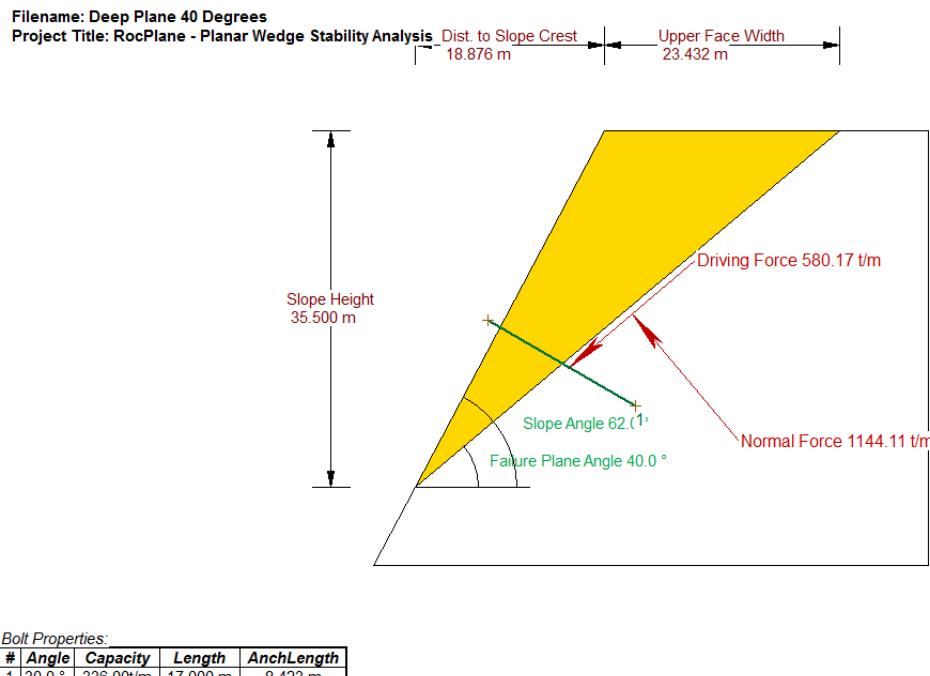
Figure 11. Factor of Safety (FOS) in dry condition with 3360 KN/m external force applied through designed cable anchors.

After several trials using different applied normal stresses on the failure plane, seven strand anchors of 1200 KN working load at 2.5 x 2.5 m grid (3400 KN/m) for a 35 m high slope were selected. The results of factor of safety using the 1200 KN anchors on the deep sliding planes are presented in Figures 11 to 14 and are summarized in Table 3.

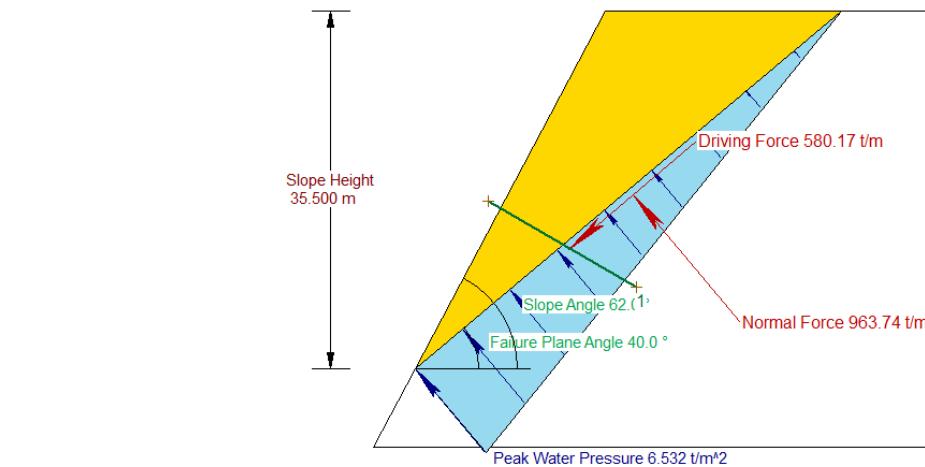
Figure 12. Factor of Safety (FOS) in wet condition under 15 m water head and 3360 KN/m external force applied through designed cable anchors.

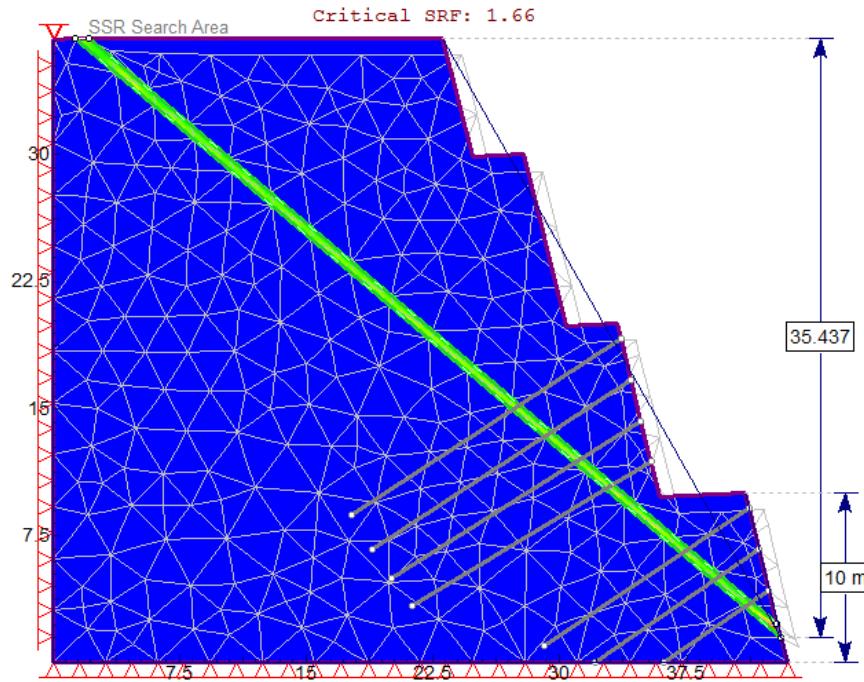
Figure 13. Deformed Mesh for the SRF = 1.72 (in dry conditions) for which no FEA convergence occurred. The critical SRF for which the FEA satisfied the condition of equilibrium with 7 strand anchors of 1200 KN (2.5 x 2.5 m grid) is 1.66 as shown.

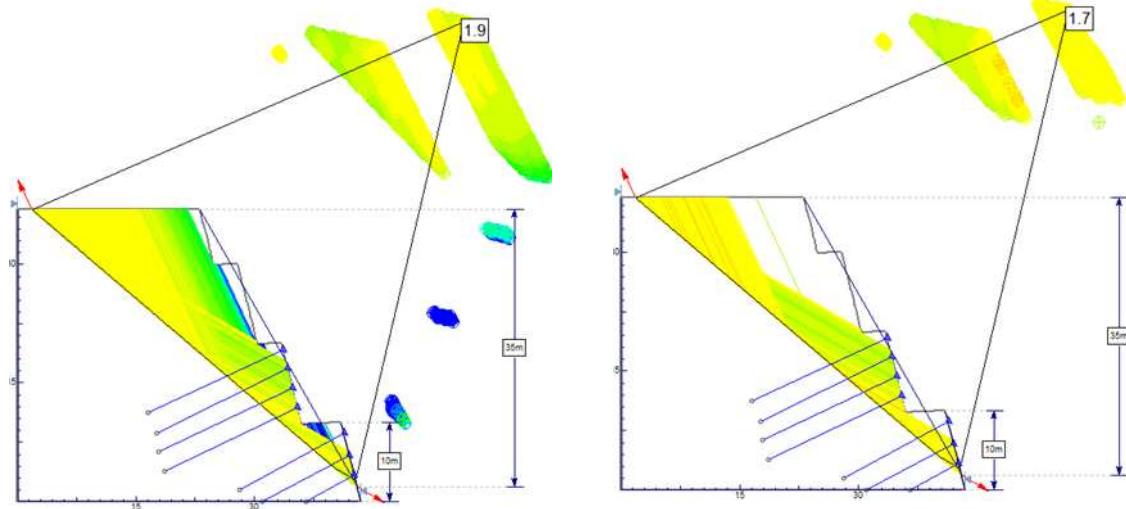
Figure 14. FOS with 7 x 1200 KN anchors in dry condition using Bishop (left) and Morgenstern-Price (right) methods.

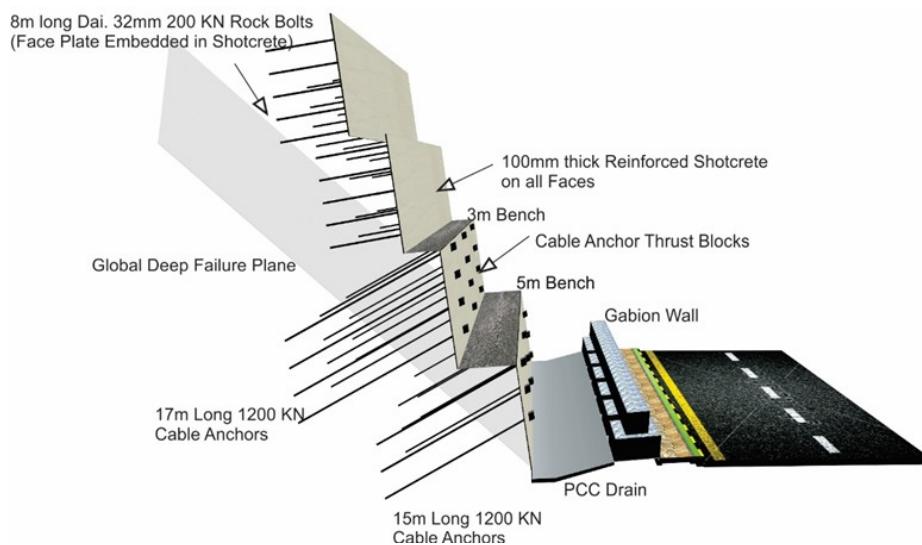
Figure 15. 3D Conceptual arrangement of reinforcing elements at both the 20 m terminus of 500 m long left slope of Box Cut #1.

It was therefore concluded that the ends of box cut #1 were most vulnerable as at these locations large and deep seated failures were kinematically possible, whereas in the middle of these slopes, only shallower failures would be possible, the unstable wedges being confined at both ends. It was therefore decided to reinforce only the terminus of the 500 m long vulnerable slope with 1200 KN cable anchors. Other intermediate and cut faces above the cable anchored slopes were, however, reinforced with 200 KN rock bolts to control the comparatively smaller scale failures. The rock bolt heads were tensioned on steel plates resting on epoxy cement base. For long term durability, the steel plates were embedded in the shotcrete. The anchor heads of high capacity cable anchors were installed on specially constructed reinforced concrete anchor blocks. A typical arrangement of the reinforcement pattern at cut slope ends is shown in Figure 15.

The arrangement of stabilization measures shown in Fig. 15 were implemented and are performing satisfactorily for the last six years.
