Geotechnical Damage Caused by the 2016 Kumamoto Earthquake, Japan

Reference: Kiyota, T., Ikeda, T., Konagai, K. and Shiga, M. (2017). *Geotechnical Damage Caused by the 2016 Kumamoto Earthquake, Japan*. International Journal of Geoengineering Case Histories, <http://casehistories.geoengineer.org>, Vol.4, Issue 2, p.78-95. doi: 10.4417/IJGCH-04-02-01

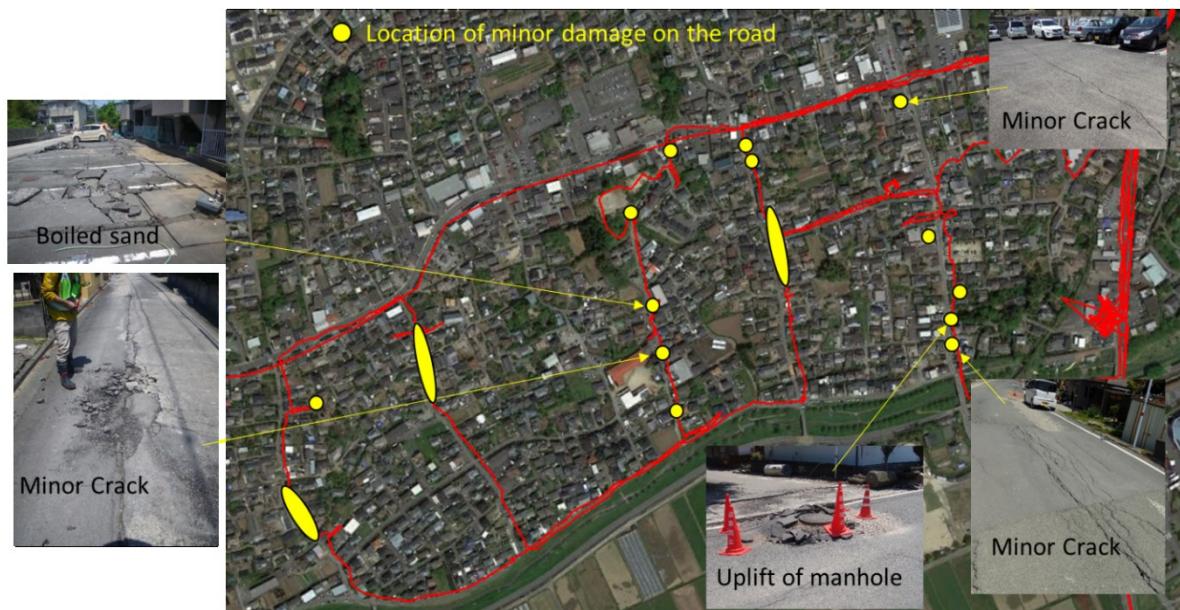
Figure 15 shows the result of the authors' quick survey. The spatial distribution of the collapsed houses was concentrated in the sloped area which consists of terrace and talus deposits, whereas ground deformation observed on the roads near the damaged houses was limited, therefore a large scale landslide might not have occurred. The cause of significant damage to the houses in this area was likely due to earthquake motion and the residual displacement of the entire sloped ground had an insignificant effect on the damaged houses. Although some houses were found to be damaged by ground deformation, as shown in Fig. 16 and 17 (sites 8 and 9), they were likely caused by localized failure of filled soil. On the other hand, the damage to the houses in the alluvial deposit area was limited whereas evidence of liquefaction was found frequently as shown in Fig. 15. It is inferred that the liquefied soil incidentally behaved like a seismic isolation system for the residential houses in this area.

Figure 15. Result of survey on ground deformation of sloped residential area in Mashiki Town (c.f. Figs. 12 and 14).

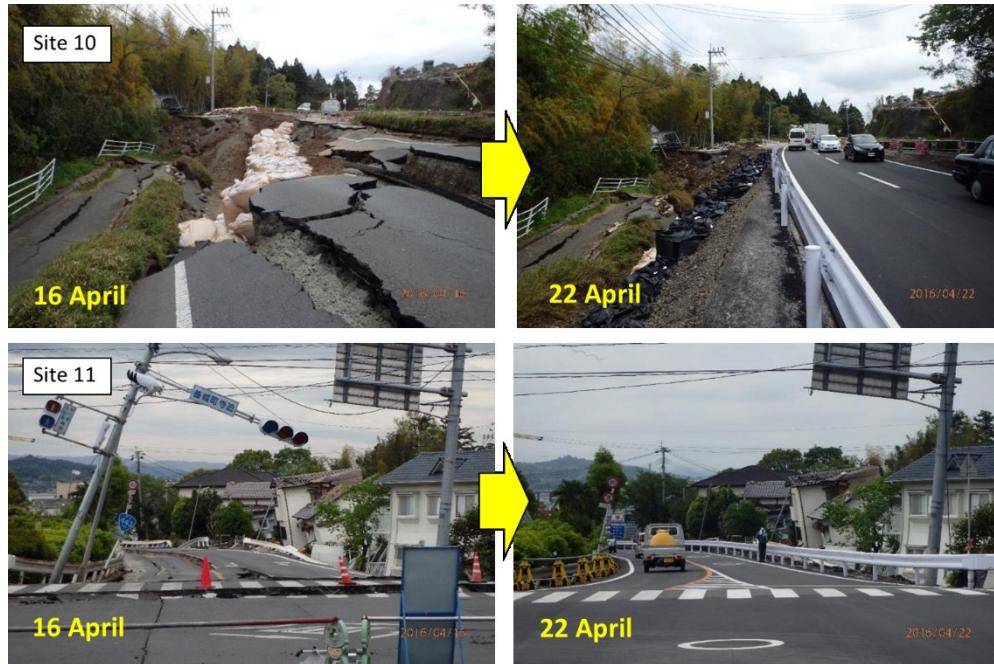
Approximately 150 m south of the above damaged site a differential settlement was observed (Photo 12b, site 11). According to the landform classification map in Fig. 14, it is indicated that the damaged site was recently constructed on the alluvial soil deposit. The damage, therefore, is attributed to strength reduction of foundation ground due to a process of liquefaction and/or that of the embankment, if the compaction work was inadequate. Immediately after the earthquake, emergency restoration work was rapidly conducted in the affected areas. As shown in Fig. 19, the restoration work for the damaged sites along Route 443 was completed a few days after the main shock.

Figure 19. Damages to Route 443 and their restoration for (a) site 10 and (b) site 11 (c.f. Figs. 12 and 14) (Site 10: $32^{\circ}47'29.71''N$, $130^{\circ}49'17.58''E$, Site 11: $32^{\circ}47'24.33''N$, $130^{\circ}49'15.82''E$).

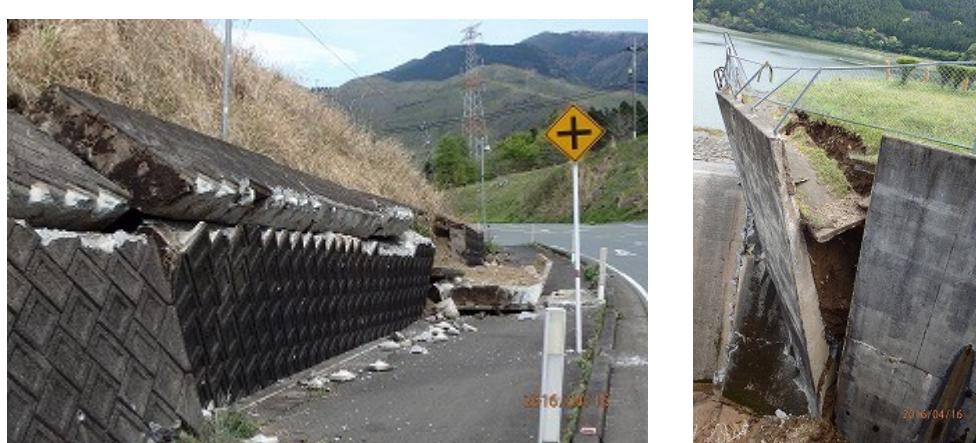
Mashiki and the surrounding areas were close to the seismic fault and suffered from a variety of geotechnical and structural damage due to the earthquakes. Damage to gravity-type and cantilever-type retaining walls (2-3 m high) was found at several locations due to surface manifestation of fault rupture. The retaining wall and dam spillway retaining wall at site 12 in Fig. 12 were structurally damaged as a result of the fault movement (Fig. 20).

Figure 20. Damage to retaining wall and spillway retaining wall (site 12 in Fig. 12) ($32^{\circ}50'29.22''N$, $130^{\circ}55'55.83''E$).

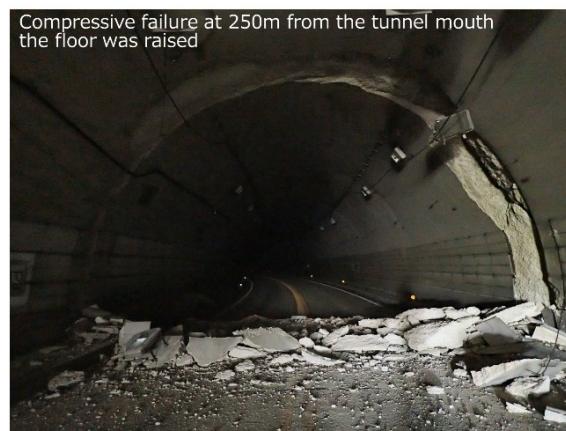
Figure 25. Tawarayama tunnel suffered from axial compression failure (Site 16 in Fig. 12) (32° 51'35.68"N, 130° 58'6.86"E).

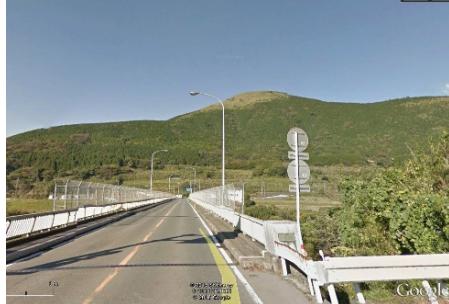
Figure 28 shows a shallow landslide near Aso Ohashi Bridge caused by the main shock on the 16th of April (site 17). The landslide had a height of about 300 m (measured from the road level to the scrap) with an inclination angle of about 50 degrees at the top and about 25 degrees at the middle and bottom of the slope. The debris was a mixture of middle Pleistocene volcanic soils and boulders (tuff breccia); Route 57 and JR Hohi Main Line (railway) was also covered by it. The debris travelled a distance exceeding 800 m and fell into the Kurokawa-River along with Aso Ohashi Bridge. Evidence of mud debris was found on the opposite side of the river which is thought to have travelled along the bridge before its collapse. For this reason, the cause of bridge failure is considered to be the impact force and/or weight of debris that flowed down from the landslide source. Moreover, in Figure 28, taken one day after the event, water seeped out from the failed surface, which may explain the reduction of shear strength of the slope ground due to increase in excess pore water pressure during the intense earthquake.

Figure 28. Landslide near Aso Ohashi Bridge (site 17 in Fig. 26).
(32° 53' 0.02"N, 130° 59' 22.80"E).

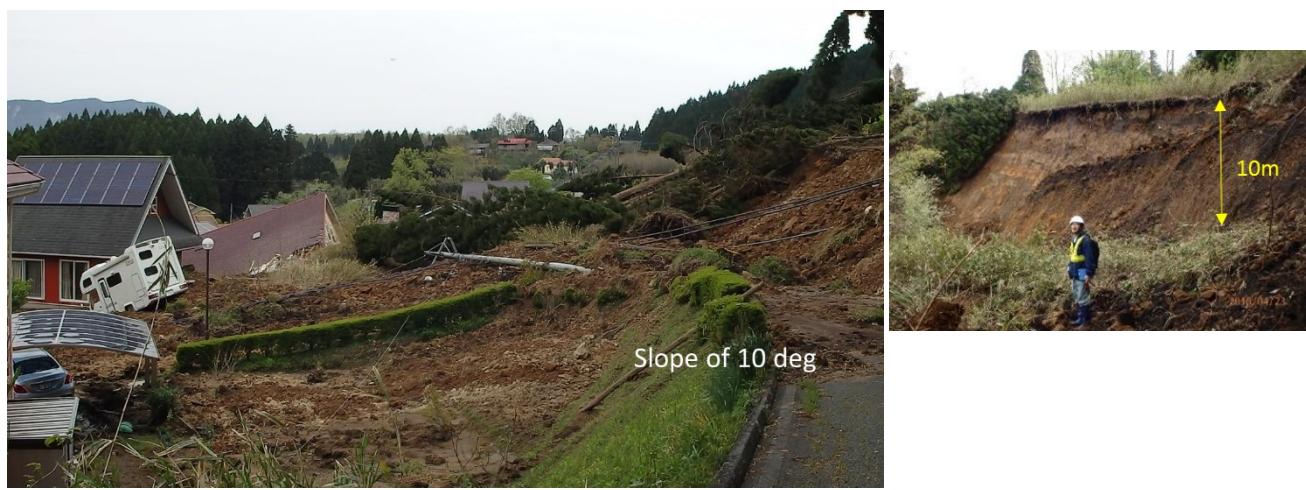
Figure 30. Landslide at gentle slope and its scrap (site 19 in Fig. 26) ($32^{\circ} 52'29.42"N, 131^{\circ} 00'49.36"E$).

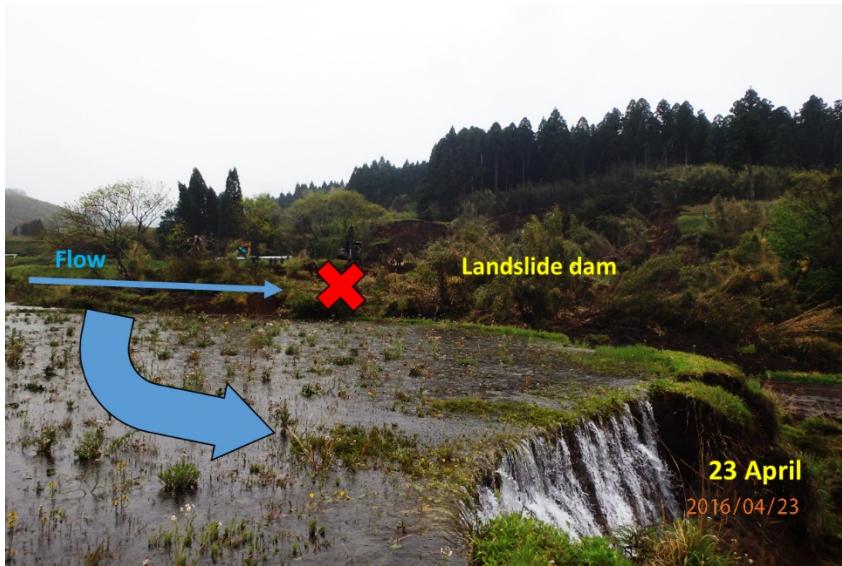
A slope failure was observed at site 20 in Fig. 26; the length of the failure was about 100 m. The debris blocked the road and a tributary of the Kurokawa River completely; the blocked tributary overflowed with water spreading into the surrounding paddy field (Figure 31). To avoid the potential risk of flooding to the downstream villages following the landslide dam breaching, the relevant authority had excavated a spillway to secure the safety of the dam. The excavation was likely finished within two weeks of the event.

Figure 31. Landslide dam formed by the earthquake and excavation work completed (site 20 in Fig. 26)
 $(32^{\circ} 53'14.06"N, 130^{\circ} 59'48.90"E)$.

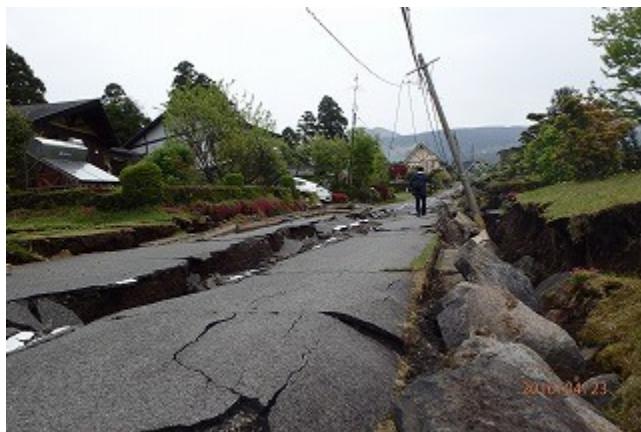
Figure 32 and 33 show damage of the road and house at site 21. Although this area reportedly survived the earthquake on the 14th of April, significant distortion of subsurface ground occurred during the main shock on the 16th of April. The spatial distribution of damage was severe at the northern part of the residential area. Figure 34 shows a comparison of aerial photos taken in 1975 and in 2016 (GSI, 2016), indicating that the damaged area used to be a paddy field but had subsequently been infilled during the construction of the housing estate. The filled soil in the damaged area is a local volcanic ash soil. Tanoue et al. (2005) reported that it is usually hard to construct a stable embankment from the ash deposited in the Central Kyushu area. It seems from Fig. 34 that the ground level of the northern part of the residential area was comparatively low in 1975, the filled soil might have been thicker for the northern side than the southern side. This might be why the earthquake-induced damage to the land was found to be severe in the northern side, however, structural damage to the residential houses in this area was negligible despite large ground deformation.

Figure 32. Damage to the road in residential area developed by filling (Site 21 in Fig. 26)
 $(32^{\circ} 52'43.89"N, 130^{\circ} 59'58.89"E)$.
