# Uplift of an Underground Tank in Northern Malabar Region, India

**ABSTRACT:** An underground reinforced concrete tank was constructed for a project in the southwest region of India. The tank was 90 m x 35 m in plan and 7.3 m deep resting on partly filled-up and partly native soil. During the peak monsoon, a sudden uplifting of the base slab by about 300 mm and subsequent failure of the foundation raft and a partition wall was observed. Laboratory testing was executed and hydrogeological survey was carried out using ground penetrating radar, seismic refraction and infiltrometer testing, and an analytical study was carried out to identify the root cause of the tank uplifting. Based on this study, it was observed that the uplifting and structural failure was essentially due to the peculiar land terrain and soil properties and the development of excess hydraulic head below the bottom of the tank. After considering different options, the rectification measures were carried out by provision of dewatering wells along the tank periphery to release the excess hydrostatic pressure and stabilize the foundation raft. The structural repair of the top of the foundation raft and partition wall

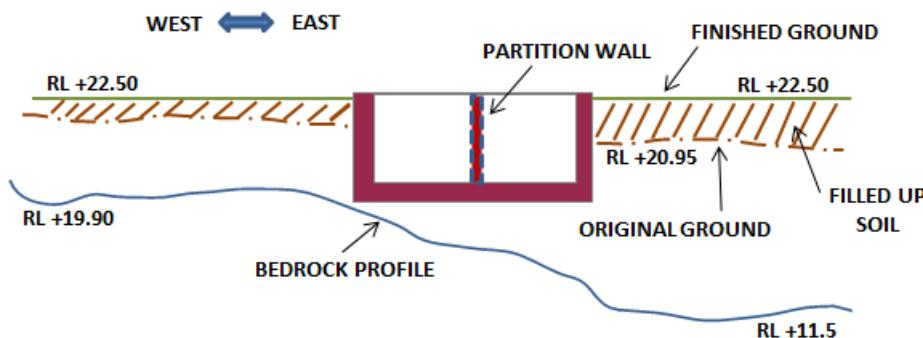
*Figure 1. Topographic features near the tank.*

The overall topography of the project site was sloping from west towards the east. The profile of bedrock was also dipping down from west towards the east as shown with varying reduced levels (RL) in Fig. 1 along with the relative location of the tank.

The general topography and geological features of the surrounding area indicate that the ground level elevation is increasing towards the west, further away from the tank location. The difference in elevation of the ground surface at the tank location and the surrounding areas has led to large amount of water flow from surrounding areas towards the tank during rainy season. Also as indicated in Fig. 1, the presence of the bedrock, which was dipping downward from west towards the east, has caused the water to flow from higher elevation to lower elevation i.e. from west towards the east direction along the bedrock surface.
