Lessons Learned from Dike Failures in Recent Decades

ABSTRACT: The paper describes five different dike failures that occurred in recent decades. The case histories were located on different rivers and involved different loading conditions. The observed failure mechanisms involved erosion and stability problems. The types of erosion observed were both internal erosion due to extreme groundwater flow and external erosion caused by the river flow and wave action. The case involving instability was caused by uplift, i.e., increased hydraulic head led to a sharp reduction in maximum shear strength between subsoil layers. Two cases demonstrate the importance of dike management and maintenance. Despite the variations in the loading conditions and failure mechanisms, all the cases show that the strength of a dike depends not only on the material used to build the dike but also on the strength of the subsoil.

Lessons Learned from Dike Failures in Recent Decades. International Journal of Geoengineering Case Histories, Vol.4, Issue 3, p.203-229. doi: 10.4417/IJGCH-04-03-04

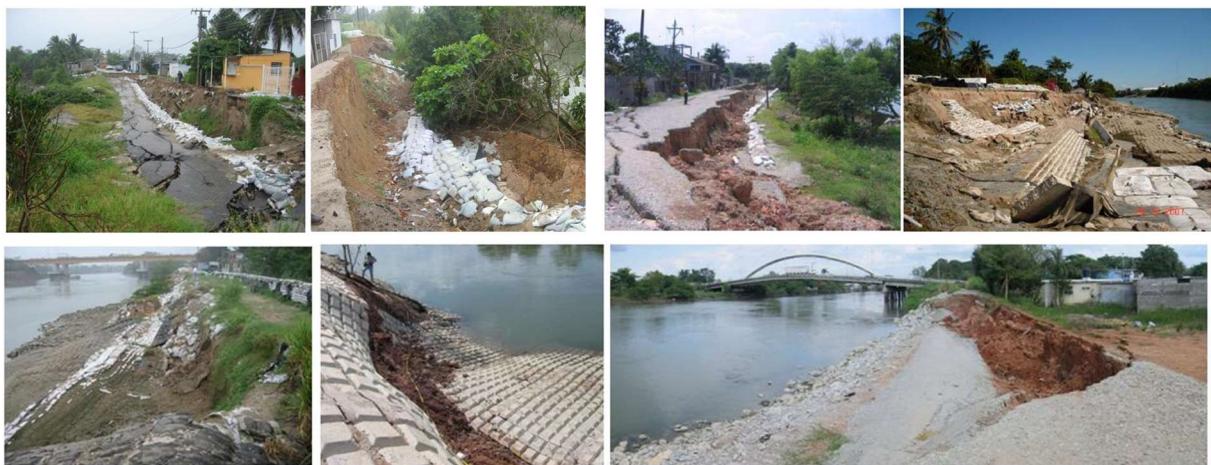
gradients generated by these fluctuations – and rain infiltration in the crests of the dikes (Figure 3). Auvinet et al. (2008) observed that problems in river banks commonly begin with erosion which, depending on the type of soil, can cause piping in some areas, possibly resulting in landslides (Figure 4). These eroded sections are generally protected with dikes consisting of clayey material. Elements that can better withstand erosion by river water are also used, examples being rock fill, systems with concrete bags (*bolsacreto* or *colchacreto*), breakwaters or sheet pile walls. River embankments may also fail when the weight of these structures exceeds the bearing capacity of the foundation soil (Figure 3). Generally, failure occurs in layers with low shear strength such as the highly compressible clays and peats which are found in unpredictable locations along the banks of the rivers in Villahermosa (Figure 1). It has also been found that factors such as scour of the riverbed and over-loading caused by the weight of additional protection such as sand bags result in dike instability. In addition, intense rainfall in the region can cause large and rapid variations in the levels of local rivers, lagoons and reservoirs.

Figure 3. Consequences of water drawdown in Tabasco State, Mexico

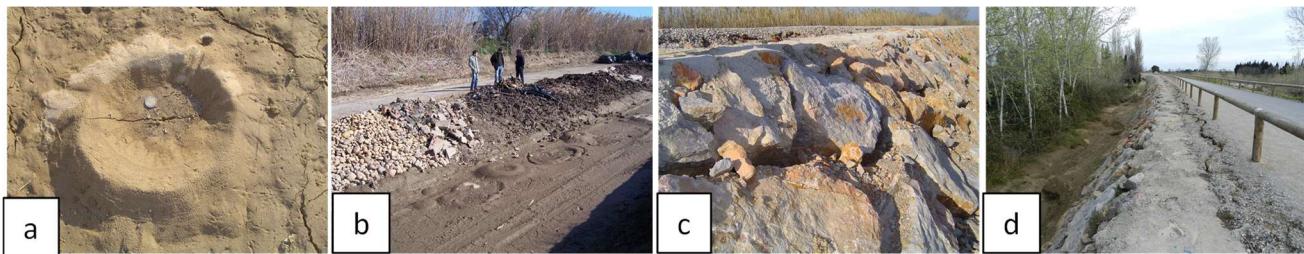
This was also a moderate event: about 800 m³/s at Rivesaltes. However, it lasted longer: 18 hours rather than the 12 hours in the November 2005 event. The dikes were loaded up to 1/2 to 2/3 of their height. CEMAGREF quickly conducted an inspection of a section of 500 m which had been identified in 1999 as being prone to sand boils. A recommendation had been made to install a drainage and seepage system on the landward side. Some of this work had been completed in 2000 with supervision from the managing authority at the time (an association of local authorities). During the winter of 2004-2005, the landward side of the dike was reinforced with concreted riprap to render it resilient to overtopping. During the 2006 event, a section of 130 m in the same location suffered damage caused by internal erosion in the form of sand boils (Figures 13a, b) and subsidence over a strip of up to 1-2 m wide in the protected plain close to the dike, including the maintenance track, and cracking of the concreted riprap (Figures 13c, d).

Figure 13. a) Sand boil (photo: Pierre Philippe, CEMAGREF), b) Multiple sand boils close to the maintenance track on the landward side of the dike (photo: Patrice Mériaux, CEMAGREF), c) Damage to the dike itself: cracks on the crest and in the riprap landside revetment (photo: Pierre Philippe, CEMAGREF), d) Damage to the dike itself: crack on the crest; this picture was taken in 2013 but similar damage occurred in 2006 (photo: Patrice Mériaux, Irstea).

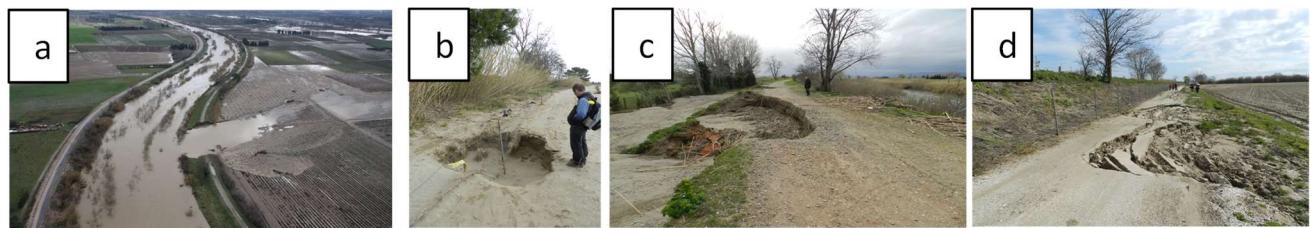
The discharge during this event is also estimated to have been approximately 1000 m³/s. There was a breach over a 75-m section in one of the areas prone to sand boils (Figure 14a). The dike itself was eroded, as well as its foundations down to the depth of the minor river bed. The exact cause of the breach is not known because there were no eyewitnesses close to the dike at the time of the breach initiation about 2 hours after the maximum discharge. The breach may have been caused by internal erosion in the dike or the foundation soils, with possible local overtopping following internal erosion and collapse. A large sinkhole was found close to the breach (Figure 14b). Significant additional damage was observed as a result of overflowing (Figure 14c), internal erosion and foundation instability (Figure 14d), as well as internal erosion in the dike itself at one location.

Figure 14. a) The March 2013 breach at the Pia location on the right of the river (photo: DREAL Languedoc-Roussillon), b) A sinkhole close to the breach (photo: Patrice Mériaux, Irstea), c) Damage caused by overflowing (photo: Patrice Mériaux, Irstea), d) Damage to a track on the landward side of the dike caused by under-seepage (photo: Patrice Mériaux, Irstea)

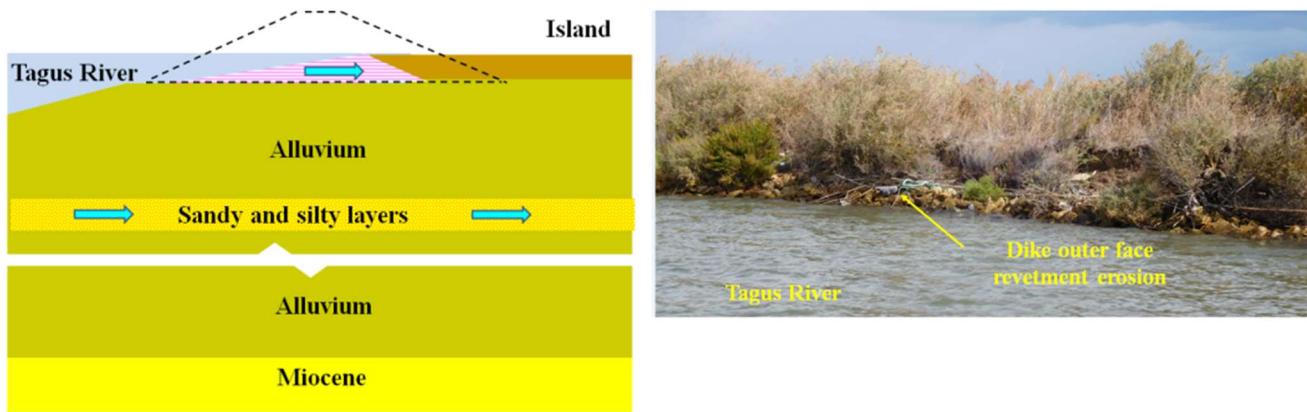
The main failure mechanism is related to the erosion of the clay fill due to water inflow and the mechanical action of the waves on the outer face of the dike. Failure originated with the erosion of the riprap revetment (Figure 39). The presence of a permeable sandy layer below the dike foundations also contributed to the failure mechanism. The actual dike failure began during the severe winter of 2015 - 2016 and involved a section with an overall length of approximately 30 m. When the failure occurred, the water level in the Tagus River was approximately Mean Sea Level, MSL, +4.20 m. In October 2016, the overall length of the dike failure line had increased to approximately 80 m.

Failure due to the clay fill erosion (Tagus river waves start to erode the rip rap revetment)

Figure 40. Dike failure due to the erosion of the clay fill, cross-section and view of the outer face.
