Geotechnical Observations of Dams Failed During the 2015 Historic Flooding in South Carolina

ABSTRACT: This paper presents a description of post-flood reconnaissance and geotechnical investigation of four earthen dams that were breached or damaged following an extreme flooding event in South Carolina in 2015. As a result of unprecedented rainfall and flooding that occurred during a five-day period at the beginning of October in 2015, a total of 51 earthen dams failed and nearly 200 were damaged. Many of these dams failed due to overtopping that led to a breach of the dam. Among the four dams investigated, full breach was observed at three dams; two of which were overtopped, and one was not. The fourth dam was not breached but was severely damaged. For each of these dams, the paper documents background information, pre-flood conditions, post-flood field observations and measurements, and laboratory testing results of collected soil samples. Impacts of vegetation on the dams and the effects of dam failure on critical infrastructure are also presented. The detailed descriptions and geotechnical investigations of the dam failures presented herein serve as case histories that can be us

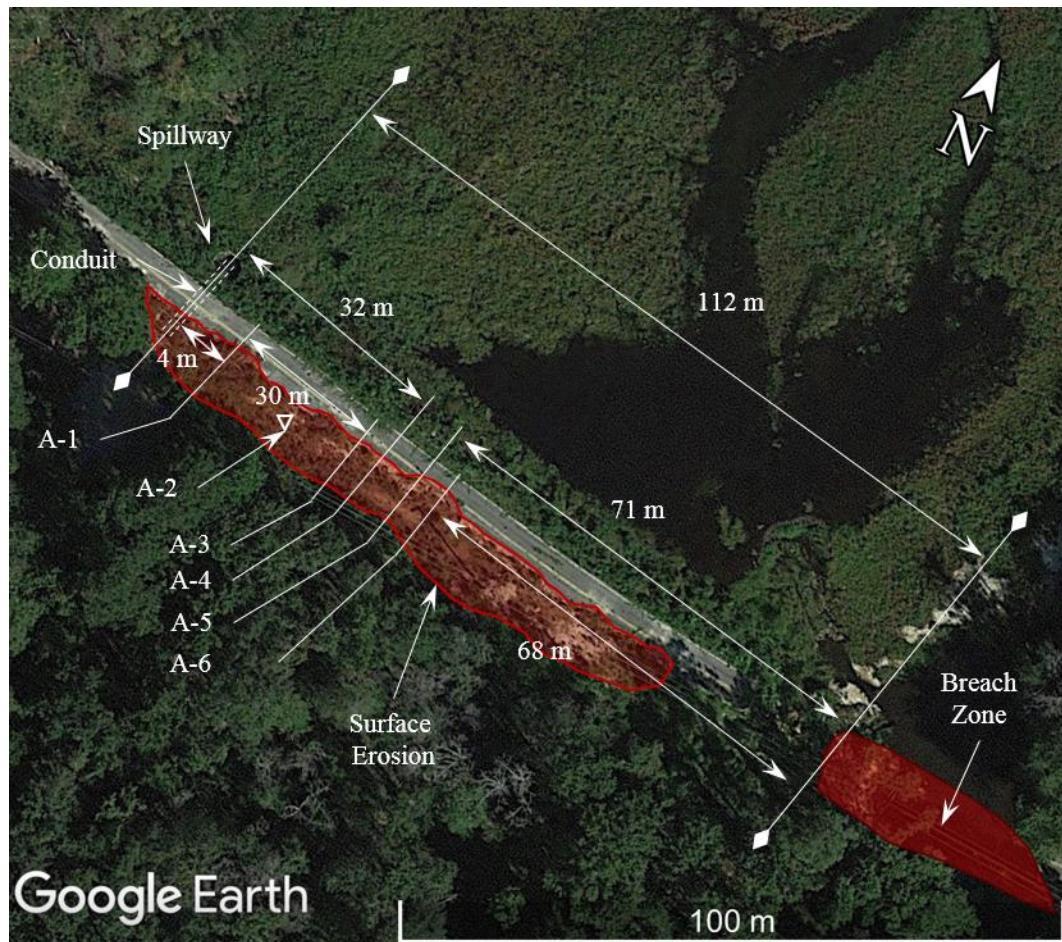
Figure 3. Location of spillway, surface erosion, breach, and sampling locations in Dam A (Google Earth, accessed on April 8, 2018).

The spillway structure of this dam is located on the west side of the dam and about 112 m from the breach zone, as shown in Figure 3. Sampling locations relative to the spillway and the breach zone are also presented in this figure. The spillway is a conduit made of a 1.2 m diameter concrete pipe, as shown in Figure 4a, with a maximum discharge capacity of approximately 17 m³/s (USACE 2016). The soil above the pipe on the downstream side was washed out, as shown in Figure 4b. It is unknown whether this structure worked as the primary spillway of the dam, or if an additional spillway structure existed before the breach.

Damage to this dam includes a complete breach and a large zone of surface erosion separate from the breach, as shown in Figure 3. The breach is located near to the east end of the dam. The breach extended approximately 50 m of the total 290 m length of the dam, and nearly 7,300 m³ of material, including soil and pavement, were washed out (see Figure 6). In the breach zone, several trees on the upstream side slope tipped over the road in the direction of water flow (see Figures 6 and 8), which provides some evidence of overtopping. In the surface erosion zone, the soil erosion along the downstream side slope extended over 60 m parallel to and 20 m perpendicular to the road, as shown in Figures 3, 5b and 7b. As shown in Figure 7a, part of the asphalt shoulder and roadway collapsed above the zone of surface erosion.

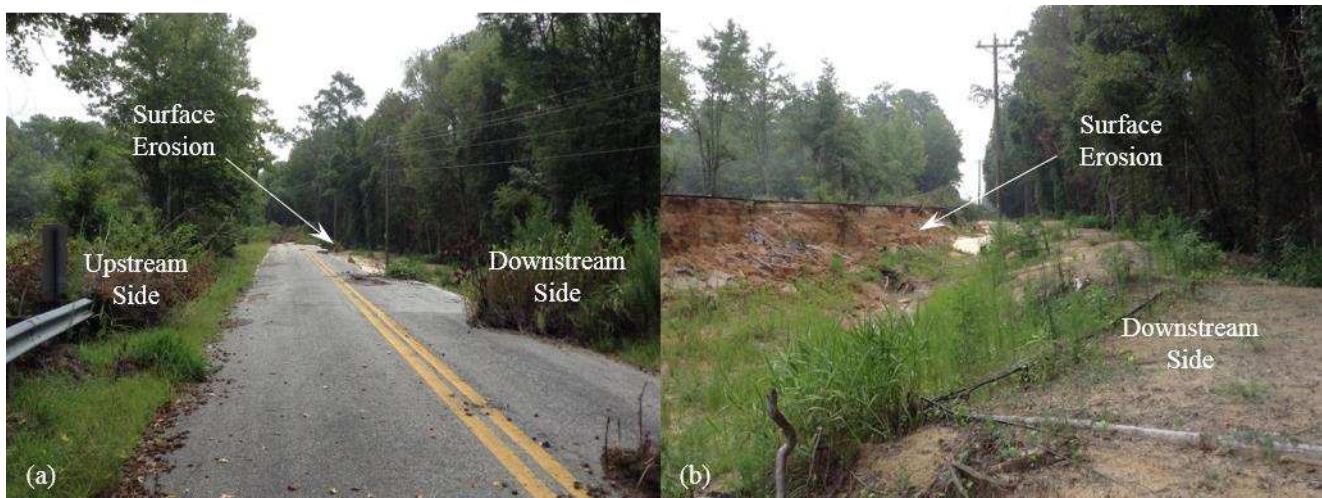
Vegetation was not present on the crest of Dam A where the road is located. However, there is vegetation on the edges of the crest adjacent to the road and on the upstream and downstream sides of the dam. Mature trees with heights of nearly 12 m were observed on the upstream side, parallel to the road and nearly 3 m away from the upstream shoulder (see Figure 5a). Trees on the downstream side have similar heights, but were found nearly 20 m away from the road (see Figure 5b). All of the mature trees appear to be part of the natural growth in the local ecosystem. It is unclear if the presence of vegetation influenced dam performance or contributed to its failure. In the area where soil was exposed on the downstream side slope (noted as surface erosion in Figure 5b), there were no trees present and no roots observed in the soil. Near the northeast section of the breach, several trees were found tipped over the road (see Figure 6), but no roots were observed in the soil.

Figure 5. Vegetation on Dam A: (a) vegetation upstream and downstream of the dam (east view from S-40-67), and (b) vegetation and surface erosion on the downstream side of the dam (east view from downstream).

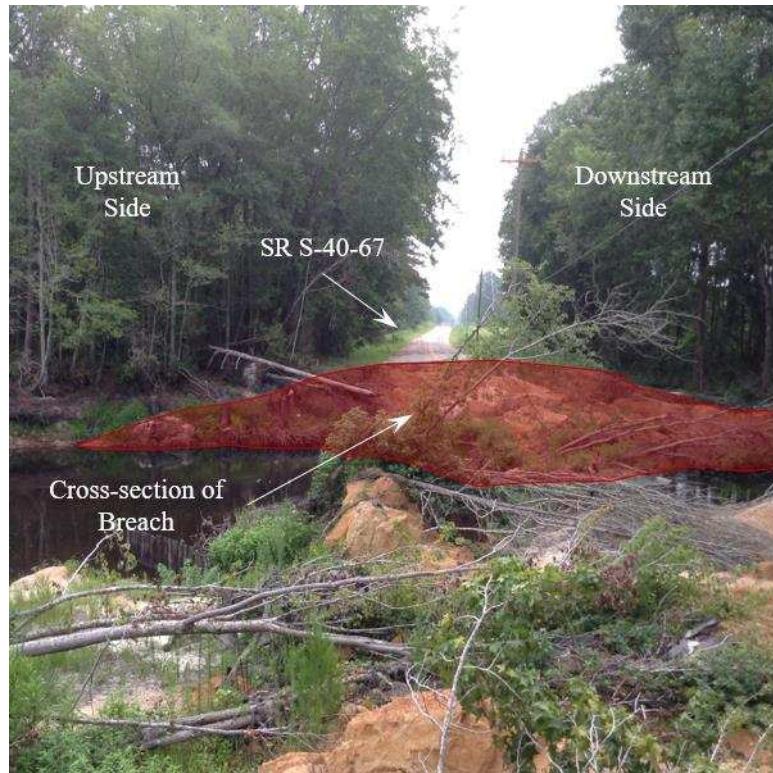
Figure 6. Cross-sectional area of breach in Dam A (east view from SR-40-67).

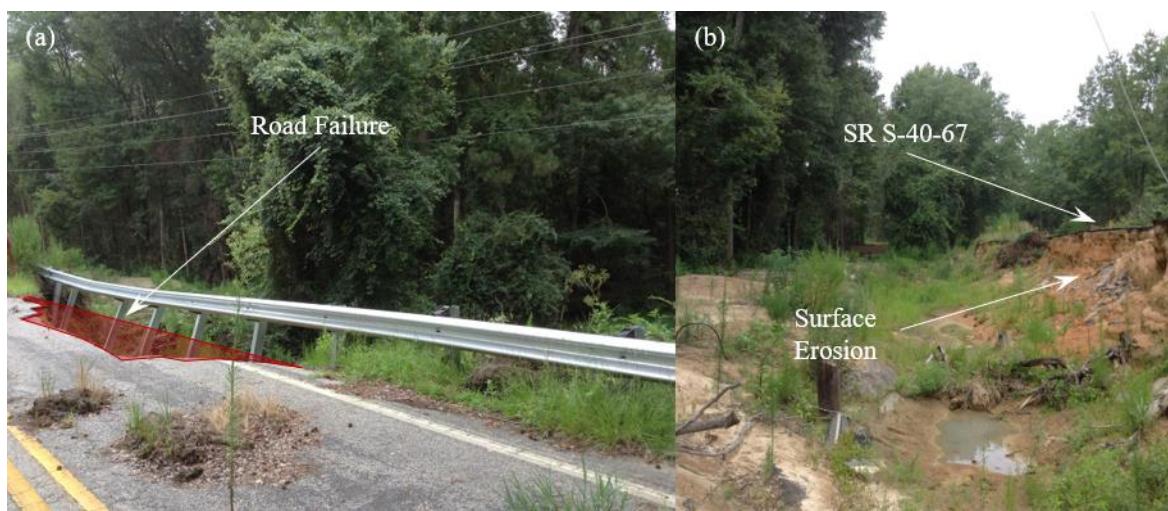
Figure 7. Failure of Dam A: (a) road failure of State Road S-40-67 (southeast view from S-40-67), and (b) surface erosion due to overtopping (west view from downstream).

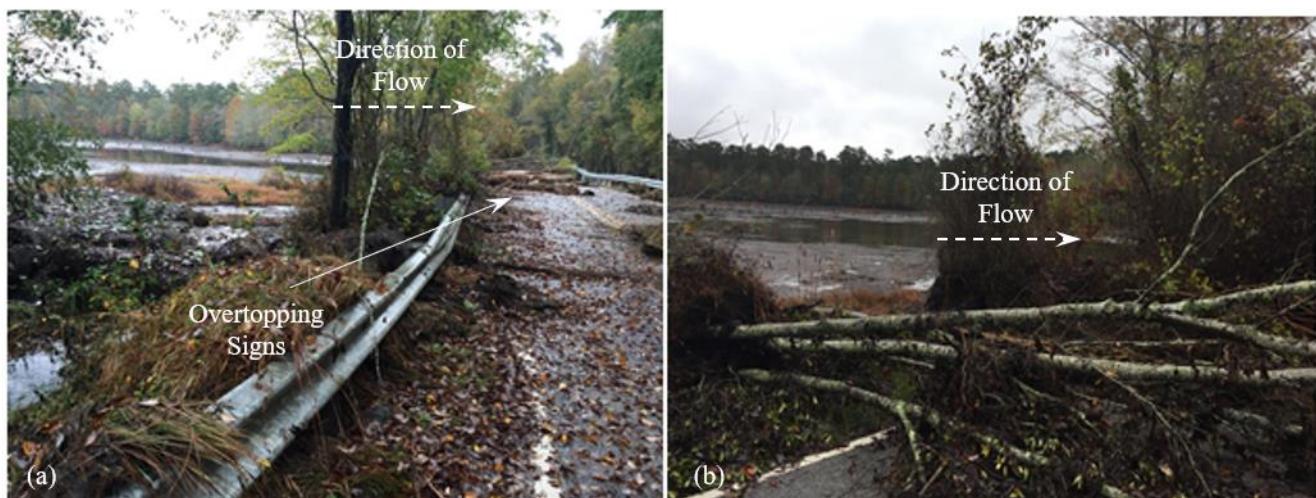
Figure 8. Evidence of overtopping during the flood for Dam A: (a) eroded vegetation and debris on the crest (east view from SR-40-67); and (b) fallen trees on the crest (north view from SR-40-67).

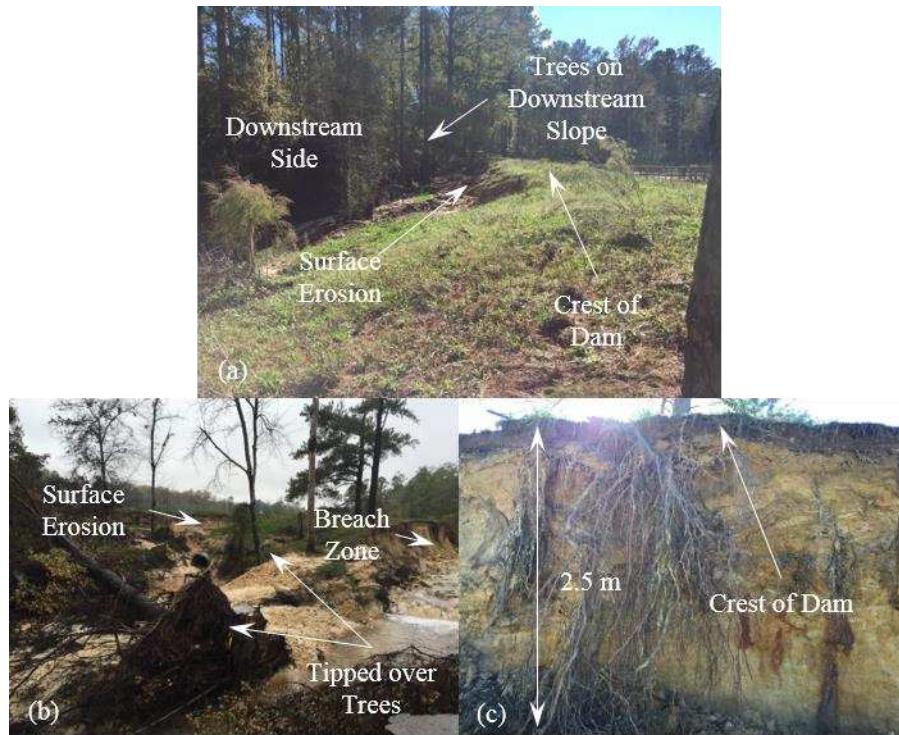
Vegetation was observed over the entire surface of the dam (see Figure 15). The upstream side-slope and crest of the dam are covered with grass and shrubs with heights less than 1 m. Several mature trees with heights from 15 to 18 m were observed on the crest and downstream side-slope of the dam (see Figures 15a and 15b). The roots of one of these trees were exposed by the dam breach, as shown in Figure 15c. The roots reach depths of nearly 2.5 m, penetrating through the upper half and into the lower half of the 4.3 m high dam. The SCDHEC inspection report from 2008 (SCDHEC 2016) also highlighted the need of removing vegetation to an acceptable grass cover. It is clear that the vegetation was not removed, as requested.

Figure 15. Vegetation on Dam B: a) low grasses and small bushes on the dam crest, trees on downstream side slope (south view from crest), (b) tipped over trees near breach and zone of surface erosion (west view from downstream), and c) presence of roots throughout the dam on the south breach wall (south view from breach).

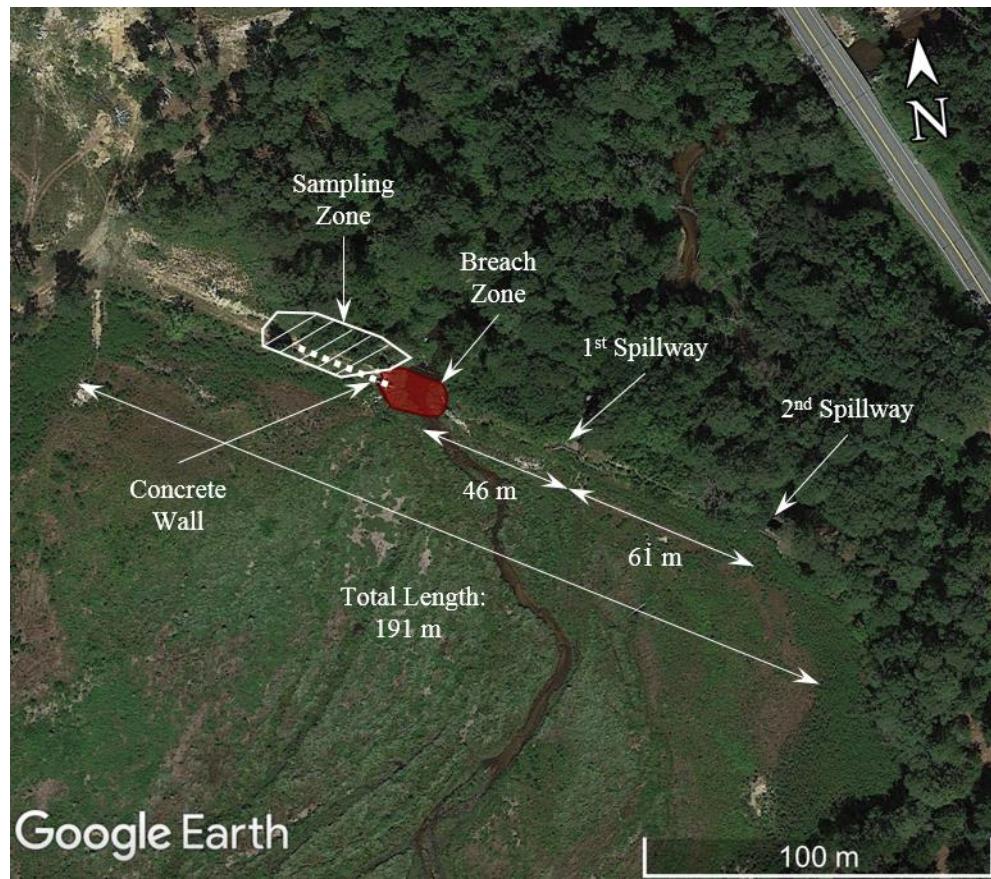
Two spillway systems were found at Dam C as shown in Figure 19. According to USACE (2016), the dam has a maximum discharge capacity of $30 \text{ m}^3/\text{s}$. One of the systems was observed in the middle of the dam (see Figures 20a) and is a spillway gate made of concrete with a length of approximately 9.5 m. The size of the opening in this spillway gate was nearly 2.5 m in width and 9.5 m in height. The spillway system includes a $10 \text{ m} \times 12 \text{ m} \times 8 \text{ m}$ (height x width x length) concrete structure located next to the gate (see Figure 20b). The purpose of this structure is unknown, but it was presumably used for power generation according to the dam owner. The second structure, a spillway gate made of concrete, wood and steel beams (see Figures 20c and 20d), and with a length of approximately 12 m, was found toward the east end of the dam. The opening of this spillway gate was nearly 10 m in length and 2 m in height. Both spillway gates appeared to be in good condition with no observed damage from the flood event. This is expected since the breach zone is 46 m away from the first spillway and 107 m away from the other (see Figure 19). It is unknown whether the spillways worked as primary or emergency drainage systems, or if they were functioning properly before the flood event.

Figure 19. Locations of the breach and the two spillways in Dam C (Google Earth, accessed on April 8, 2018).

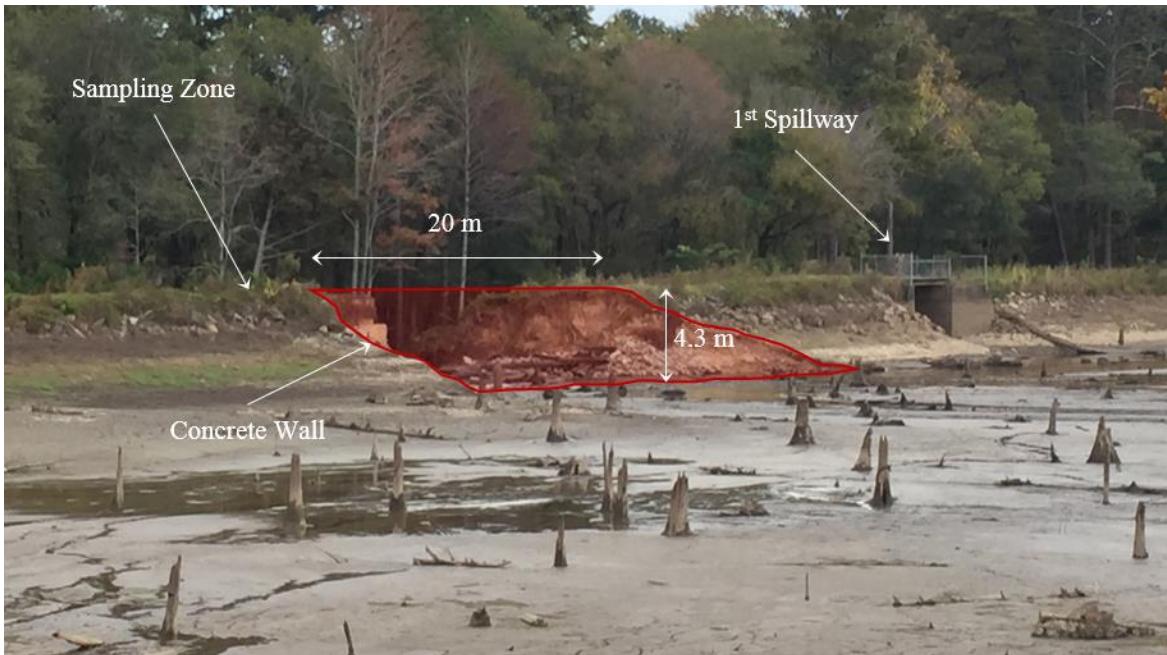
The dam was completely breached during the flood event as shown in Figure 22. The breach was located near the middle of the dam, 46 m northwest from the location of the first spillway gate (see Figure 19). The length of the breach was approximately 20 m of the total 191 m length of the dam, and nearly 900 m^3 of soil were washed out. Eyewitnesses during the flood event indicated that overtopping did not occur. Subsequent field observations did not find evidence of surface erosion on the downstream side slope or near the spillways.

Figure 22. Picture of the breached section of Dam C (northeast view from subdivision). Drained pond in the foreground.

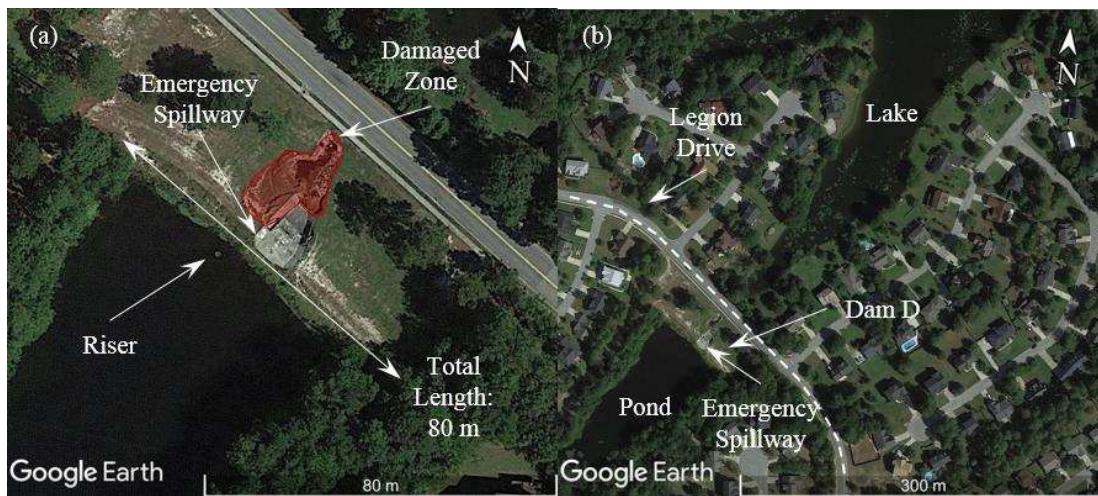
Figure 25. Aerial views of Dam D: a) geometry, draining structures, and damaged zone, and b) location relative to surrounding community (Google Earth, accessed on April 8, 2018).

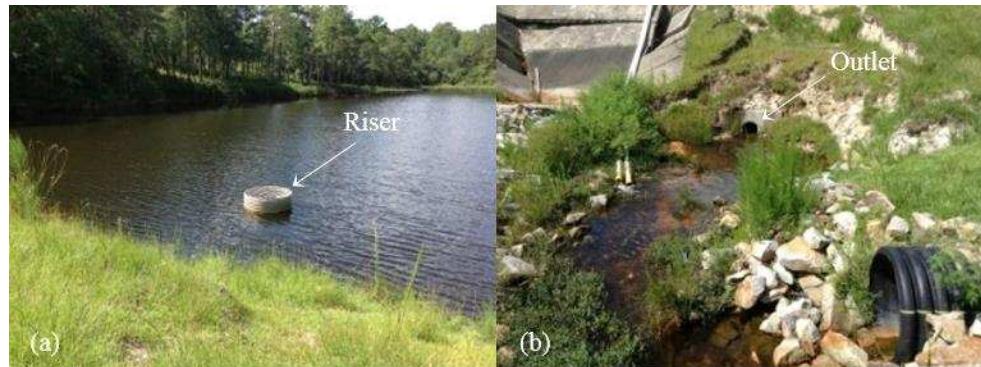
Two spillway systems were found at Dam D. The primary spillway is composed of a corrugated-metal riser used as an inlet (see Figure 27a), and a conduit made of a 0.6 m diameter concrete pipe used as an outlet (Figure 27b). The inlet is located nearly 10 m west of the crest of the dam, while the outlet is located at the toe of the downstream side slope. The second spillway is an emergency (overflow) spillway made of a trapezoidal-shaped concrete channel located in the middle of the dam (see Figure 28). The channel is 7.4 m in length at the base and has side slopes of nearly 45° (see Figure 26). From the photograph in Figure 26a (taken in October 2014), the concrete spillway appears to have been in good condition prior to the heavy rainfall event. After the event, two additional 10 cm diameter PVC pipes were installed on the emergency spillway to lower the water level in the pond (Figure 28a and 28b). All discharge water is directed toward a 1.5 m concrete culvert pipe located below Legion Drive that drains to the lake located downstream (see Figure 25b and 28b).

Figure 27. Primary spillway in Dam D: a) riser structure (southwest view from crest); and b) outlet pipe (southwest view from downstream).
