Geotechnical Effects of Hurricane Harvey in the Houston, Beaumont, and Port Arthur Areas

ABSTRACT: The Geotechnical Extreme Events Reconnaissance (GEER) Association deployed multiple teams of engineers from academia and practicing firms to the coast of Texas in late August and early September 2017 following Hurricane Harvey. This report summarizes the observations and data from the GEER team that focused primarily on the inland effects of Hurricane Harvey in the Houston area with some observations in the Port Arthur / Beaumont area east of Houston. Rain, not storm surge or wind, caused the observed damage in Houston, Beaumont, and Port Arthur by overwhelming stormwater management facilities and creating high flows and flooding in and near area waterways. The major Houston-area flood structures, Addicks and Barker Dams, performed well from a geotechnical perspective. Observed damages included shallow slides along levees, severe erosion along riverways, isolated road and culvert erosion and uplift, and area-wide flood effects in low and poorly drained neighborhoods.

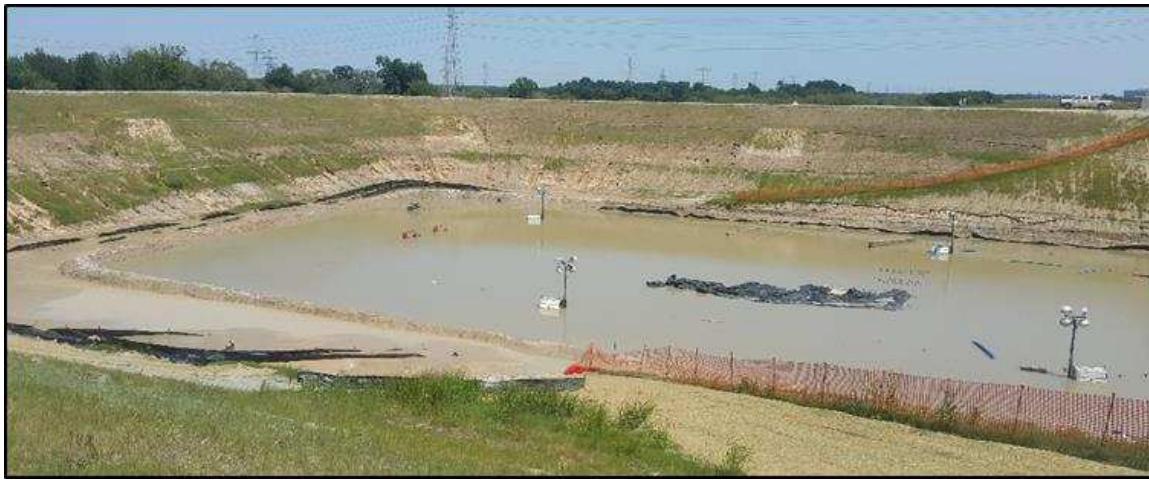
The USACE had contracted to construct new outlet structures and cutoff walls at each dam. This construction was in progress at the time of Hurricane Harvey and was suspended until the consequences of and recovery from the flooding could be assessed. At the time of the hurricane, cofferdams were in place and parts of the cutoff walls had been constructed. The cofferdams performed suitably in keeping the water in the reservoir from flooding the construction zone; however, the high backwater from the channel to Buffalo Bayou flooded the Addicks construction zone (see Fig. 7), and rainwater and underseepage pooled in the Barker cofferdammed area.

Figure 7. Interior of Addicks construction cofferdam for new outlet structure, flooded from Buffalo Bayou backwater; note erosion channels on slopes (September 9, 2017, 29.79063° N, 95.62586° W).

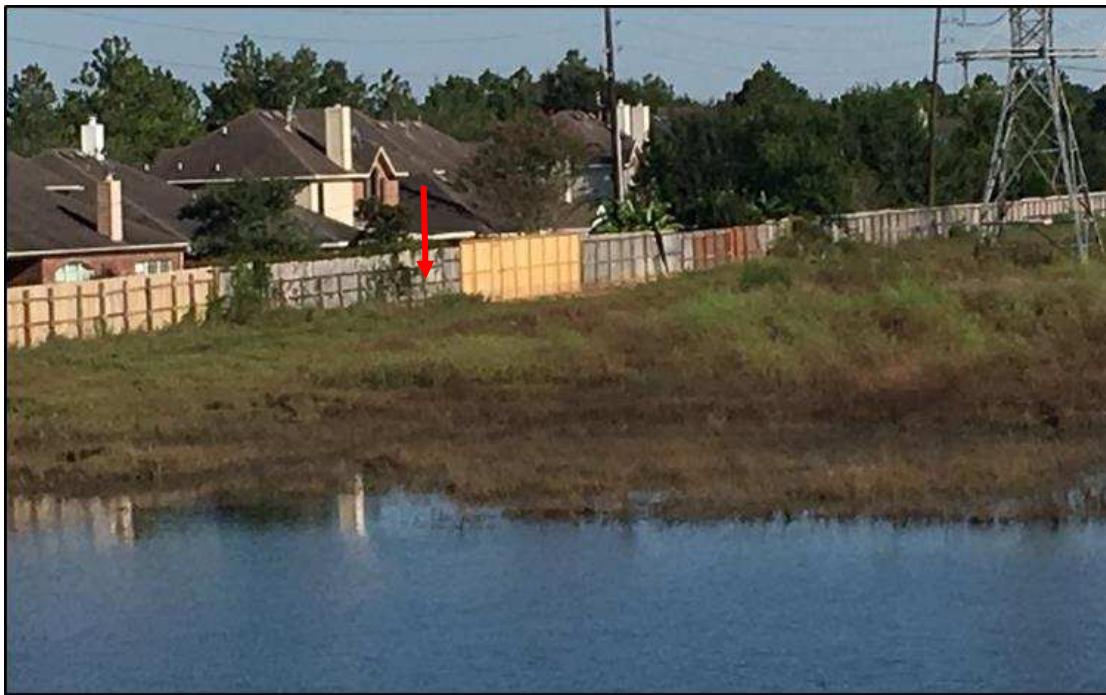
Figure 11. High water mark on fences surrounding residential area (September 9, 2017, 29.70706° N, 95.72835° W).

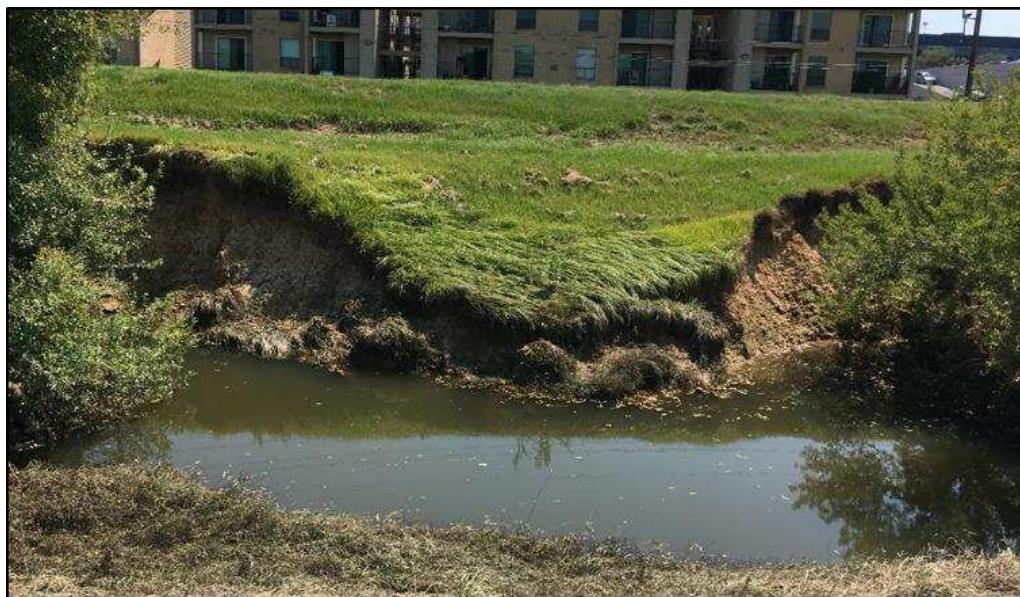
Nearby runoff that is not captured by the dams is managed in drainage ditches or creeks immediately adjacent to the dams' downstream toes. These drainage channels, along with numerous other stormwater / flood management features, are managed by the Harris County Flood Control District. The team observed several slope failures that will require repairs along Turkey Creek near the southeast corner of Addicks Dam (see Figure 12). Contributing factors to the sloughs could have included the steepness of the banks, flow forces acting on trees on the banks or diverted by trees in the waterway, undercutting by flood flows, reduced shear strength in the clay soils, and the drawdown of the creek water level.

Figure 12. Slope failures along Turkey Creek drainage ditch (September 9, 2017, 29.79009° N, 95.59639° W).

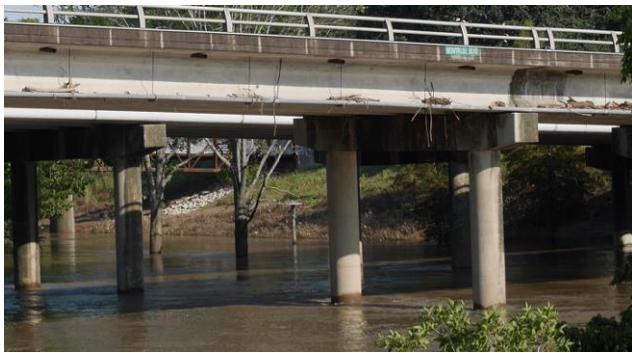
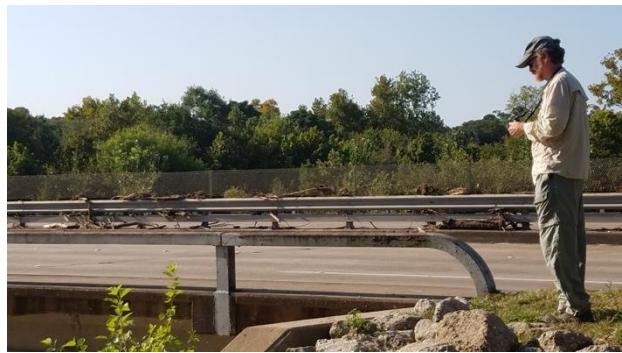
Figure 24. Buffalo Bayou evidence of bridge overtopping (flood debris:) a) Montrose Bridge (September 9, 2017, 29.76307° N 95.39377° W), and b) Memorial Bridge (September 9, 2017, 29.76219° N 95.38425° W).

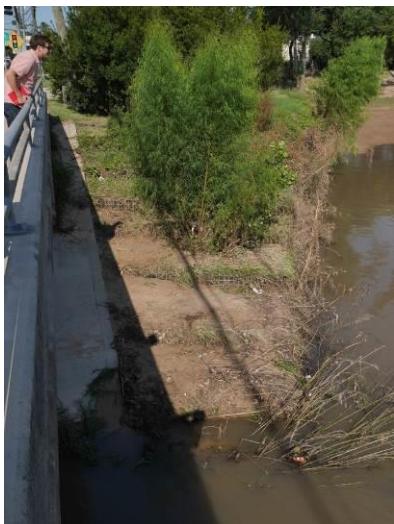
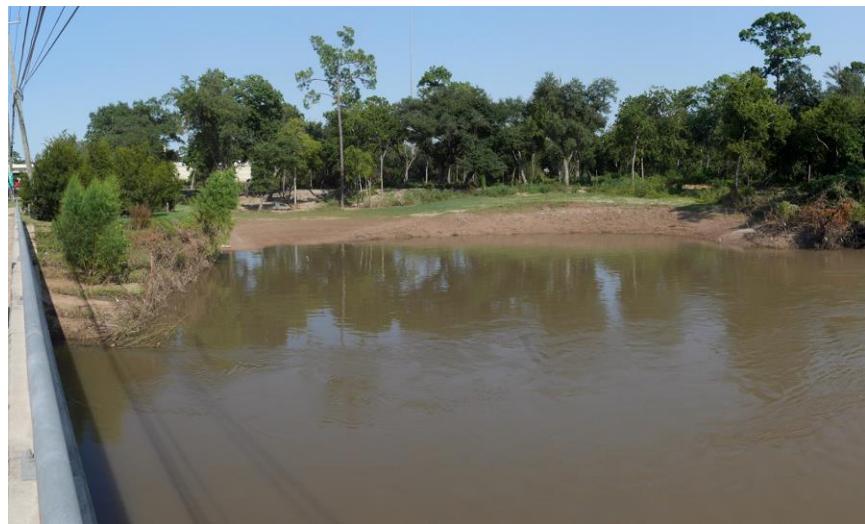
Figure 25. Buffalo Bayou evidence of scour a) Bridge abutment, and b) Downstream of Woodway Drive Bridge (September 9, 2017, 29.76457° N 95.45815° W).

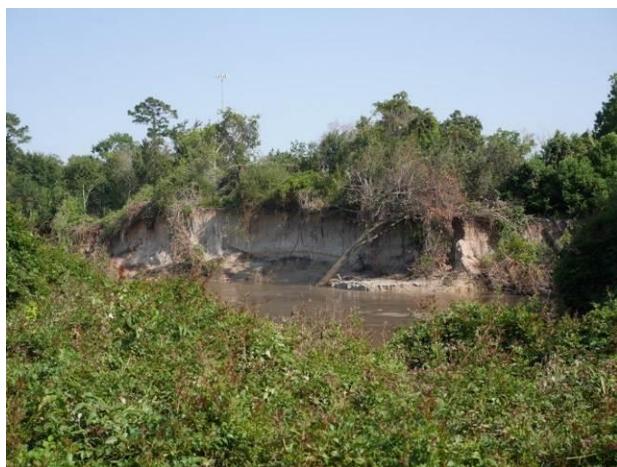
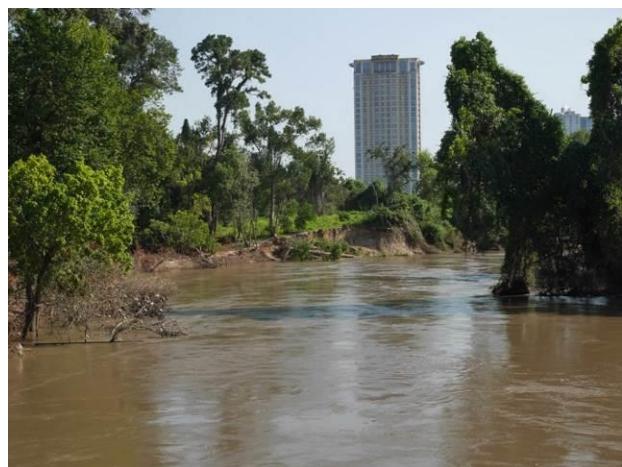
Figure 26. Buffalo Bayous slope failures (September 9, 2017, 29.76318° N, 95.45945° W).

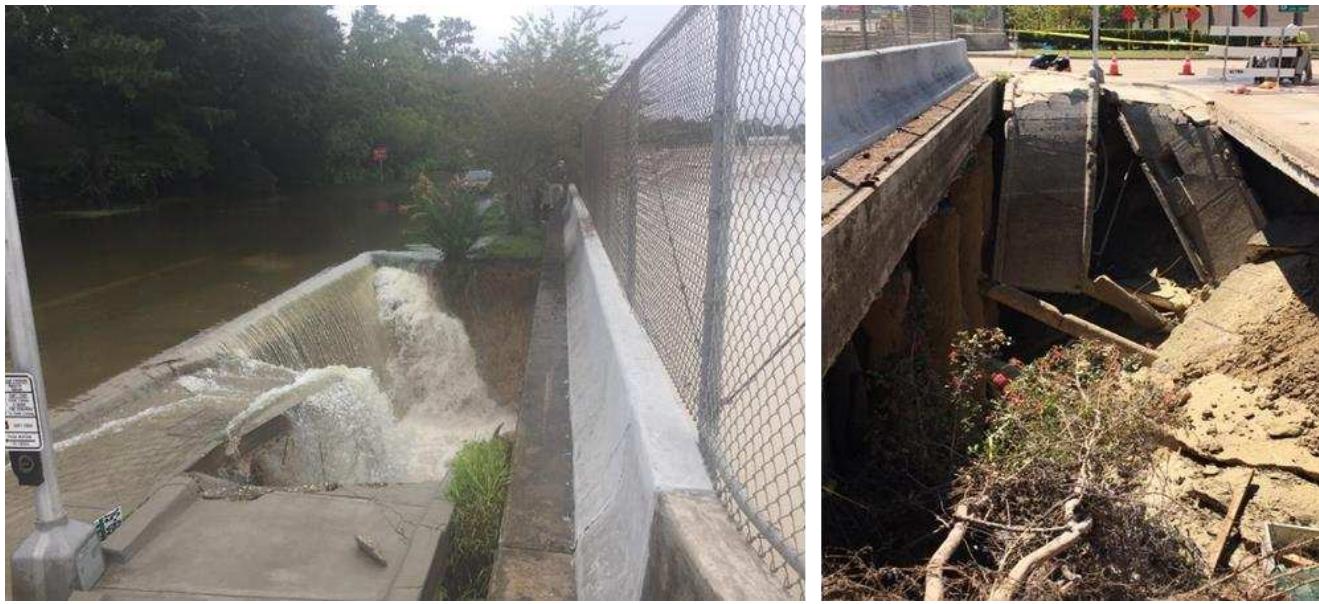
The roadway damage consisted of an uplifted road slab (or slabs) on Beltway 8 and a washout of the adjacent access road, West Sam Houston Parkway N, which is supported about 6.7 m (22 ft) above the parkway by a cantilevered retaining wall consisting of precast panels, which are supported by H-pile reinforced concrete piers. It appears that flood water from the area west of the parkway flooded the access road, drained down behind the retaining wall, and uplifted the Beltway 8 slabs. These flows then washed out soil behind the wall and under the access road and adjacent sidewalk, leaving a 5 m- (17 ft) deep hole. Fig. 32 photographs show the state of the damaged roadway during and after the flooding event. Fig. 33 shows repair work conducted on the uplifted slabs.

Figure 32. Damage of the walkway slab on Beltway 8 (left photo courtesy Brian Klein, a resident in the area, August 27, 2017, and right photo courtesy of a construction worker on site, $29.76735^\circ N$, $95.56219^\circ W$).

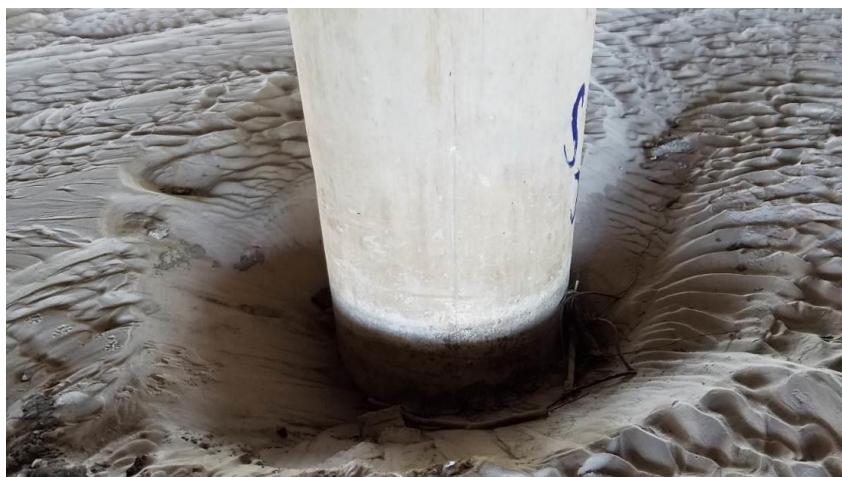
Figure 40. Scour around columns on San Jacinto Banks (sandy soil). The scour hole was approximately 2.4 m (8 ft) across and 0.6 m (2 ft) deep (September 11, 2017, Time 10:59 CDT, $30.243364^\circ N$, $95.46452^\circ W$).

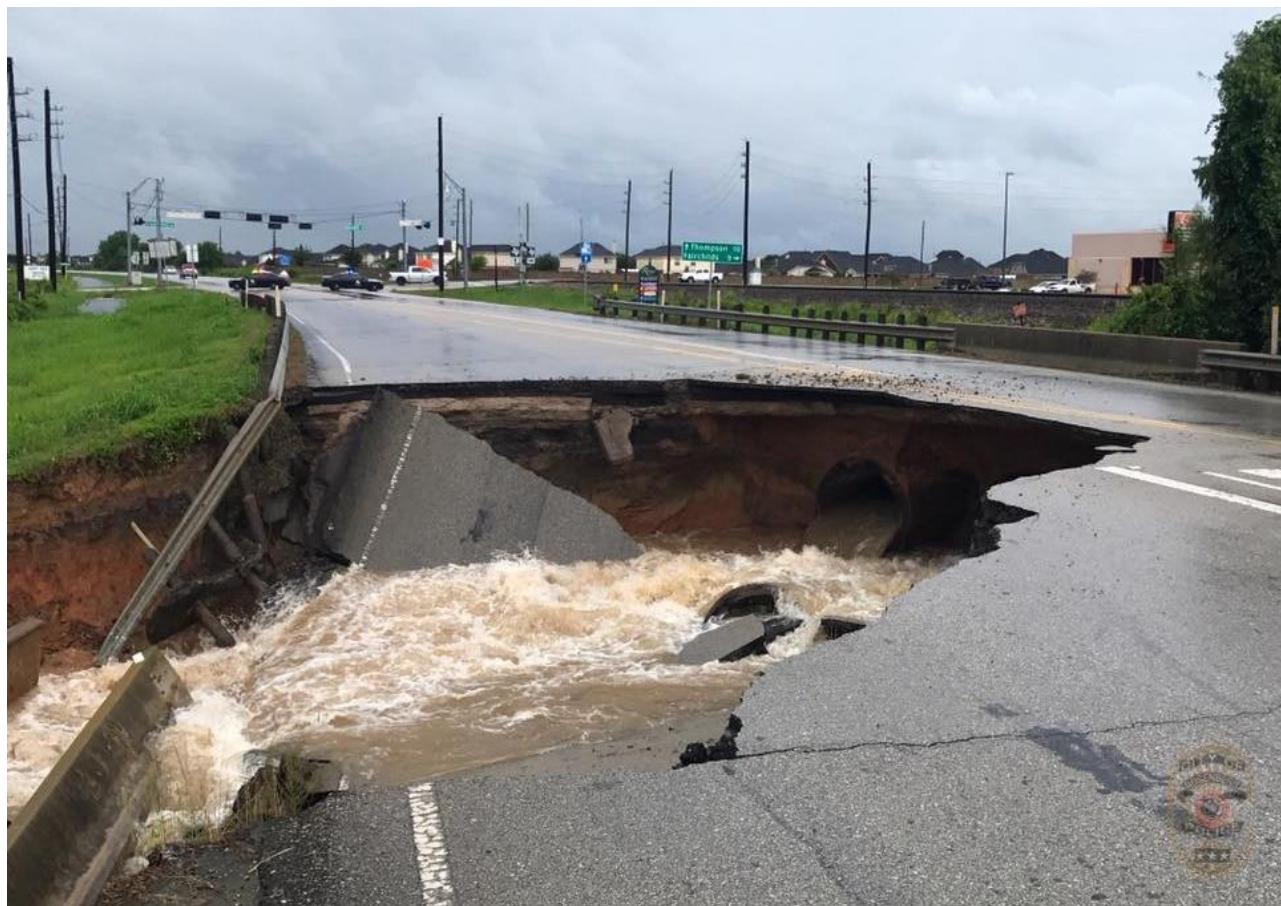
Erosion of the road progressed from the downstream side (see Fig. 43) until the entire width of the road washed out, stopping within 18 m (60 ft) of the adjacent railroad tracks. Repair construction was underway at the time of our visit. Possible erosion mechanisms could have included overtopping flow, culvert leakage or failure, or embankment seepage.

*Figure 43. FM 762 Washout on August 27, 2017
(Courtesy of the Rosenberg Police Department, 29.5442° N, 95.7434° W).*

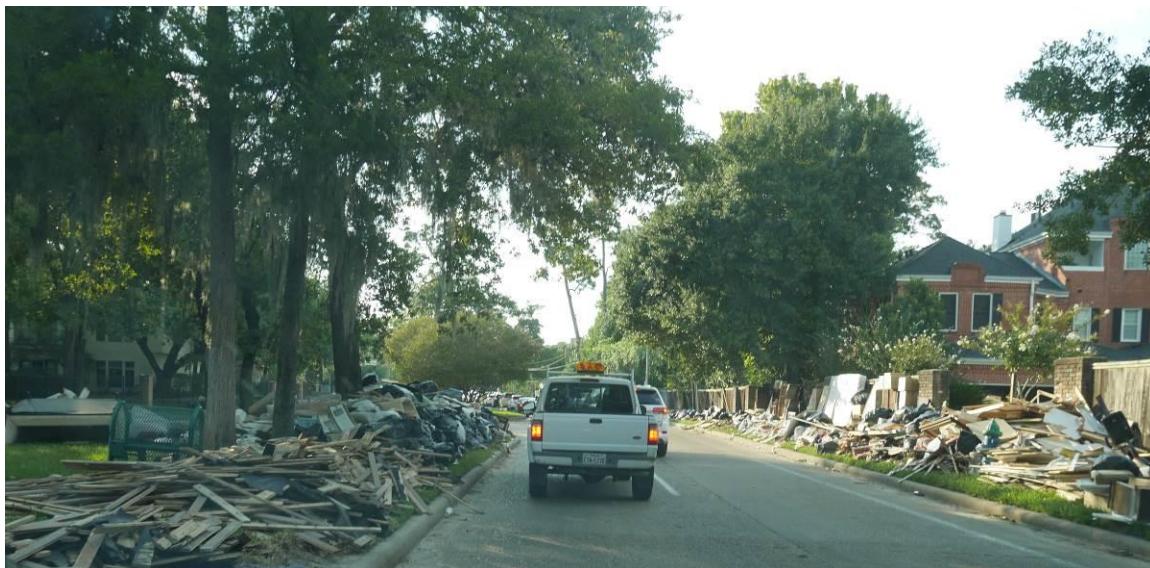
Figure 45. Residential flood damage debris, Houston.
