Geotechnical Extreme Event Site Reconnaissance in Puerto Rico After The Passage of Hurricane Maria

Francisco Silva-Tulla, Consulting Civil Engineer, GeoEngineering and Environment, Lexington, Massachusetts, U.S.A.; email: silva@alum.mit.edu

Miguel A. Pando, Associate Professor, Department of Civil, Architectural, and Environmental Engineering, Drexel University, Philadelphia, PA, 19104, U.S.A.; email: miguel.a.pando@drexel.edu

Reference: Silva-Tulla F., and Pando M. A. (2020). Geotechnical Extreme Event Site Reconnaissance in Puerto Rico after the Passage of Hurricane Maria. International Journal of Geoengineering Case Histories, Volume 5, Issue 4, pp. 1-25, doi: 10.4417/IJGCH-05-04-01

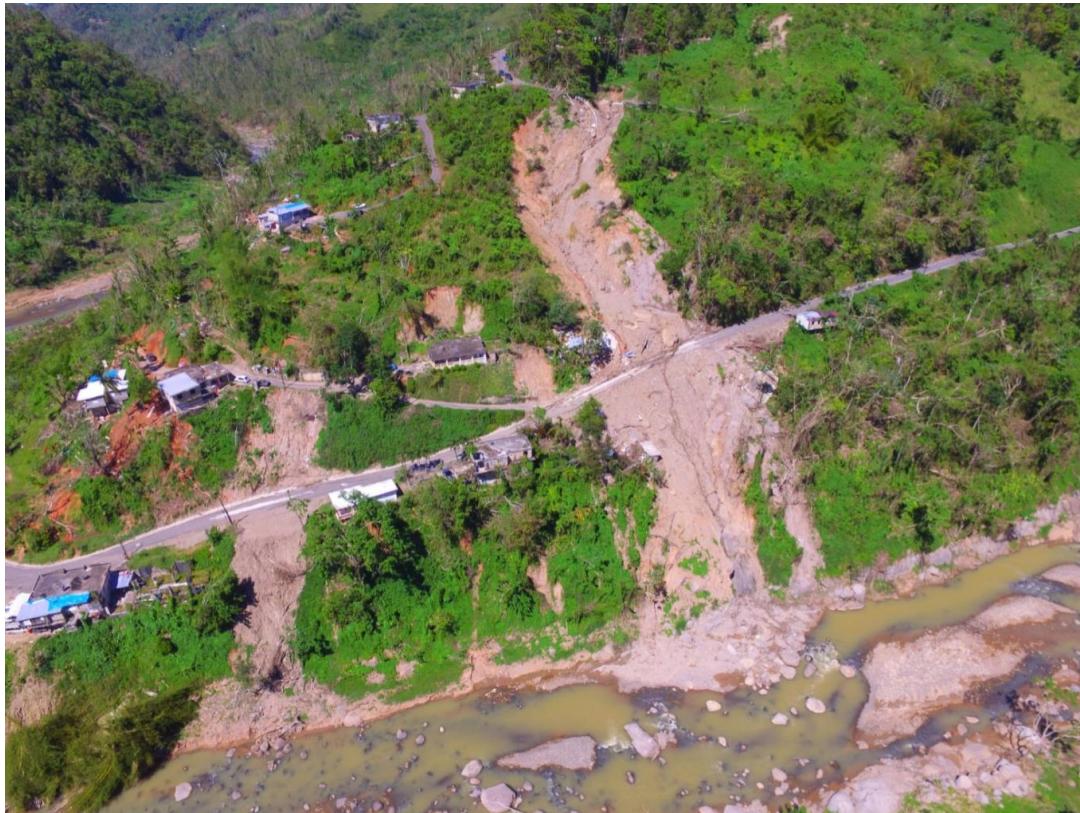
The majority of the slides shown in Figure 14 consisted of shallow debris flows. Figure 16 shows a site, visited by the GEER team, which was affected by some debris flows; this site is located along Puerto Rico State Road 4131 (PR-4131) near the Rio Blanco River in the municipality of Lares. The largest debris flow shown destroyed three homes along the lower road alignment (Silva-Tulla et al., 2018). Luckily, the inhabitants of those homes were not present at the time of the landslide. The debris flow initiated just above the highest road cut on a switchback along PR-4131. The upper area is the primary zone of volume loss, while the lower portion of the road was only covered by debris. The hillslope material slid directly into the river below, which carried much of the small- to medium-sized sediment downstream. Figure 17 shows aerial imagery of the landslide before and after Hurricane Maria.

Figure 16. Photo of debris flow above the Rio Blanco River along PR-4131 in Municipality of Lares (photo taken using UAV at location: Lat. +18.250348° Lon. -66.884155°, looking toward the North).

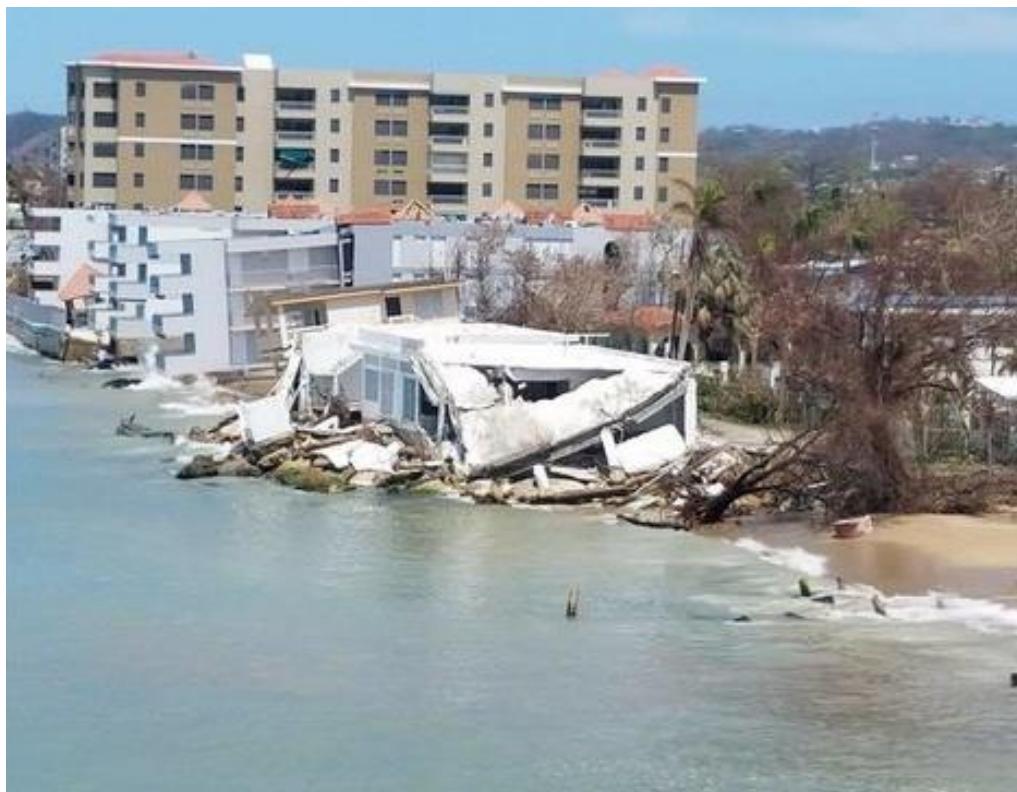
After Hurricane Maria, several buildings in the area of Site CE3 suffered severe damage, as shown in Figure 20. This figure shows extensive damage from waves or scour at the three-story Rincón Ocean Club I building, which was supported on shallow footings, and at the common areas of the terrace and swimming pool. A large volume of soil eroded from the front of the buildings and from beneath the swimming pool. Footings and beams supporting the terrace were exposed and sheared off from the building foundation. Part of Building A collapsed into the ocean and what remained standing was severely cracked. The Victoria Del Mar Condominium, the tallest building in this area and located to the north of Rincón Ocean Club I, also suffered extensive damage due to coastal scour. The terrace and swimming pool area of this condominium collapsed thanks to the storm.

The beachfront in the Córcega Beach area suffered extensive coastal scour. The approximately 6 to 9 m (20 to 30 ft) of beachfront shown in the pre-storm photo (Figure 19) was drastically reduced at the time of the site reconnaissance. The GEER Team did not observe sand washout deposits or shoreline erosion protection measures during the field reconnaissance of Site CE3. Unfortunately, there were no storm tide sensors available near Rincón to help assess tidal levels or the magnitude of wave action during this hurricane. However, NOAA (2017) reported highest water levels of 0.3 to 0.6 m (1 to 2 ft) above maximum higher high water (MHHW) for the northwest coastline of PR, where MHHW is defined as the average daily highest tide. This is consistent with a high-water elevation mark data recorded at USGS Stations (Silva-Tulla et al., 2018).

Figure 20. Oceanfront damage in Córcega Beach area (Site CE3; Silva-Tulla et al., 2018).

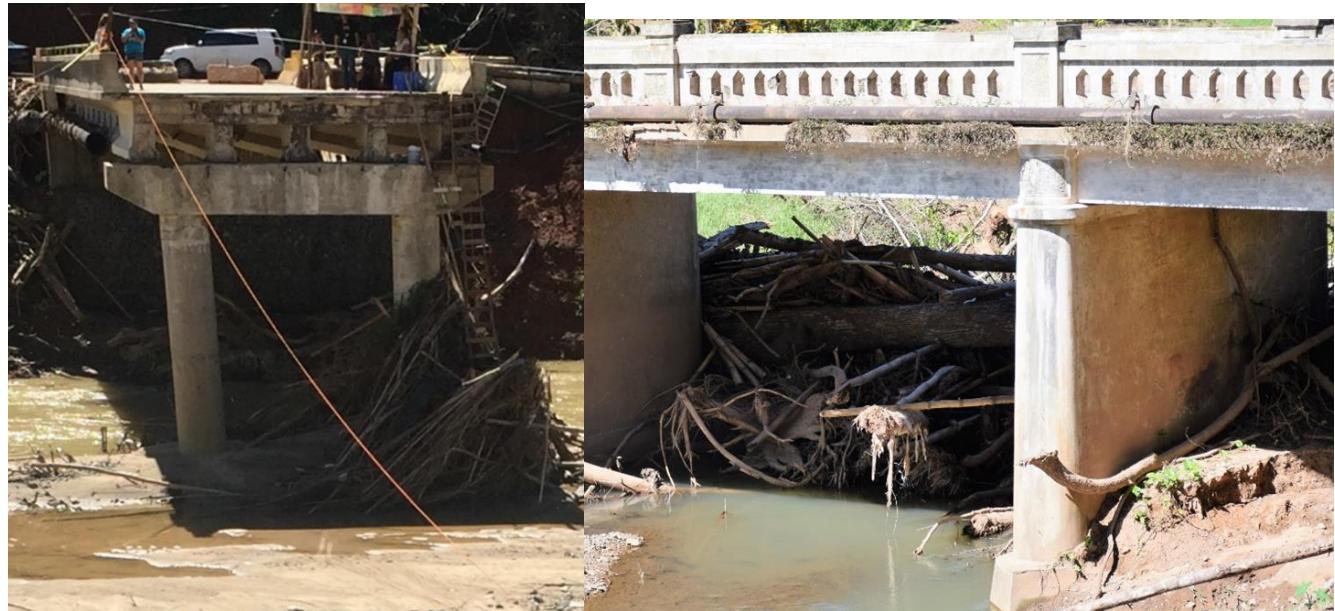
The GEER team visited several bridge sites and observed damage related to the large hydrodynamic forces from the increased volume and flow speeds associated with Hurricane Maria floods. Figure 22 shows photos from two bridge sites visited by the GEER team; these provide an idea of the magnitude of debris accumulation and the associated large hydrodynamic forces.

(Lat: +18.301439°, Lon: -66.698319°, 11/02/17)
a) PR-123 bridge failure ("Los Olvidados")

(Lat: +18.28683°, Lon: -67.10610°, 11/03/17)
b) Debris blocked at bridge

Figure 22. Images showing debris accumulation and damage at bridges during Hurricane Maria (Silva-Tulla et al., 2018).
