Post-2017 Hurricane Season Assessment of Civil Infrastructure Impacts on Beach and Near-Beach Environments

ABSTRACT: This paper presents an overview of observations and preliminary measurements of coastal infrastructure in the aftermath of Hurricanes Harvey and Irma in 2017. Two teams mobilized by the Geotechnical Extreme Events Reconnaissance (GEER) Association were sent to document perishable data along the Texas coastline (Port Aransas, Holiday Beach, East Matagorda Peninsula, and Follets Island) and Florida Keys (Simonton Beach, Sombrero Beach, and Coco Plum Beach). Significant damage from sediment overwash and road undercutting was observed at beach access paths and roads that transect dune fields. It was also observed that beach access points weaken the line of coastal defense provided by dunes, vegetation, and structures. The lessons learned from these field reconnaissance missions indicate that longshore non-uniformity in the dune system should be well-documented. Measurements of the geometry of beach access pathways and dunes, including the height, width, length, and vegetation coverage, should be collected prior to recovery of the system post-storm.

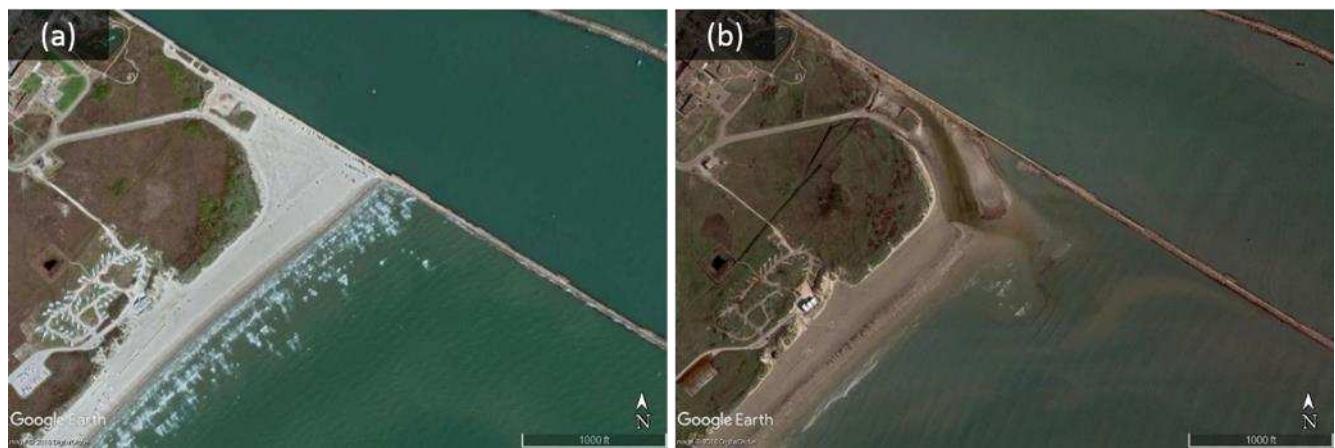
Southwest of the jetties that protect Port Aransas Pass, several paths transect the dune system to provide beach access to Port Aransas. The closest of these beach access points at the end of East Cotter Avenue experienced severe undercutting and paralleled a newly-formed eroded runnel that extended from the road, around a large dune, to the beach (Figure 3). This breach was observed to start at a small culvert under East Cotter Avenue, extend northwest toward the jetty, follow the jetty for approximately 120 m (394 ft), then turn southwest toward the GoM. At the beginning of the breach, a maximum undercut depth of 0.4 m (1.2 ft) was measured on the west side of East Cotter Avenue (Figure 4). The toe of the large dunes between the jetty and East Cotter Avenue and at the end of the beach access road were severely eroded (Figure 5). A scarp measuring approximately 0.9 m (3 ft) was observed and a thick wrack line of debris was deposited at the toe of the scarped dune. This location, along with several other beach access points in Port Aransas, provides evidence that these transects through the dune system provide a pathway for flow channelization, resulting in increased erosion.

Figure 3. (a) Pre-storm satellite imagery (imagery date February 22, 2017) and (b) post-storm satellite imagery (imagery date August 29, 2017) show the eroded runnel created during Hurricane Harvey near Port Aransas Pass (location 27°50'6.39"N, 97°2'50.56"W). Map data: Google Earth, Digital Globe.

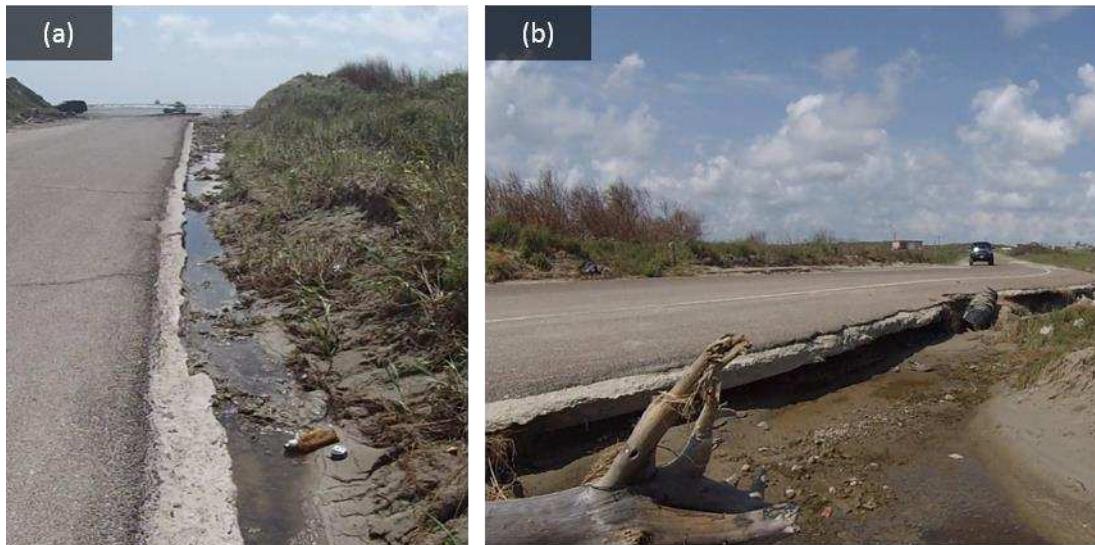
Figure 4. (a) Road undermining due to erosion and scour was observed on both sides of East Cotter Avenue, and (b) a 0.4 m undercut was measured at the beginning of a newly formed breach (collected September 3, 2017; location 27°50'8.53"N, 97°2'55.00"W).

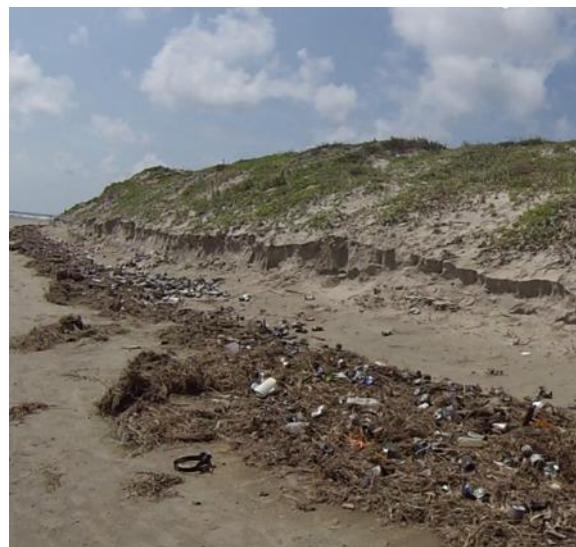
Between beach access roadways, dunes containing uniform longshore vegetation were not overtopped in this study area in Port Aransas. Observations indicate that the vegetated dune system remained relatively intact at further proximity from the beach access points, with only small volumes of sediment deposition measured at the toe of the dunes. However, at beach access points, increased storm surge inundation in backbarrier regions and sediment transport were observed. As a result, the damage to roadways and buildings behind the dunes appeared to be exacerbated near the beach access pathways. Because the pathways at this location are very narrow and surrounded by dunes, the pathway provided only a single channel for storm surge retreat after the storm passed, and likely caused a delay in flooding relief. Therefore, observations suggested that the beach access points in Port Aransas likely increase the vulnerability of communities located behind the dunes near the beach access points.

Figure 5. The dune near East Cotter Avenue was eroded and a thick wrack line of debris was deposited at the toe of the scarpd dune (collected September 3, 2017; location 27°50'6.60"N, 97°2'51.64"W).

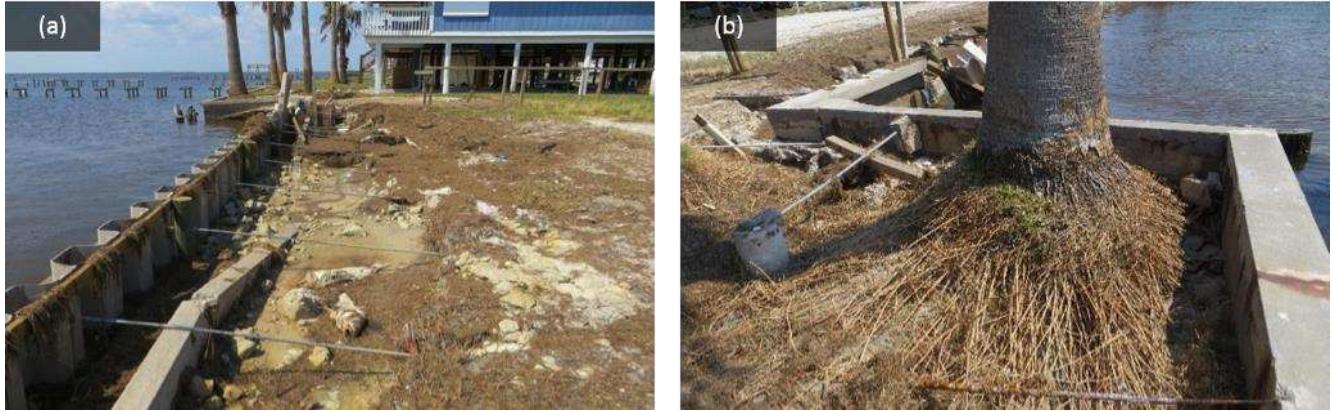
During the reconnaissance survey, houses in Holiday Beach were found heavily damaged by wind and bay surge, particularly those located on the bayfront street that parallels the canals. Anchored bulkhead retaining walls constructed along the bayfront property line were overtopped during Hurricane Harvey and severely eroded on their backsides, exposing supporting steel rods (Figure 6a). Scouring around trees and other fixed obstacles was also observed (Figure 6b). Although Holiday Beach is located on Copano Bay and is not subject to GOM wave action, the damage due to hydrodynamic forces in this region was extensive. Observations show the bulkhead was overtopped during Hurricane Harvey, leaving fish and other debris on land. As the water levels retreated, sediment appeared to be transported from the backside of the bulkhead and around the base of fixed objects, leaving these structures damaged and in need of repair. The condition of the bulkheads and service life

maintenance prior to Hurricane Harvey remain unknown, and it is unclear if it affected the damage observed during the survey.

Figure 6. (a) Supporting steel rods were exposed after storm surge retreat scoured the backside of a bulkhead, and (b) scour was also observed around other fixed objects (collected September 3, 2017; location 28°10'11.24"N, 97°1'2.03"W).

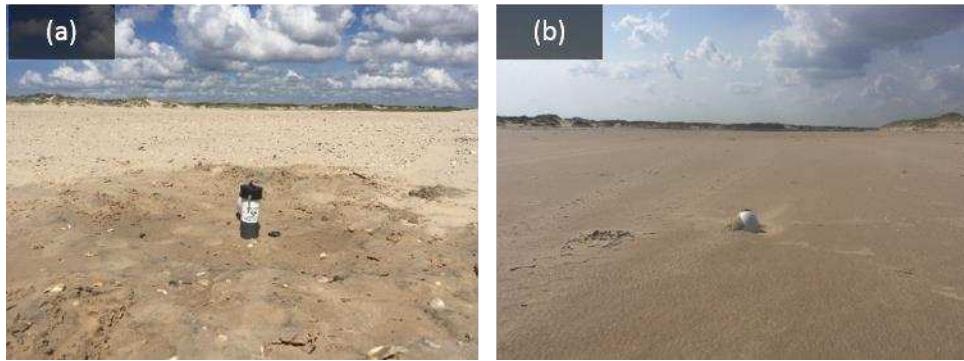
The infilled storm cut through East Matagorda Peninsula hydraulically connects GoM and bay surface waters only during elevated storm water levels. During Hurricane Harvey, the maximum water surface elevation at the backshore (GoM side of the cut) was 1.8 m above Mean Sea Level (MSL) and 1.0 m above MSL at the back-barrier location (bay side of the cut) as measured by rapid response field measurement units containing pressure transducers. The dunes at this site were not overtopped. Surface hydraulic connection through the cut lasted for approximately six hours. During this time, up to 0.50 m (1.6 ft) of GoM sediment was deposited in the backshore (back-barrier) region of the cut as a result of onshore-directed transport of sediment eroded from the shoreface by hurricane wave action. Figure 7 shows before and after photos of the backshore area on the GoM side of the cut, clearly indicating the accretion that occurred at this location. The cut serves as a roadway to access the back-barrier areas and is an example of what can happen to shore-perpendicular gaps in the dune line during hurricane impact.

Figure 7. (a) Pre-storm (collected August 23, 2017) and (b) post-storm observations (collected August 30, 2017) of the backshore area fronting the East Matagorda cut where 0.5 m of sediment accretion was observed (location 28°36'43.57"N, 95°56'24.88"W).

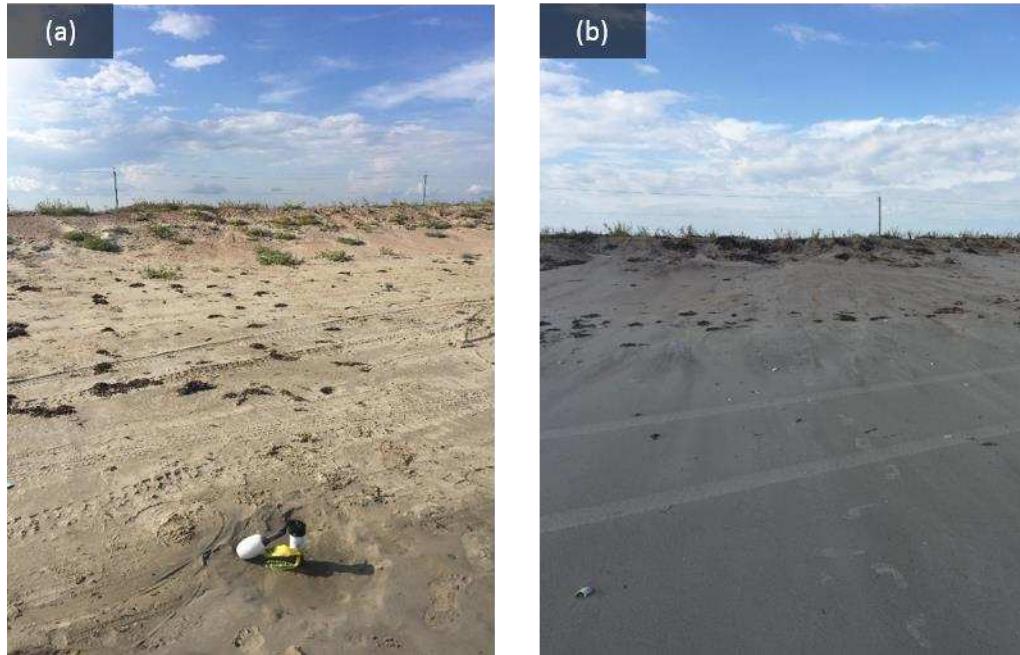
The recently nourished, relatively longshore uniform beach on Follets Island experienced dune collision and re-grading of the beach profile by storm surge and waves, but was not overtopped or severely overwashed as observed in other study locations discussed herein (Figure 8). Significant erosion of the dune line was observed due to heavy rainfall. A shore-parallel ridge-runnel system was observed in the foreshore (Figure 9a). At the beach access point from Bluewater Highway, sediment

Figure 8. (a) Pre-storm (collected August 24, 2017) and (b) post-storm observations (collected August 31, 2017) of the dune show regrading of the beach profile and washout from heavy rainfall on the dune peak (location 29°1'27.93"N, 95°11'24.93"W).

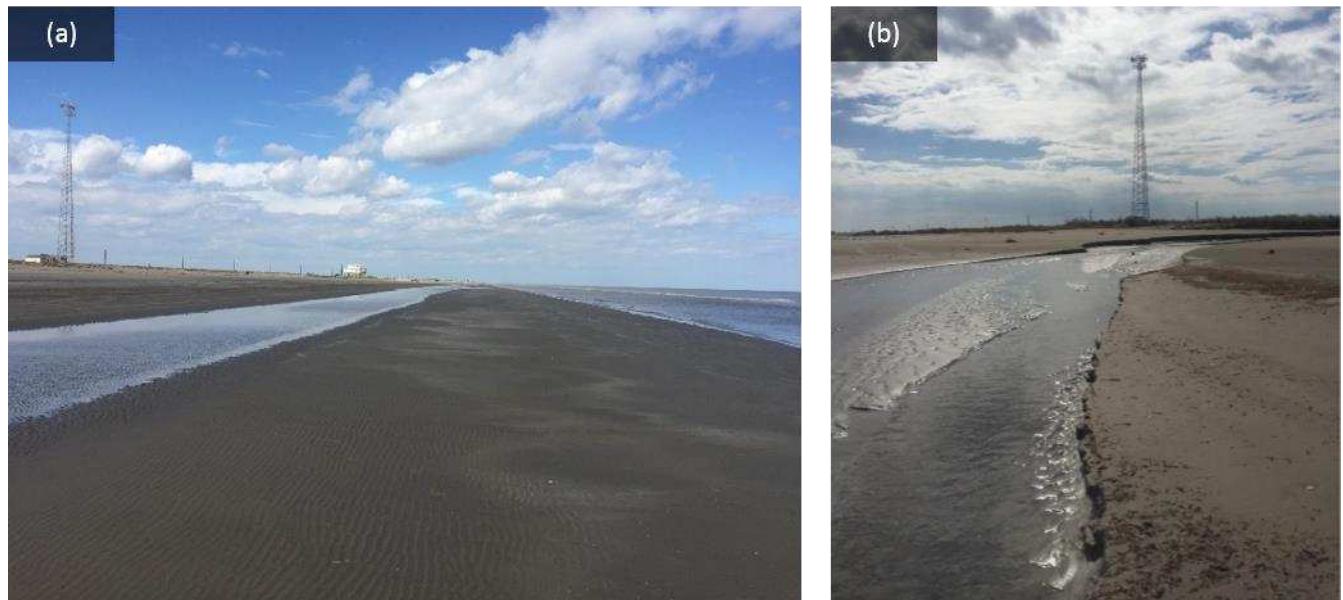
deposits were observed on the road (257R) and a channel was formed connecting the flooded backbarrier region to the beach along the eastern and western flanks of the dunes (Figure 9b). This study location on Follets Island shows the protection afforded by dunes against storm flooding, but it also demonstrates damaging erosion along the sides of roadways. It also highlights that beach access points can serve as a funnel as rainwater and storm surge retreat, allowing the channelization of sediment transport.

Figure 9. (a) A ridge-runnel system formed parallel to the shore, and (b) a channel was eroded from the beach access point to the GoM (location 29°1'27.93"N, 95°11'24.93"W).

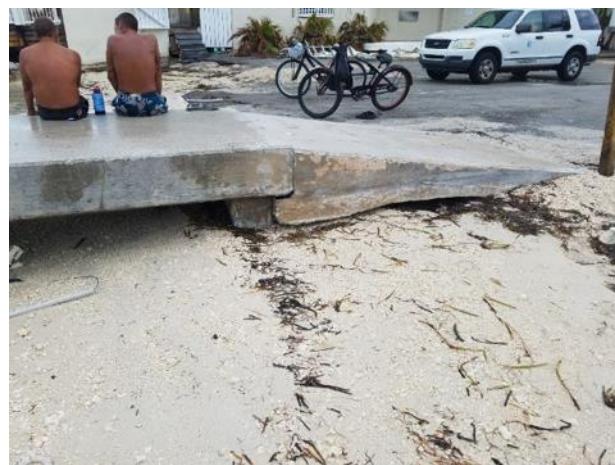
Figure 11. A concrete structure located on the eastern edge of Simonton Beach was undermined due to scour around the structure (collected September 27, 2017; location 24°33'43.32"N, 81°48'20.22"W).

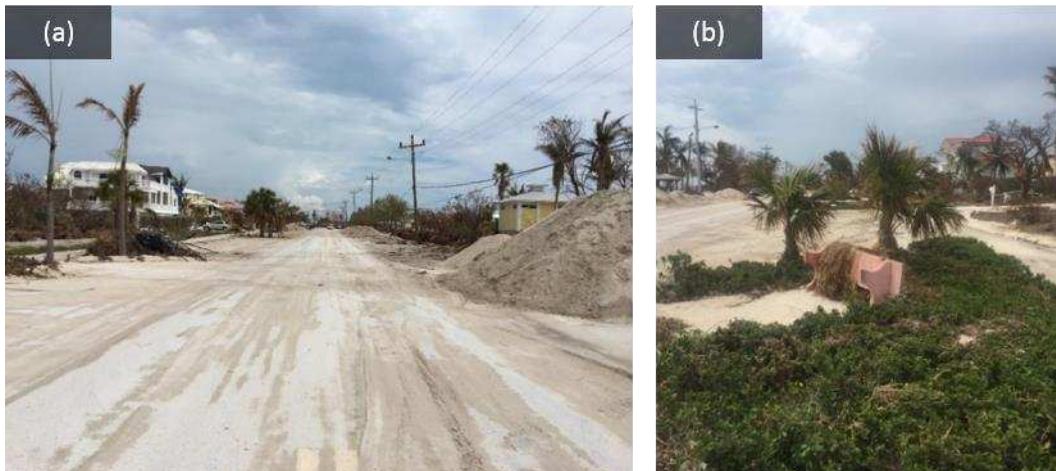
At the time of reconnaissance, sections of Sombrero Beach Road were still covered with sand deposits (Figure 12) that were transported from the small nourished beach in Sombrero Beach Park. Homeowners were removing sand from inside their houses (Figure 13), which were buried with up to about 1 m (3 ft) of sediment. Additional evidence of damage by storm surge and waves was observed as structural and flood damage to houses, including the collapse of a wall located in front of an oceanfront home (Figure 14). Undermining of another home was observed to expose the foundation, likely causing structural damage in the form of large cracks in the floor slab to the beach house (Figure 15).

Figure 12. (a) Large volumes of sediment were deposited on Sombrero Beach Road (facing east) and (b) a concrete bench was overturned, trapping debris on its side (collected September 26, 2017; location $24^{\circ}41'33.01"N, 81^{\circ}5'5.57"W$).

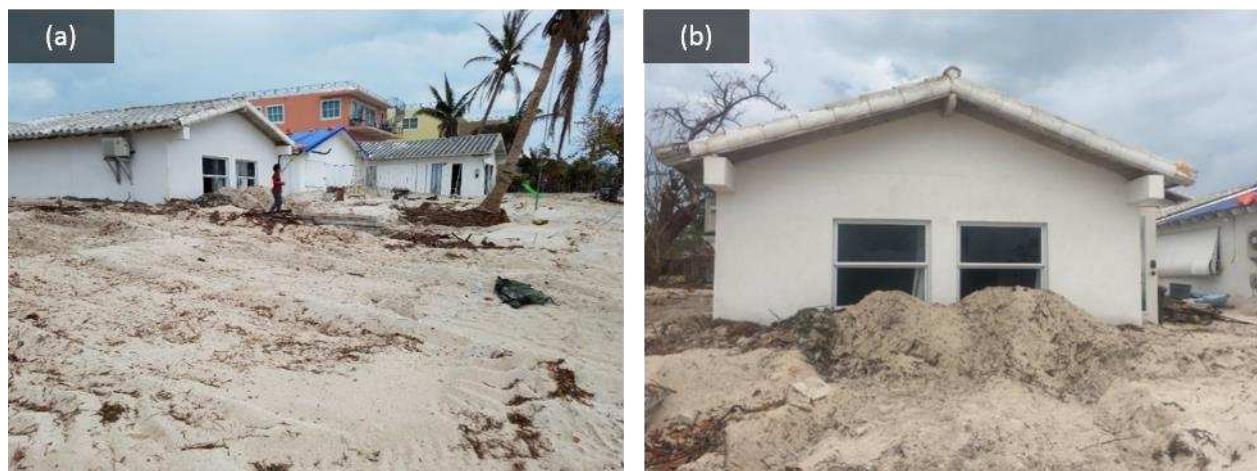
Figure 13. (a) Large volumes of sediment were deposited around houses and other structures and (b) buried them with approximately 1 m of sand, reaching the bottom of window sills (collected September 26, 2017; location $24^{\circ}41'31.52"N, 81^{\circ}4'56.31"W$).

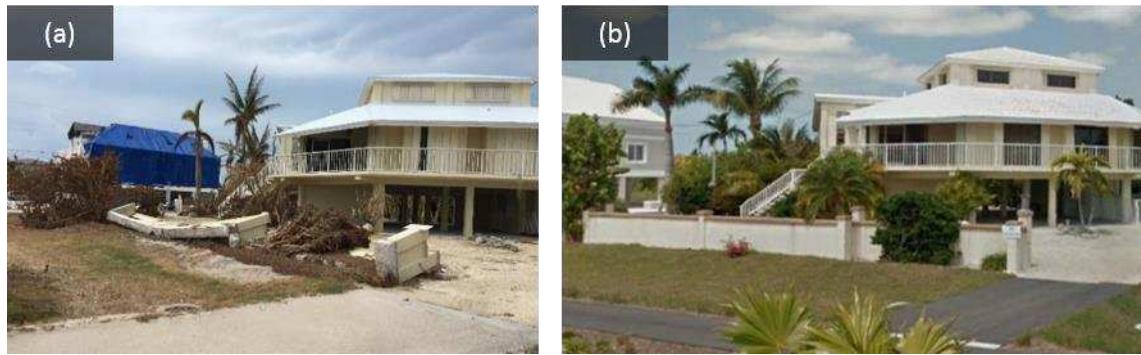
Figure 14. (a) A wall located in front of a home on Sombbrero Beach Road collapsed during Hurricane Irma (collected September 26, 2017; location $24^{\circ}41'34.26''N, 81^{\circ}5'0.93''W$); (b) the pre-existing structure appeared to be intact prior to the storm. Map Data: Google (2018).

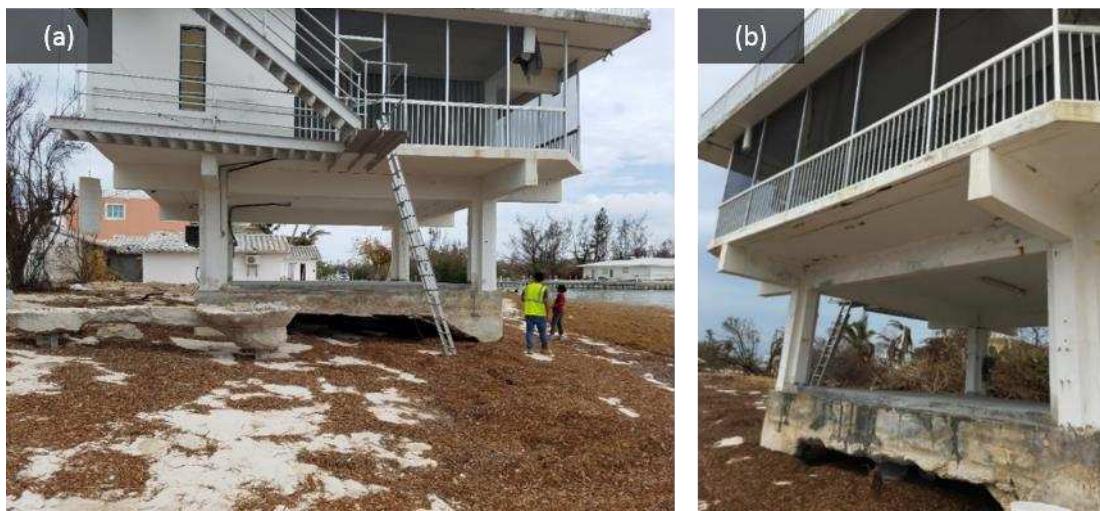
Figure 15. (a) The foundation of an elevated home was undermined due to scouring around the structure; (b) a close-up view shows damage to the structural integrity of the home (collected September 26, 2017; location $24^{\circ}41'31.86''N, 81^{\circ}4'57.29''W$).

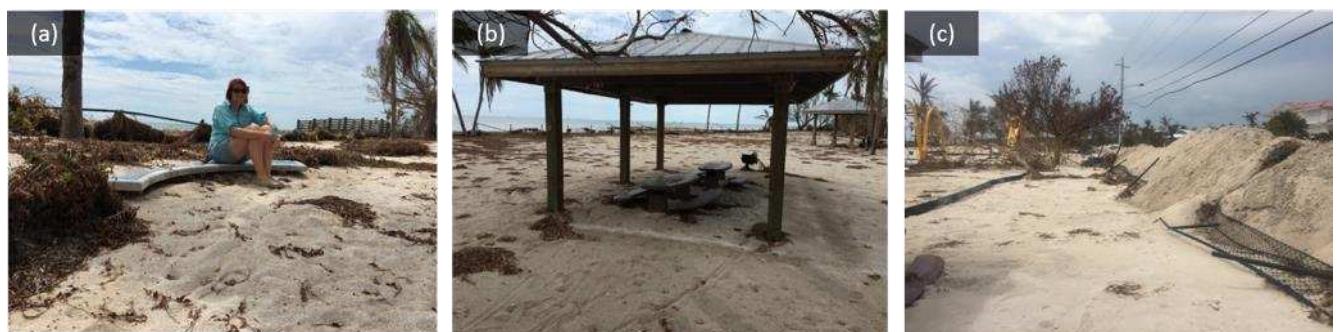
At Sombrero Beach Park, most of the park structures, such as fences, walking paths, and a beach access ramp, were damaged, and playground equipment was buried by about 0.6 m (2 ft) of sediment (Figure 16). Observations at this location further indicate that geotechnical impacts resulting from storm surge and waves are magnified by the surrounding infrastructure. At the park locations, sediment freely moved and deposited around park structures and on the roadway. However, at the walls and foundations of homes, which are impermeable fixed structures, sediment was eroded from around and beneath the structures. Sombrero Beach is another example that civil infrastructure can direct sediment erosion by interfering with the flow and natural sediment transport paths. Furthermore, it also highlights that small sediment-volume beaches, particularly those with no pre-existing dune structure, can be heavily damaged during extreme events.

Figure 16. (a) Concrete park benches were nearly buried with sand (approximately 2 m), (b) some park structures were only mildly damaged and buried with sediment, (c) while others were severely damaged and in need of repair (collected September 26, 2017; location $24^{\circ}41'32.20''N, 81^{\circ}5'4.09''W$).

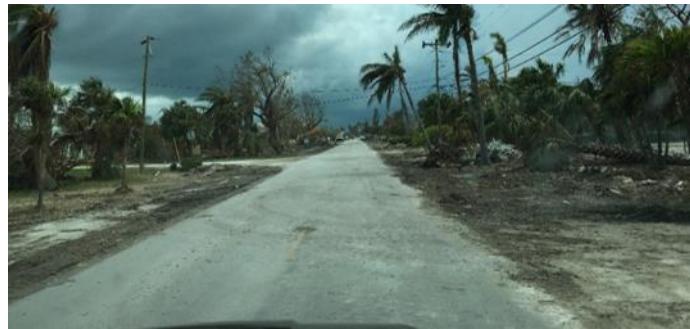
On Coco Plum Drive, evidence of wind and inundation by storm surge was observed from the debris deposited onto the roadway (Figure 17). At Coco Plum Beach Park, large volumes of sediment were transported from the beach, narrowing its

Figure 17. Sand and debris were deposited on Coco Plum Drive (collected September 26, 2017; location 24°43'34.52"N, 81°0'36.53"W).

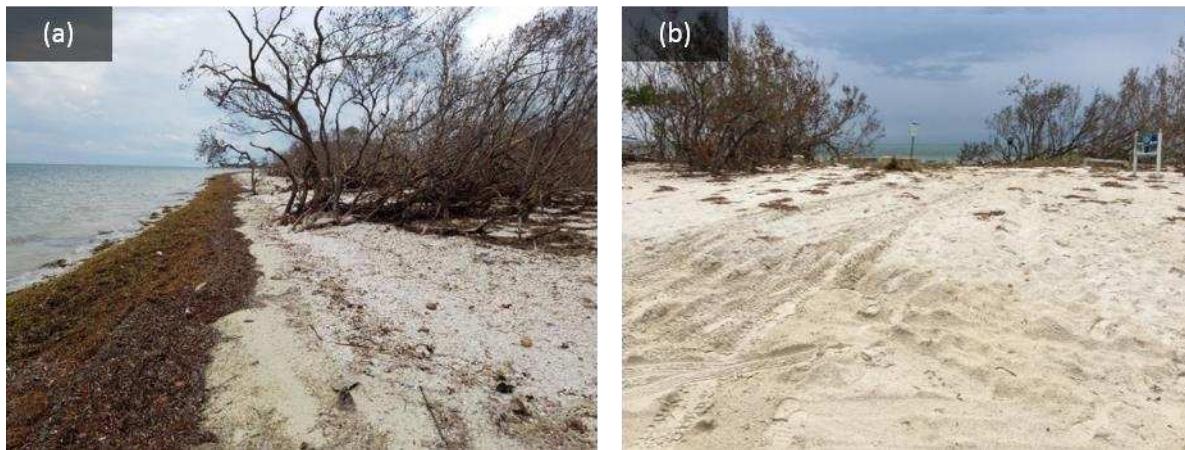
width, and deposited in the parking area (Figure 18). From the observations, the densely vegetated regions of the island trapped much of the sediment in a 20 m to 25 m zone, except at the beach access point where the transect in the vegetation served as a transport pathway through which sediment was channelized.

Figure 18. (a) The beach width was narrowed due to erosion and algae washed up on the beach, and (b) sediment approximately 0.3 m in depth was deposited in the beach access area (collected September 26, 2017; location 24°43'48.42"N, 81°0'5.81"W).
