Bridge Abutment Remediation – A Case Study

Reference: Sundaram, M., Sugawara, J. and Sivakumar, S. (2022). Bridge Abutment Remediation – A Case Study.

International Journal of Geoengineering Case Histories, Volume 7, Issue 4, pp. 1-7,

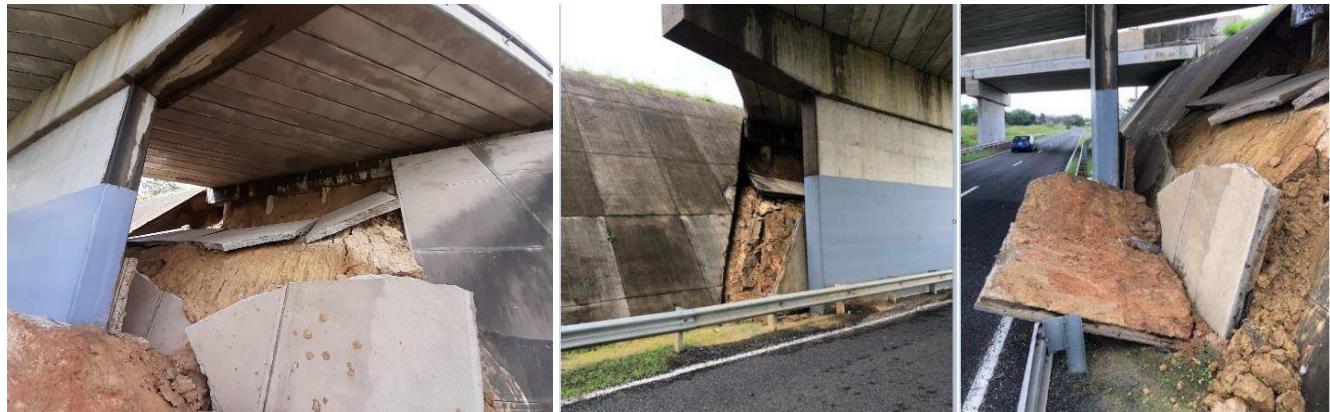
In November 2021, after a downpour, fill material from the crest of the abutment started to move, causing the concrete panels to slip and buckle, and to eventually topple onto the pier below and the guard rails. About 50 cubic meters of material failed from the abutment (Figure 2). However, the bridge pier prevented further movement of the fill material, containing it within the toe of the slope.

A total of 112 millimeters of rainfall was experienced in the month prior to the failure, which was almost double the mean annual rainfall. An additional 30 millimeters fell on the day of failure. The failed material was saturated and fluidized near

the surface. A seepage line was identified two meters below the headstock and was visible to about six meters from edge of the abutment. It is likely that water infiltration from pavement edges may have saturated the abutment fill behind the panels. Therefore, the main cause of the failure is thought to be excessive pore water pressure buildup behind the panels, perched water within the embankment, blockage of weepholes, and softening of the fill material from infiltrated stormwater.

Figure 2. Abutment condition after failure.

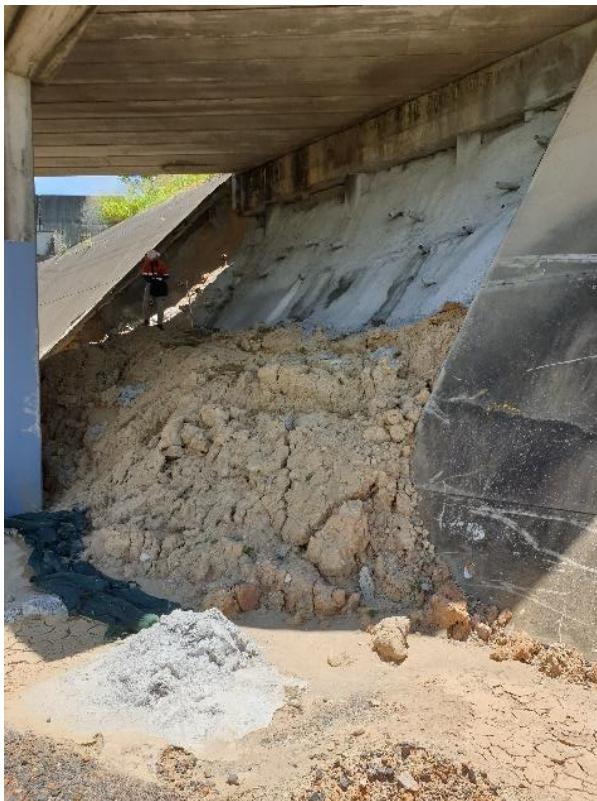
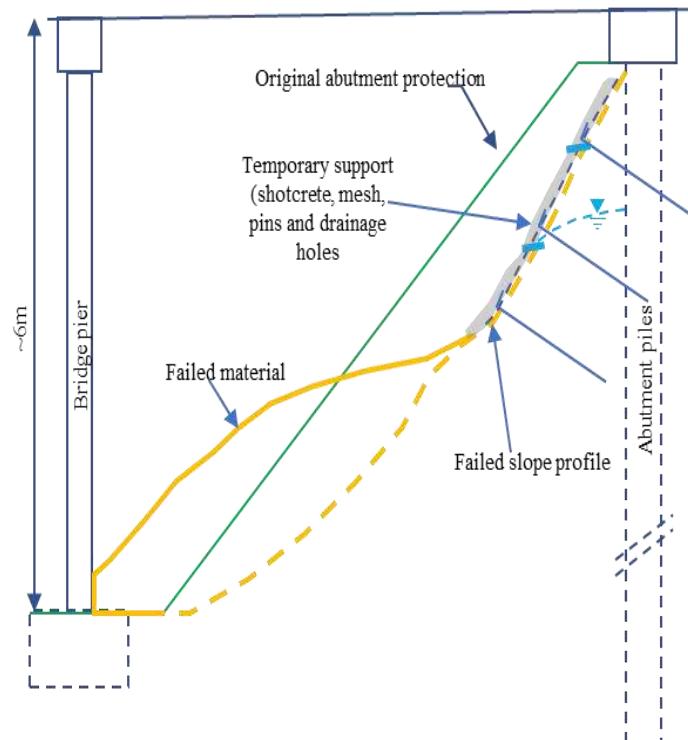
Figure 3. Temporary remediation (shotcrete with mesh, drainage holes, and driven pins) installed within 24 hours of the failure. The sketch illustrates the slope profile and temporary remediation installed. Seepage continued to occur two meters below the headstock at a reducing rate.

Due to a forecast of further rainfall in the days following the failure, there was an urgent requirement to making the abutment safe and prevent further slips from the exposed surface. The following immediate and urgent mitigation measures were implemented within 24 hours (Figure 3):

- Removal of failed material from batter face and abutting against slope toe to provide passive support.
- Installation of two rows of 1-m long drainage pipes.
- Installation of three rows of 2-meter long, 20-millimeters diameter caged steel reinforcement bars (driven) at 1-meter spacing.
- Application of 160 millimeters (average) thick shotcrete with SL82 mesh.
- Closure of one lane on the road below with temporary traffic lights with contra flow.
- Risk management advice included daily inspections of the site (to later be reduced to weekly, granted there were no further movements) and checks after rainfall events.

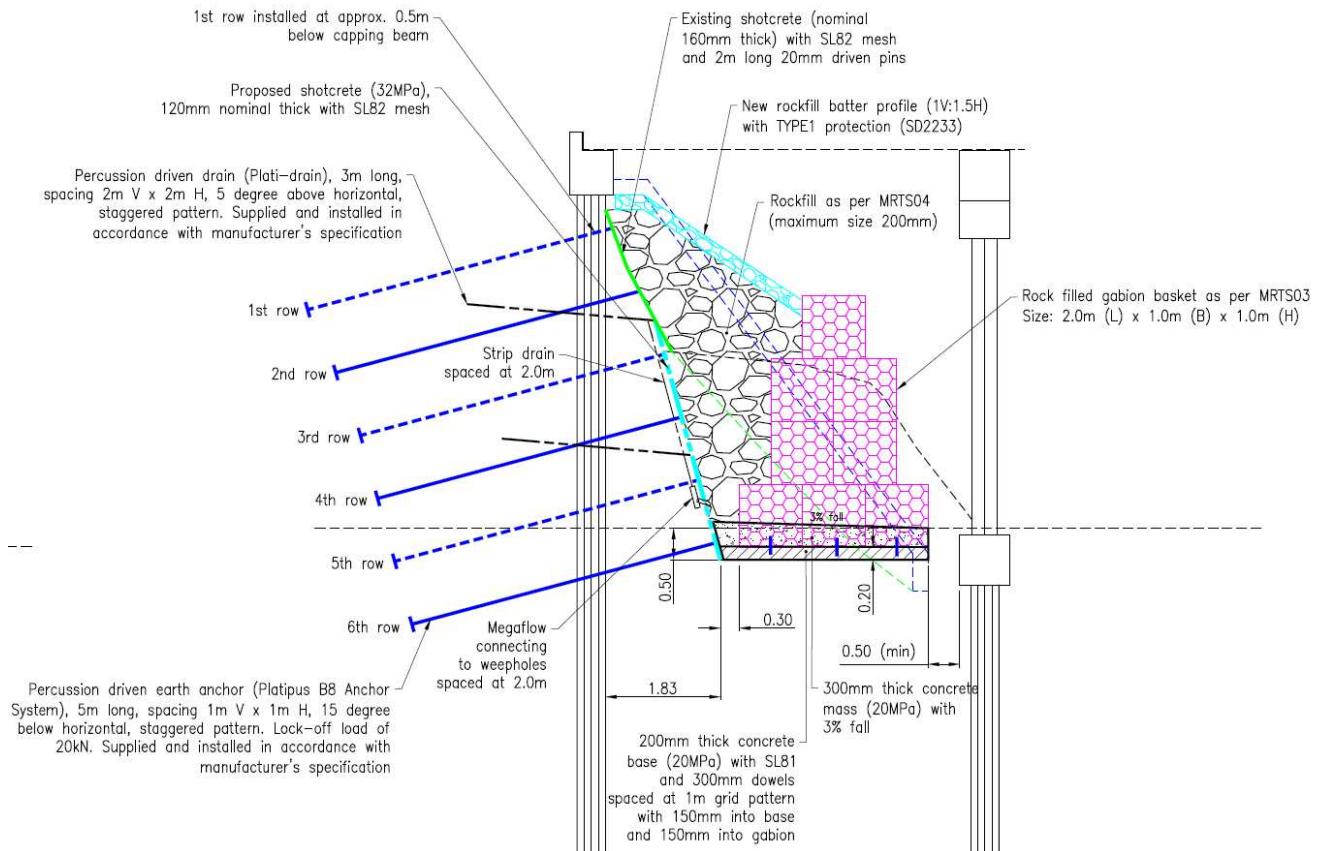
Figure 4. Permanent remediation of the bridge abutment.

- Installation of percussion anchors (300 millimeters wide head, 20 kilo Newton lock-off load) via slots cut into existing shotcrete (urgent works) at 1 meter vertical and horizontal spacing in a staggered pattern.
- Staged excavation at 1.2 meters lifts, followed by installation of percussion anchors, mesh and shotcrete, a row at a time until the toe of excavation was reached for formation of foundation for gabion.
- Installation of percussion drainage (three meters long by two rows at two meters staggered spacing).

It is worth noting that percussion anchors were chosen as they are quick to install, do not need specialized equipment, suit the application in a small space, and can be loaded soon after installation. Figure 4 shows the final design adopted to remediate the bridge abutment.

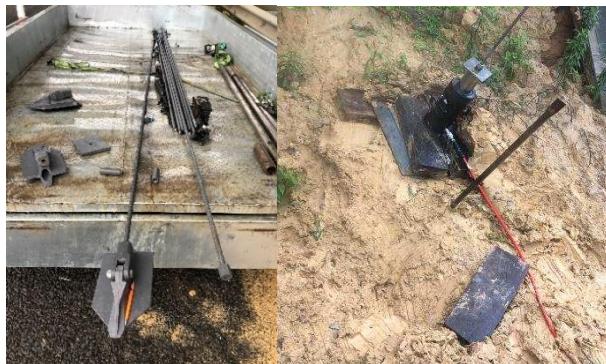
The construction of the remediation works commenced in May 2022. The appointed contractor proposed an alternative anchor head size to the size proposed in the design. This was mainly to accommodate a smaller machine to drive the percussion anchors. The proposal was accepted provided that the working load of 80 kilo Newton could be achieved. Three test anchors (180 millimeters head size) were tested prior to the commencement of production anchors. Two of the anchors achieved >25 kilo Newton and the test had to be terminated due to soft material around the collar (Figure 5). One anchor was tested to 100 kilo Newton (at 850 millimeters extension) and the test was terminated as the load reached 80 per cent of ultimate breaking load of the steel tendon, 120 kilo Newton. On that basis, the proposed 180 millimeters anchor head was accepted as the minimum size that could be used. However, during construction, a mixture of 180-millimeter and 300-millimeter head sizes were used since there was a supply issue with the smaller heads. No issues were encountered during installation of the anchors.

Figure 5. Percussion anchor (180-millimeter head) and load testing.

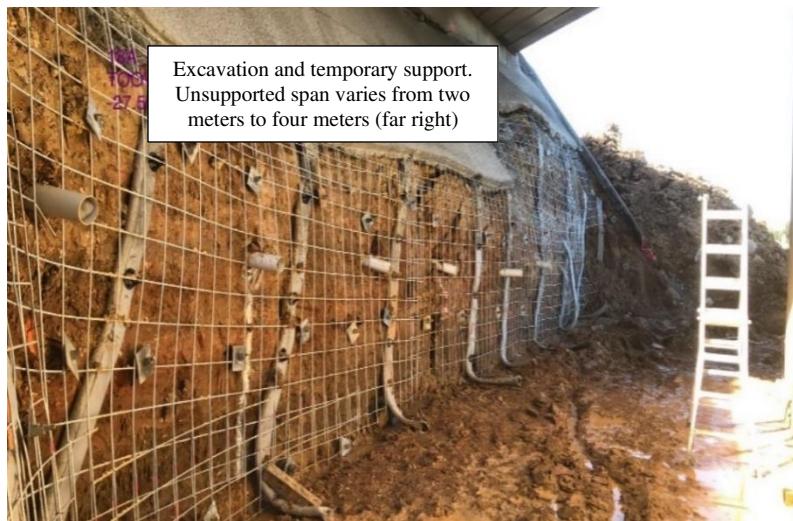
The excavation, anchor installation, and shotcrete application progressed well for the first three rows of anchors, after which, the contractor inadvertently excavated to full depth not following the support sequences specified in the design drawings. This resulted in the exposure of the slope face between 2-4 meters high without full protection. Consequently, approximately, 0.5 meter thick soil movement occurred behind the highest exposed face (Figure 6) with displacement of 250 millimeters in shotcrete below the headstock. On the same day, 13 millimeters of rainfall exacerbated the movement. Additional rows of anchors and steel mesh were installed to stabilize the movement. As a precautionary measure, the highway speed was also reduced to 60 kilometers per hour to minimize any vibration-induced movements. Surveillance was also increased to ensure safety was not compromised. The rate of the movement reduced after the installation of additional support measures and ceased two days after shotcrete application was completed (Figure 7).

Figure 6. Excavation completed to formation level. The abutment is supported with percussion anchors and reinforced shotcrete. Note larger unsupported span on the far right.

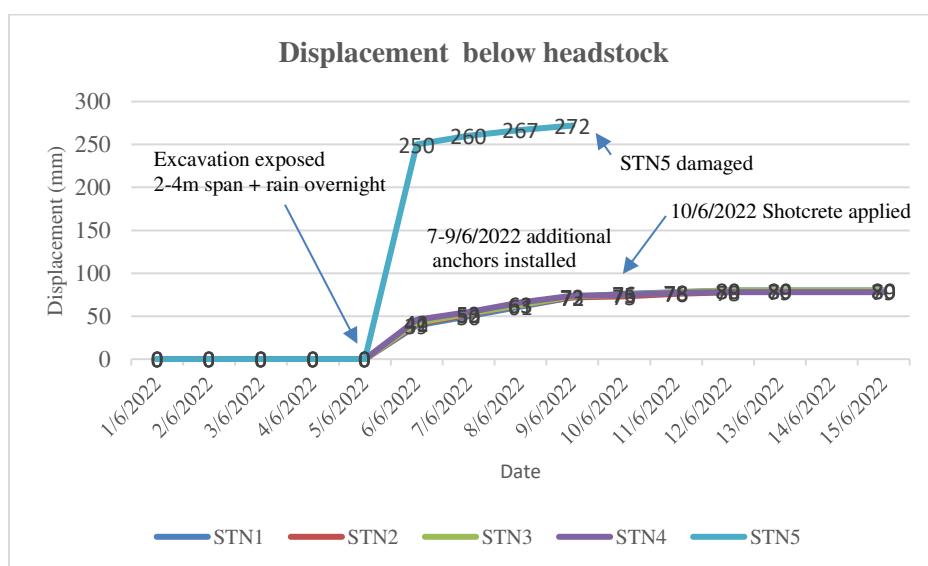
Figure 7. Displacement (mm) in shotcrete below headstock. Station 5 (STN5) located on far right. Displacement ceased two days after shotcrete application.
