Images Collected from the Internet Reveal the Failing Mechanism of the Tailing Dam Breach at Kolontar, Hungary

ABSTRACT: *The failure of the red sludge tailing dam at Kolontar in 2010 was the most severe environmental disaster in the history of Hungary. The official investigations are confidential because the legal case has not been closed. The publicly accessible information from the breach of the dam are the photographs taken by the media and news agencies. Collecting these images and analyzing the recorded fractures and displacements of the dam reveal the failing mechanism. The breach of the dam resulted from failing to sliding, which had been developed in three stages. This conclusion is consistent with the observed movements of the dam deduced from a persistent scattered radar interferometry deformation analysis conducted between 2003 and 2010.*

Reference: Garai J., and Kovács I. (2025). *Images Collected from the Internet Reveal the Failing Mechanism of the Tailing Dam Breach at Kolontar, Hungary*. International Journal of Geoengineering Case Histories, Vol.8, Issue 1, p.64-81. doi: 10.4417/IJGCH-08-01-04

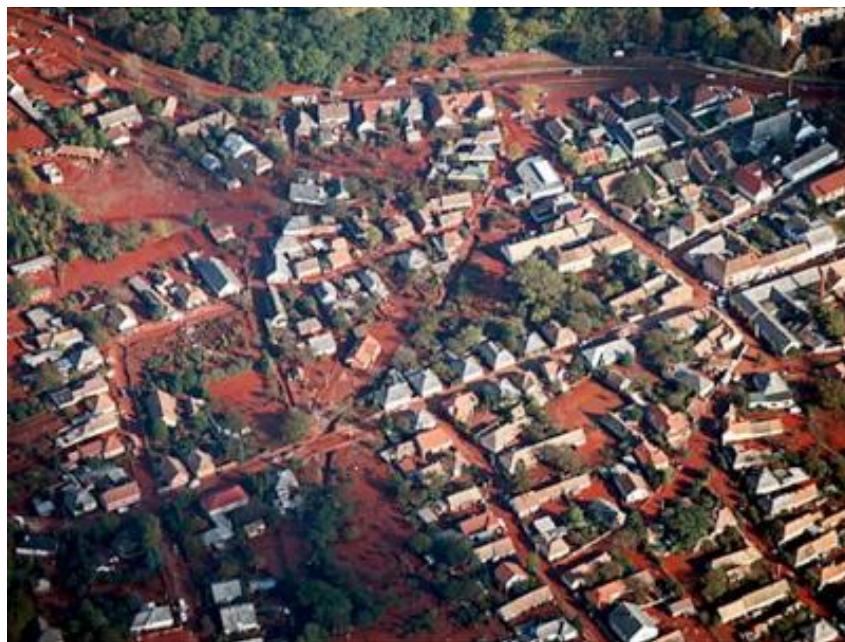
The failure of the dam occurred on October 4th around noon. The dam broke over a 50 m length, resulting in the release of 1 million m^3 of highly basic sludge (Figures 1, 2). The flood of sludge killed 10 people and another 286 were injured (Banvolgyi, Gy., 2010).

Figure 1. The scale of the disaster: the highly toxic sludge flooded the neighboring villages in the valley of Torna. (Source: <http://www.nydailynews.com/news/world/bodies-found-hungary-toxic-red-sludge-seeped-danube-river-article-1.188733>.)

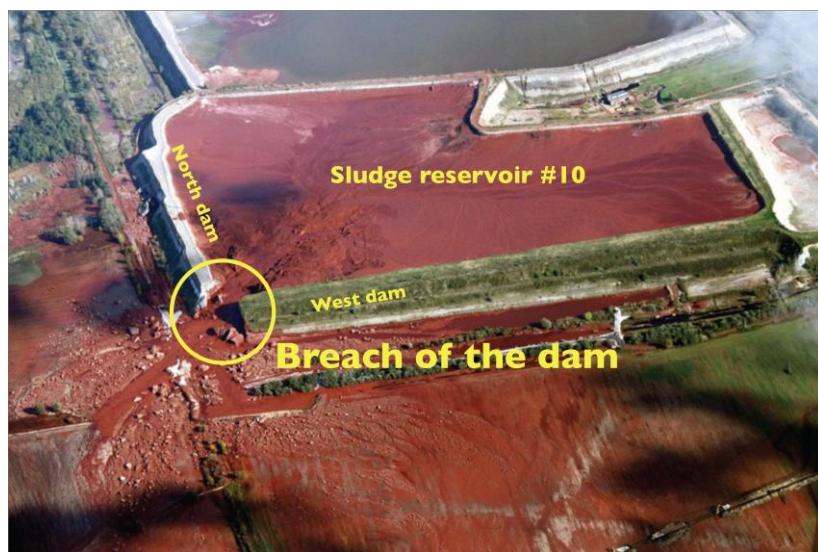
Figure 2. Aerial photo of the breach of the tailing dam.
(Source: <https://www.ndtv.com/world-news/hungarys-toxic-sludge-spill-as-big-as-gulf-oil-leak-435094>.)

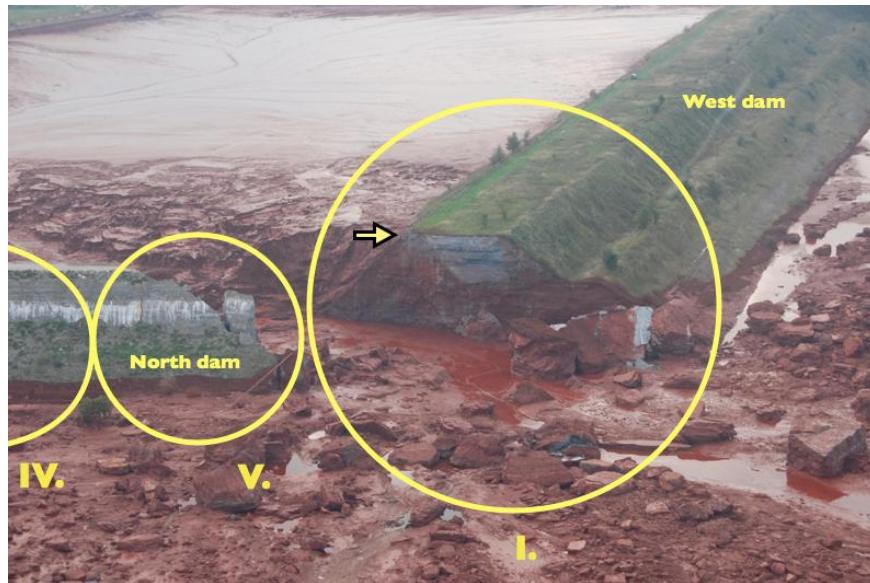
Investigating the collected photos, five fracture locations had been identified. These locations are numbered I-V and shown in Figures 7 and 8. The entire dam section, between fracture Locations I and II, have been displaced. The section between Locations I and V is missing because it had been washed out by the outflow of the sludge. At Location I, the mark of the sludge on the surface of the exposed fracture shows that the displacement occurred at the breach (see Figure 7).

Figure 7. Photo showing the fracture Locations I, IV, and V. The red mark of the sludge on the open surface of the fracture at Location I is the same as the original sludge level. Thus, this fracture occurred right at the breach of the dam before the sludge level decreased in the reservoir. (Source: https://www.aljazeera.com/photo_galleries/europe/20101072047436735; <http://www.kormany.hu/en/photo-galleries/negy-eve-tortent-a-vorosiszap-katasztrof/>.)

This location has one characteristic fracture (0_a), which has been exposed at the breach (Figure 7). The fracture occurred at the corner of the North and West dams and its surface is perpendicular to the West dam. This fracture is clearly the result of tensional stress acting in the direction of the axis of the West dam. The fracture occurred at the breach because the marks of the red sludge on the exposed surface are at the same elevation as the original level in the reservoir (Figure 7). The North

dam has been detached following the development of this fracture and displaced from the West dam, creating an opening. This opening was one of the initiators of the breach. The direction of the flow channel F_1 is consistent with this conclusion.

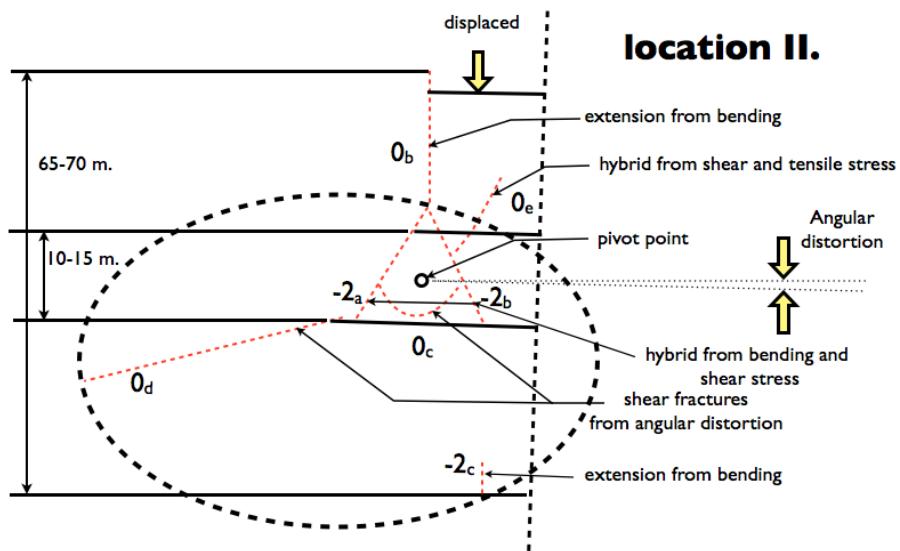
Location II is in the middle of the North dam. The fracture pattern is quite complex. Based on the fracture pattern, it can be identified that the fractures -2_a and -2_b relate to bending (Figure 6). The tension side of the bending was the outer side of the reservoir. However, on this side (outward from the reservoir), shear fractures 0_c and 0_d are also present, indicating compression stress on the same side (Figures 4 and 5).

Figure 13. The identified fractures at Location II are shown. Dashed circles mark fractures, formed from compression and tension in the same location. The coexistence of the extension and shear fractures in the same location can only be possible if the stress conditions changed in time.

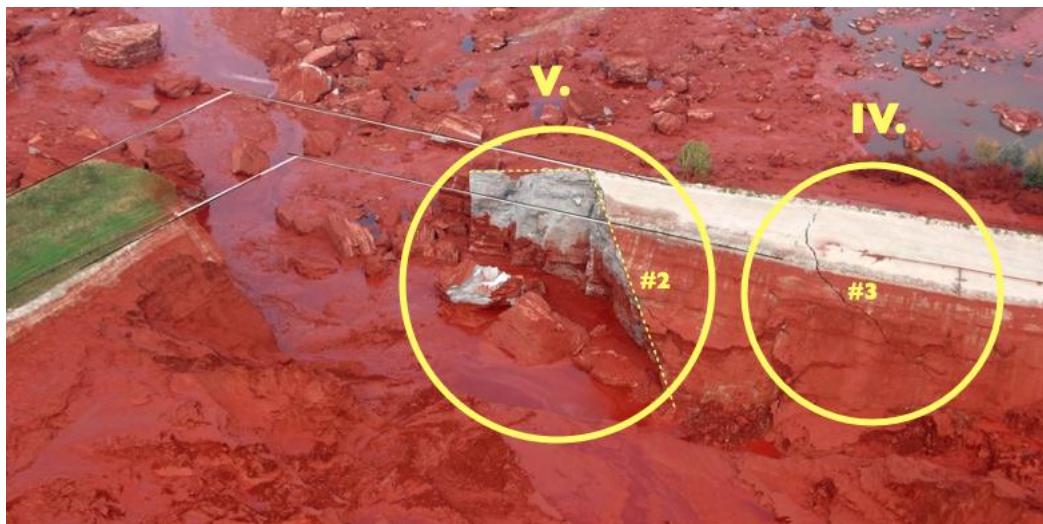
The fracture pattern of these sites shows hybrid failure (Figure 17).

Figure 17. The fractures at Locations IV and V are hybrid fractures caused by the outflowing pressure of the red sludge and the additional settlement. These fractures occurred after the breach of the dam and they have no relevance to the failing of the dam. (Source: https://commons.wikimedia.org/wiki/File:Ajka_accident_d7df9fea08_b.jpg.)
