Images Collected from the Internet Reveal the Failing Mechanism of the Tailing Dam Breach at Kolontar, Hungary

ABSTRACT: *The failure of the red sludge tailing dam at Kolontar in 2010 was the most severe environmental disaster in the history of Hungary. The official investigations are confidential because the legal case has not been closed. The publicly accessible information from the breach of the dam are the photographs taken by the media and news agencies. Collecting these images and analyzing the recorded fractures and displacements of the dam reveal the failing mechanism. The breach of the dam resulted from failing to sliding, which had been developed in three stages. This conclusion is consistent with the observed movements of the dam deduced from a persistent scattered radar interferometry deformation analysis conducted between 2003 and 2010.*

Reference: Garai J., and Kovács I. (2025). *Images Collected from the Internet Reveal the Failing Mechanism of the Tailing Dam Breach at Kolontar, Hungary*. International Journal of Geoengineering Case Histories, Vol.8, Issue 1, p.64-81. doi: 10.4417/IJGCH-08-01-04

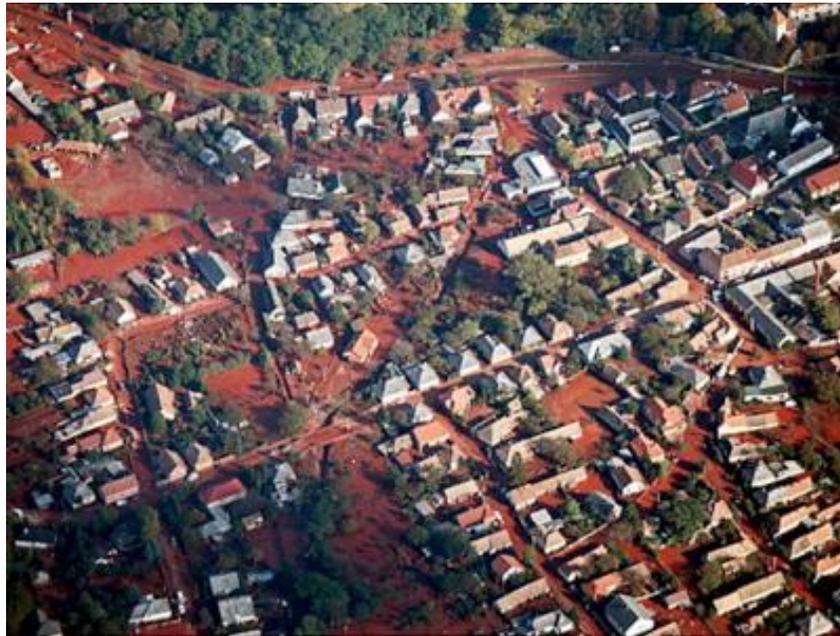
The failure of the dam occurred on October 4th around noon. The dam broke over a 50 m length, resulting in the release of 1 million m^3 of highly basic sludge (Figures 1, 2). The flood of sludge killed 10 people and another 286 were injured (Banvolgyi, Gy., 2010).

Figure 1. The scale of the disaster: the highly toxic sludge flooded the neighboring villages in the valley of Torna. (Source: <http://www.nydailynews.com/news/world/bodies-found-hungary-toxic-red-sludge-seeped-danube-river-article-1.188733>.)

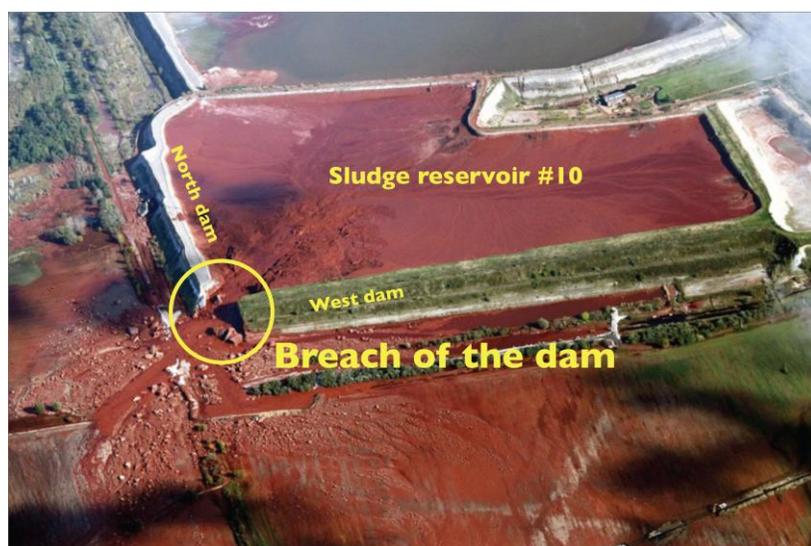
Figure 2. Aerial photo of the breach of the tailing dam. (Source: <https://www.ndtv.com/world-news/hungarys-toxic-sludge-spill-as-big-as-gulf-oil-leak-435094>.)

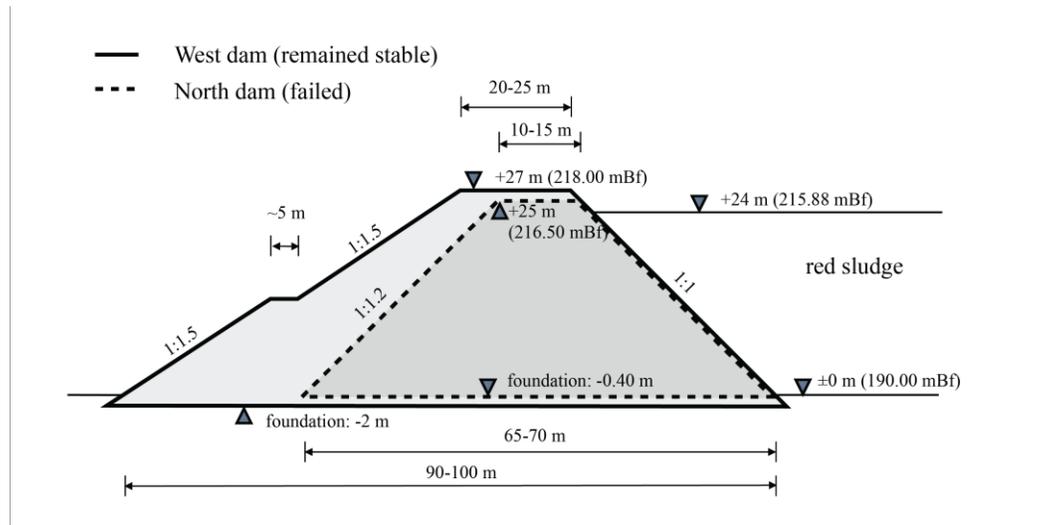
Figure 3. The cross sections of the North and West dams (Farkas et al., 2013). The Northern dam primarily was designed to separate two reservoirs. The cross section of the dam therefore is significantly smaller in comparison to the West dam, which was designed to support the sludge pressure of the reservoir.

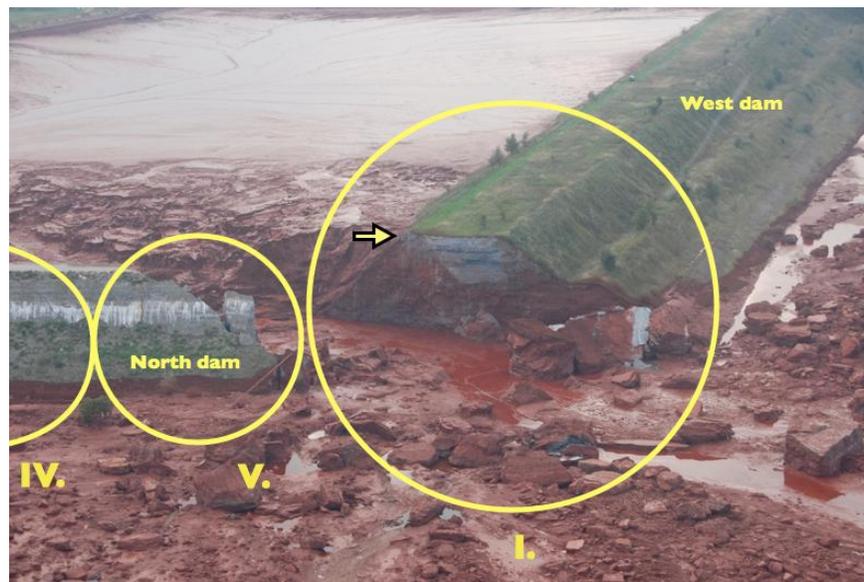
Figure 7. Photo showing the fracture Locations I, IV, and V. The red mark of the sludge on the open surface of the fracture at Location I is the same as the original sludge level. Thus, this fracture occurred right at the breach of the dam before the sludge level decreased in the reservoir. (Source: https://www.aljazeera.com/photo_galleries/europe/20101072047436735; <http://www.kormany.hu/en/photo-galleries/negy-eve-tortent-a-vorosiszap-katasztrof>.)

This location has one characteristic fracture (0_a), which has been exposed at the breach (Figure 7). The fracture occurred at the corner of the North and West dams and its surface is perpendicular to the West dam. This fracture is clearly the result of tensional stress acting in the direction of the axis of the West dam. The fracture occurred at the breach because the marks of the red sludge on the exposed surface are at the same elevation as the original level in the reservoir (Figure 7). The North

dam has been detached following the development of this fracture and displaced from the West dam, creating an opening. This opening was one of the initiators of the breach. The direction of the flow channel F_1 is consistent with this conclusion.

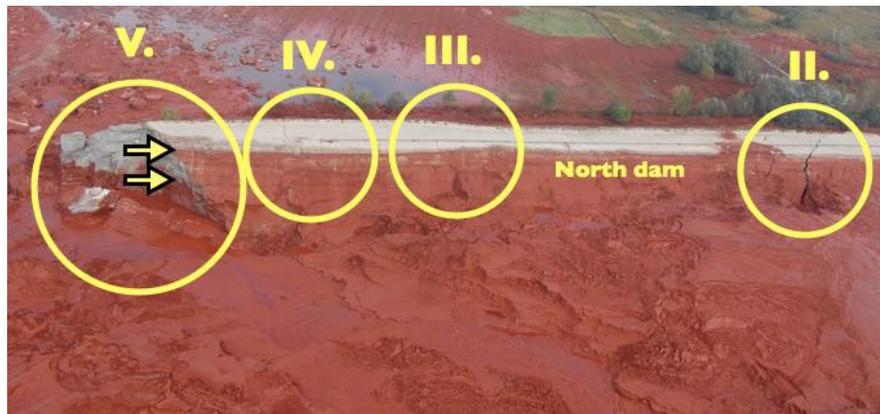
At Location V, the mark of the red sludge on the fracture (Figure 8) is lower than the original one, which indicates that this fracture occurred after the breach, when the sludge level in the reservoir was already lowered.

Figure 8. Photo showing fracture Locations II-V. The red mark of the sludge on the open surface of the fracture at Location V is shown. This mark is much lower than the original level in the reservoir, indicating that this fracture was formed after the breach, when the sludge level was significantly lower. (Source: <http://toleducation.org/achievements/red-legacy/>.)

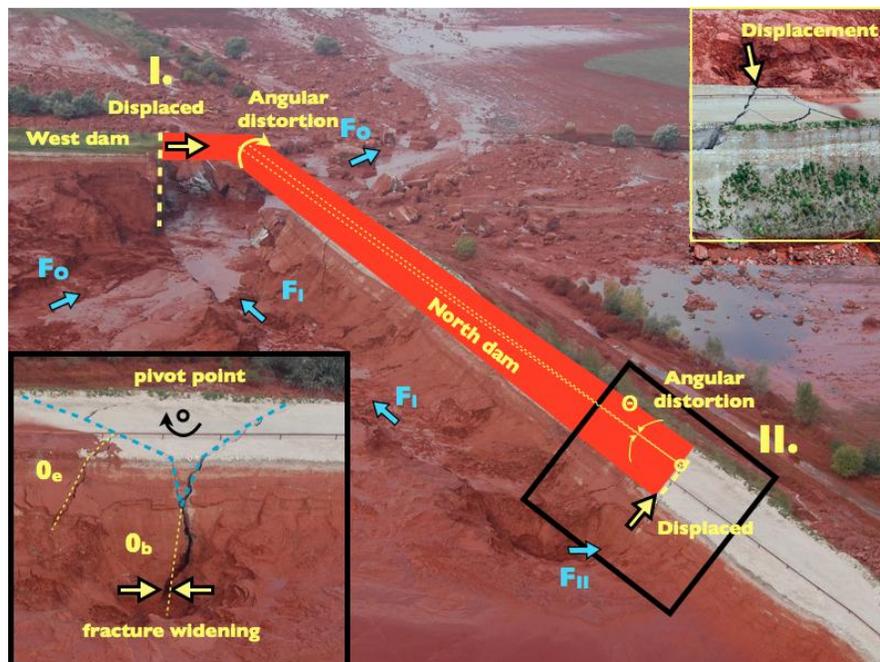
Displacements outward from the reservoir at Locations I and II of the western part of the North dam had been identified (Figure 9). The dam remained intact between these two locations; it is reasonable to assume that the entire dam section between them had been displaced. The displacements at the two ends of the failed dam section are different, which induced an angular distortion on the failed section. This distortion can be identified from the widening of the fracture at Location II (see Figure 9) and from the position of the detached pipe at Location II (see Figure 10). Thus, the failed section of the dam between Locations I and II has been displaced, and an angular distortion has been induced (Figure 9).

Figure 9. The failed section of the North dam is shown in red. This entire section had been displaced outward from the reservoir. Angular distortion also occurred from the bigger displacement at Location I. The widening of fracture 0_b supports the angular distortion. The channels created by the outflow are visible on the surface of the red sludge. The identified flow directions (F) are shown. (Sources: <http://www.hungarianambiance.com/2011/09/possibility-of-act-of-terrorism-cant-be.html> and <https://phys.org/news/2011-04-wildlife-largely-absent-red-sludge.html#nRlv>.)

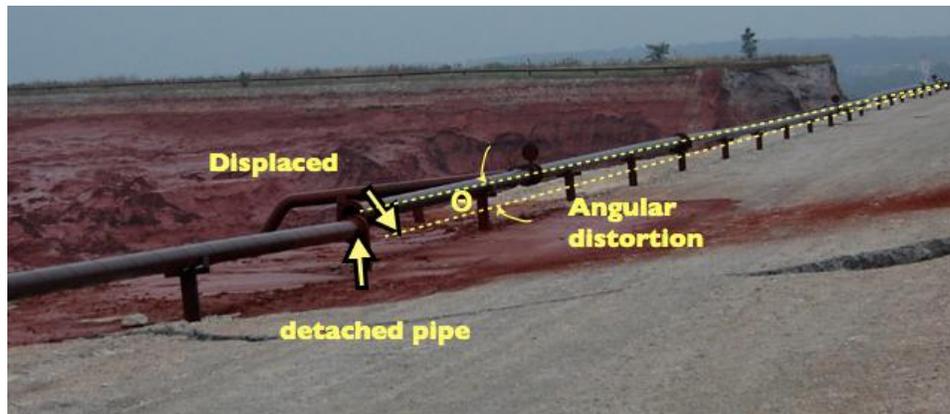
Figure 10. The angular distortion of the failed section of the dam can be seen from the position of the displaced broken pipe. On the failed part of the dam the pipe moved towards the reservoir despite the outward movement of the failed dam section. This indicates that the displacement resulting from angular distortion exceeded the outward displacement of the dam. (Source:

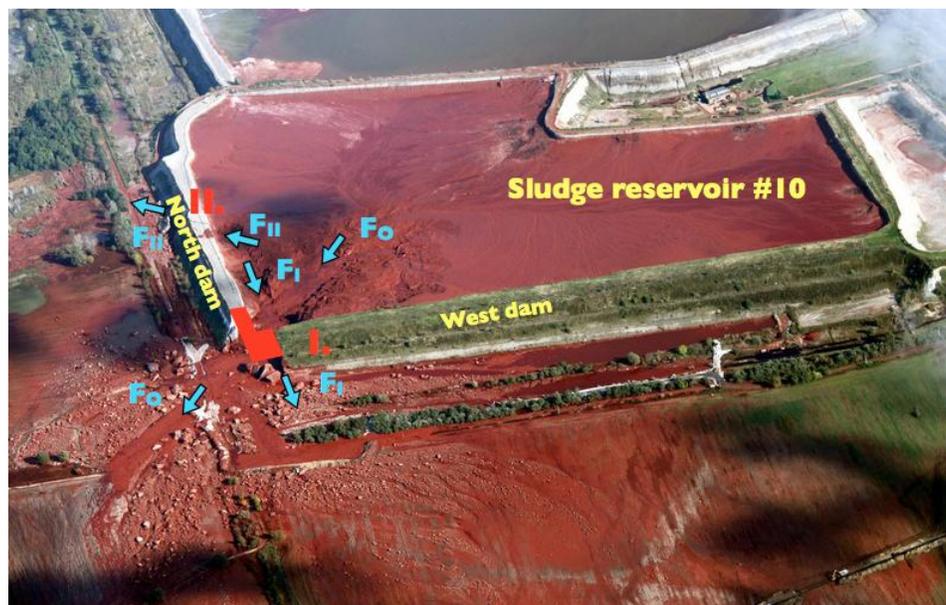
Figure 11. Based on the created flow channels in the red sludge, the flow directions were reconstructed. The initial flows F_1 and F_2 occurred at Locations I and II, pointing toward the direction of the existing fractures. The direction of flow F_1 changed to F_0 when the western part of the North dam had been washed away, creating a big opening. (Source: <https://www.ndtv.com/world-news/hungarys-toxic-sludge-spill-as-big-as-gulf-oil-leak-435094>.)

The flow directions pointing towards Location I (F_I) and Location II (F_{II}) are narrow, indicating that these were the initial flows which were active right after the breach of the dam. These channels, F_I and F_{II} , are also deeper than the third one, F_O . The bigger depth of these channels indicates that these are the initial flows, when the initial hydraulic gradient was the highest. The flow directions further confirm that the fractures developed at Locations I and II initiated the breach of the dam. The third identified flow direction (F_O) is shallower and wider, pointing toward the direction of the biggest opening. It is concluded that the flow F_I changed its direction to F_O when part of the North dam had been washed away.

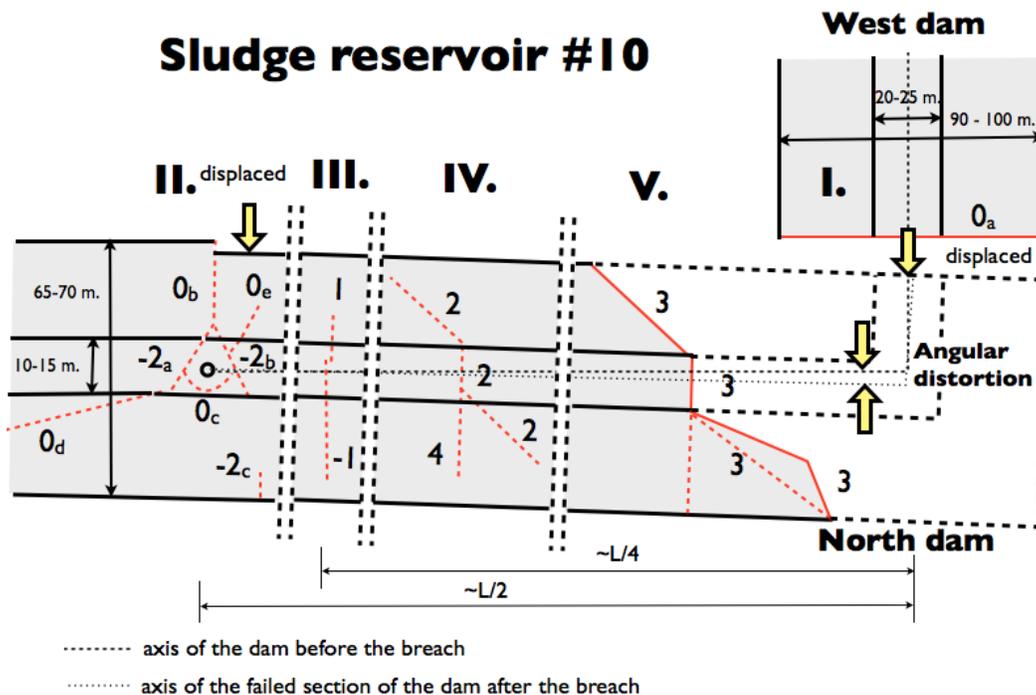
The five locations of the fractures can be seen in Figures 7 and 8. The individual fractures are numbered in the sequence of their occurrence. Minus and plus signs are used to indicate if the fractures occurred before or after the breach respectively. Number zero has been assigned to the fractures that occurred at the breach of the dam. The schematic patterns of the identified fractures and the assigned numbers are shown in Figure 12.

Figure 12. The sketch of the identified fractures is shown. The fractures are numbered in the sequence of their occurrence. Minus and plus signs are used to indicate if the fracture occurred before or after the breach respectively. Number zero has been assigned to the fractures that occurred at the breach of the dam.

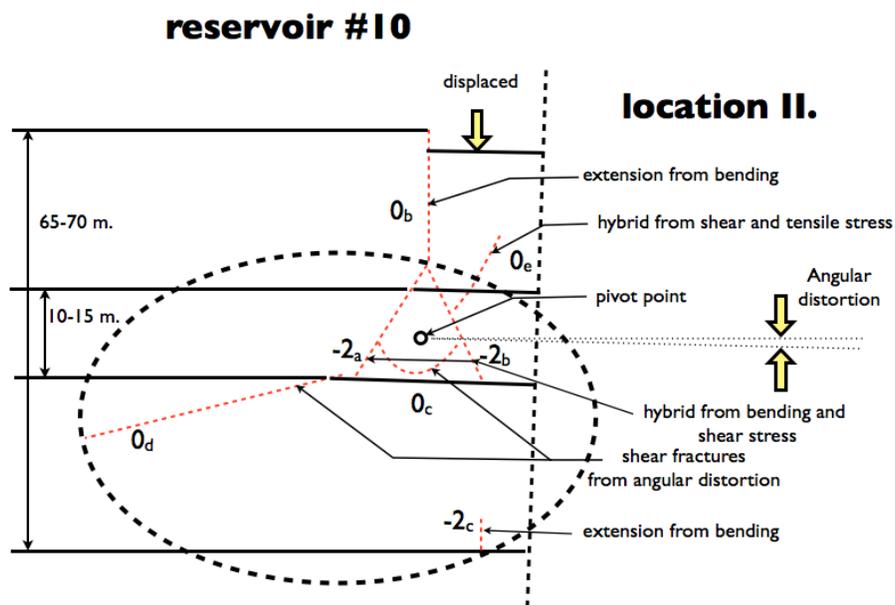
Location II is in the middle of the North dam. The fracture pattern is quite complex. Based on the fracture pattern, it can be identified that the fractures -2_a and -2_b relate to bending (Figure 6). The tension side of the bending was the outer side of the reservoir. However, on this side (outward from the reservoir), shear fractures 0_c and 0_d are also present, indicating compression stress on the same side (Figures 4 and 5).

Figure 13. The identified fractures at Location II are shown. Dashed circles mark fractures, formed from compression and tension in the same location. The coexistence of the extension and shear fractures in the same location can only be possible if the stress conditions changed in time.

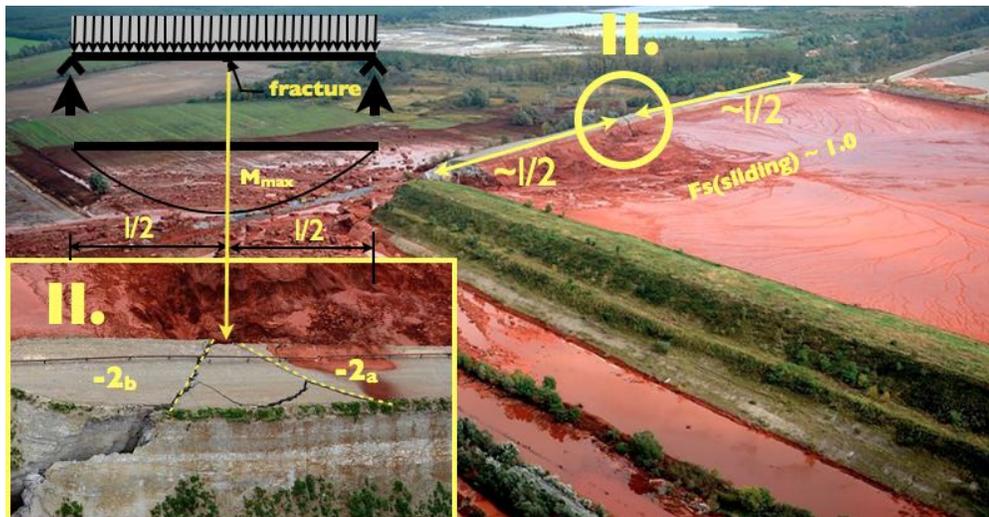
The coexistence of compressional and tensional stresses at the same side of the dam is possible only if the stress conditions changed in time. At the breach, displacement and angular distortion occurred. These movements should develop compression stress on the outward and tensile stress in the inward side and shear stress. The bending related fractures -2_a and -2_b are not consistent with the stress condition at breaching, which indicates that these fractures -2_a and -2_b were already present when the breach occurred. The fracture pattern -2_a and -2_b is an indicative of failing from bending (Figure 6), which developed from the pressure of the red sludge acting from the reservoir site on the dam. The bending related fracture pattern is further supported by the location of the fractures, which is in the middle of the North dam, where the maximum bending moment should occur in a beam subject to uniform load (Figure 14).

Figure 14. Location II is at the middle of the North dam, where the bending moment has its maximum under uniformly distributed load. The fracture pattern (Figure 6) and the location suggest that these fractures (-2a, and -2b) occurred from the bending. These fractures were formed before the breach of the dam. (Sources: <http://toleducation.org/achievements/red-legacy/>; <http://www.hungarianambiance.com/2011/09/possibility-of-act-of-terrorism-cant-be.html>.)

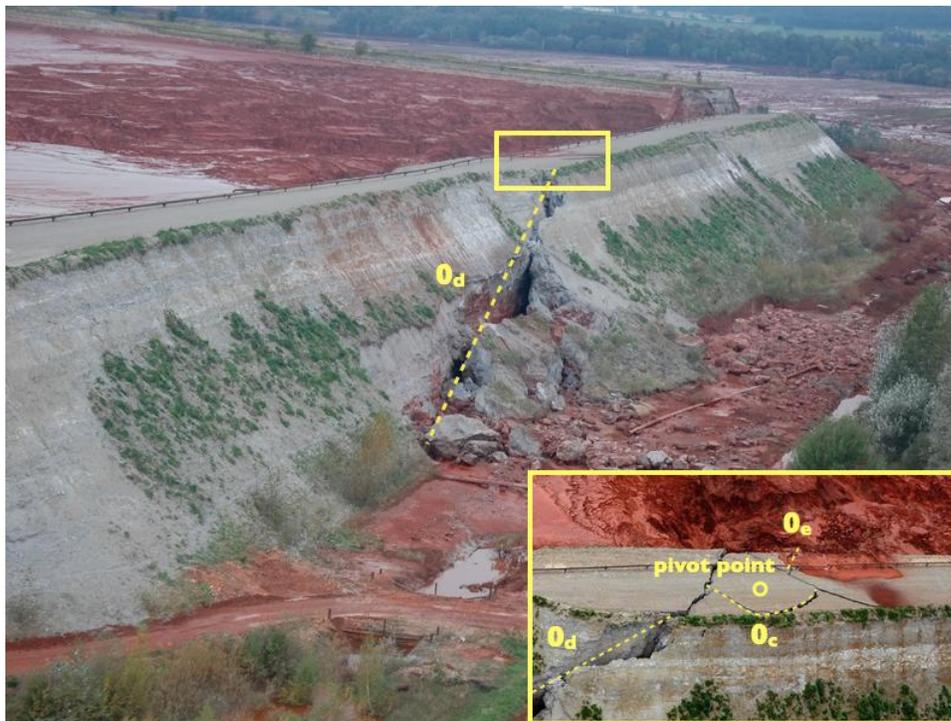
The last straw leading to the breach of the entire dam section was when the tensional resistance of the West dam was exhausted. The dam, whose sliding resistance had already been exhausted, had been detached at fracture 0_a and the dam moved outward from the reservoir, activating the preexisting bending fractures at Location II. The displacement also induced an angular distortion which generated tensile and shear stresses on the reservoir side, resulting in fractures 0_b and 0_c respectively. The angular distortion of the dam produced compression stress at the outward site of the reservoir, which resulted in the development of shear fractures 0_c and 0_d on the outward side of the dam (Figure 15). The detachment occurred along the extension fracture (0_b) (Figure 9), and the preexisting fracture -2_a (Figure 14). Fracture 0_c (Figure 9) is a hybrid fracture caused by extension (angular distortion) and shear stresses (displacement).

Figure 15. Shear fractures (0_c and 0_d) caused by compressional stress at Location II are shown. These fractures were formed at the breach, resulting from the angular distortion of the failed dam section. On the opposite (reservoir) side, at the same time, extension fracture 0_b occurred (Figure 9), extending the existing fracture of -2_b . (Sources: <https://www.nbcnews.com/slideshow/toxic-red-sludge-floods-towns-near-budapest-39514793>; <http://www.hungarianambiance.com/2011/09/possibility-of-act-of-terrorism-cant-be.html>).

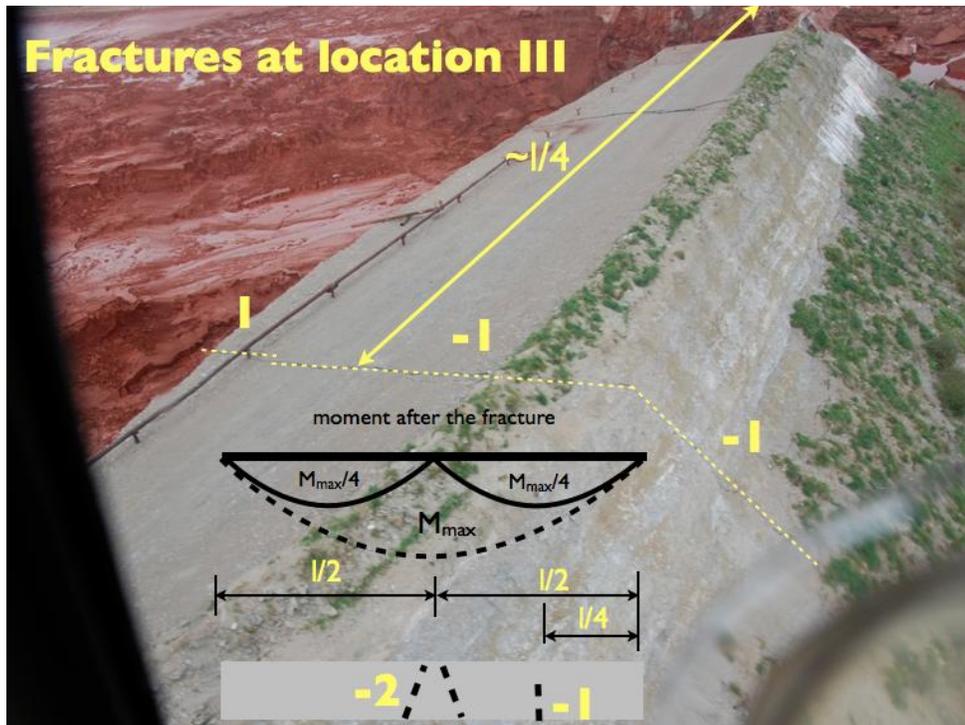
There are two independent fractures (1 and -1) perpendicular to the axis of the North dam. Based on the fracture direction, it is concluded that these fractures are the result of tensile stress acting in the direction of the axis of the dam (Figure 4). Both of these fractures resulted from bending, but there is a time gap between their occurrences. Following the development of fractures $-2_{a,b}$ at Location II, the maximum bending moment shifted from the middle of the dam to 1/4 of the length of the dam, which is where Location III is (Figure 16). The tensile strength relating to the bending moment of sludge pressure caused fracture -1 at the outward side of the dam. This failure occurred before the breach of the dam. At this weakened cross section, the angular distortion occurring at the breach and the additional flow pressures after the breach led to the development fracture 1 on the opposite side.

Figure 16. The location and the shape of fracture -1 is shown. Both the location and the shape of the rupture indicate that the failing was caused by bending. Following the formation of fractures -2 at Location II, the maximum moment was formed at Location III, resulting in the fracture of -1. (Source: <http://www.hungarianambiance.com/2011/09/possibility-of-act-of-terrorism-cant-be.html>.)

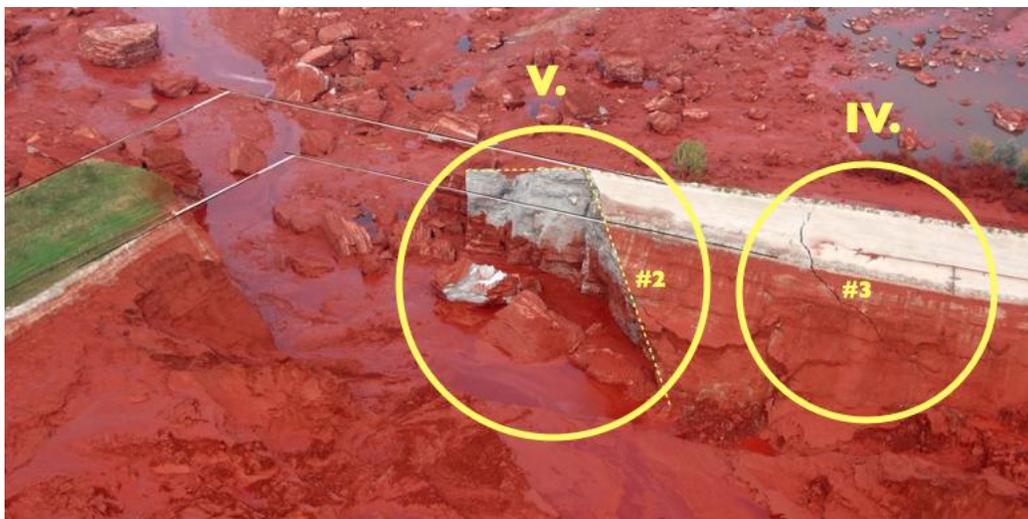
The fracture pattern of these sites shows hybrid failure (Figure 17).

Figure 17. The fractures at Locations IV and V are hybrid fractures caused by the outflowing pressure of the red sludge and the additional settlement. These fractures occurred after the breach of the dam and they have no relevance to the failing of the dam. (Source: https://commons.wikimedia.org/wiki/File:Ajka_accident_d7df9fea08_b.jpg.)

If the fractures at Locations IV and V existed before the breach, then the transformation of the force and the torque would be very limited beyond these locations. Elimination of the torque would not allow the development of the angular distortion beyond Location IV or V. Thus, these fractures at Locations IV and V were formed after the breach. The mark of the red sludge on the surface of fracture 2 also shows that this failing occurred after the breach when the level of the red sludge was reduced from its original elevation (Figure 8). The widening of fracture 3 towards the top of the dam indicates that additional angular distortion in the vertical direction occurred, most likely resulting from the outflow of the sludge, which washed out the soil below the dam section at the opening. The settlement of the dam section led to the development of the extension fracture 4. All fractures at Locations IV and V had been developing after the breach of the dam; therefore, these fractures have no relevance to the breach. The list of all the fractures, as well as the type and the cause of the respective failure, is given in Table 1.

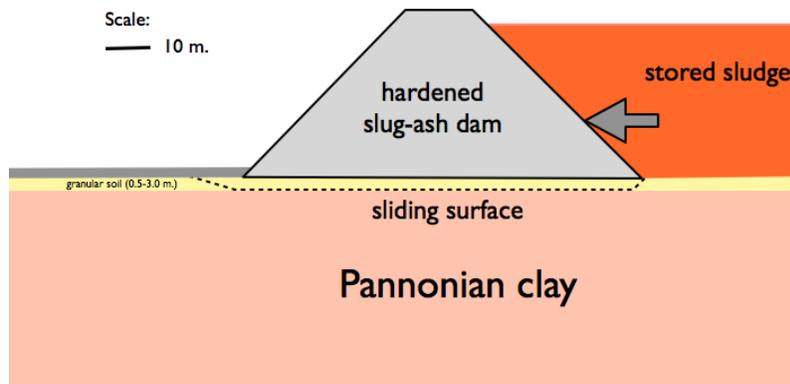
The granular soil (sandy gravel) under the dams, with its weight and its bearing capacity at the toe of the dam, increased the resistance against sliding. Thus, the failure of the dam occurred where the thickness of the granular soil is the smallest (Ndagijimana, 2019). This conclusion is consistent with the failed section of the dam, where the granular layer was the

thinnest (0,5 m) under the dam (Farkas et al., 2013). The dams with a bigger cross section had additional weights, which prevented the sliding failure, even though the resistance against sliding was nearly exhausted.

Figure 18. Schematic cross section of the soil profile and sliding surface of the failing is shown. The high pH and the cation exchange weakened the internal friction of the clay on the surface of the layer. The increasing horizontal pressure of the sludge on the dam led to the sliding failure of the dam along this weak resistant layer. The weight of the granular layer and its bearing capacity at the toe of the dam increased the resistance against sliding. Thus, failure of the dam occurred where the thickness of the granular layer was the thinnest.
