Lack of Maintenance Compromises Tunnel Structural Safety

ABSTRACT: *The Chekka tunnels represent a critical section of the Northern Lebanon Highway. The approximately 350-m long twin tunnels are the most important tunnels in the country. They are used by regular and freight traffic and are a vital link to the capital, Beirut. The tunnels were completed in the early 1970s on the eve of the Lebanon civil war. Given the state of affairs in the country for about two decades of strife, the tunnels were not maintained nor did they undergo any regular inspection. This unique condition of near-abandonment continued up until recently, when the first signs of distress were documented. These consisted of severe and extensive cracking, particularly in the portal approach of the southbound tunnel, along with significant deterioration of the tunnel lining and radial section joints. The danger to traffic and, potentially, to the structure itself was evident. In this paper, the results of an extensive site inspection and evaluation program are presented. The underlying causes of the observed damage are analyzed and discussed using a modeling approach of the progressive loading conditions. Remedia

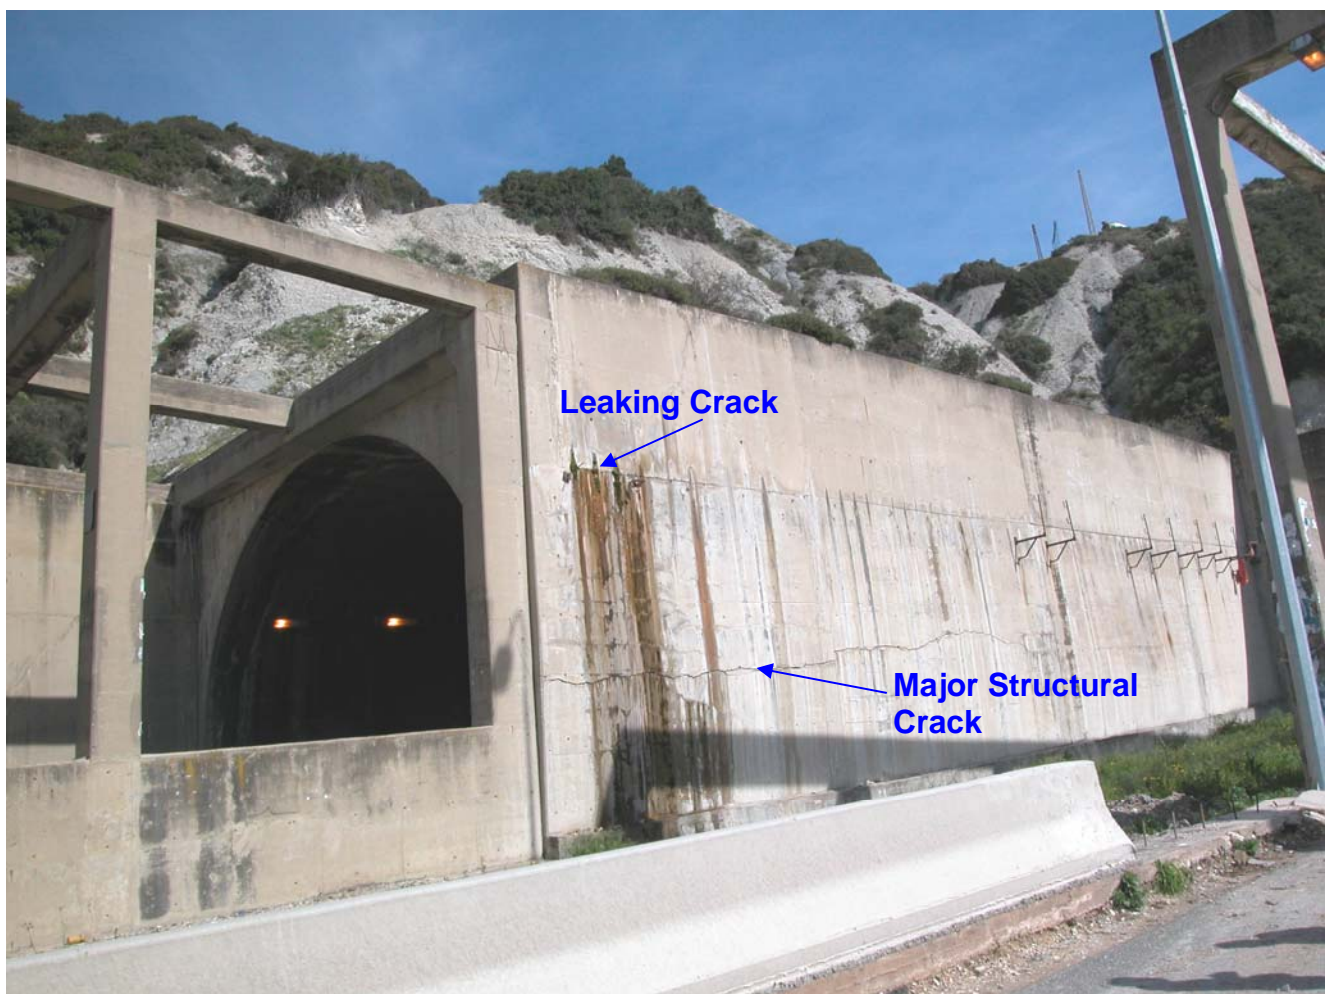
Figure 1. Southbound Tunnel Portal - View of External Distress.

The major crack along the 35-m long portal structure at the southbound tunnel exit (shown in Fig. 1 and Fig. 2) which initiated the engineering intervention, was attributed to increased differential loading. This possible cause for the structural damage was identified following the observation of a relatively large slumped mass of soil loading the western side of the portal structure of the southbound tunnel (Fig. 3). The slumped soil mass was due to weathering of the friable chalky limestone rock on the adjacent exposed slopes and subsequent instability and mass transport. The differential loading of one side of the portal frame structure by the slumped soil mass, along with other contributing factors, could have led to the observed cracking of the eastern wall of the portal along with the associated lateral deformations of up to 15 cm (Fig. 1 and Fig. 2). Additional pictures of this particular tunnel segment are provided in the online database that accompanies this paper.

1. A major longitudinal structural crack was clearly evident on the outside face of the eastern wall of the tunnel portal frame in the last 35 m span of the exit side of the southbound tunnel (Fig. 1). Signs of water leakage through a crack in the eastern wall were evident at the junction between the tunnel portal and the 4.72 m high retaining parapet. This pattern of damage was indicative of a number of problems with the tunnel portals, which are typically identified as potentially problematic areas in a number of situations (Rothfuss et al., 1995).

1. The major structural cracks on the outside face of the eastern wall of the portal frame were repaired by “crack-injection” using low viscosity, two-component epoxy resin. The injection was completed after thorough cleaning and preparation of the affected areas and the provision of injection ports to ensure thorough filling of the cracks. Similar treatments were applied to all cracks and damaged areas in the tunnel concrete lining (Fig. 15).

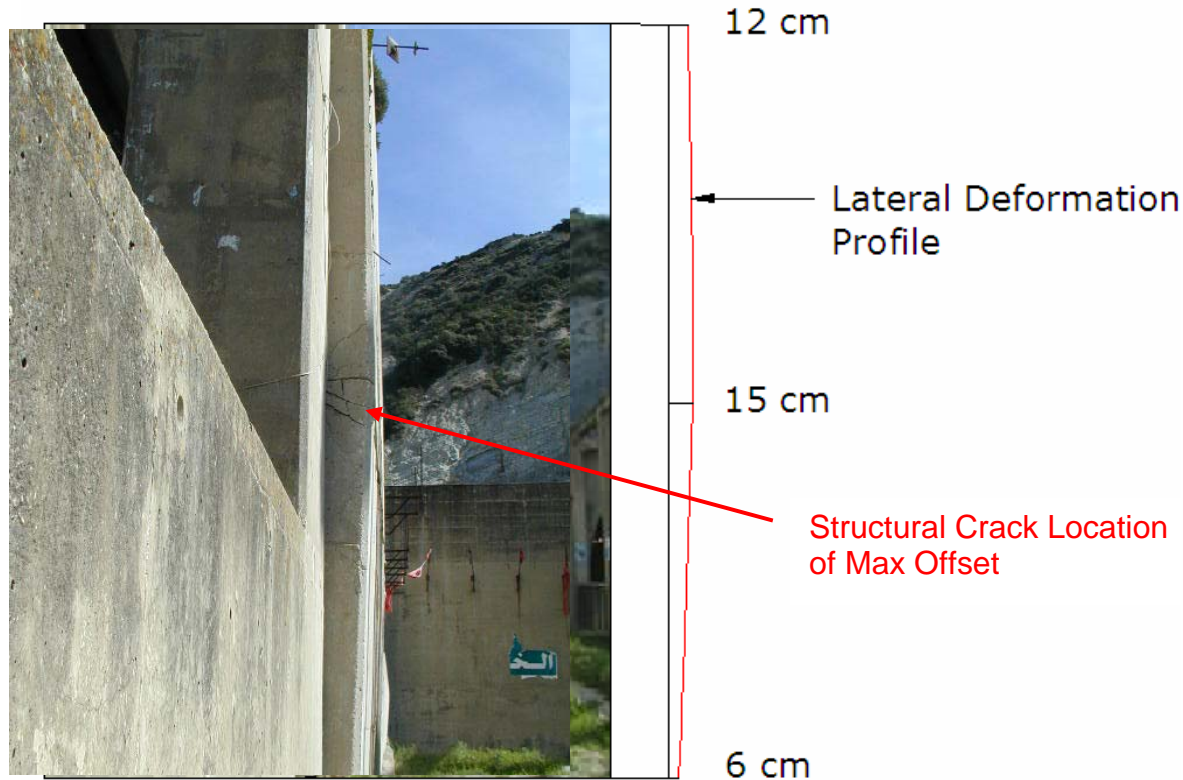
Figure 2. Close-up View of the Outward Movement/bulging of the Eastern Portal Wall.

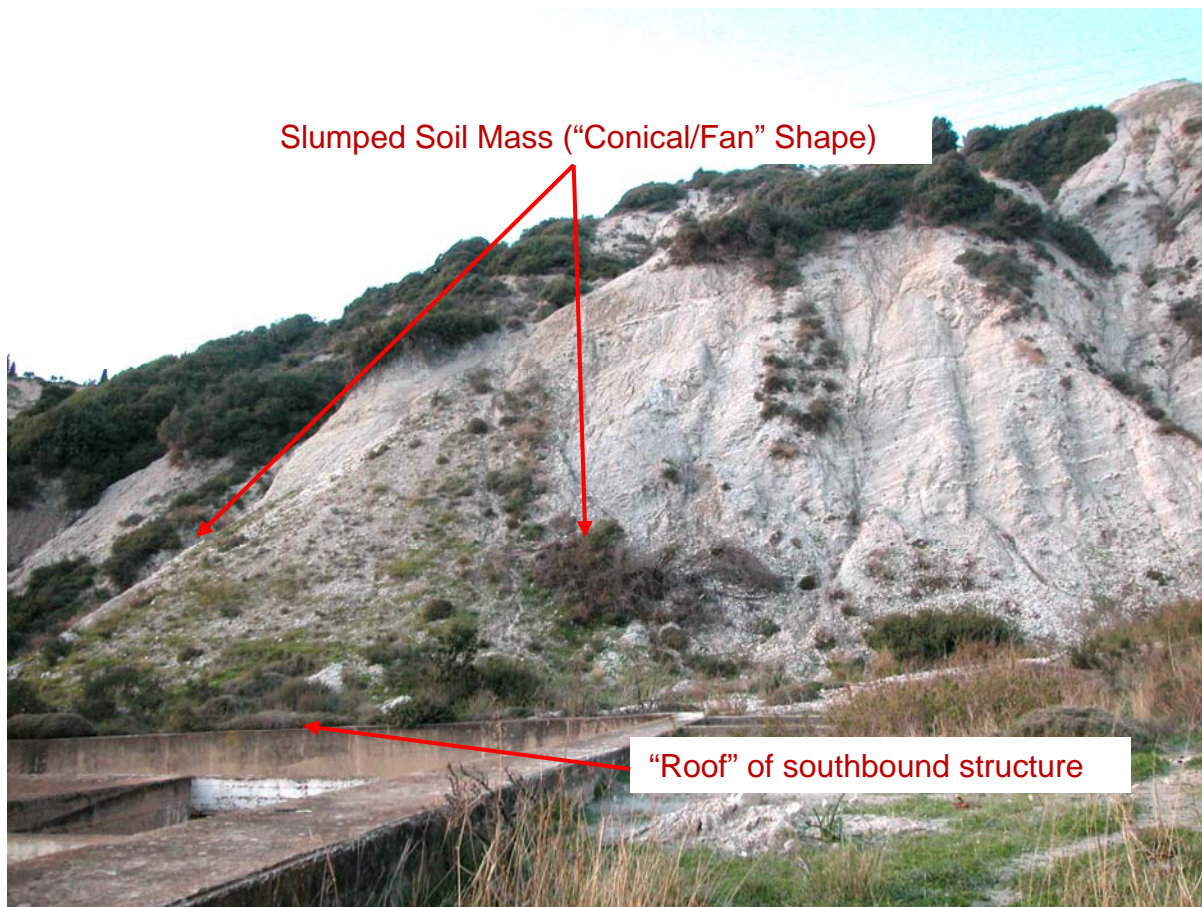
Figure 3. Slumped Soil Mass Loading the Top of the Southbound Tunnel Exit Structure.

1. “Soil 1”, is characteristic of the slumped mass above the southbound tunnel cross-section (Fig. 3). This soil type is characterized by relatively low values of the Menard modulus, dry density and unconfined compressive strength.
2. “Soil 2” is typical of the soft marlstone layers. This material is typical of materials in a band 4 to 6 m thick as evidenced in boreholes BH-1, BH-2, and BH-5.
3. Finally, the third type is the intact marly-limestone rock of the Chekka Formation.

1. Controlling surface water flow and improving drainage around structure area.
2. Removal of the slumped mass on top of the southbound tunnel exit structure and the provision of long-term stability and erosion control measures to eliminate the possibility of recurrence. These provisions included the installation of rock bolts/nails with a high strength steel wire mesh facing (Fig. 13 and Fig. 14). A program for regular inspection and maintenance of the structures was also developed.

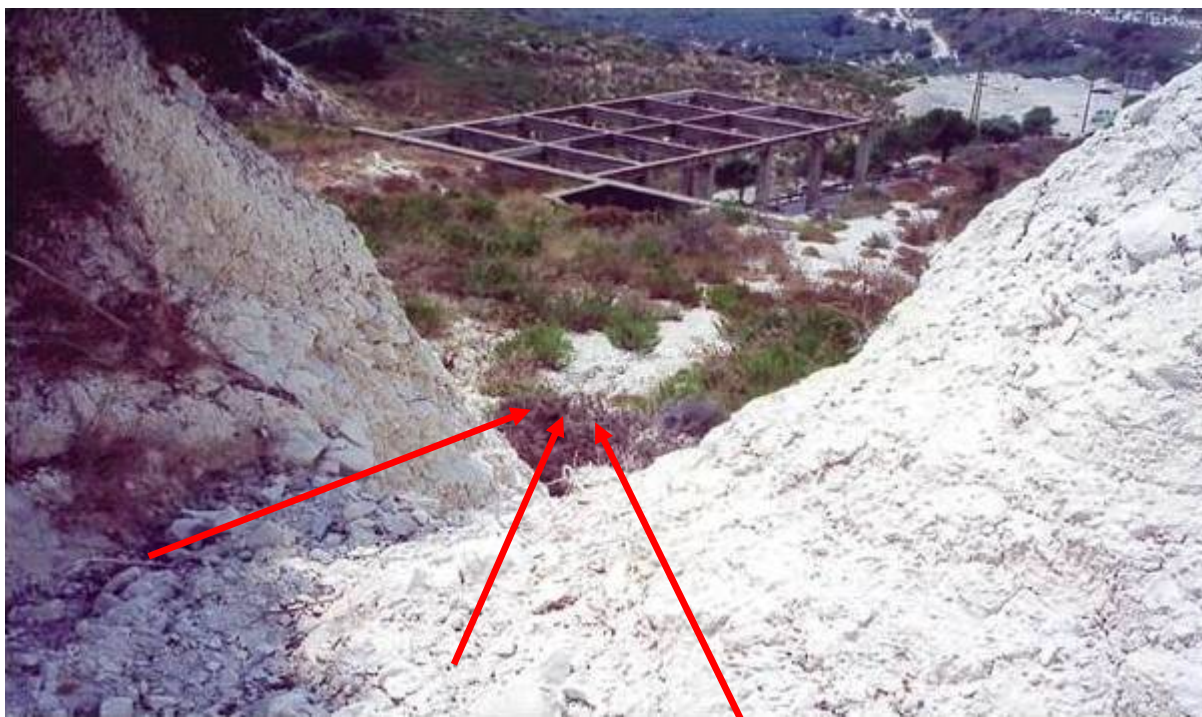
Figure 4. Direct Surface Flow (arrows) Towards South Facing Tunnel Exit/entrance Structures -View From Top.

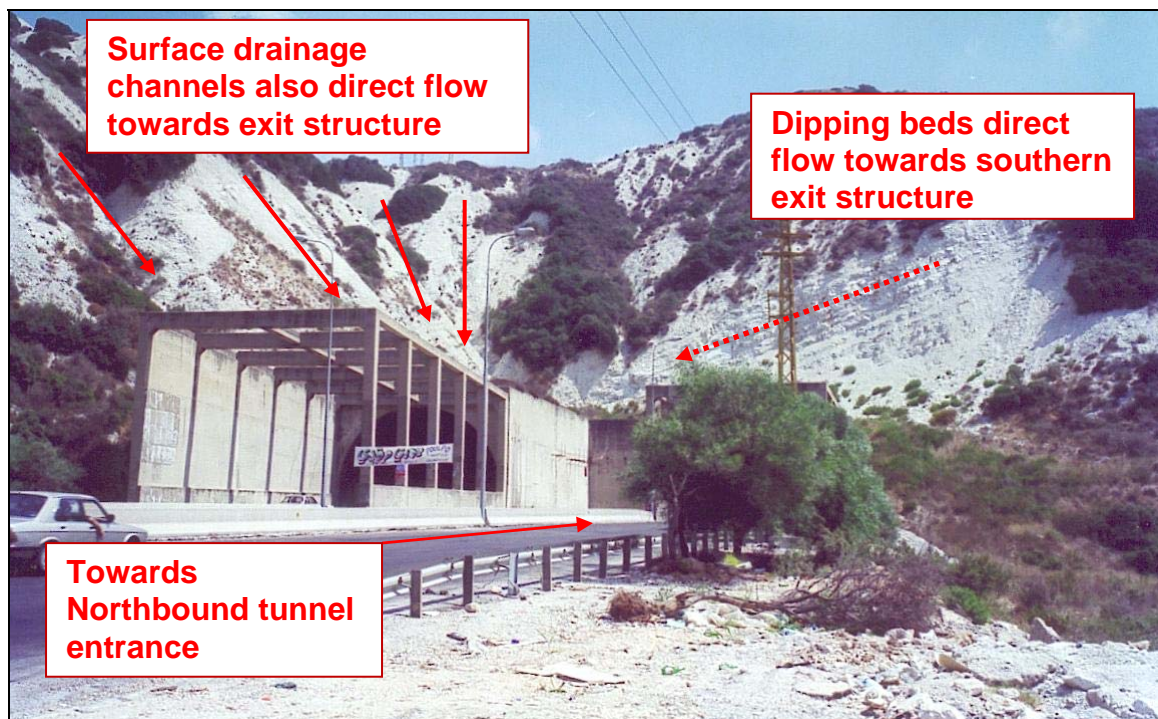
Figure 6. Dipping Beds and Surface Drainage Channels Increase Flow Towards Southbound Tunnel Exit Structure and “Sump” Area Above Tunnels.

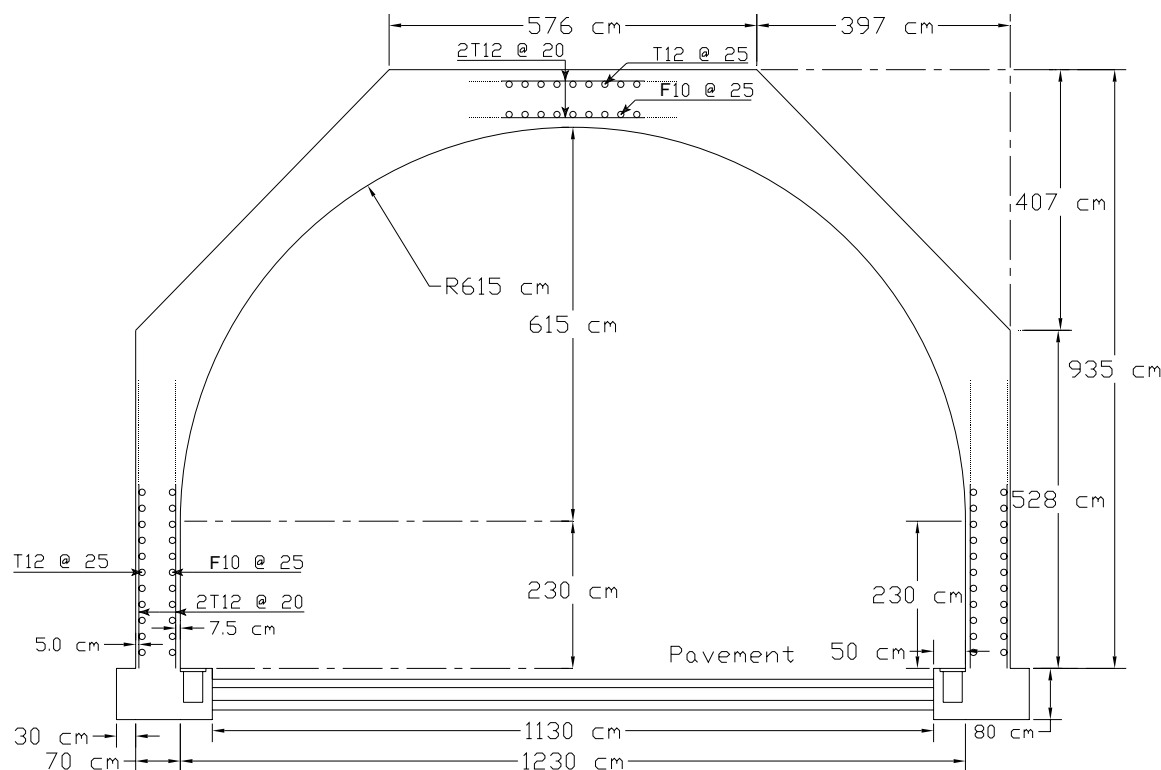
Figure 10. Geometry of the 35-m Long Extension of the Southbound Tunnel Portal.

Table 3 presents the bending moments calculated from the FE analyses and the ultimate moment section capacity at the position of the observed crack ~ 2.5 m above the footing level (Fig. 10).

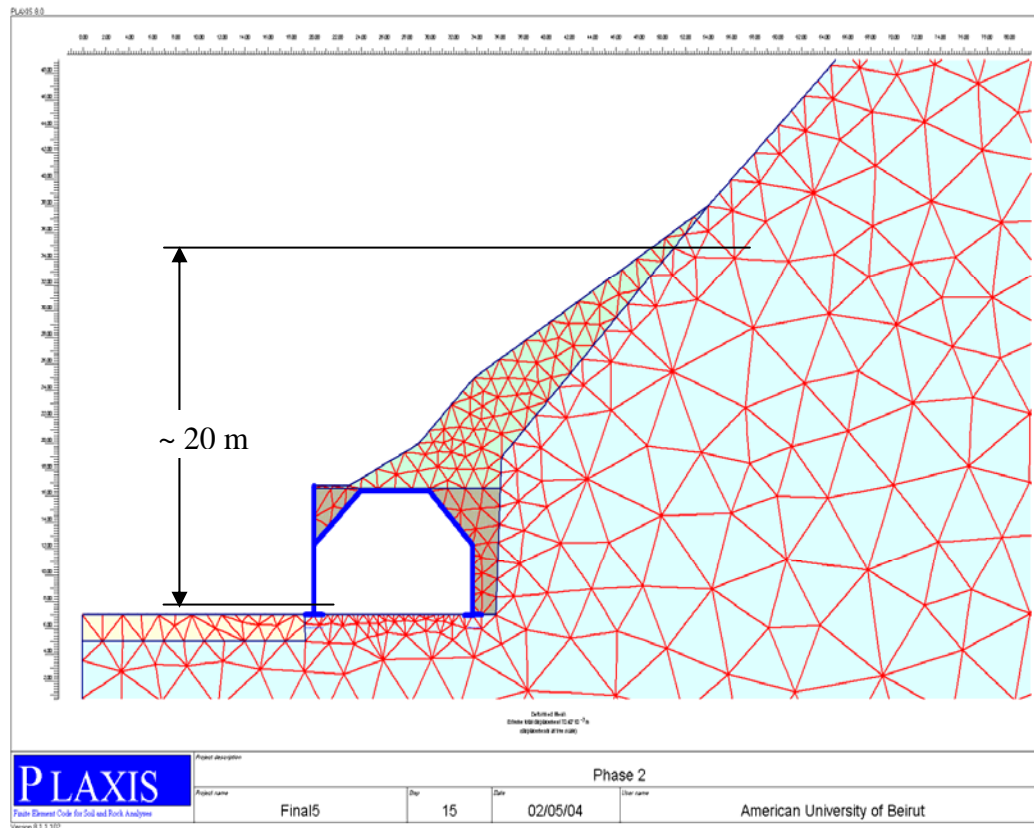
Fig.11 is a detail view of the finite element mesh near the tunnel portal, showing the soil and rock strata as described in Table 2. The intact rock is shown in light blue, while the slumping soil mass is green. The olive green color represents the engineered backfill soil at the end of construction. It is important to note here that the slumping soil mass was only activated for Stage 2.

Figure 11. Finite Element Model Showing the Various Strata and the Loading Sequences – Stages 1 and 2.

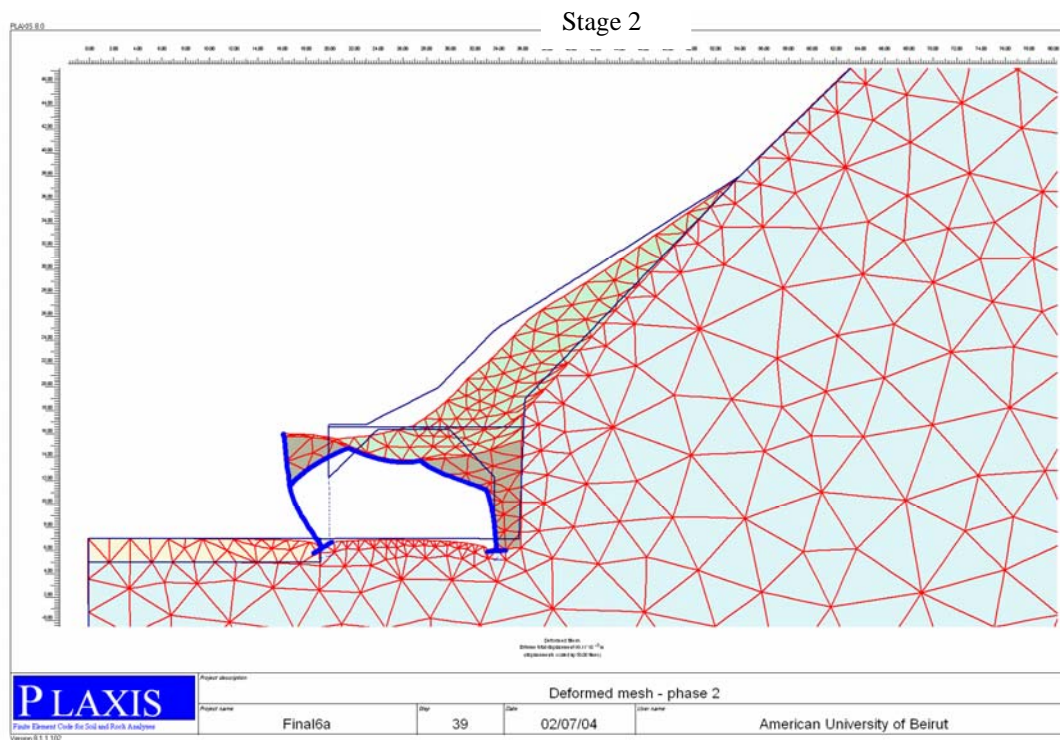
For conditions representing the current loading, Stage 2, the analyses yielded the deformed mesh shown in Fig. 12. The FE results for Stage 2 suggest the following:

1. The maximum bending moment values calculated are much larger than the ultimate moment capacity of the critical wall section. This implies that the additional loading due to the slumped soil accumulated on top of the tunnel section is indeed a major contributing cause of the observed failure of the portal wall section.
2. The values of the shear forces are within the section capacities.

Figure 12. Deformed Mesh for Stage-2 (Deformations Are Scaled up 50 times).
