# The May 25<sup>th</sup> 2011 Railroad Embankment Failure in Ann Arbor, Michigan, As a Means for Teaching Geotechnical Engineering

**ABSTRACT:** A 30-m long railroad embankment failure that occurred on May 25 2011 in the city of Ann Arbor, Michigan, is presented. Emphasis is given on the field observations of the failure, the characterization of the site conditions and the seepage and slope stability analyses, all of which represent important components of the training and practice of a geotechnical engineer. The failure occurred following a record wet season that resulted in ponding water against the embankment and high enough water pressures and exit gradients that resulted in instability of the railroad embankment. Detailed background material and the methodology for using the case history in geotechnical engineering education are presented.

Reference: Zekkos, D., Athanasopoulos-Zekkos, A., Grizi, A., and Greenwood, W. (2016). *The May 25th 2011 Railroad Embankment Failure in Ann Arbor, Michigan, As a Means for Teaching Geotechnical Engineering*. International Journal of Geoengineering Case histories, Vol.3, Issue 4, p.234-245. doi: 10.4417/IJGCH-03-04-03

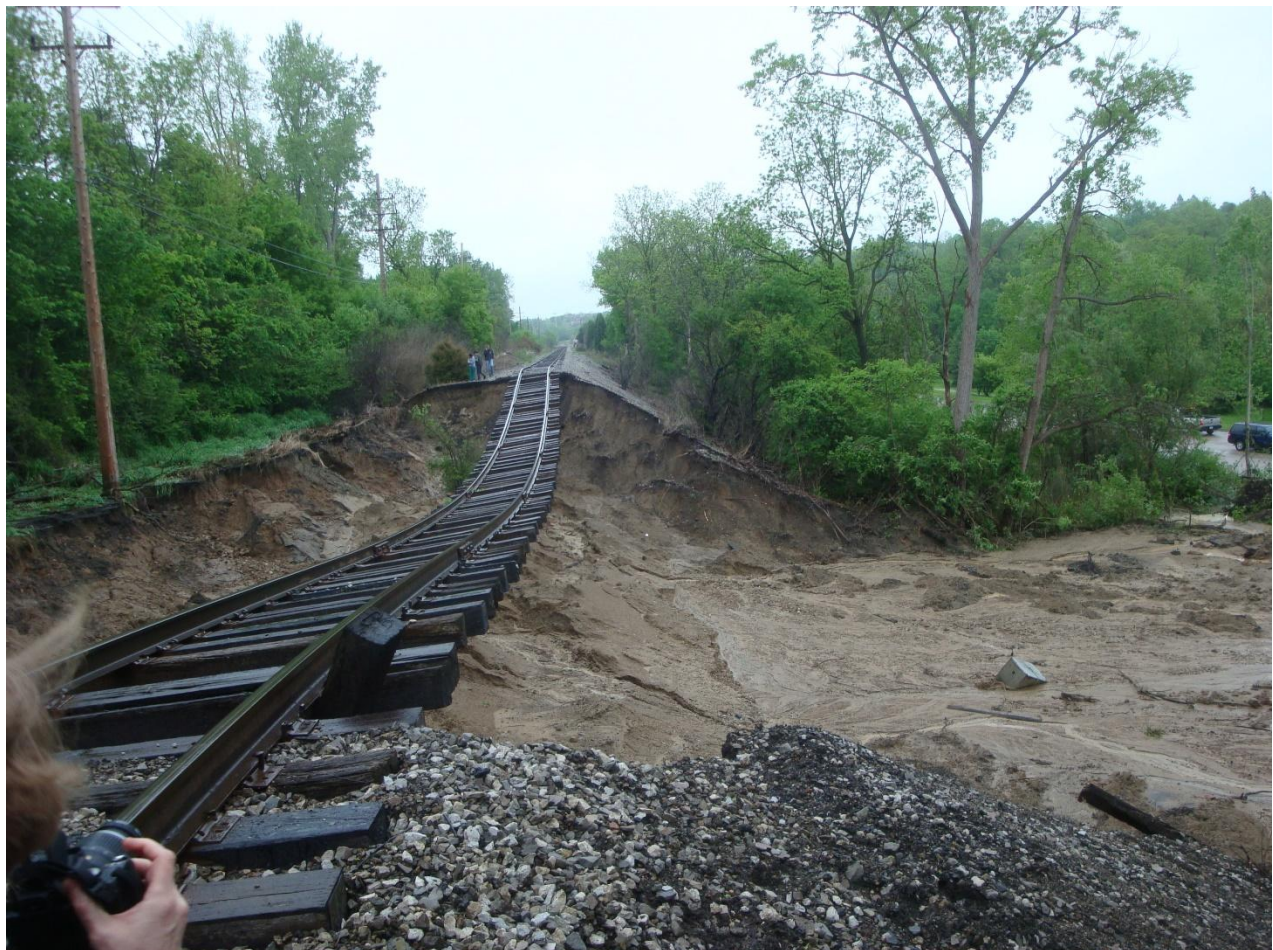
*Figure 1. View of the railroad embankment failure looking East.*

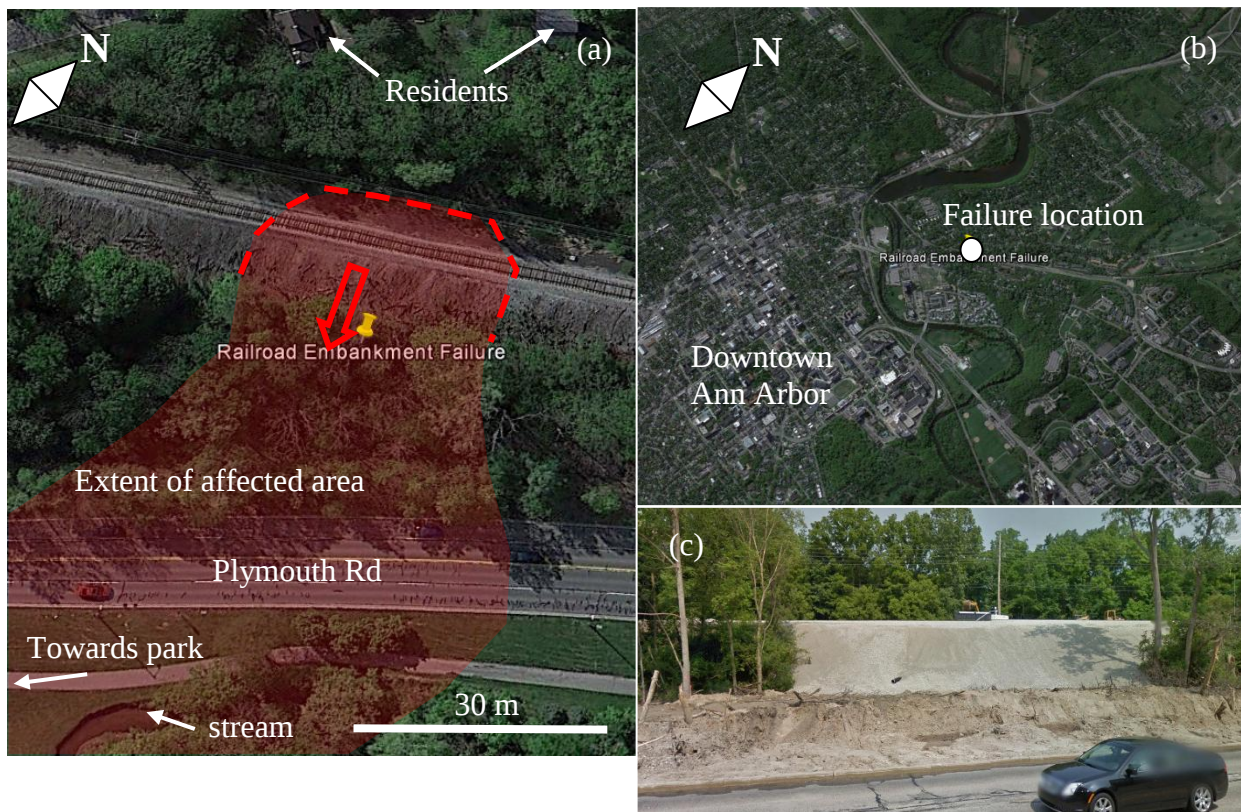
Figure 2. (a) Satellite imagery of the railroad embankment at the failure location; (b) location of the failure; (c) View of the repair works as recorded by coincidence by the Google Earth Camera.

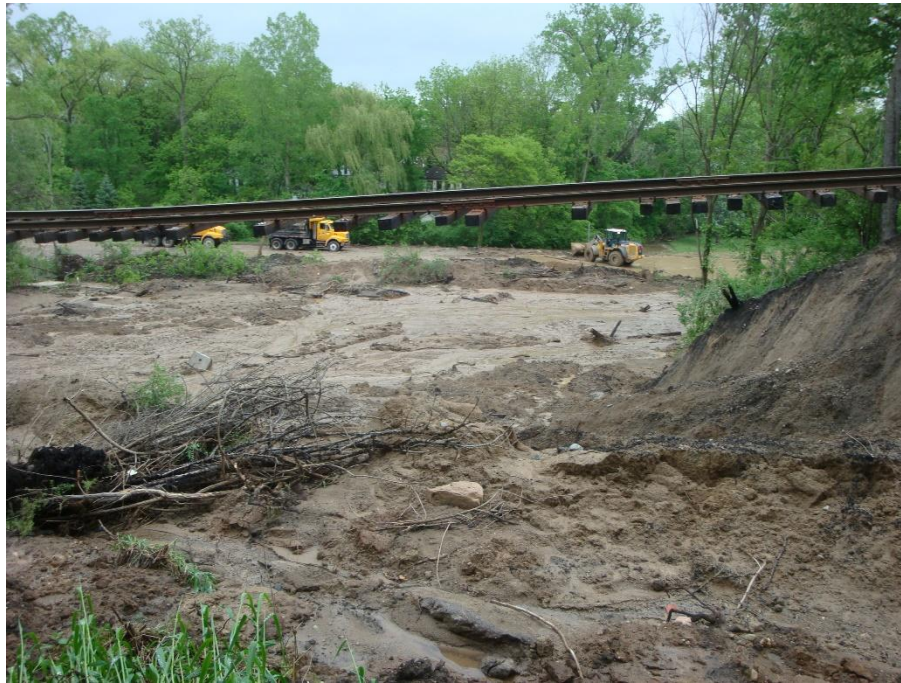
- (a) Shutdown of the railroad for an extended period of time;
- (b) Closure of Plymouth Rd for two days; and
- (c) Flooding and debris deposition on the downslope side of the embankment that damaged a public park southwest of Plymouth Rd and deposited additional sediments in a natural stream, as shown in Fig. 4.

*Figure 4. View of the conditions downhill of the failure showing deposition of debris and water. Trucks and dozer are operating on Plymouth Rd. and flooded area further back is a flooded public park.*

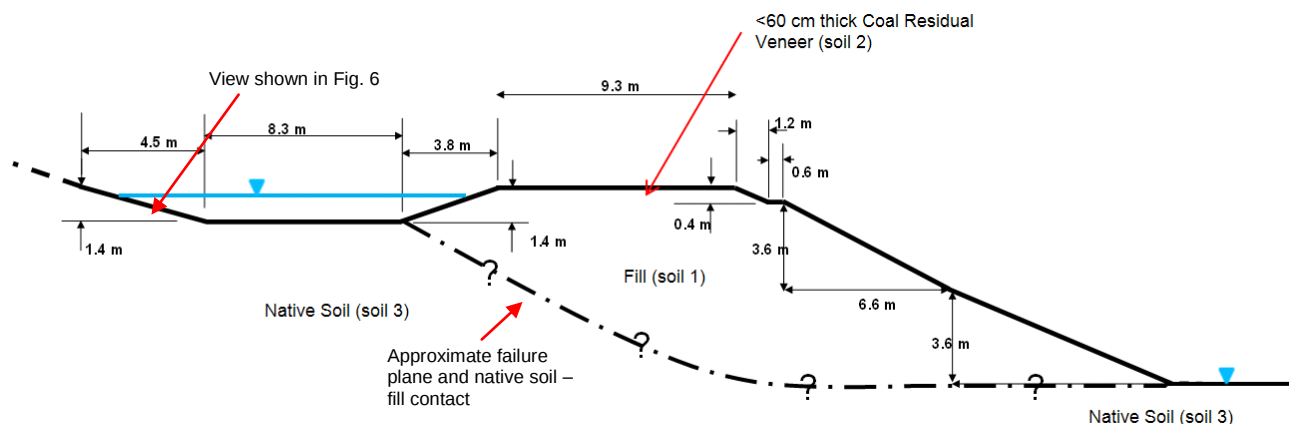
The embankment is constructed partially on a naturally sloping ground and has a total height of 7.6 m as shown in Fig. 5. Its crest, that supports the railroad lines, has a width of 9.3 m. The embankment fill consists of two layers. The main layer (Fill Soil 1) is a silty sand (SM). A surficial layer of very small thickness is also present and consists of coal ash residuals (Soil 2). The natural soil that underlays the embankment is a sandy clay of low plasticity (CL) that geologically is described as very dense glacial deposits (Native Soil-Soil 3).

Figure 5. Cross-section of the railroad embankment at the location of the failure.

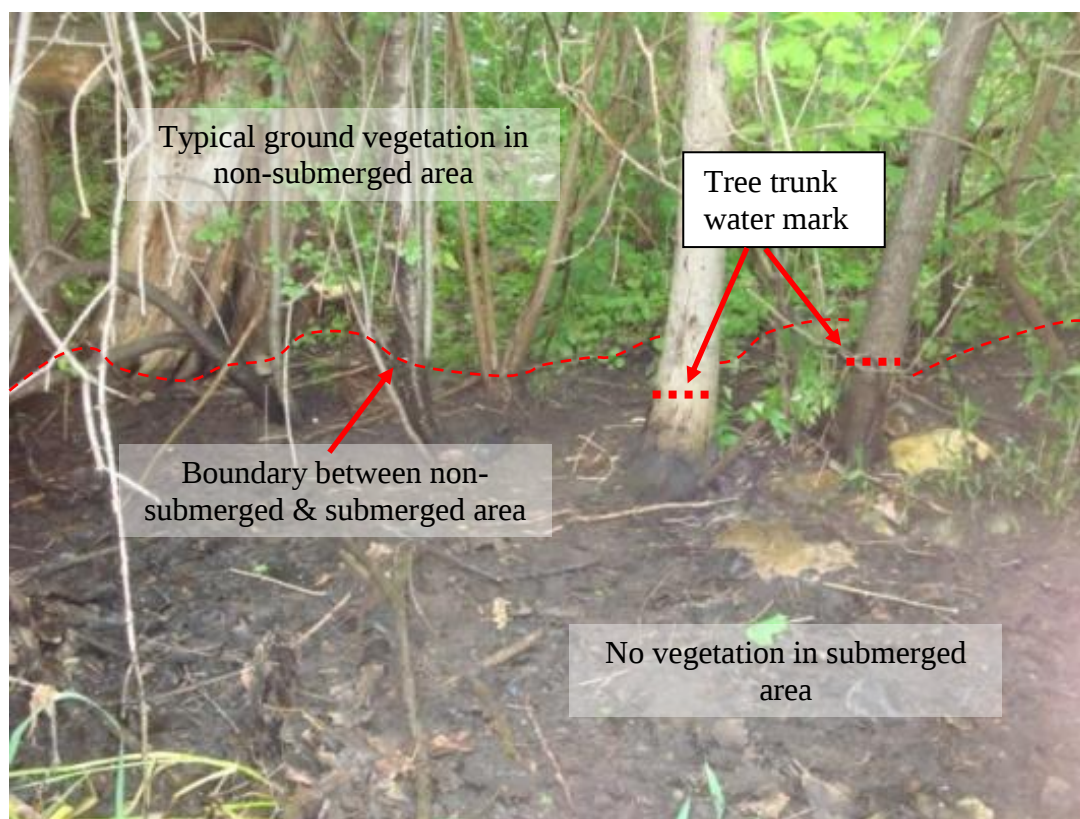
During the site visit, it was observed that the failure location was at a local natural depression that was receiving and accumulating surface water from a wider area. After careful inspection, the authors hypothesized the existence of seasonal ponding water. The surface soil on the uphill side of the embankment was very wet with vegetation that is typical of marshes, such as reeds. Next to the embankment where the water appeared to nearly permanently ponding and below trees there was no vegetation (see web-based supporting information titled “Photos and “Videos”). These conditions were found to be unique compared to other locations along the axis of the embankment. In addition, the level of water could be clearly seen as a watermark on the trunks of trees, as shown in Fig. 6. Based on these observations it was evaluated that the depth of the ponding water could have reached up to 120 cm. Local residents confirmed the existence of ponding water adjacent to the embankment. In fact, it appears that a neighbor used to feed visiting ducks at that location. Retention of ponding water was not part of the original embankment design. It is important to note that ponding water existed for at least some

period of time prior to failure. However, the spring of 2011 was particularly wet and probably more water accumulated compared to previous years. It is also not entirely clear whether a clogged storm drain existed in that location.

Figure 6. Area previously covered by ponding water and water mark on tree trunks.

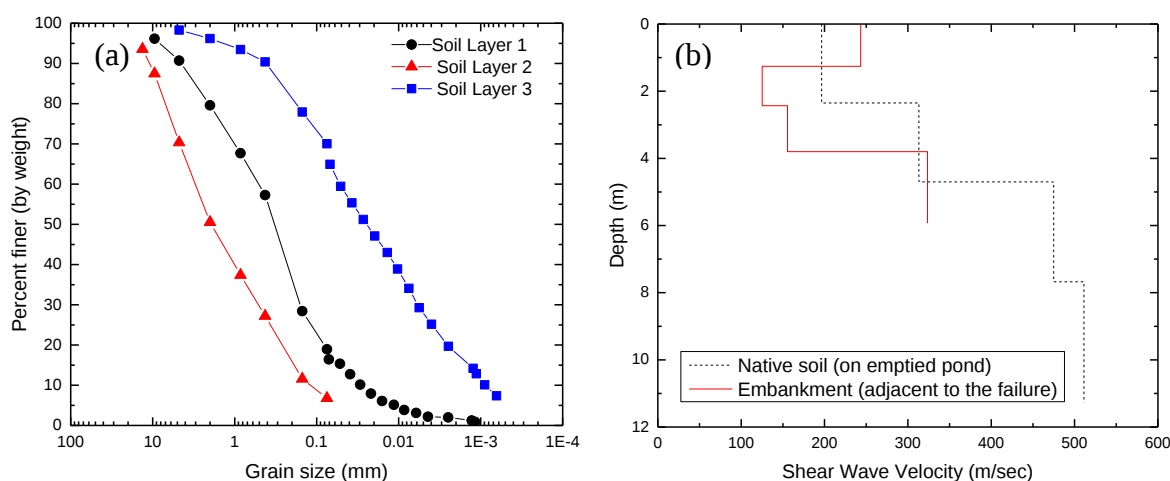
**Soil Layer 1:** This soil layer represents the main embankment layer, as shown in Fig. 5, and is classified per USCS as silty sand (SM). 18.9% of the material are non-plastic fines as shown in Fig. 8a. Since undisturbed samples were impossible to collect for the sandy fill, tests were conducted on reconstituted specimens at two different density states to evaluate the range of shear strengths expected for these materials. The direct shear tests were conducted in dry conditions. The shear strength of the material at a dense state was evaluated on the basis of direct shear testing, and the peak friction angle was found to be equal to  $46^\circ$ , whereas the post-peak was found to be equal to  $38^\circ$  without any cohesion, as shown in Fig. 9. The large-displacement friction angle at a dense state is approaching the peak friction angle of the soil at the loose state that was found to be equal to  $35^\circ$ . The hydraulic conductivity of the soil at a dry unit weight of  $1.71 \text{ gr/cm}^3$ , was equal to  $5.1 \times 10^{-5} \text{ cm/sec}$  based on a falling head hydraulic conductivity test conducted in the laboratory.

Figure 8. Results of (a) grain size distribution analyses and (b) in-situ shear wave velocity

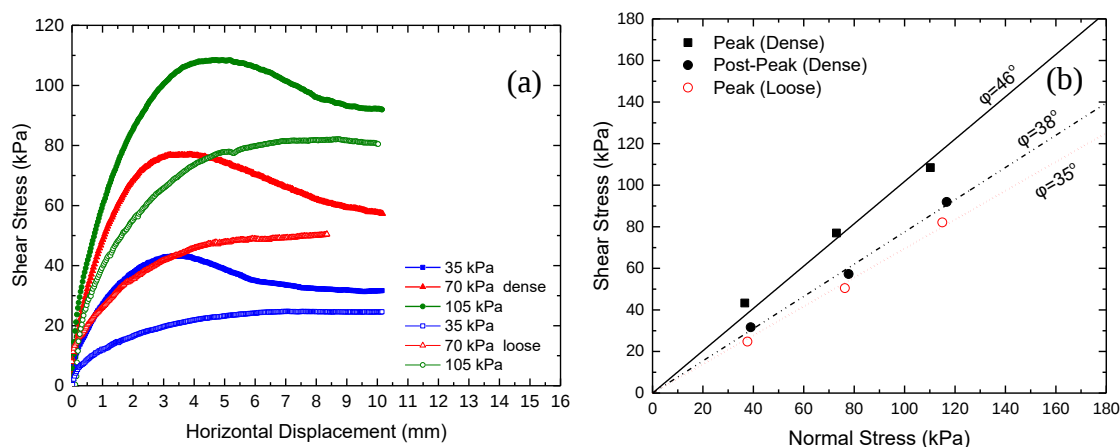
Figure 9. Direct shear results at nominal vertical stresses of 35 kPa, 70 kPa, and 105 kPa on reconstituted specimens of Soil Layer 1.

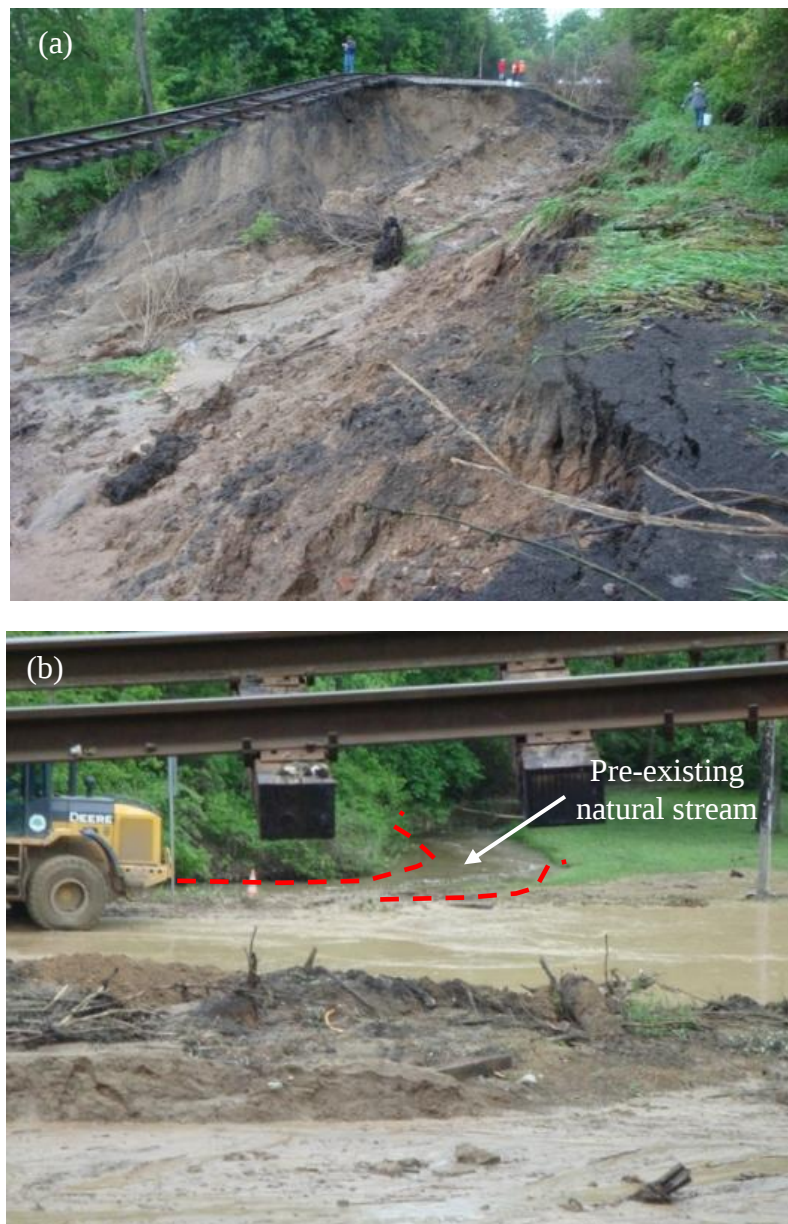
**Soil Layer 2:** This embankment layer is restricted to the top few cm from the surface and is essentially coal ash residuals that are black in color and can be clearly seen in Fig. 10. The fines are non-plastic and represent only 6.8% of the total mass of the soil, whereas the gravelly size particles are equal to 29.6%. It is classified per USCS as well-graded gravelly sand with silt (SW-SM). This soil layer is not expected to have played a significant role in the failure since it is of very small thickness and restricted at the surface only. Thus, more comprehensive testing to characterize its properties was not conducted.

Figure 10. View of the failure from the crest of the failure surface where (a) the left-in-place embankment is shown; (b) the mass of soil with large amount of water is shown at the toe of the failure reaching the pre-existing natural stream.

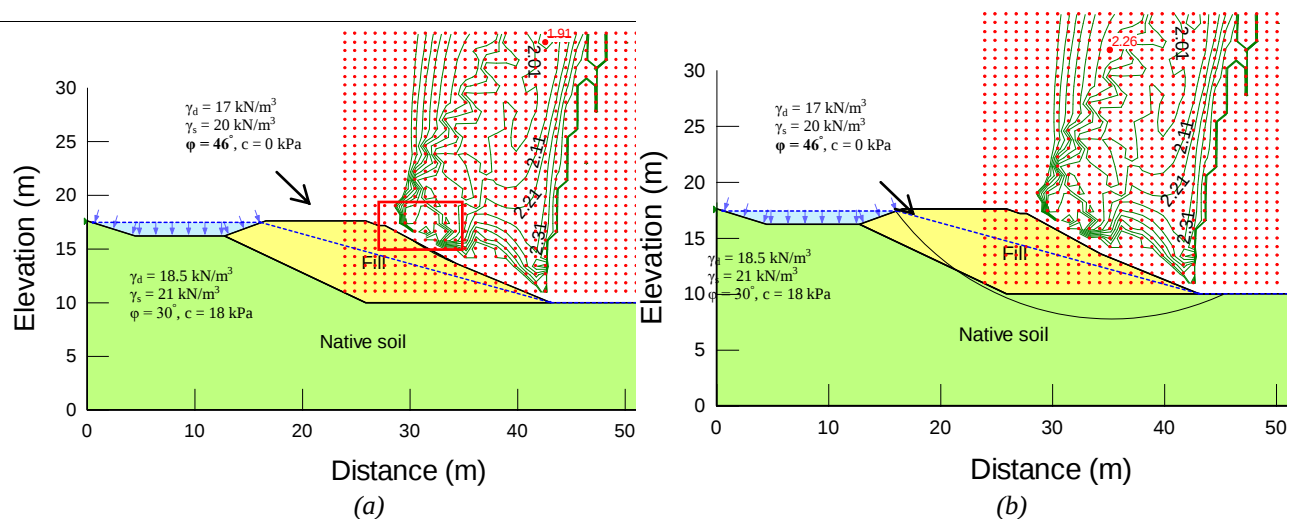
Following site characterization and the assessment of the embankment and failure surface geometry, stability and seepage analyses were conducted using the software programs SEEP/W and SLOPE/W (Geostudio, 2007) and the Spencer method of analysis (Spencer 1967). For stability assessment, parametric analyses were also conducted for reasonable variations of soil properties, as well as variations of the water depth of the ponding water (60 – 120 cm) that is reasonably well documented based on the field observations. These parametric analyses are critical in assessing the impact of uncertainties in the results. The parametric stability analyses indicate that even for the highest ponding water depth, the factor of safety remains significantly higher than one, i.e., it varies between 1.4-1.9 (for friction angles equal to  $38^\circ$  and  $46^\circ$  respectively) for a shallow failure surface that is restricted within the embankment, and is shown in Fig. 11a within the red box. Note that although the failure planes shown are “classic” numerical failure surfaces of purely frictional material with zero cohesion, even for low cohesions of 1-3 kPa, the observation that shallow failure surfaces are most critical remains valid. Higher values of factor of safety that vary between 1.5 and 2.3 were calculated for deeper failure surfaces that intersect the native soil (soil layer 3). Example results of the analyses are presented in Fig. 11.

Figure 11. Indicative results of embankment stability analyses for hydrostatic pore pressures. (a) showing lowest Factor of Safety (FS) of 1.91 for shallow failure planes (in the red box); (b) showing indicative FS of 2.26 for a failure plane that intersects the native soils.

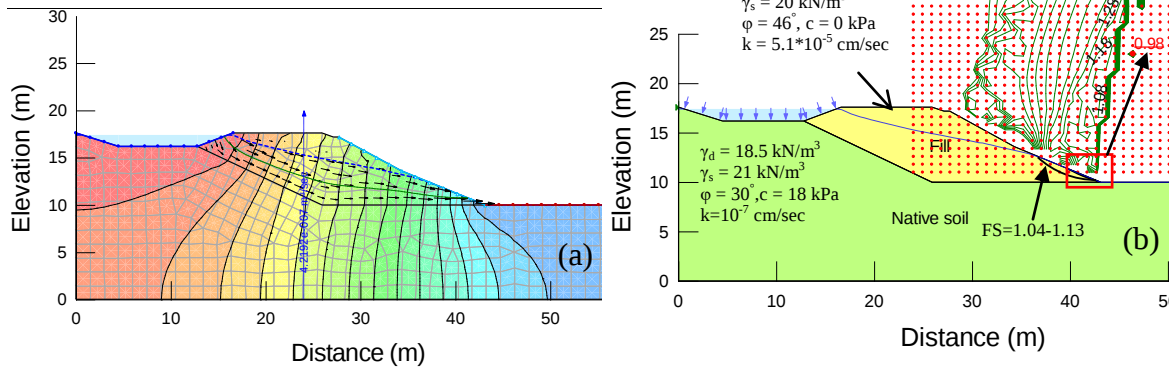
Subsequently, seepage analyses were conducted using the estimated hydraulic conductivities. As described earlier, the natural soil has significantly lower hydraulic conductivity than the embankment soils. Thus, the analyses indicate that when the ponding water depth increases, the exit gradients at the toe of the embankment become high, and vary between 0.48 and 0.78, which are dangerously high and close to critical gradients ( $\sim 0.9$ ). The stability analyses using the calculated hydraulic pressures, indicate failure of the embankment with factors of safety around one, as shown in Fig. 12. Note that this is not surprising as the seepage analysis gives a more realistic pore pressure profile (Fig. 12a) than that of an arbitrarily assumed piezometric surface (e.g., Fig. 11) with the flow concentrating more on the higher hydraulic conductivity soil. The results, indicate that the failure is caused by the high pore pressures that may even cause piping. The numerical results, are supported by the following interesting field observation: The reeds in the ponding water area adjacent to the embankment were found to be bent sideways and positioned horizontally with a direction that was pointing with great accuracy to the exact location where the ponding water initially drained quickly, as shown in Fig. 12.

Figure 12. Indicative results of combined (a) seepage and (b) stability analyses using seepage analyses results

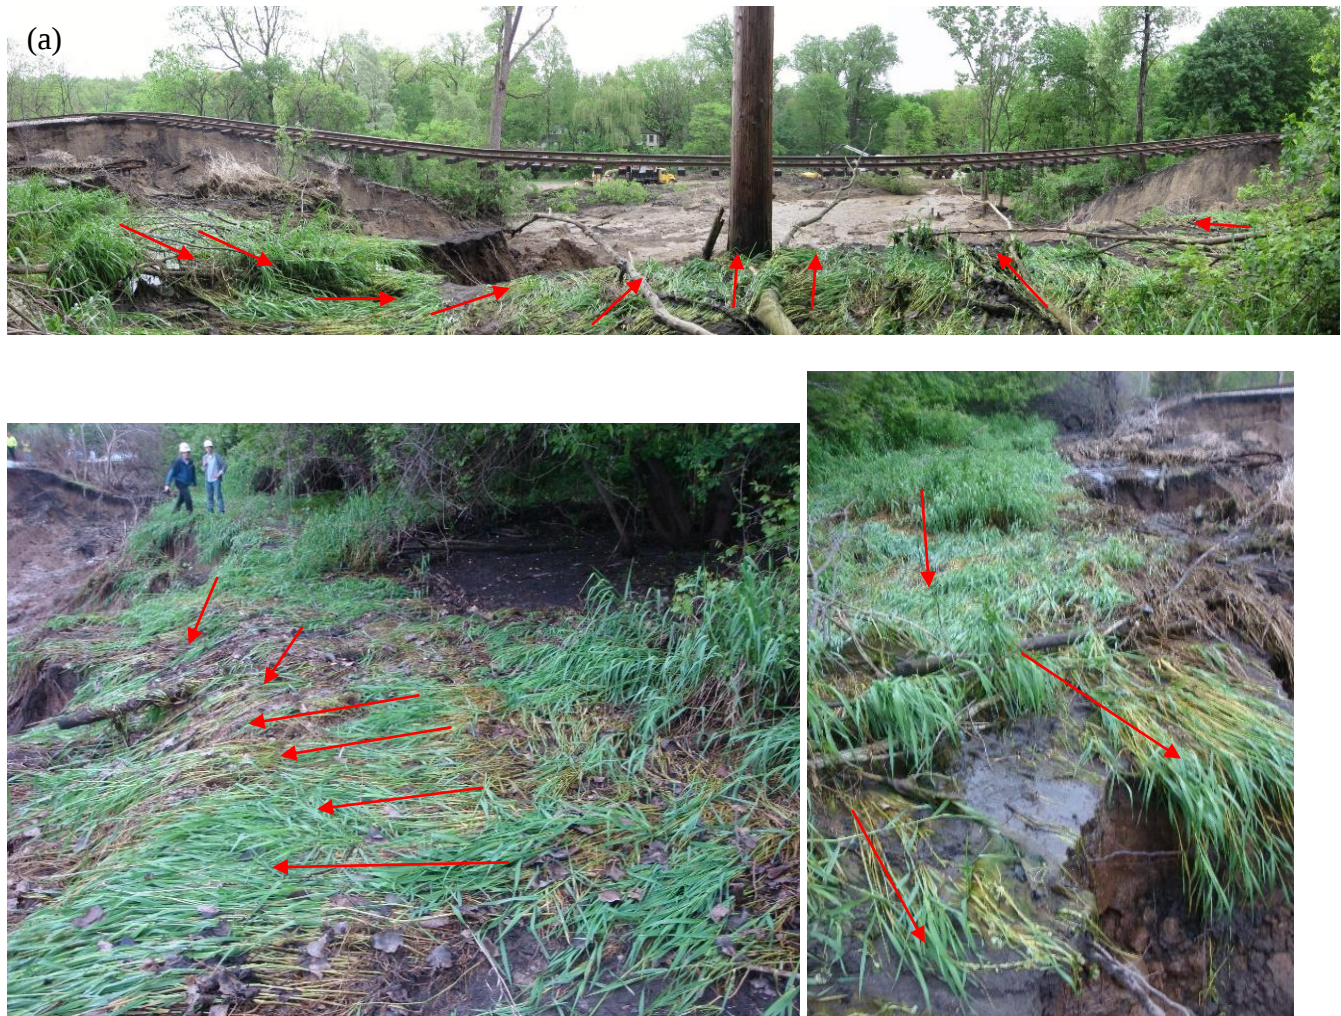
Figure 13. View of the failure and the reeds uphill of the embankment. The arrows are parallel to the direction of the fallen reeds that bent and broke during the abrupt emptying of the ponding water and fell on the ground with their orientation pointing to the initiation point of failure. (Fig. 13a by Karl Jansen, ceephotos.com)
