# Geotechnical Damage Caused by the 2016 Kumamoto Earthquake, Japan

**ABSTRACT:** On the 16<sup>th</sup> of April 2016, the Kumamoto earthquake ( $M_w$  7.0) hit the Central Kyushu Region, Japan, following a  $M_w$  6.2 shock on the 14<sup>th</sup> of April. The earthquake sequences caused severe damage in Kumamoto Prefecture. This paper presents quick reconnaissance results focusing on geotechnical damage features, which were observed during field investigations immediately after, one, and two weeks after the main shock. The damage surveys were carried out in southern Kumamoto City, Mashiki Town, Aso Caldera area and their suburbs. In southern Kumamoto City, evidence of liquefaction was found at many locations, and some buildings and river levees suffered from significant settlement and deformation; damage to an embankment of Kyushu Highway also seemed to be the result of liquefaction. The majority of the damaged residential houses were found in Mashiki Town and its suburbs, which may be linked to intense earthquake motions associated with the seismic fault location. In Aso Caldera area, a number of moderate to large scale landslides and their significant impact to structures wer

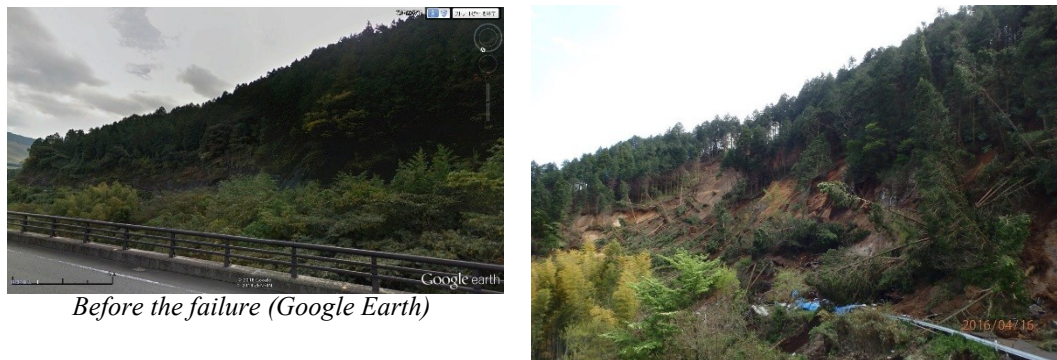
Figure 22. Slope failure along prefectural road No. 28 (site 14 in Fig. 12) ( $32^{\circ}50'32.96''\text{N}$ ,  $130^{\circ}55'40.65''\text{E}$ ).

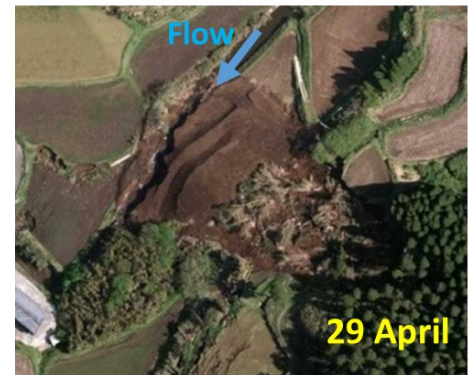
A slope failure was observed at site 20 in Fig. 26; the length of the failure was about 100 m. The debris blocked the road and a tributary of the Kurokawa River completely; the blocked tributary overflowed with water spreading into the surrounding paddy field (Figure 31). To avoid the potential risk of flooding to the downstream villages following the landslide dam breaching, the relevant authority had excavated a spillway to secure the safety of the dam. The excavation was likely finished within two weeks of the event.

Figure 31. Landslide dam formed by the earthquake and excavation work completed (site 20 in Fig. 26) ( $32^{\circ} 53'14.06''N$ ,  $130^{\circ} 59'48.90''E$ ).
