Geological Engineering Reconnaissance of Damage Caused by the October 15, 2006 Hawaii Earthquakes

Edmund W. Medley, Senior Consultant, Geosyntec Consultants Inc., Oakland, CA, USA, Email: emedley@geosyntec.com

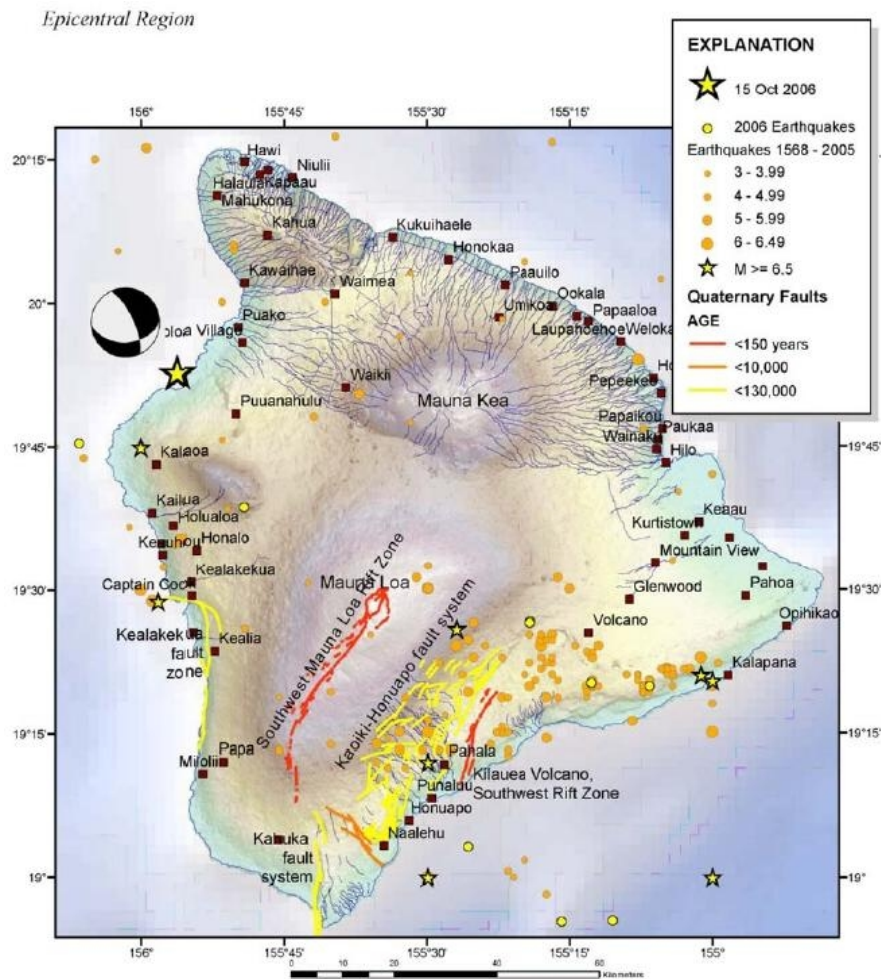
Figure 2. The Island of Hawaii: locations of towns, volcanoes, principal historical earthquakes, major faults and Kiholo Bay M_w 6.7 earthquake of October 15, 2006. (Chock, 2006; after USGS).

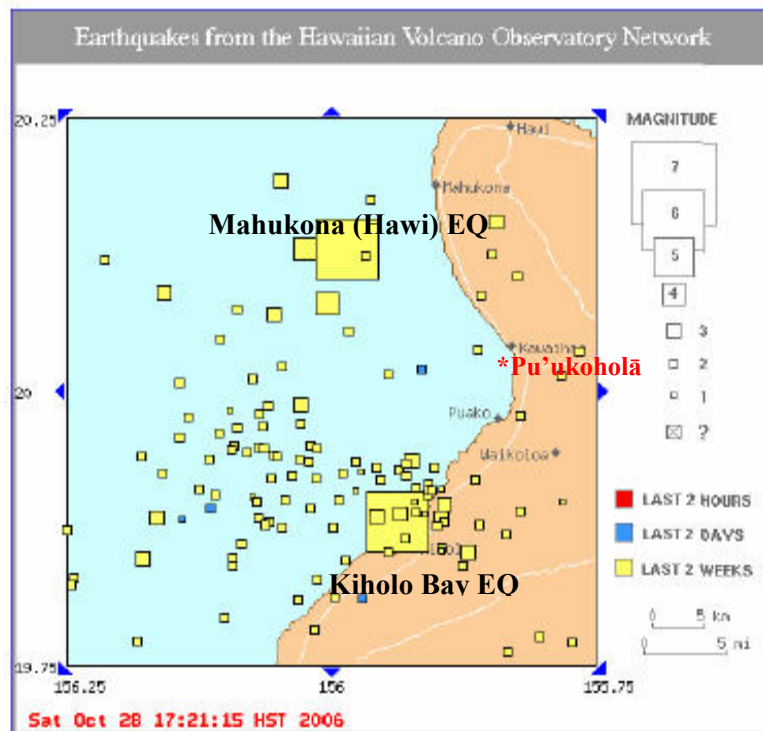
Figure 3. Locations of Kiholo Bay M_w 6.7 and Mahukona (Hawi) M_w 6.0 earthquakes of October 15, 2006 (after Chock, 2006; after USGS-Hawaiian Volcano Observatory) and location of Pu'ukoholā heiau (and Mailekine heiau) south of Kawaihae.

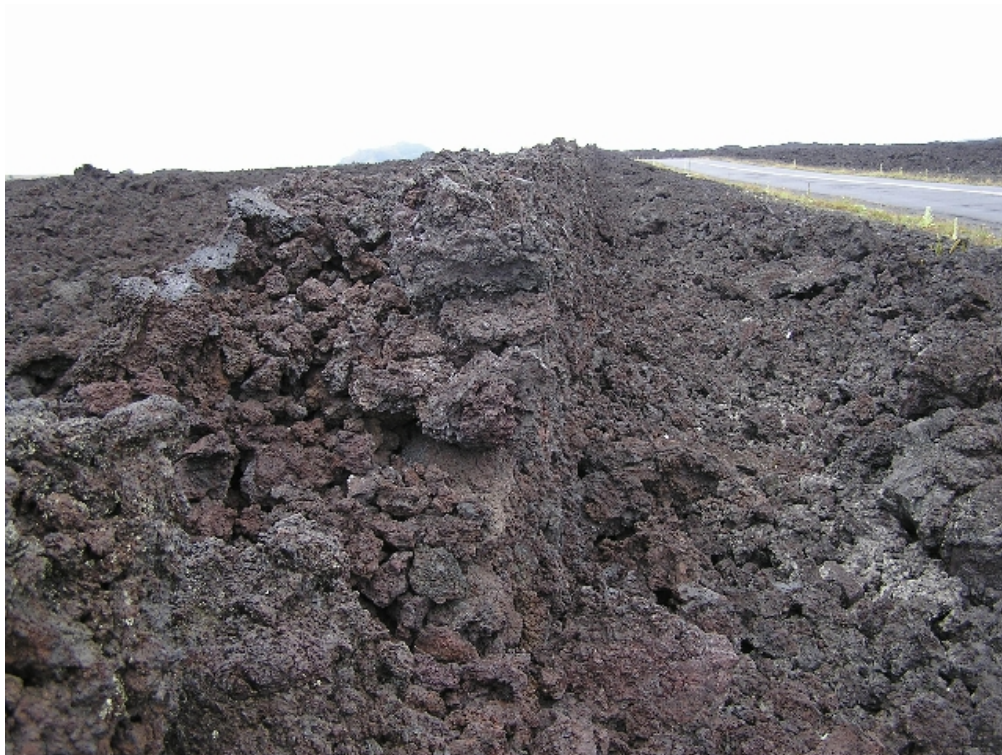
Figure 9. Location 11, Saddle Road (Hwy 200). Lava flow of a'a clinker and dry stacked wall of clinker composed of a'a blocks.

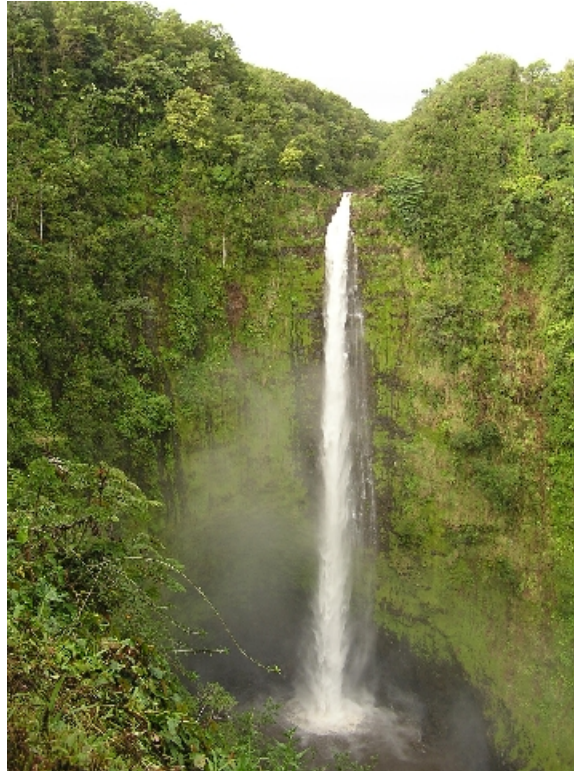
Figure 30. Location 2, Akaka Falls, Hamakua Coast. Scars in the cliff face may not be attributable to the earthquakes.

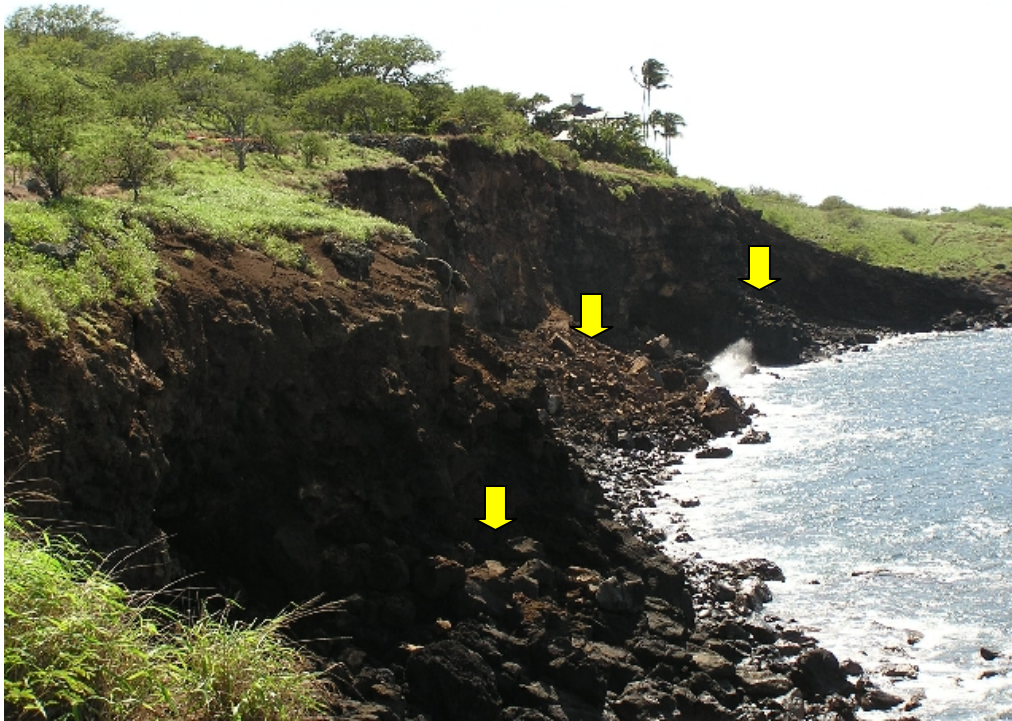
Figure 34. Location 23, failed cliffs (arrowed) south of Honoipu Landing (Ala Kuakini Trail).

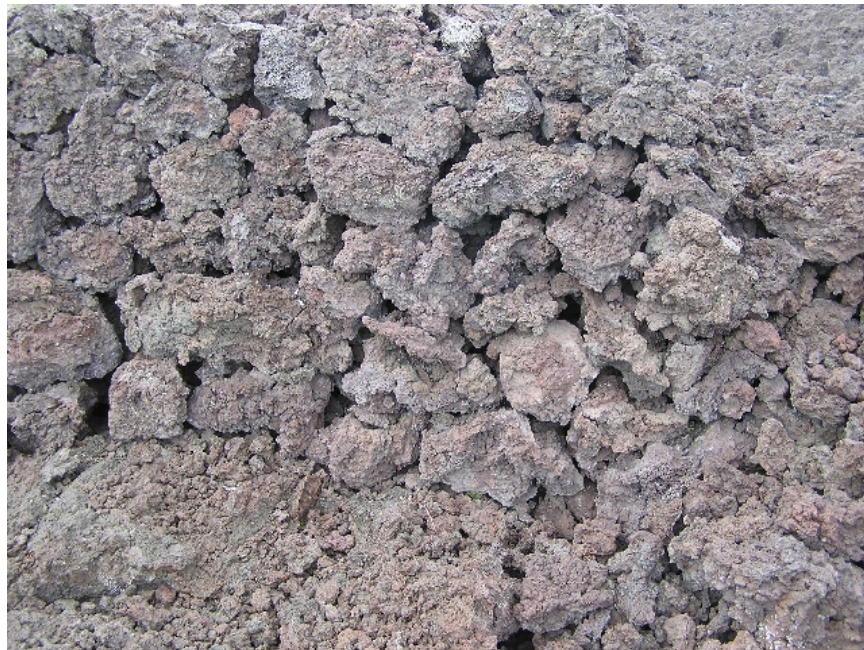
Figure 40. Location 11, Saddle Road (Hwy 200). Stacked rock wall of a 'a clinker.

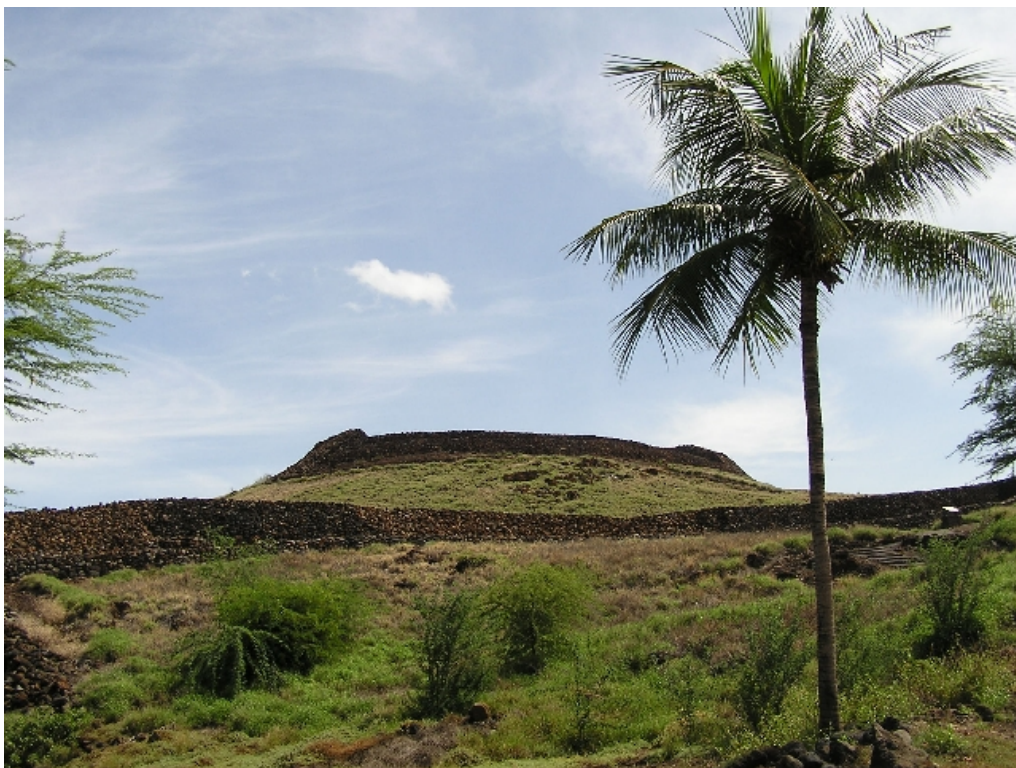
Figure 46. Location 29. Mailekini Heiau in middle ground, and Pu'ukoholā Heiau on top of hill.

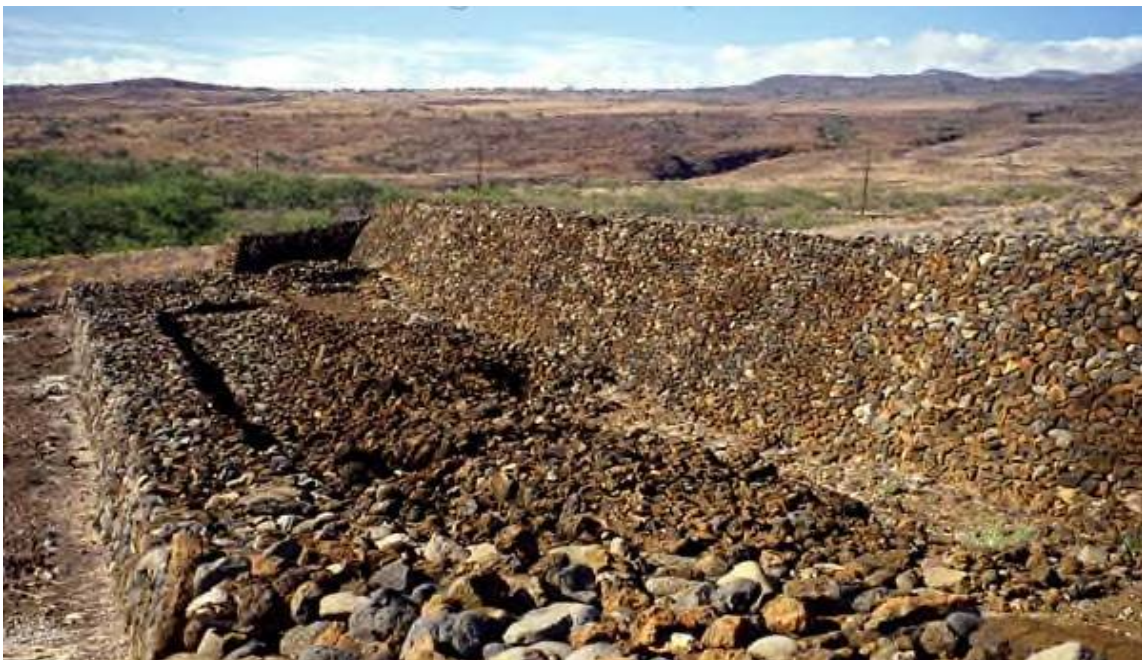
Figure 50. Location 29. Pre-earthquake view of Mailekini Heiau (Medley and Zekkos, 2007; original photo from www.pacificworlds.com/kawaihae).

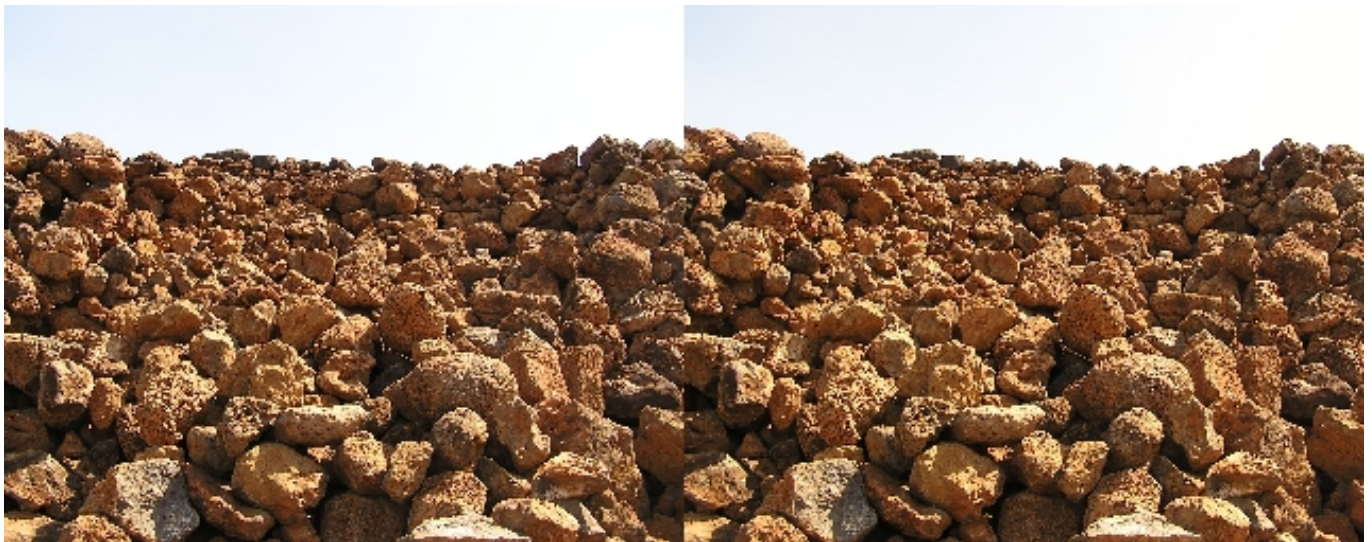
*Figure 58. Location 29, slump failure in high rock wall of Pu'ukoholā heiau, west side.
Stereo pair 3-D version of Figure 57.*

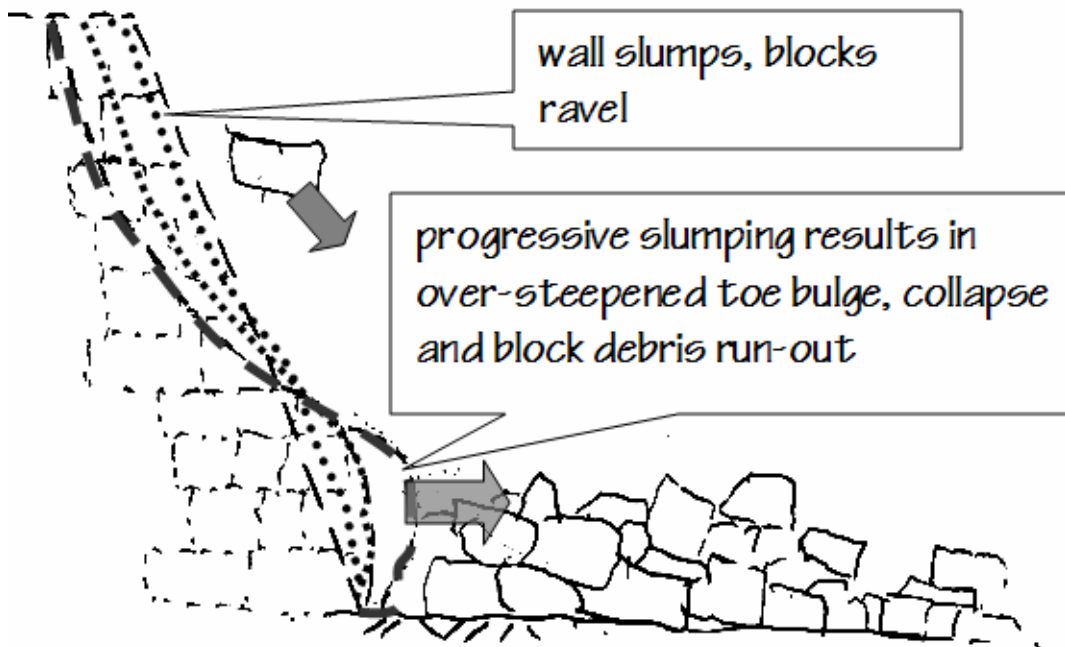
Figure 60. Raveling, bulging and slumping of the face of a rock block edifice (Medley and Zekkos, 2007).
