Geological Engineering Reconnaissance of Damage Caused by the October 15, 2006 Hawaii Earthquakes

Edmund W. Medley, Senior Consultant, Geosyntec Consultants Inc., Oakland, CA, USA, Email: emedley@geosyntec.com

KEYWORDS: Geological Engineering, Hawaii, Earthquake Damage, Rock Mass, Basalts, Rock Block Structures

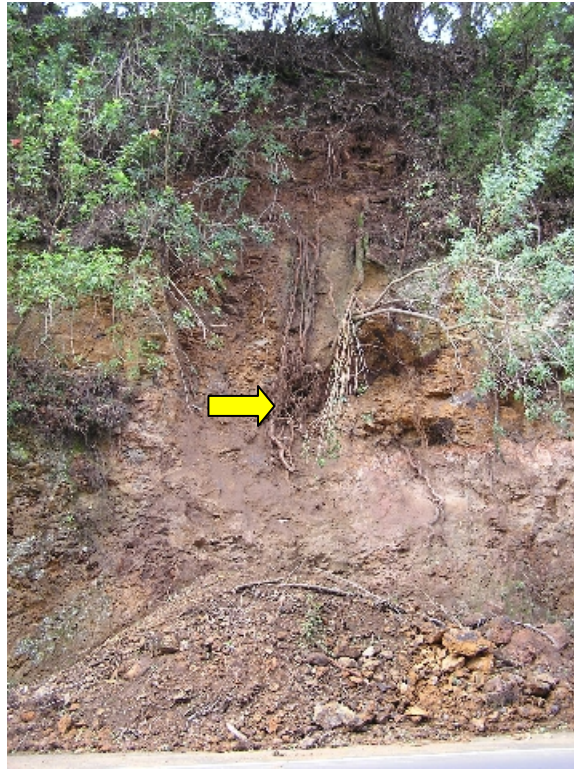
Weathered rock was often found to have failed along fractures occupied by tree roots. Where slopes had been stable long enough for tree roots to take hold in fractures, sections of the slopes peeled off to expose the roots (Figure 27, and Figure

Figure 27. Location 16, Near Kapa'au (Kohala), Hwy 270. Tree roots (arrowed) within relict rock mass fractures degraded the stability of road cuts in soil.

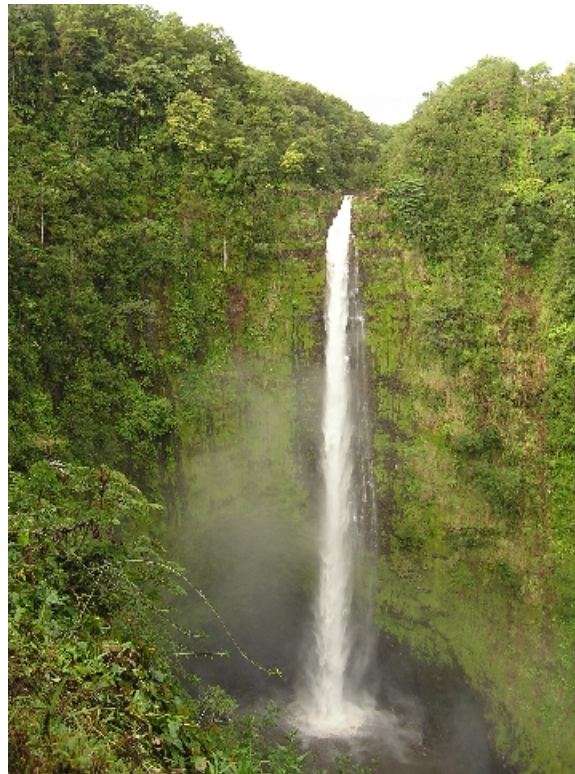
Apparently recent slides were observed on the cliff face of the Akaka Falls (Figure 30). Other earthquake effects at the State Park property were apparently limited to fallen trees and damaged hand railings.

Figure 30. Location 2, Akaka Falls, Hamakua Coast. Scars in the cliff face may not be attributable to the earthquakes.

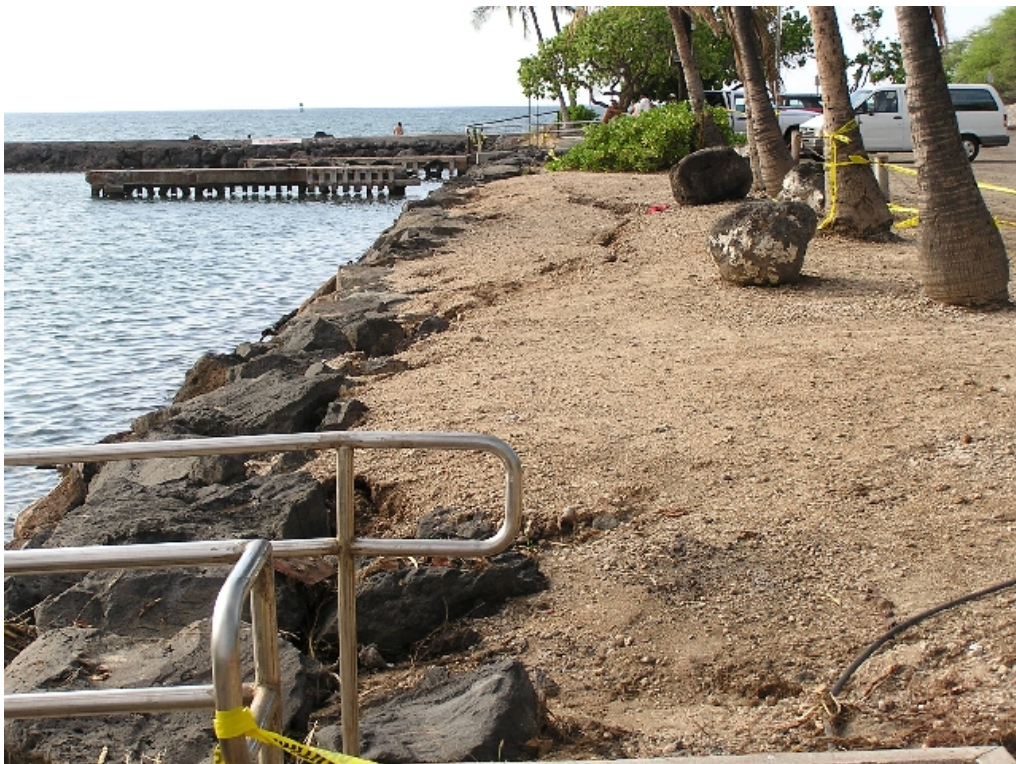
Figure 37. Location 27, Kawaihae Small Boat Harbor, showing arcuate ground crack resulting from lateral spreading.

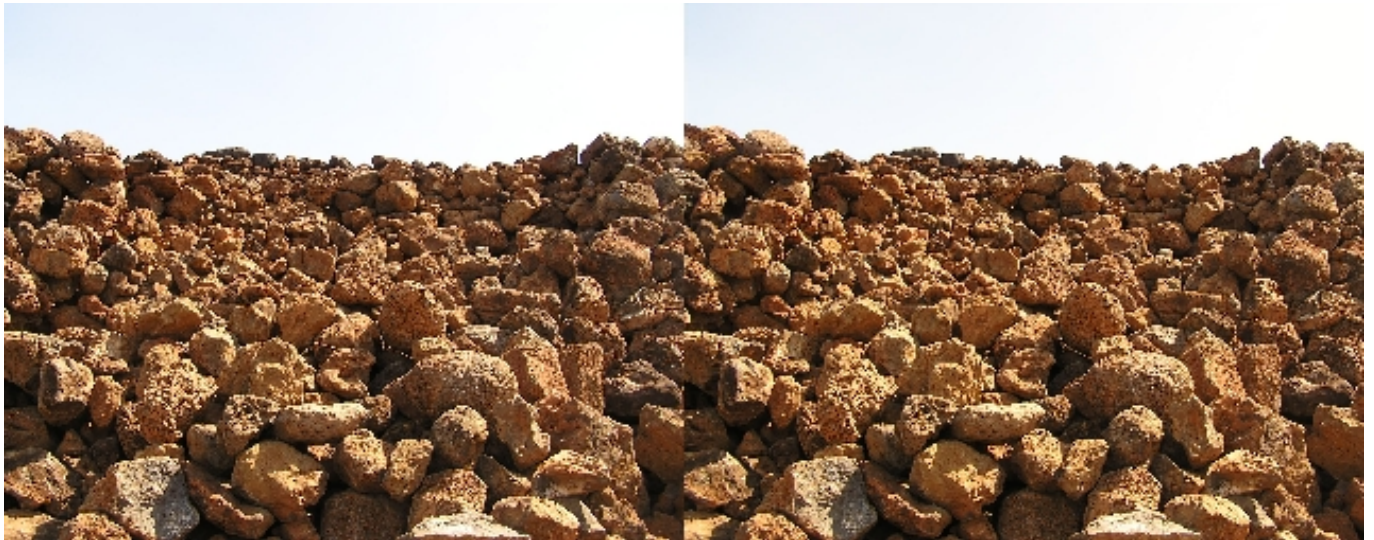
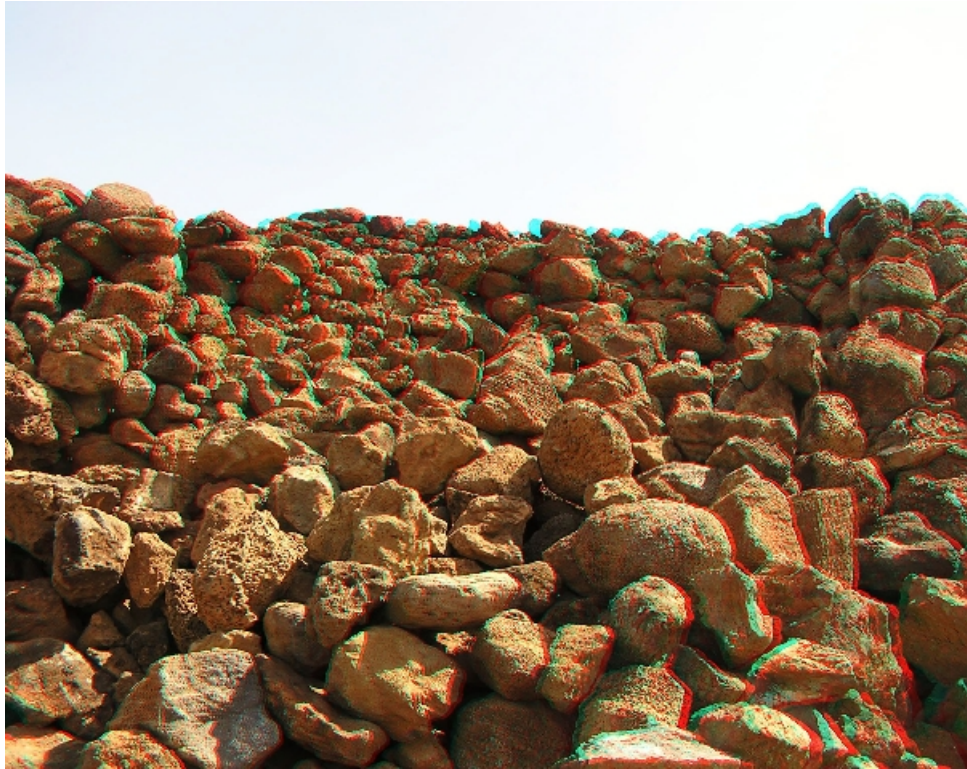
*Figure 57. Location 29, slump failure in high rock wall of Pu'ukoholā heiau, west side.
See 3-D stereo images of Figure 58 and Figure 59.*

*Figure 58. Location 29, slump failure in high rock wall of Pu'ukoholā heiau, west side.
Stereo pair 3-D version of Figure 57.*

Figure 59. Location 29, slump failure in high rock wall of Pu'ukoholā heiau, west side.
3-D anaglyph stereo version of Figure 57.
