# Geological Engineering Reconnaissance of Damage Caused by the October 15, 2006 Hawaii Earthquakes

**Edmund W. Medley**, Senior Consultant, Geosyntec Consultants Inc., Oakland, CA, USA, Email: [emedley@geosyntec.com](mailto:emedley@geosyntec.com)

**ABSTRACT:** Two strong earthquakes shook the Island of Hawaii, Hawaii on the morning of October 15, 2006. Peak Ground Accelerations reached 1.2g, and earthquake felt intensity of MMI VIII. Earthquake damage of public and private property totaled about \$200 million, with no fatalities. Geological engineering reconnaissance of earthquake damage resulting from the earthquakes focused on the apparent relationships between the observed geology and the damage. Some roadway embankments failed causing temporary closure of Island highways. Landslides were common at steep coastal cliffs. Liquefaction and lateral spreading occurred in coralline fill at Kawaihae Harbor. There were extensive road cut failures, in which the performance of road cuts in soil slopes was generally better than that of rock slopes. Where a'a clinker underlay massive a'a basalt blocks in road cut slopes, the loose clinker dislodged thereby undermining the blocks, and cau

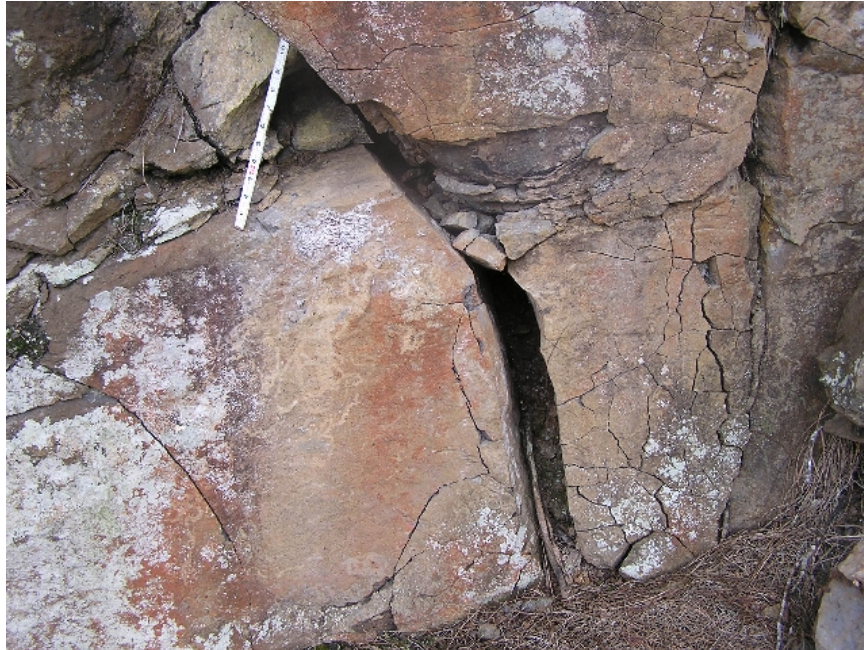
Figure 29. Location 9, Hwy 19 near Honoka'a. Wide fracture likely not caused by earthquake- note debris and tree root.

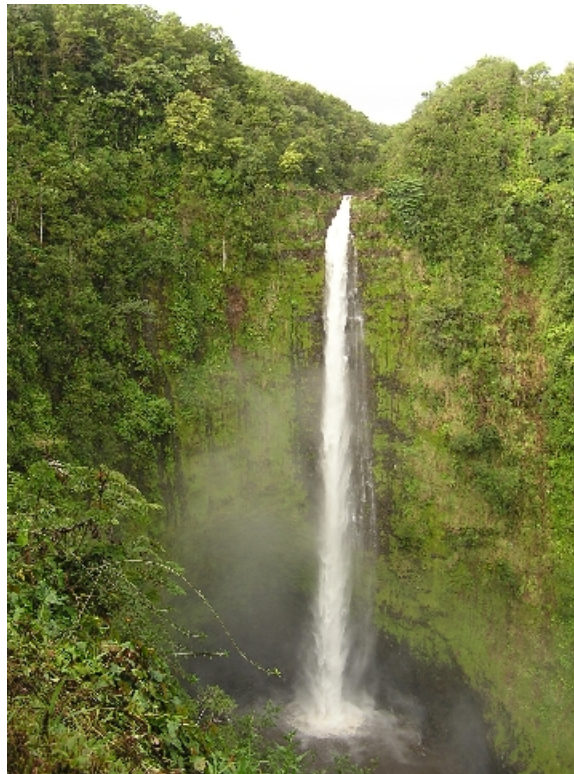
Apparently recent slides were observed on the cliff face of the Akaka Falls (Figure 30). Other earthquake effects at the State Park property were apparently limited to fallen trees and damaged hand railings.

*Figure 30. Location 2, Akaka Falls, Hamakua Coast. Scars in the cliff face may not be attributable to the earthquakes.*

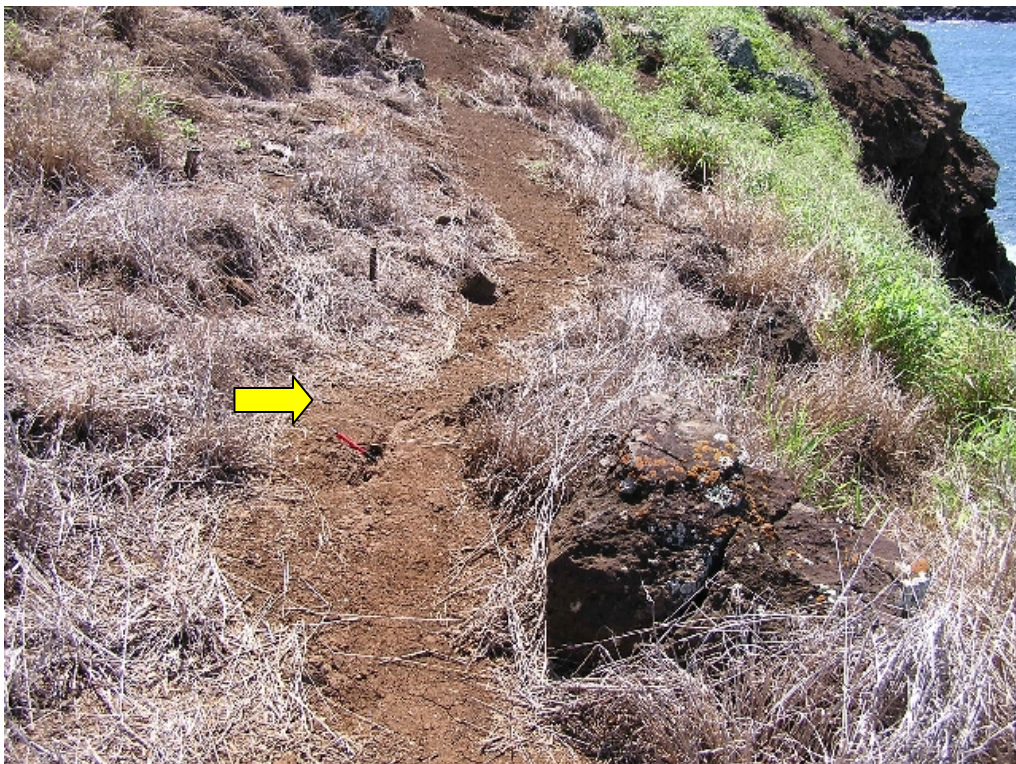
*Figure 35. Location 23, Ala Kuakini Trail. Tension cracks behind cliff top (arrowed) in foreground.*

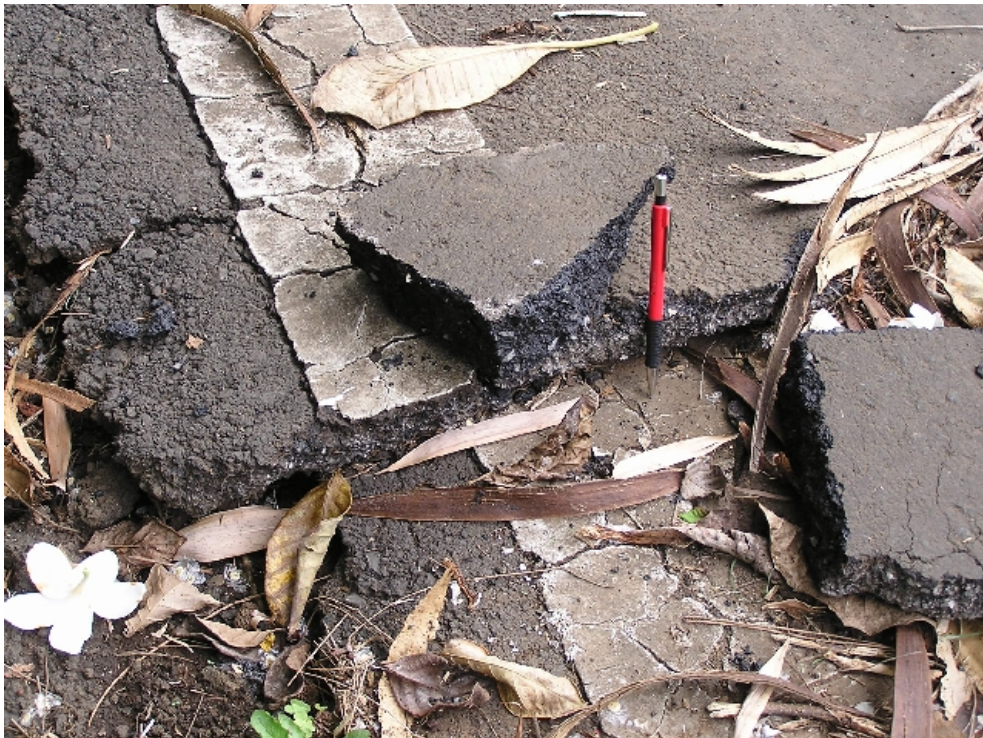
*Figure 65. Location 20, bridge at approximately Mile Post 28, Hwy 270.  
Thrusting of asphalt concrete pavement.*
