Geological Engineering Reconnaissance of Damage Caused by the October 15, 2006 Hawaii Earthquakes

Edmund W. Medley, Senior Consultant, Geosyntec Consultants Inc., Oakland, CA, USA, Email: emedley@geosyntec.com

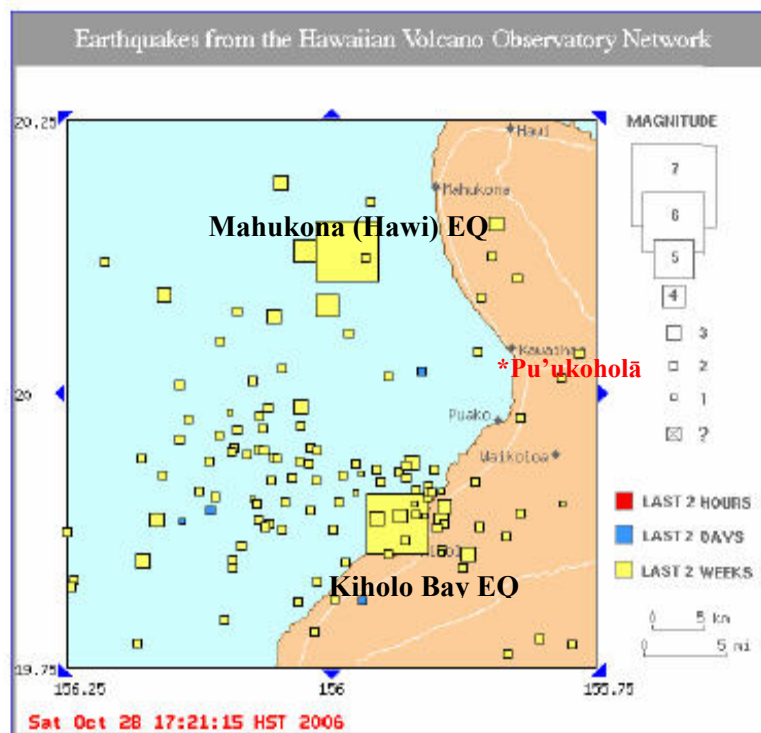
Figure 3. Locations of Kiholo Bay M_w 6.7 and Mahukona (Hawi) M_w 6.0 earthquakes of October 15, 2006 (after Chock, 2006; after USGS-Hawaiian Volcano Observatory) and location of Pu'ukoholā heiau (and Mailekine heiau) south of Kawaihae.

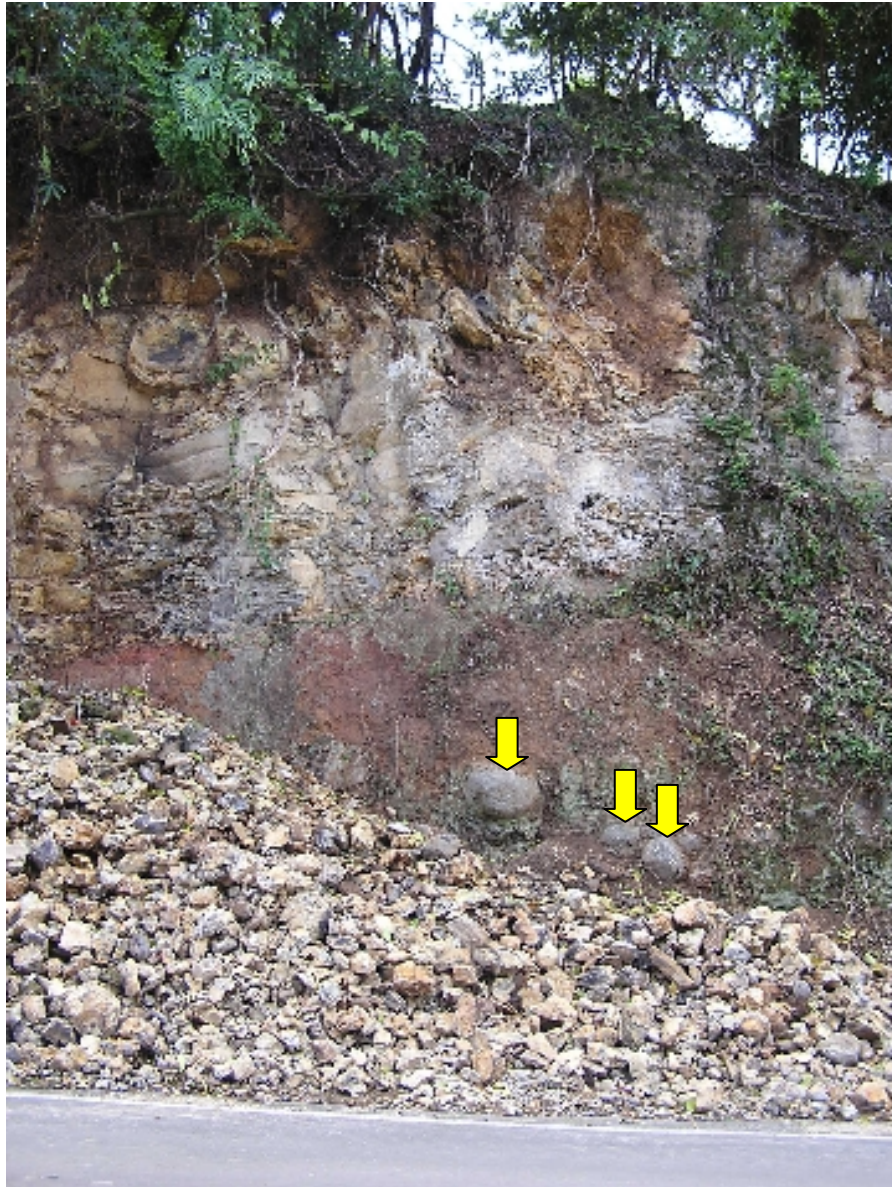
Figure 24. Location 18, Hwy 270 at Makapala. Failure (pile of rock fragments at front) of stronger rock underlain by baked zone soil, with weathered corestone boulders (arrowed).
