Geological Engineering Reconnaissance of Damage Caused by the October 15, 2006 Hawaii Earthquakes

Edmund W. Medley, Senior Consultant, Geosyntec Consultants Inc., Oakland, CA, USA, Email: emedley@geosyntec.com

KEYWORDS: Geological Engineering, Hawaii, Earthquake Damage, Rock Mass, Basalts, Rock Block Structures

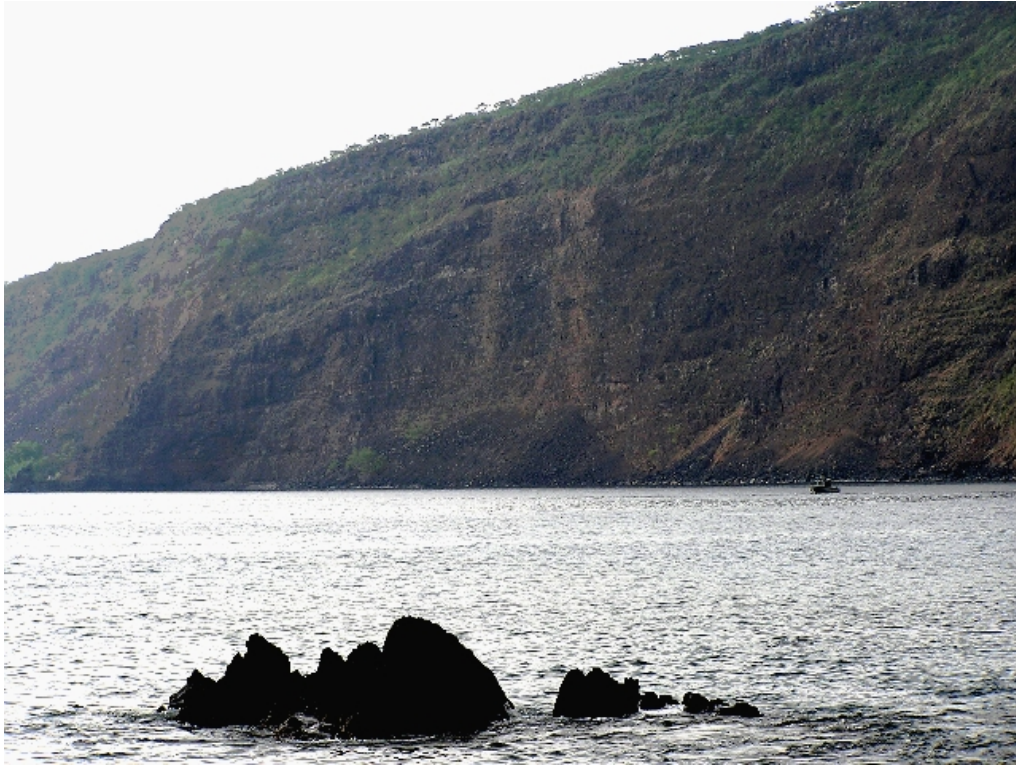
A dramatic earthquake-triggered landslide occurred at Kealakekua Bay (Figure 36), near the Captain Cook Monument, south of Kailua-Kona from the Pali Kapu o Keōua, a fault trace and the head scarp of the Alike mega-landslide that occurred about 100,000 years ago. The area seaward and landward of the cliffs and shore, including nearby roads and hiking trail, were closed by the State because of unstable ground and the risk of future landslides. Consequently the area was not investigated during the reconnaissance.

Figure 36. Location 36, Napo'opo'o, facing the Pali Kapu o Keōua, a fault/mega-landslide scarp.

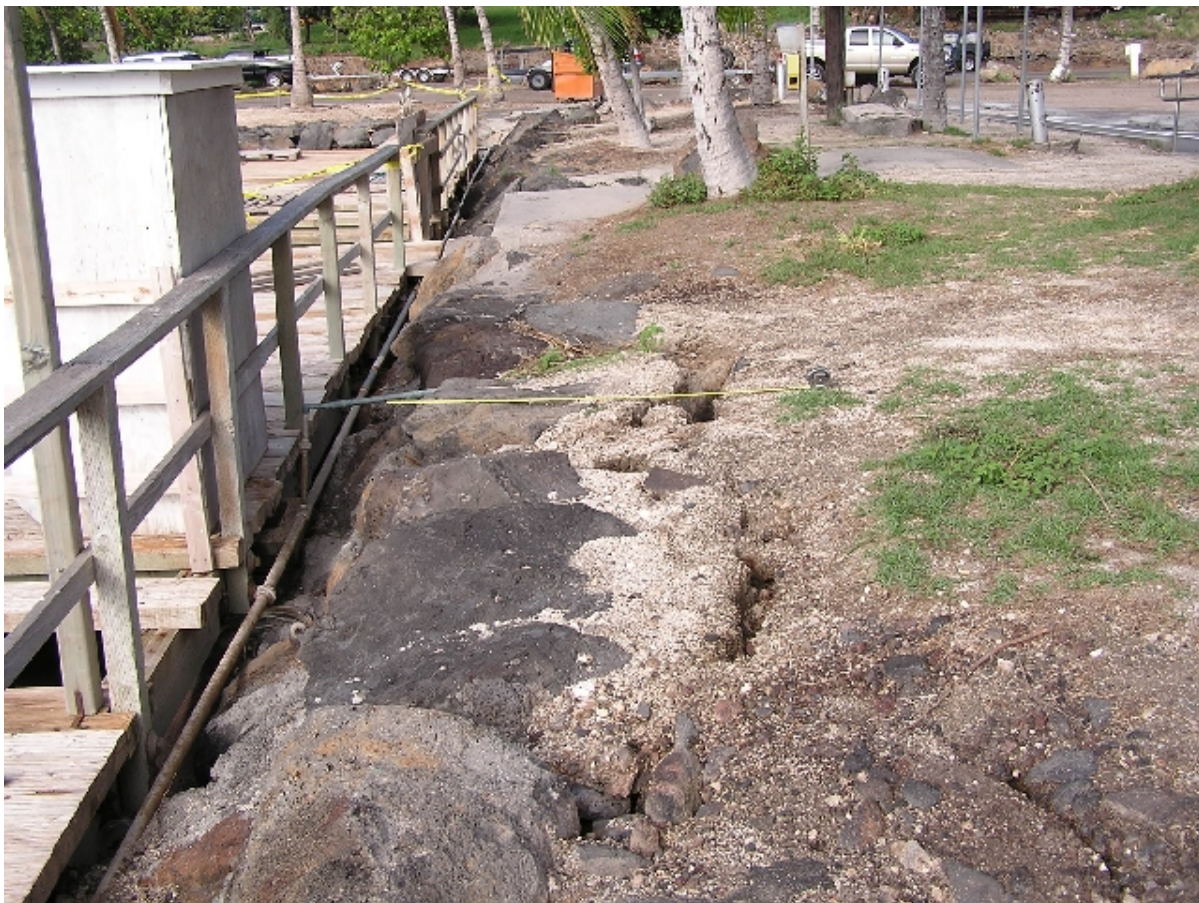
As reported by Robertson et al. (2006) and Chock (2006), sand boils were observed throughout the Harbor area, indicative of liquefaction of the underlying fill. The resulting lateral spreading of 15 to 30 cm caused up to 15 cm of settlement of the asphalt pavement at the shipping container area and lateral displacement of the pile supported concrete wharf.

Figure 38. Location 27, Kawaihae Small Boat Harbor. Lateral spreading, and damage to dock. Liquefied sand was ejected from the ground crack (white sand).

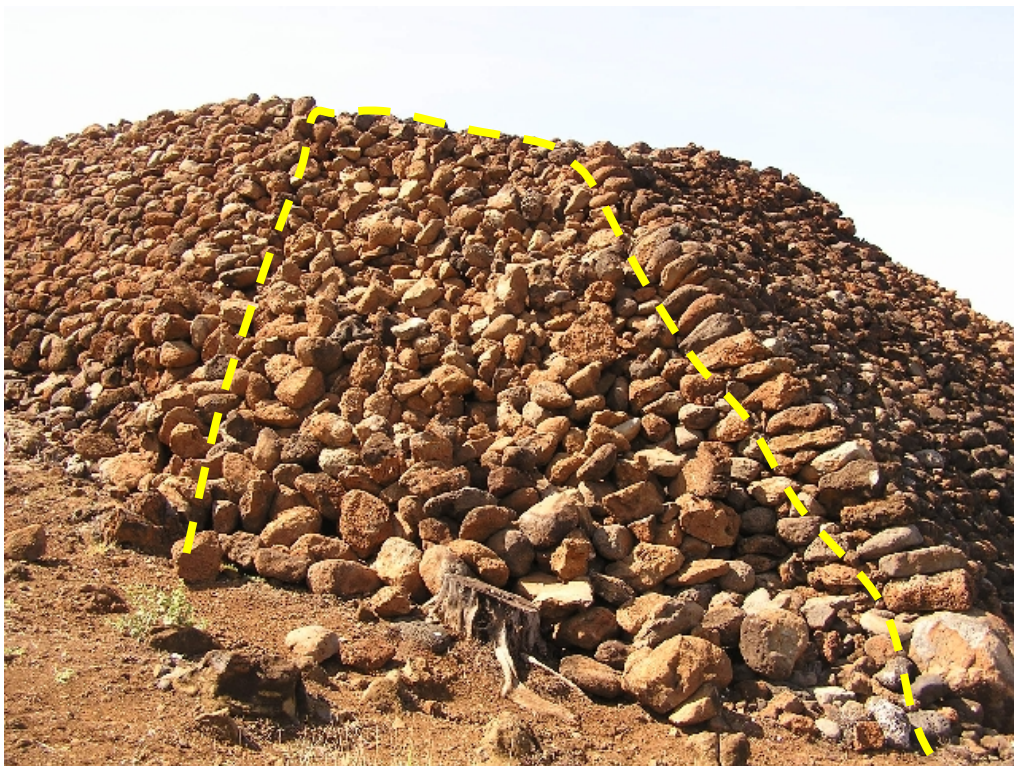
Figure 56. Location 29, Pu'ukoholā heiau, northeast corner. Dashed lines indicate boundary of ravel zone.
