Lack of Maintenance Compromises Tunnel Structural Safety

ABSTRACT: *The Chekka tunnels represent a critical section of the Northern Lebanon Highway. The approximately 350-m long twin tunnels are the most important tunnels in the country. They are used by regular and freight traffic and are a vital link to the capital, Beirut. The tunnels were completed in the early 1970s on the eve of the Lebanon civil war. Given the state of affairs in the country for about two decades of strife, the tunnels were not maintained nor did they undergo any regular inspection. This unique condition of near-abandonment continued up until recently, when the first signs of distress were documented. These consisted of severe and extensive cracking, particularly in the portal approach of the southbound tunnel, along with significant deterioration of the tunnel lining and radial section joints. The danger to traffic and, potentially, to the structure itself was evident. In this paper, the results of an extensive site inspection and evaluation program are presented. The underlying causes of the observed damage are analyzed and discussed using a modeling approach of the progressive loading conditions. Remedia

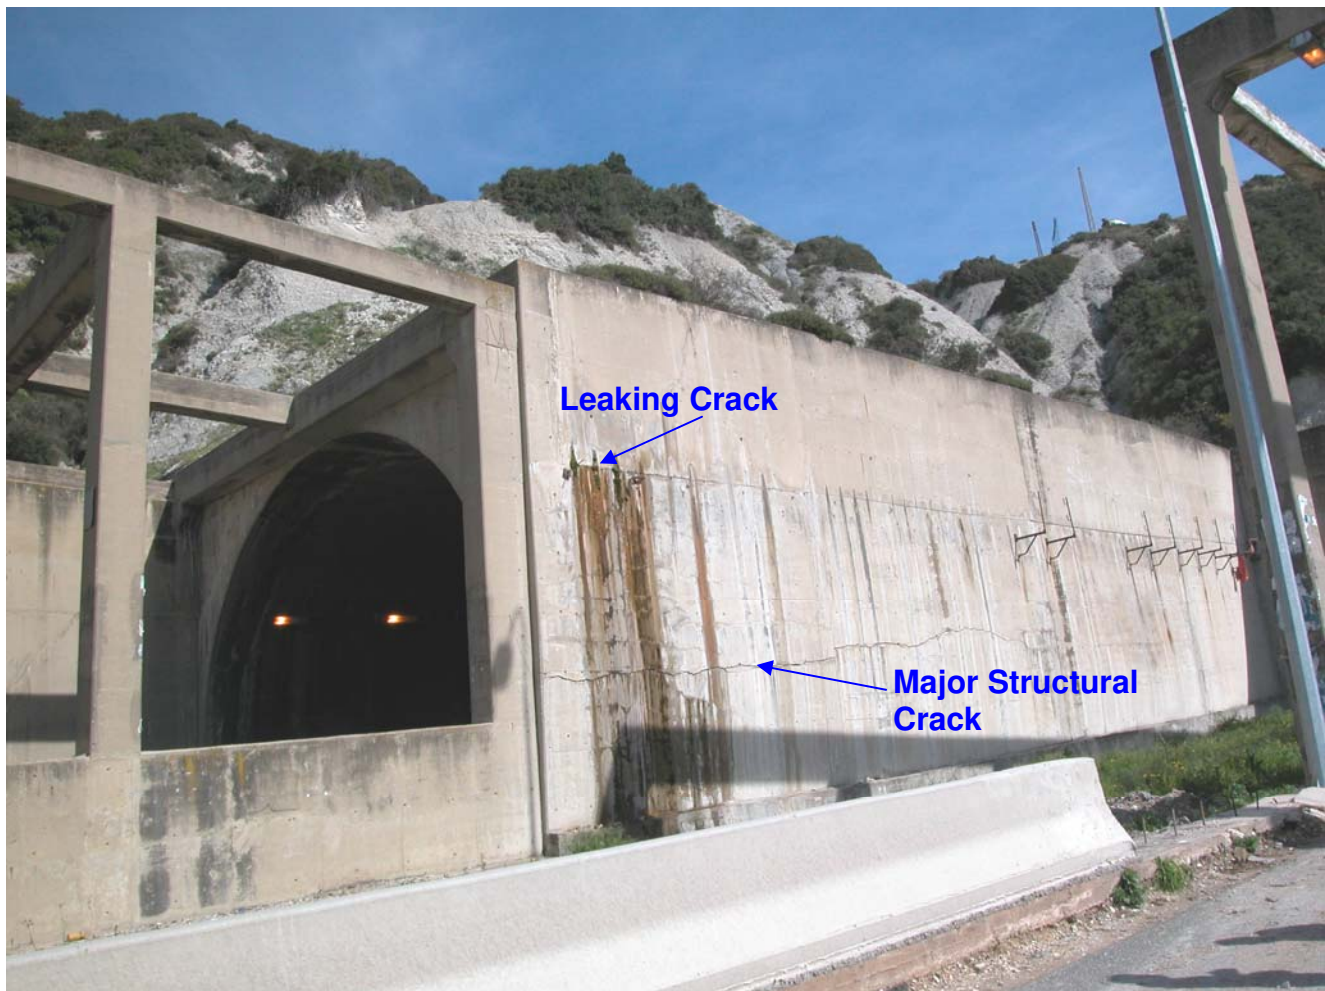
Figure 1. Southbound Tunnel Portal - View of External Distress.

The major crack along the 35-m long portal structure at the southbound tunnel exit (shown in Fig. 1 and Fig. 2) which initiated the engineering intervention, was attributed to increased differential loading. This possible cause for the structural damage was identified following the observation of a relatively large slumped mass of soil loading the western side of the portal structure of the southbound tunnel (Fig. 3). The slumped soil mass was due to weathering of the friable chalky limestone rock on the adjacent exposed slopes and subsequent instability and mass transport. The differential loading of one side of the portal frame structure by the slumped soil mass, along with other contributing factors, could have led to the observed cracking of the eastern wall of the portal along with the associated lateral deformations of up to 15 cm (Fig. 1 and Fig. 2). Additional pictures of this particular tunnel segment are provided in the online database that accompanies this paper.

1. A major longitudinal structural crack was clearly evident on the outside face of the eastern wall of the tunnel portal frame in the last 35 m span of the exit side of the southbound tunnel (Fig. 1). Signs of water leakage through a crack in the eastern wall were evident at the junction between the tunnel portal and the 4.72 m high retaining parapet. This pattern of damage was indicative of a number of problems with the tunnel portals, which are typically identified as potentially problematic areas in a number of situations (Rothfuss et al., 1995).

1. The major structural cracks on the outside face of the eastern wall of the portal frame were repaired by “crack-injection” using low viscosity, two-component epoxy resin. The injection was completed after thorough cleaning and preparation of the affected areas and the provision of injection ports to ensure thorough filling of the cracks. Similar treatments were applied to all cracks and damaged areas in the tunnel concrete lining (Fig. 15).

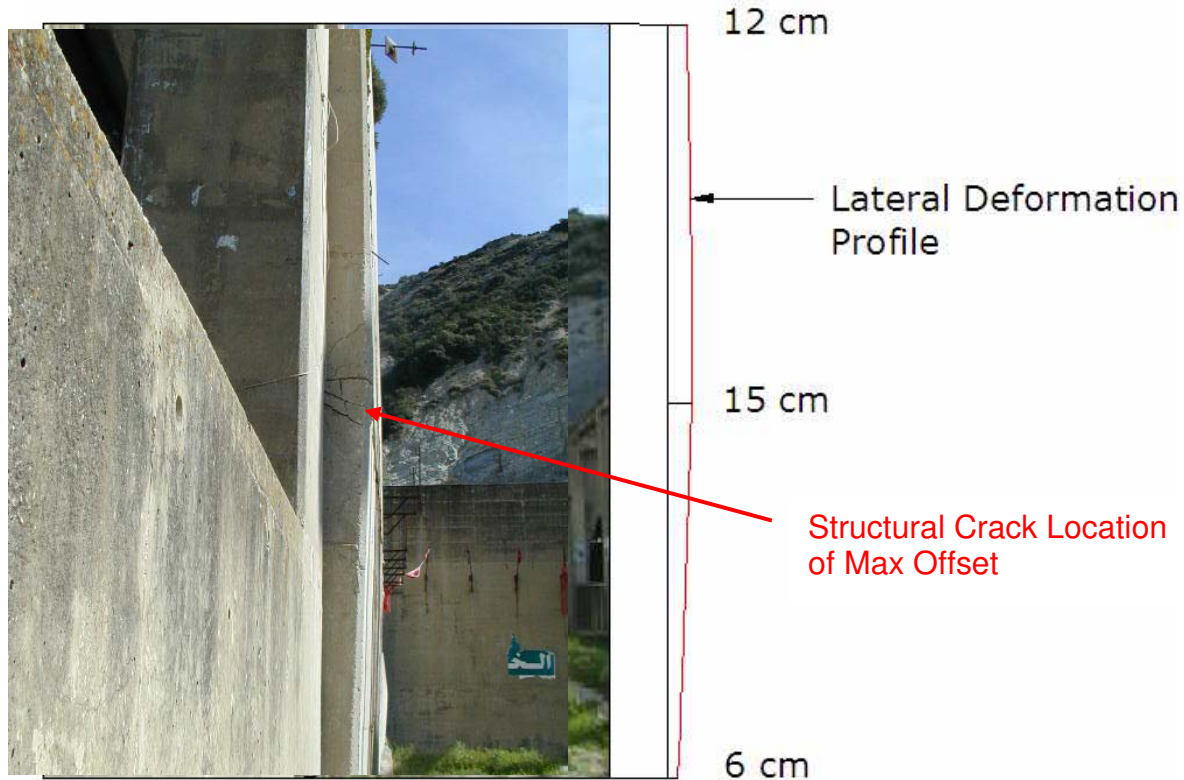
Figure 2. Close-up View of the Outward Movement/bulging of the Eastern Portal Wall.

2. The eastern wall of the southbound tunnel portal was further strengthened after the accumulated weathered material above it was removed and the crack treatment/repair completed. Strengthening was achieved by connecting a 15-cm reinforced concrete jacket to the existing wall.
3. Whereas the distress signs were evident along the eastern projecting portal wall only, the FEM analyses suggested that cracks could have developed along the inaccessible outside tension face of the backfilled western wall of the portal. As such, strengthening provisions for that element were taken. Jacketing was ruled out given that the outer surface is backfilled and cannot be exposed. Instead, the installation of passive nails/rock bolts at elevations of grade plus 2 m and grade plus 4 m was recommended, tying the wall to the intact rock and reducing the stresses on the wall itself.

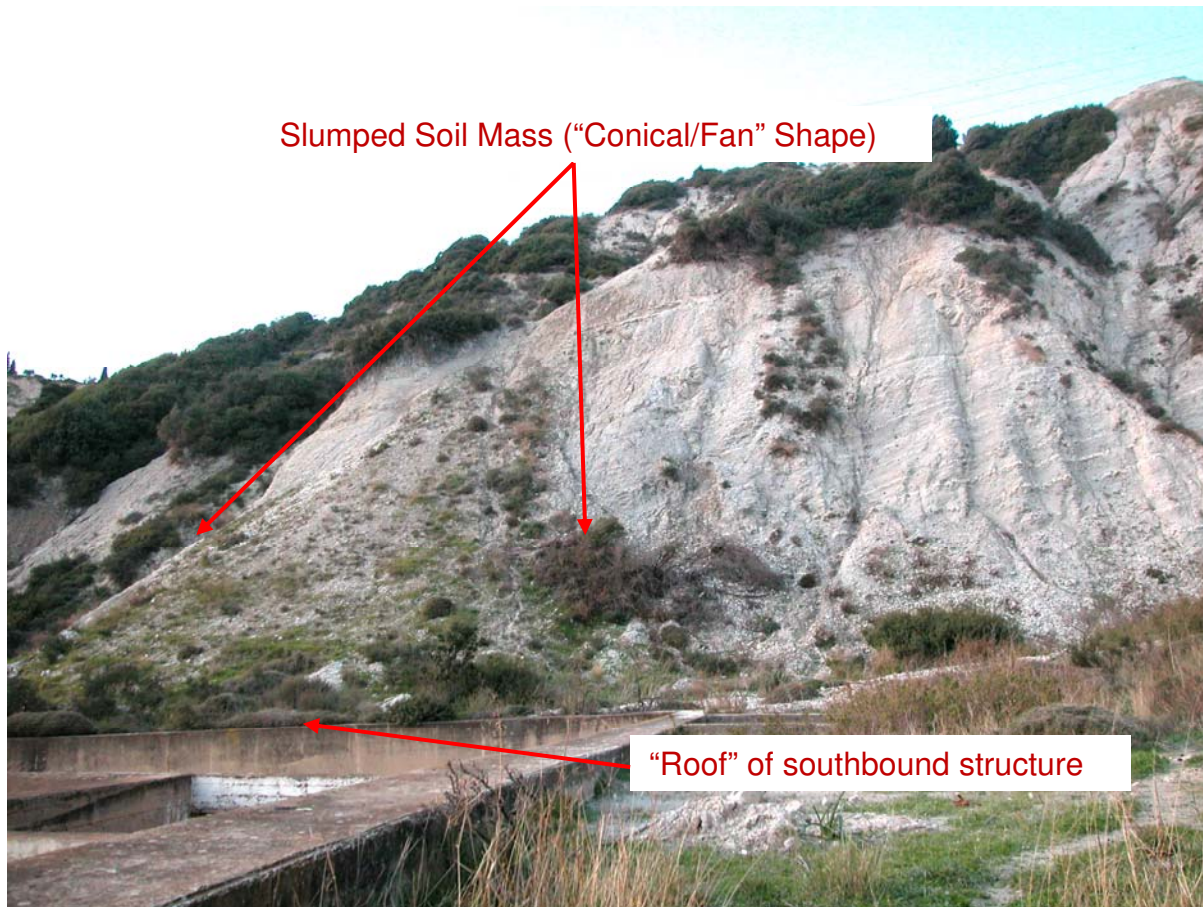
Figure 3. Slumped Soil Mass Loading the Top of the Southbound Tunnel Exit Structure.

1. “Soil 1”, is characteristic of the slumped mass above the southbound tunnel cross-section (Fig. 3). This soil type is characterized by relatively low values of the Menard modulus, dry density and unconfined compressive strength.
2. “Soil 2” is typical of the soft marlstone layers. This material is typical of materials in a band 4 to 6 m thick as evidenced in boreholes BH-1, BH-2, and BH-5.
3. Finally, the third type is the intact marly-limestone rock of the Chekka Formation.

1. Controlling surface water flow and improving drainage around structure area.
2. Removal of the slumped mass on top of the southbound tunnel exit structure and the provision of long-term stability and erosion control measures to eliminate the possibility of recurrence. These provisions included the installation of rock bolts/nails with a high strength steel wire mesh facing (Fig. 13 and Fig. 14). A program for regular inspection and maintenance of the structures was also developed.

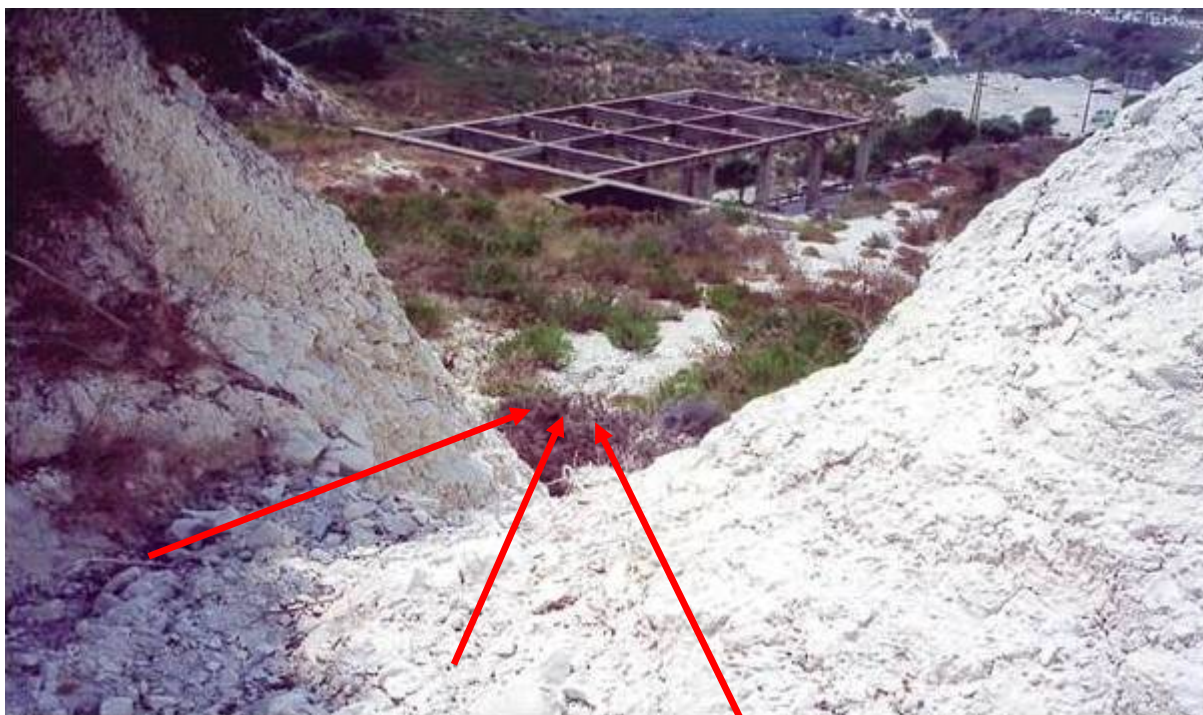
Figure 4. Direct Surface Flow (arrows) Towards South Facing Tunnel Exit/entrance Structures -View From Top.

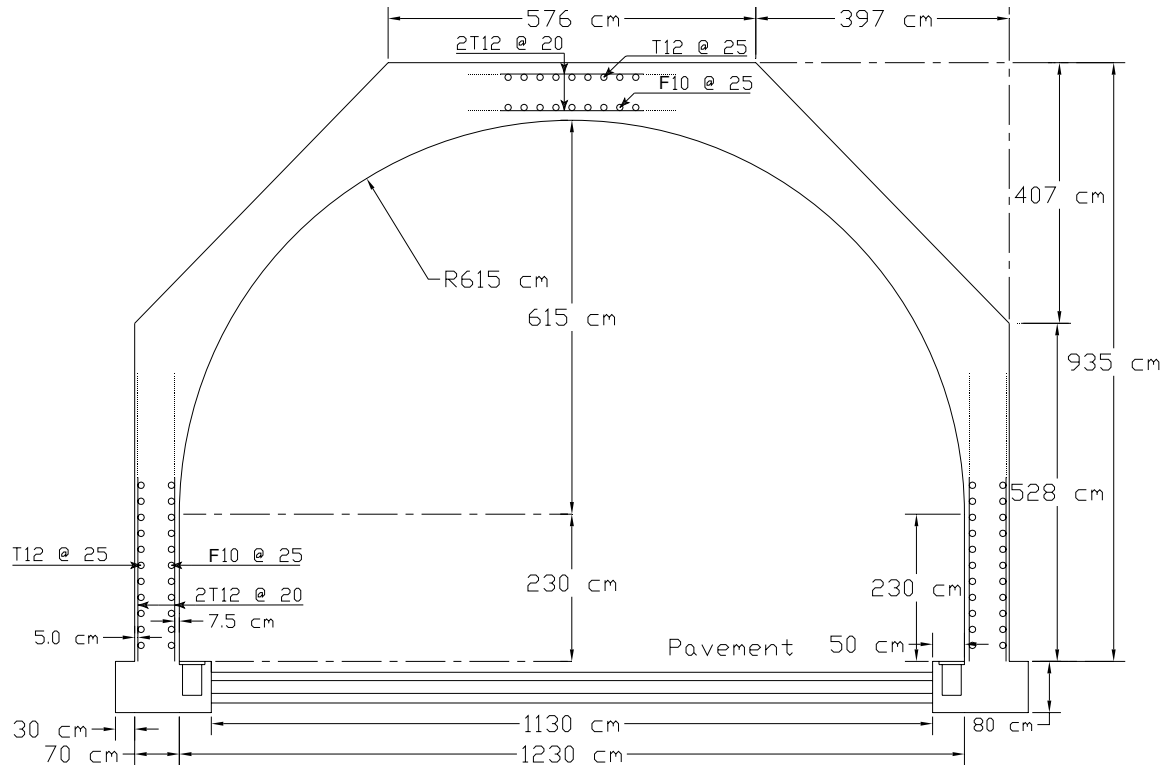
Figure 10. Geometry of the 35-m Long Extension of the Southbound Tunnel Portal.

Table 3 presents the bending moments calculated from the FE analyses and the ultimate moment section capacity at the position of the observed crack ~ 2.5 m above the footing level (Fig. 10).

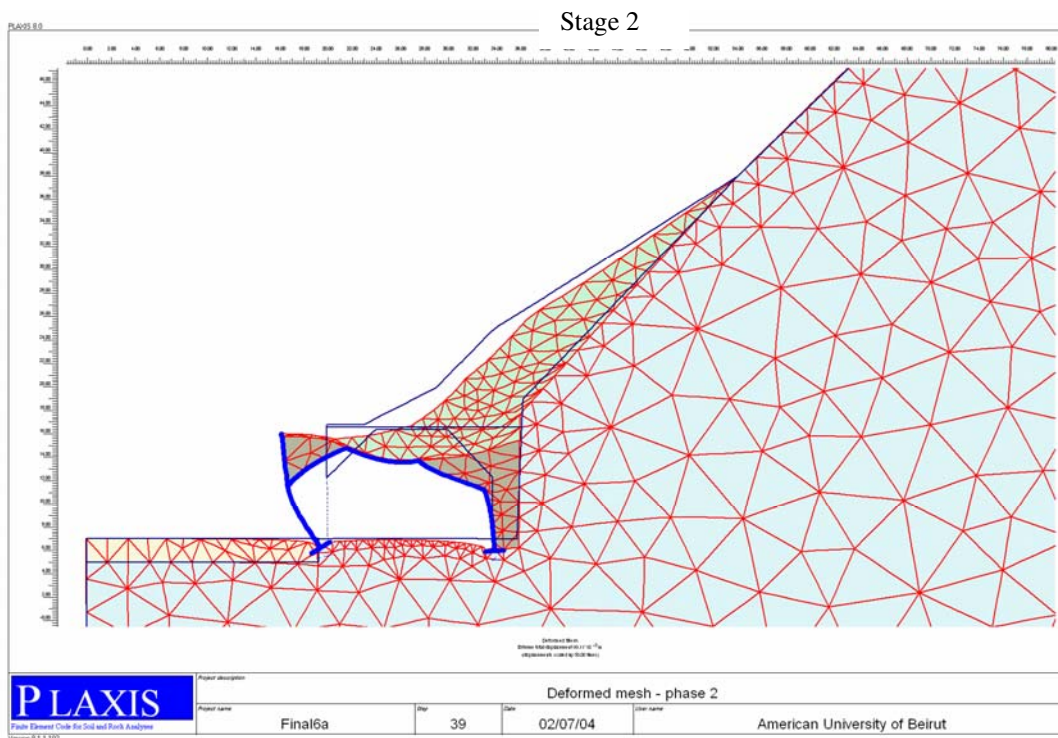
For conditions representing the current loading, Stage 2, the analyses yielded the deformed mesh shown in Fig. 12. The FE results for Stage 2 suggest the following:

1. The maximum bending moment values calculated are much larger than the ultimate moment capacity of the critical wall section. This implies that the additional loading due to the slumped soil accumulated on top of the tunnel section is indeed a major contributing cause of the observed failure of the portal wall section.
2. The values of the shear forces are within the section capacities.

Figure 12. Deformed Mesh for Stage-2 (Deformations Are Scaled up 50 times).
