Lack of Maintenance Compromises Tunnel Structural Safety

KEYWORDS: Tunnels, maintenance, structural failure, finite element analysis

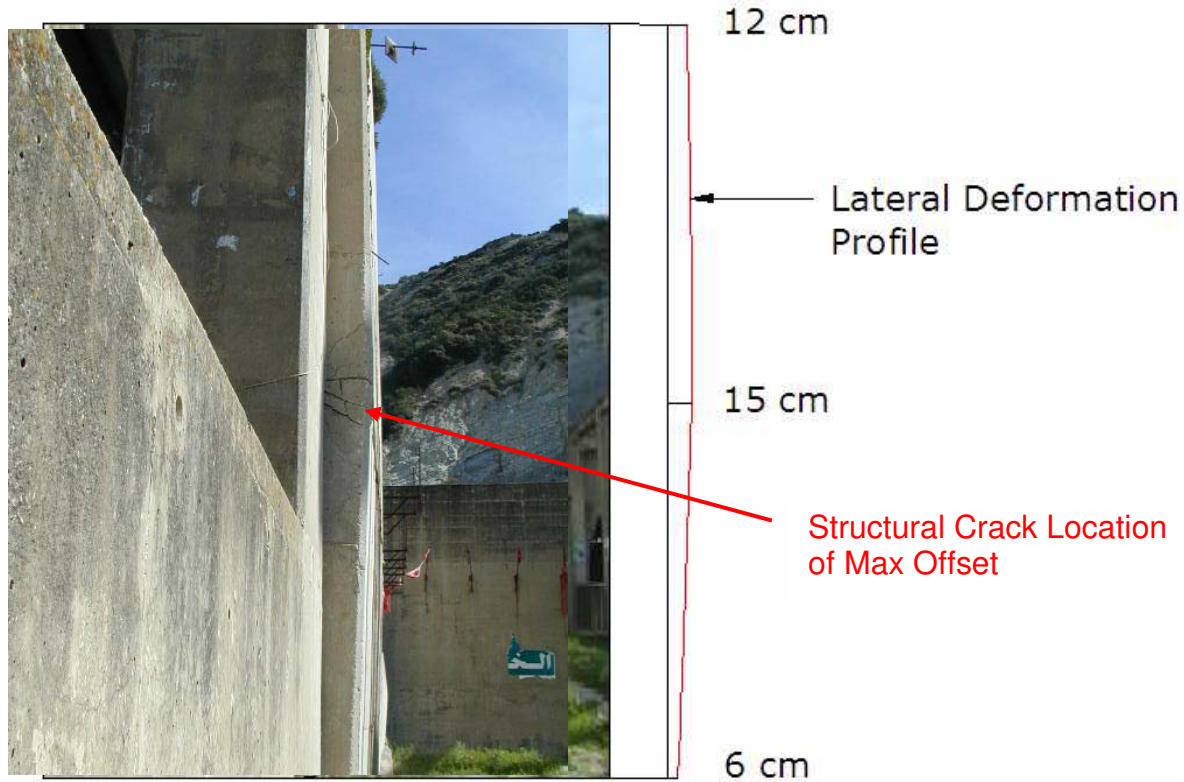
Figure 2. Close-up View of the Outward Movement/bulging of the Eastern Portal Wall.

The major crack along the 35-m long portal structure at the southbound tunnel exit (shown in Fig. 1 and Fig. 2) which initiated the engineering intervention, was attributed to increased differential loading. This possible cause for the structural damage was identified following the observation of a relatively large slumped mass of soil loading the western side of the portal structure of the southbound tunnel (Fig. 3). The slumped soil mass was due to weathering of the friable chalky limestone rock on the adjacent exposed slopes and subsequent instability and mass transport. The differential loading of one side of the portal frame structure by the slumped soil mass, along with other contributing factors, could have led to the observed cracking of the eastern wall of the portal along with the associated lateral deformations of up to 15 cm (Fig. 1 and Fig. 2). Additional pictures of this particular tunnel segment are provided in the online database that accompanies this paper.

2. The eastern wall of the southbound tunnel portal was further strengthened after the accumulated weathered material above it was removed and the crack treatment/repair completed. Strengthening was achieved by connecting a 15-cm reinforced concrete jacket to the existing wall.
3. Whereas the distress signs were evident along the eastern projecting portal wall only, the FEM analyses suggested that cracks could have developed along the inaccessible outside tension face of the backfilled western wall of the portal. As such, strengthening provisions for that element were taken. Jacketing was ruled out given that the outer surface is backfilled and cannot be exposed. Instead, the installation of passive nails/rock bolts at elevations of grade plus 2 m and grade plus 4 m was recommended, tying the wall to the intact rock and reducing the stresses on the wall itself.

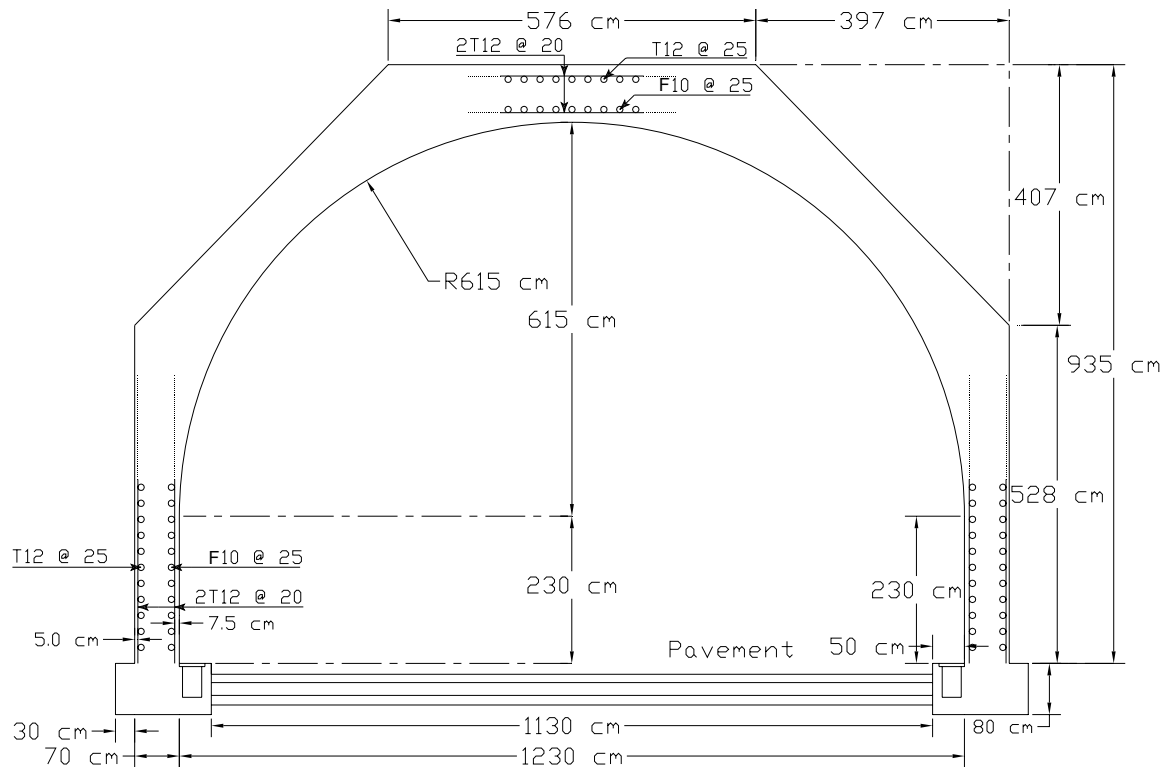
Figure 10. Geometry of the 35-m Long Extension of the Southbound Tunnel Portal.

Table 3 presents the bending moments calculated from the FE analyses and the ultimate moment section capacity at the position of the observed crack ~ 2.5 m above the footing level (Fig. 10).
