Lack of Maintenance Compromises Tunnel Structural Safety

ABSTRACT: *The Chekka tunnels represent a critical section of the Northern Lebanon Highway. The approximately 350-m long twin tunnels are the most important tunnels in the country. They are used by regular and freight traffic and are a vital link to the capital, Beirut. The tunnels were completed in the early 1970s on the eve of the Lebanon civil war. Given the state of affairs in the country for about two decades of strife, the tunnels were not maintained nor did they undergo any regular inspection. This unique condition of near-abandonment continued up until recently, when the first signs of distress were documented. These consisted of severe and extensive cracking, particularly in the portal approach of the southbound tunnel, along with significant deterioration of the tunnel lining and radial section joints. The danger to traffic and, potentially, to the structure itself was evident. In this paper, the results of an extensive site inspection and evaluation program are presented. The underlying causes of the observed damage are analyzed and discussed using a modeling approach of the progressive loading conditions. Remedia

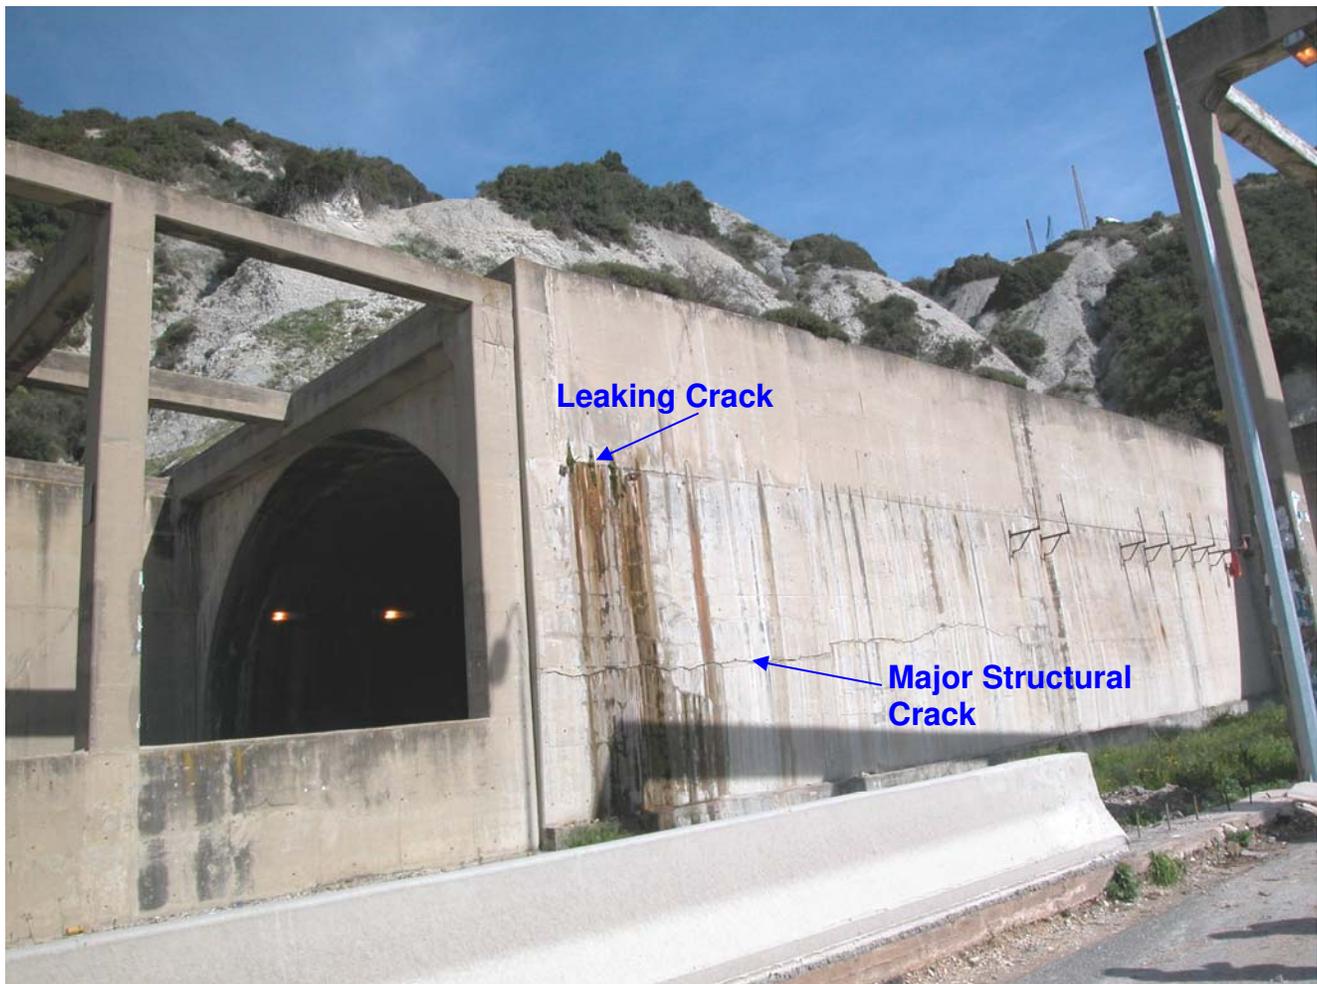
The main causes of alarm were significant signs of structural distress along the 35-m long reinforced concrete portal structure, at the exit of the southbound tunnel. The clearest and most critical among these was a major near-horizontal crack (crack width > 5 mm) running all along the exposed side of the structure (Fig. 1), along with a lateral offset of the portal wall on the order of 15 cm, with the greatest movement occurring at the crack elevation (Fig. 2). The distress signs had become severe enough that they could be clearly seen from the road by northbound drivers/passengers. It was only then, due to growing public fears and apprehension at using the tunnels, that the priorities were shifted to address the potential failure of the structures.

Figure 1. Southbound Tunnel Portal - View of External Distress.

The major crack along the 35-m long portal structure at the southbound tunnel exit (shown in Fig. 1 and Fig. 2) which initiated the engineering intervention, was attributed to increased differential loading. This possible cause for the structural damage was identified following the observation of a relatively large slumped mass of soil loading the western side of the portal structure of the southbound tunnel (Fig. 3). The slumped soil mass was due to weathering of the friable chalky limestone rock on the adjacent exposed slopes and subsequent instability and mass transport. The differential loading of one side of the portal frame structure by the slumped soil mass, along with other contributing factors, could have led to the observed cracking of the eastern wall of the portal along with the associated lateral deformations of up to 15 cm (Fig. 1 and Fig. 2). Additional pictures of this particular tunnel segment are provided in the online database that accompanies this paper.

1. A major longitudinal structural crack was clearly evident on the outside face of the eastern wall of the tunnel portal frame in the last 35 m span of the exit side of the southbound tunnel (Fig. 1). Signs of water leakage through a crack in the eastern wall were evident at the junction between the tunnel portal and the 4.72 m high retaining parapet. This pattern of damage was indicative of a number of problems with the tunnel portals, which are typically identified as potentially problematic areas in a number of situations (Rothfuss et al., 1995).

1. The major structural cracks on the outside face of the eastern wall of the portal frame were repaired by “crack-injection” using low viscosity, two-component epoxy resin. The injection was completed after thorough cleaning and preparation of the affected areas and the provision of injection ports to ensure thorough filling of the cracks. Similar treatments were applied to all cracks and damaged areas in the tunnel concrete lining (Fig. 15).

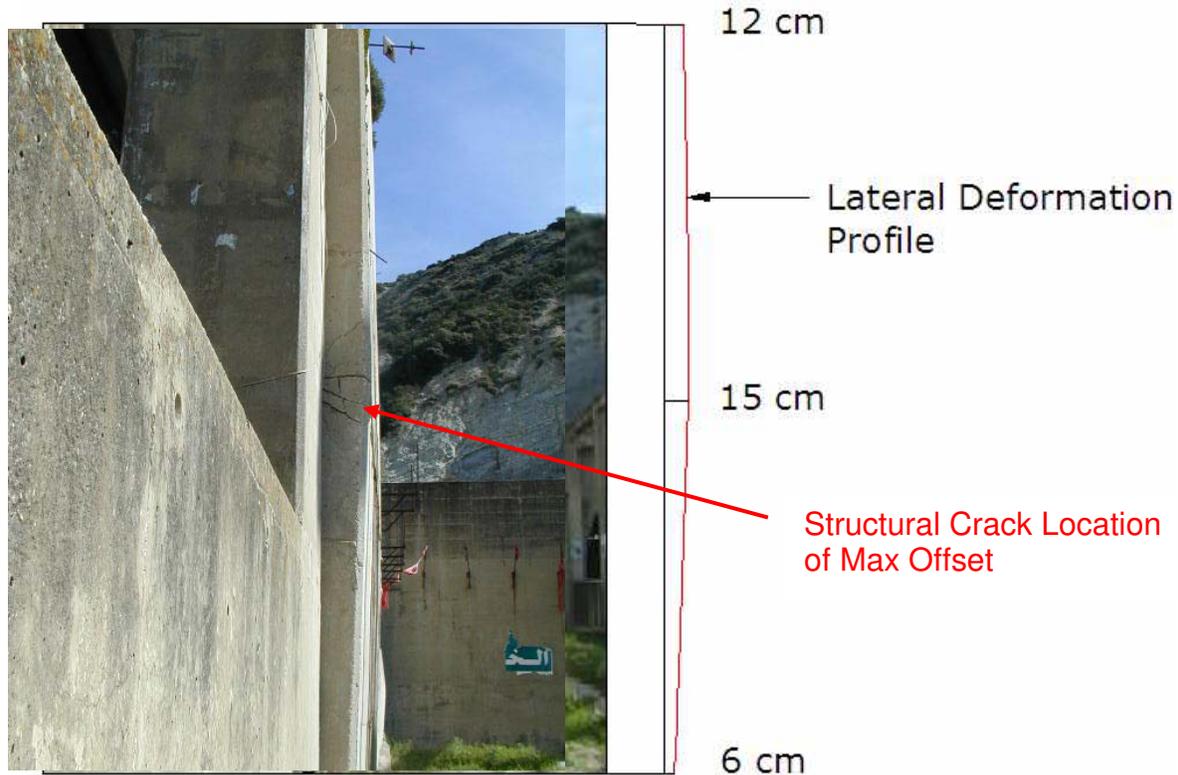
Figure 2. Close-up View of the Outward Movement/bulging of the Eastern Portal Wall.

2. The eastern wall of the southbound tunnel portal was further strengthened after the accumulated weathered material above it was removed and the crack treatment/repair completed. Strengthening was achieved by connecting a 15-cm reinforced concrete jacket to the existing wall.
3. Whereas the distress signs were evident along the eastern projecting portal wall only, the FEM analyses suggested that cracks could have developed along the inaccessible outside tension face of the backfilled western wall of the portal. As such, strengthening provisions for that element were taken. Jacketing was ruled out given that the outer surface is backfilled and cannot be exposed. Instead, the installation of passive nails/rock bolts at elevations of grade plus 2 m and grade plus 4 m was recommended, tying the wall to the intact rock and reducing the stresses on the wall itself.

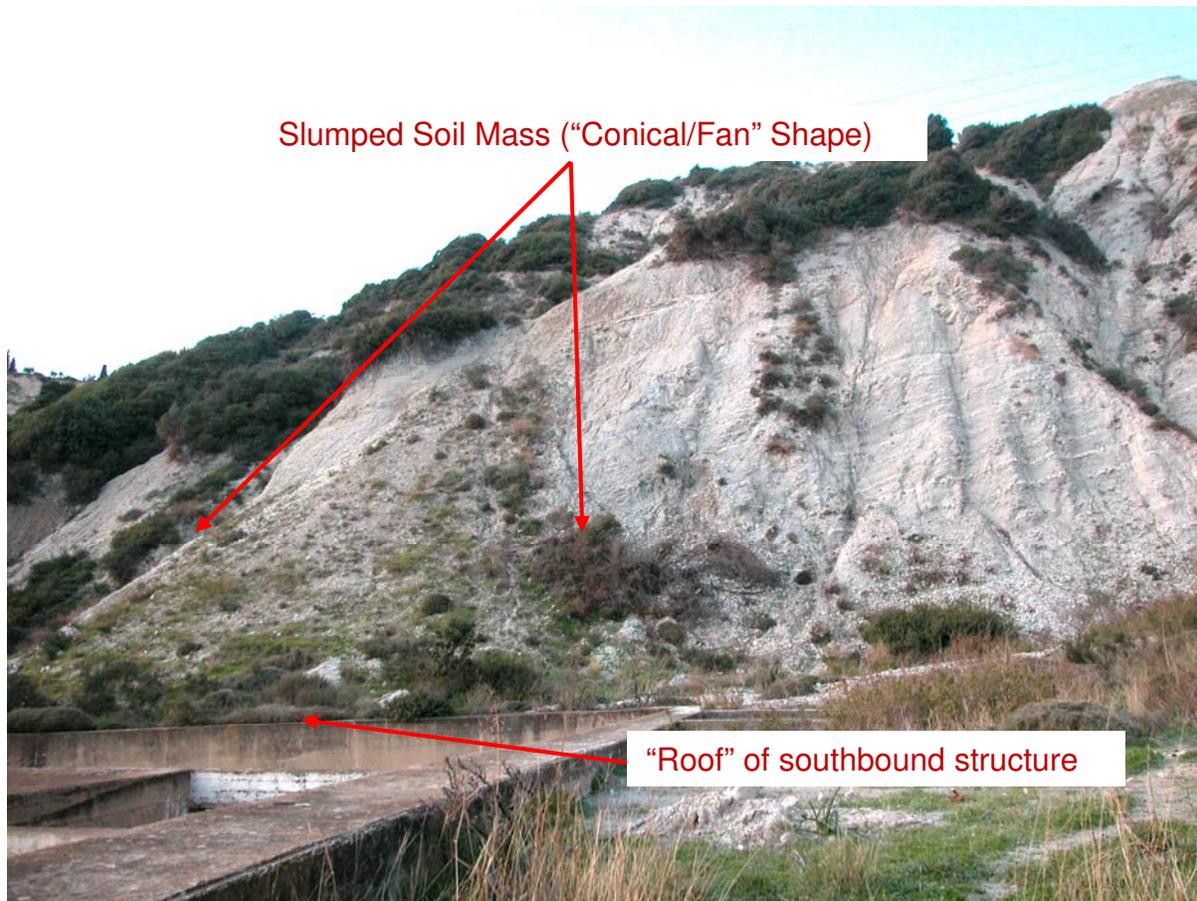
In addition to the differential loading on one side of the portal structure due to accumulation of eroded materials and mass movement, the tunnel structures clearly suffered from poor drainage. Here again, time and lack of maintenance and repair caused the failure of all the water control provisions described in subsequent sections of this paper. The "natural" flow paths from the surrounding hills lead to the upper platform along the tunnel portal as seen in Fig. 4. The tunnels exhibit signs of water leakage along their entire lengths, which resulted in, and are associated with, weakened concrete lining and significant carbonation depths. Plots of carbonation of concrete, f'_c , and mapping of leaking cracks/joints are provided in the online database that accompanies this paper.

Figure 3. Slumped Soil Mass Loading the Top of the Southbound Tunnel Exit Structure.

1. “Soil 1”, is characteristic of the slumped mass above the southbound tunnel cross-section (Fig. 3). This soil type is characterized by relatively low values of the Menard modulus, dry density and unconfined compressive strength.
2. “Soil 2” is typical of the soft marlstone layers. This material is typical of materials in a band 4 to 6 m thick as evidenced in boreholes BH-1, BH-2, and BH-5.
3. Finally, the third type is the intact marly-limestone rock of the Chekka Formation.

1. Controlling surface water flow and improving drainage around structure area.
2. Removal of the slumped mass on top of the southbound tunnel exit structure and the provision of long-term stability and erosion control measures to eliminate the possibility of recurrence. These provisions included the installation of rock bolts/nails with a high strength steel wire mesh facing (Fig. 13 and Fig. 14). A program for regular inspection and maintenance of the structures was also developed.

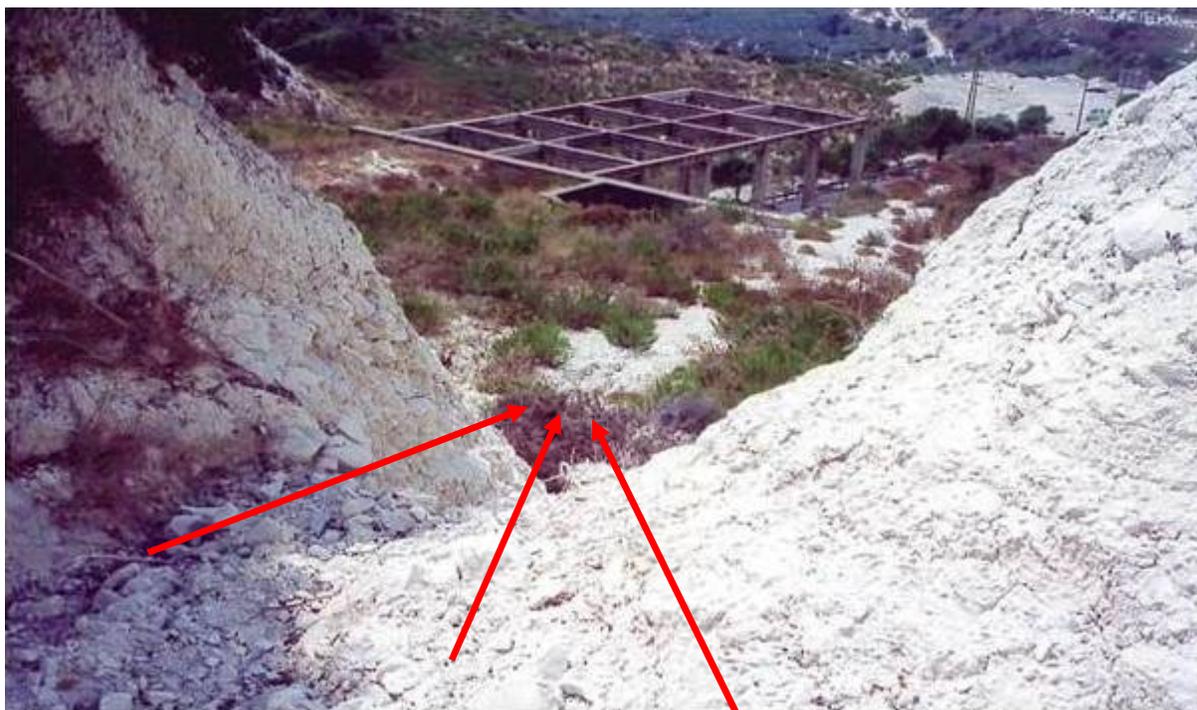
Figure 4. Direct Surface Flow (arrows) Towards South Facing Tunnel Exit/entrance Structures -View From Top.

1. A water runoff interception scheme, with particular emphasis on the slopes contributing to the flow patterns towards the southbound tunnel exit. A schematic of the layout of the system is shown in Fig. 15. The interceptor trenches and drainage channels are concrete-lined and feed into controlled sumps and outlets, moving surface water away from the portals and vulnerable tunnel sections.

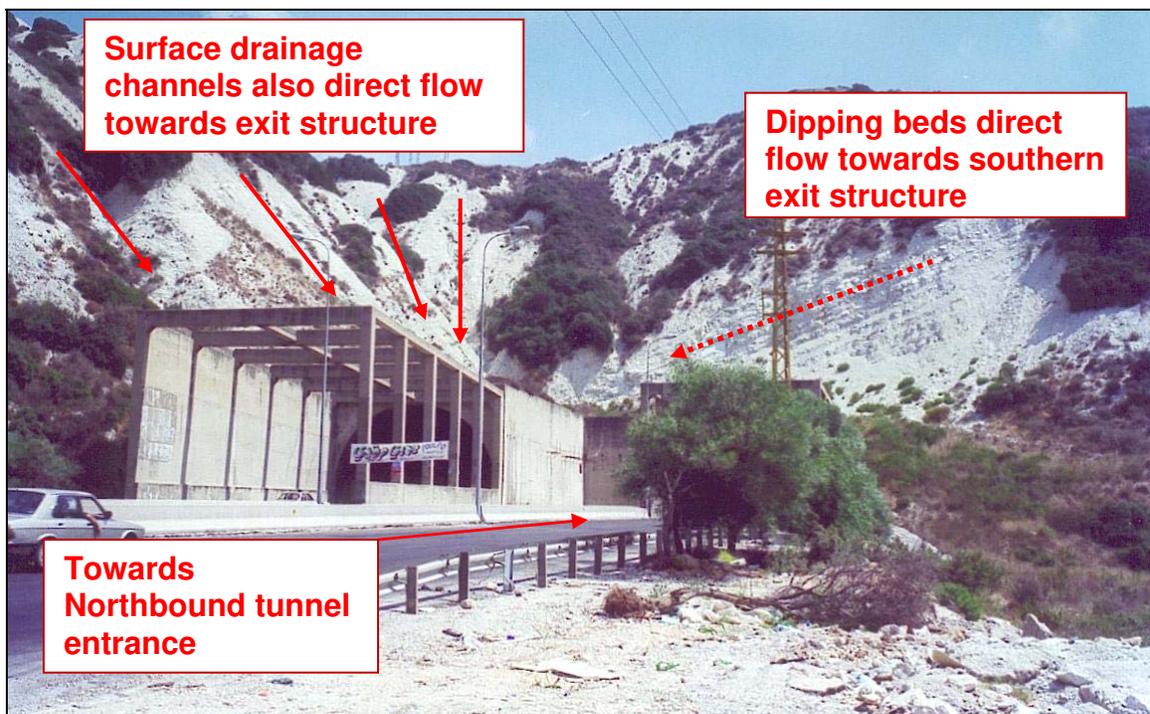
Figure 6. Dipping Beds and Surface Drainage Channels Increase Flow Towards Southbound Tunnel Exit Structure and “Sump” Area Above Tunnels.

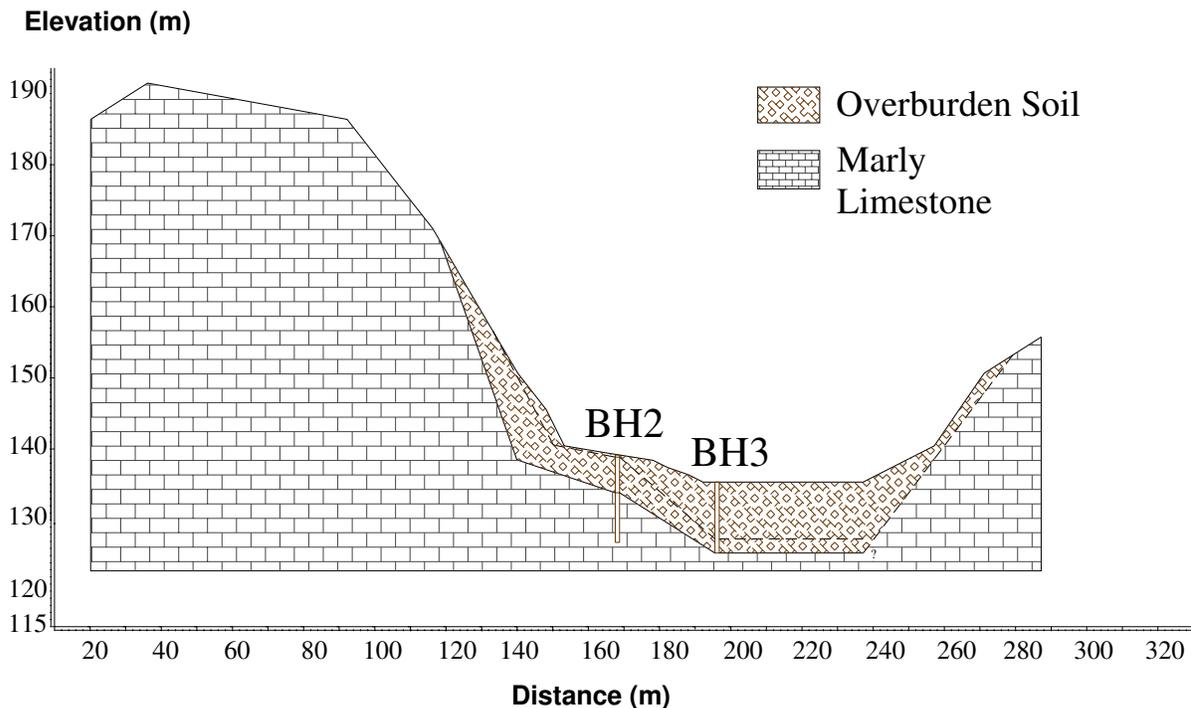
Figure 8. Transverse Section Across South tunnel (A-A in Fig. 7). Tunnel Portal Between Two Hills.

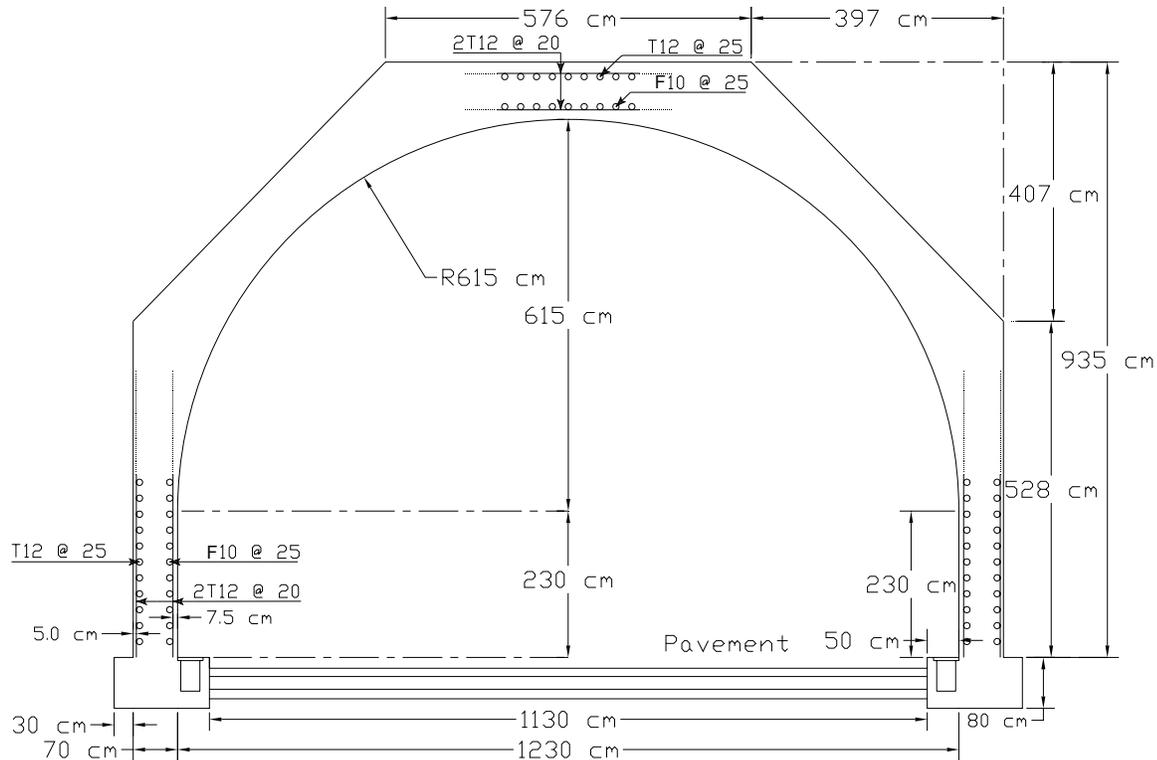
Figure 10. Geometry of the 35-m Long Extension of the Southbound Tunnel Portal.

Table 3 presents the bending moments calculated from the FE analyses and the ultimate moment section capacity at the position of the observed crack ~ 2.5 m above the footing level (Fig. 10).

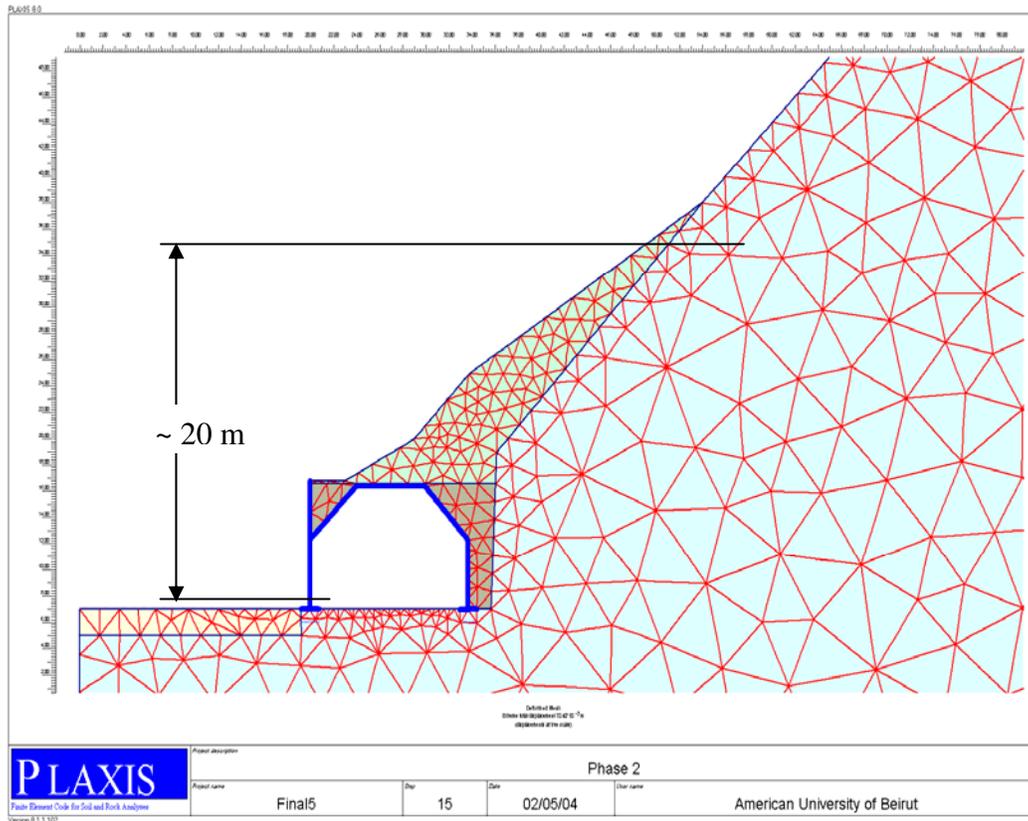
Fig.11 is a detail view of the finite element mesh near the tunnel portal, showing the soil and rock strata as described in Table 2. The intact rock is shown in light blue, while the slumping soil mass is green. The olive green color represents the engineered backfill soil at the end of construction. It is important to note here that the slumping soil mass was only activated for Stage 2.

Figure 11. Finite Element Model Showing the Various Strata and the Loading Sequences – Stages 1 and 2.

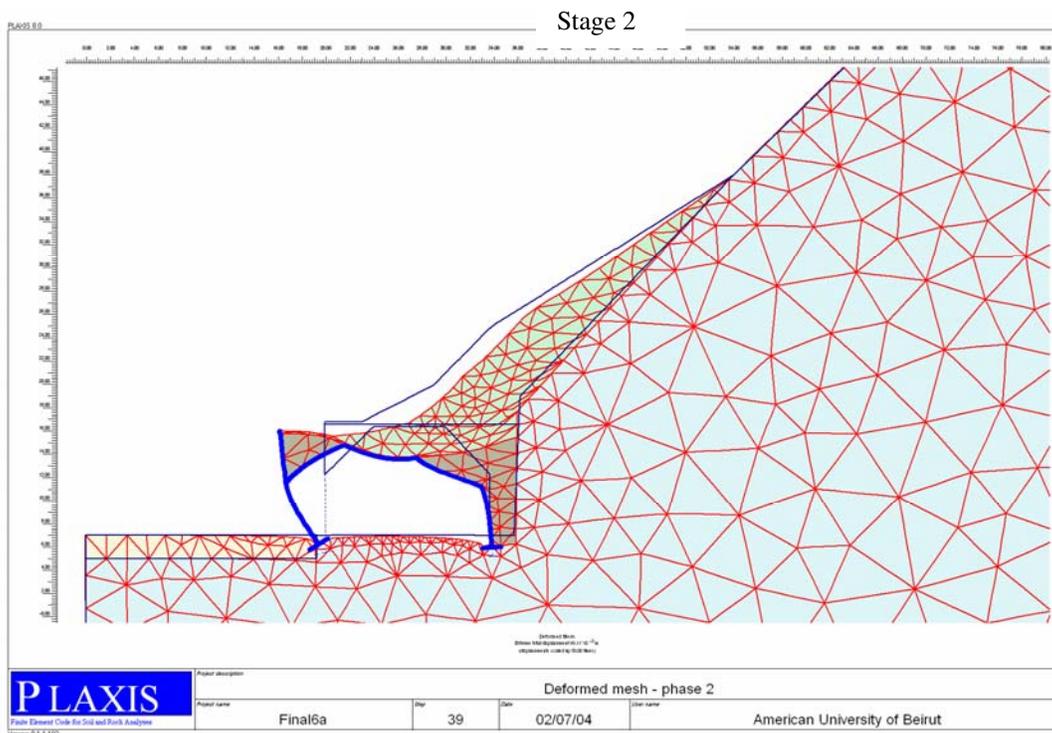
For conditions representing the current loading, Stage 2, the analyses yielded the deformed mesh shown in Fig. 12. The FE results for Stage 2 suggest the following:

1. The maximum bending moment values calculated are much larger than the ultimate moment capacity of the critical wall section. This implies that the additional loading due to the slumped soil accumulated on top of the tunnel section is indeed a major contributing cause of the observed failure of the portal wall section.
2. The values of the shear forces are within the section capacities.

Figure 12. Deformed Mesh for Stage-2 (Deformations Are Scaled up 50 times).

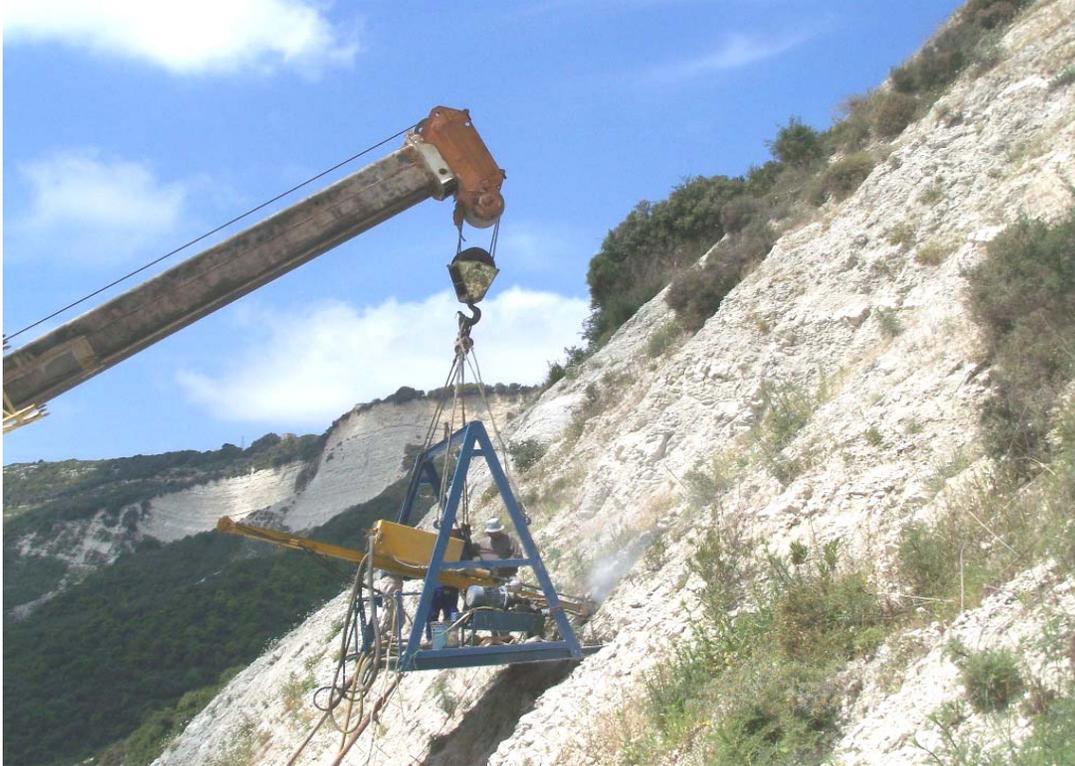
Figure- 13. Installation of the Nails/bolts Along the Western Slopes.

3. Repair and rehabilitation of the distressed structural elements including jacketing and repair of the eastern outer wall and the provision of passive nails/rock bolts on the western wall, tying into the parent intact rock, thus reducing pressures on the wall and lateral deformations.

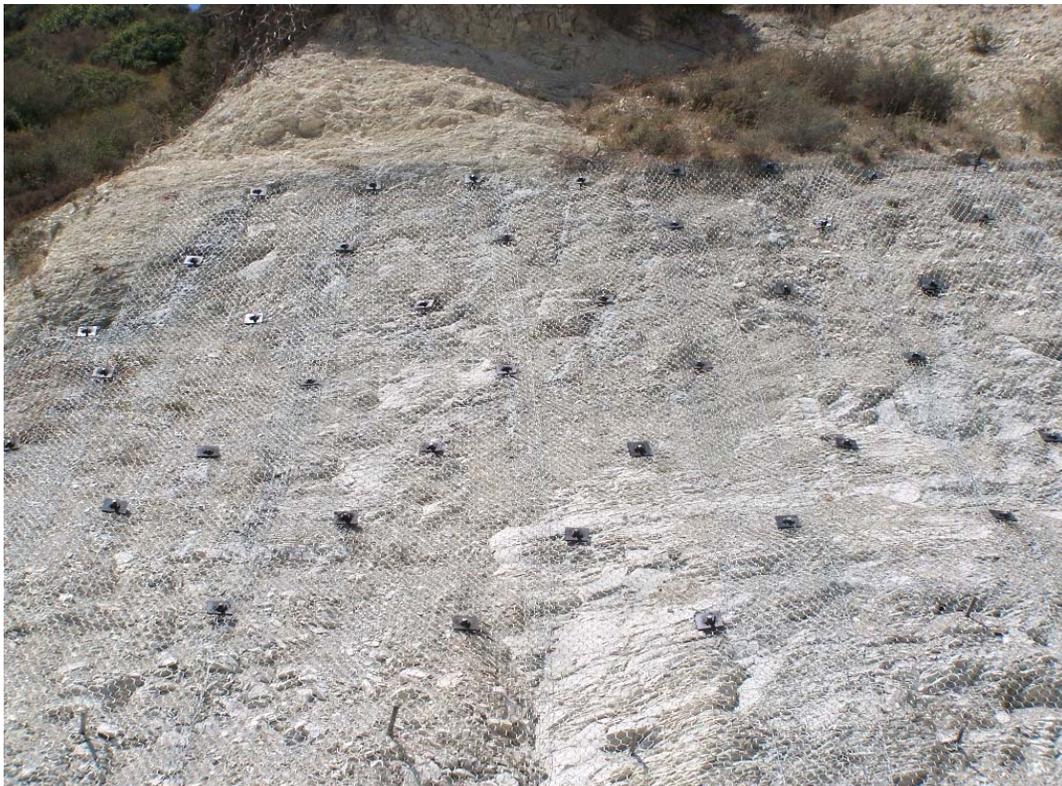
Figure 14. Completed Rock Bolts/nails and Wire Mesh Installation Along the Western Slope.

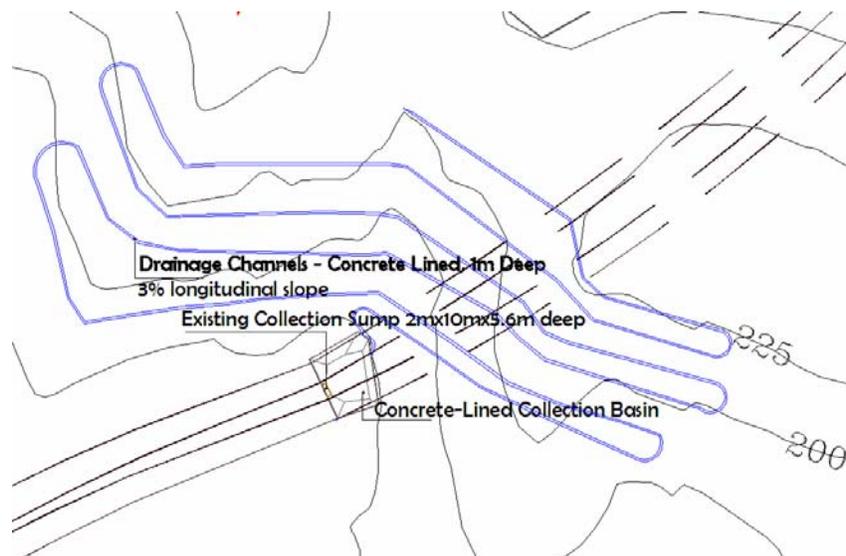
Figure 15. Schematic Plan of the Drainage/interception Channels (Trace of Tunnels Shown as Dashed Lines).

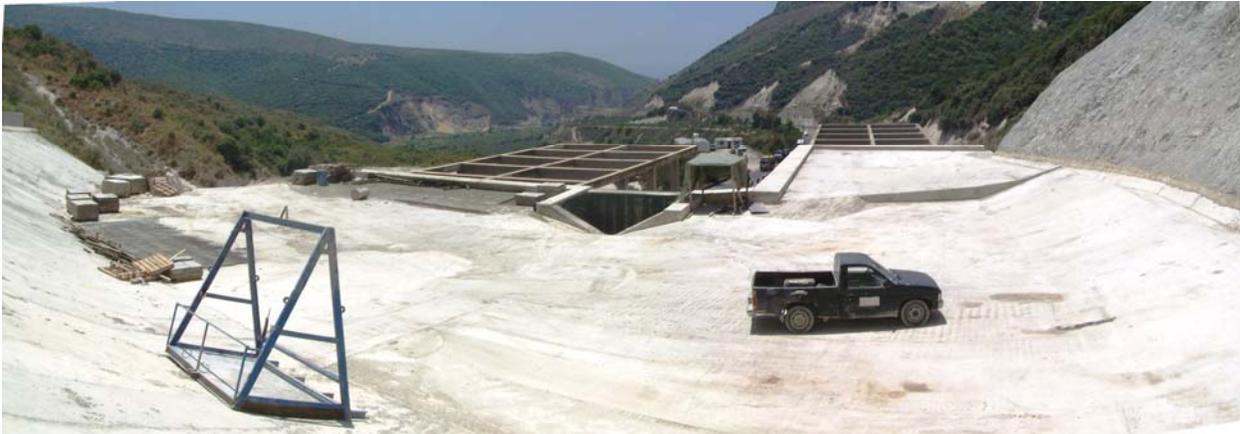
Figure 16. Regraded and Remediated Area Above the Portals and Southern Entrance/exit of Tunnels.

2. The surface water drainage provisions were re-designed to incorporate the already existing drainage structures that were not in service conditions. Surface run-off is collected by directing the rainwater by adequate leveling the area above the exit/entrance structures, into concrete-lined channels, which carry the water into the existing sump for storage and subsequent evacuation by gravity outside the project area. Fig. 16 shows the remediated area above the tunnels, with the v-notched entrance to the sump and peripheral drainage channels.

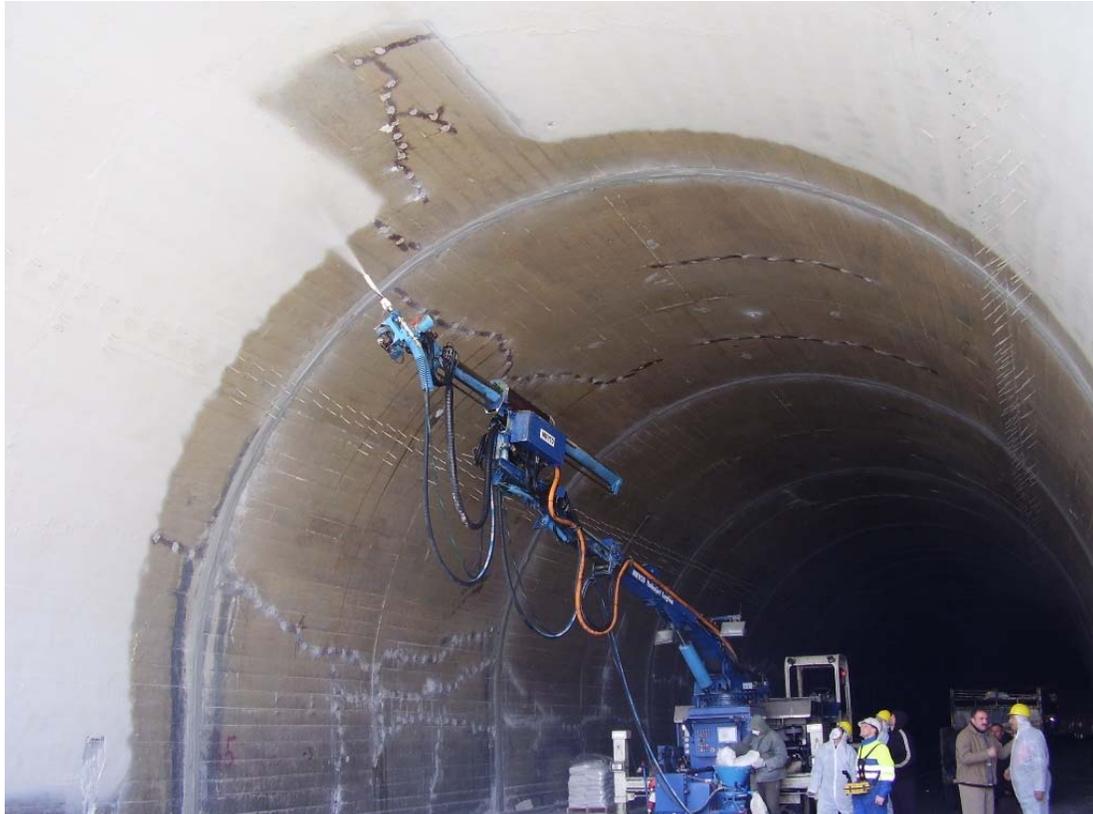
Figure 17. Installation of the Sprayed Membrane. Also Shown Are the Repaired Cracks in Original Lining.

4. Repair and sealing of all cracks and fissures in the original concrete tunnel lining, followed by placement of a sprayed 4-mm thick waterproofing membrane and a protective layer of fiber-reinforced shotcrete.

4. Water proofing was provided through a projected/sprayed membrane. The sprayable membrane selected was a MASTERSEAL 345. The membrane was applied using an automated, computer controlled robotic arm, which insured thorough coverage/thickness and uniform application (Fig. 17).
