Leaning Tower of Pisa: Behaviour after Stabilization Operations

ABSTRACT: It is well known that the foundations of the Leaning Tower of Pisa were stabilised using the method of underexcavation to reduce the southward inclination of the Tower by about 10 percent in combination with controlling the seasonally fluctuating water table beneath the north side. Having been closed to the public since early in 1990, the Tower was re-opened in December 2001. The paper summarises the response of the Tower during the period of implementation of the stabilisation works. Monitoring of the movements of the Tower has been continuing and the observations obtained since 2001 are presented. It is shown that over the six years between 2003 and 2008 the induced rate of northward rotation of the Tower has been steadily reducing to less than 0.2 arc seconds per year. Similarly the rate of induced settlement of the centre of the foundation has been steadily reducing and is approaching the background rate of settlement of the Piazza. Piezometer measurements close to the north side of the foundation shows that the drainage system has been successful in stabilising the groundwater levels beneath the north s

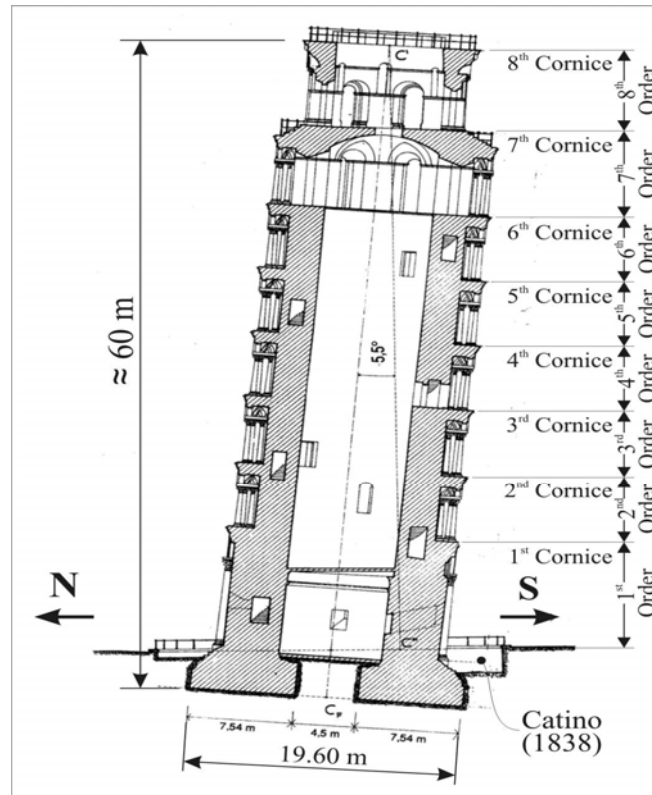
Figure 3. Cross-section in the plane of maximum inclination, situation in year 1993.

The purpose of this paper is to update the information on the behaviour of the Leaning Tower of Pisa after the work of stabilisation ended in 2001. The Tower of Pisa is the bell tower of the Cathedral and is one of the four monuments within the medieval Piazza dei Miracoli, three of which are shown in Fig. 1. Its construction began in 1173 and continued (with two long interruptions) for about two hundred years as illustrated in Fig. 2. The Tower is built as a hollow masonry cylinder surrounded by six colonnades with columns and vaults rising from the base cylinder. The outer and inner walls are faced with competent San Giuliano marble, while the annular cavity between is filled with miscellaneous rock fragments and mortar, forming a typical medieval infill masonry structure. The Tower commenced leaning southwards during the second construction stage as shown in Fig. 2, and thereafter its inclination continued to increase. Fig. 3 shows the cross section through the Tower in the plane of maximum tilt as it was in 1993 before the stabilisation work commenced. The average foundation pressure is 500kPa and a detailed computer analysis (Burland and Potts, 1994), indicates that the pressure at the south edge was about 1000kPa with the soil in a state of local yield, while the pressure at the north edge was close to zero.

Weight	142 MN
Height of the centre of gravity	22.6 m
Overturning moment	327MNm
Average foundation pressure:	≈ 500 kPa

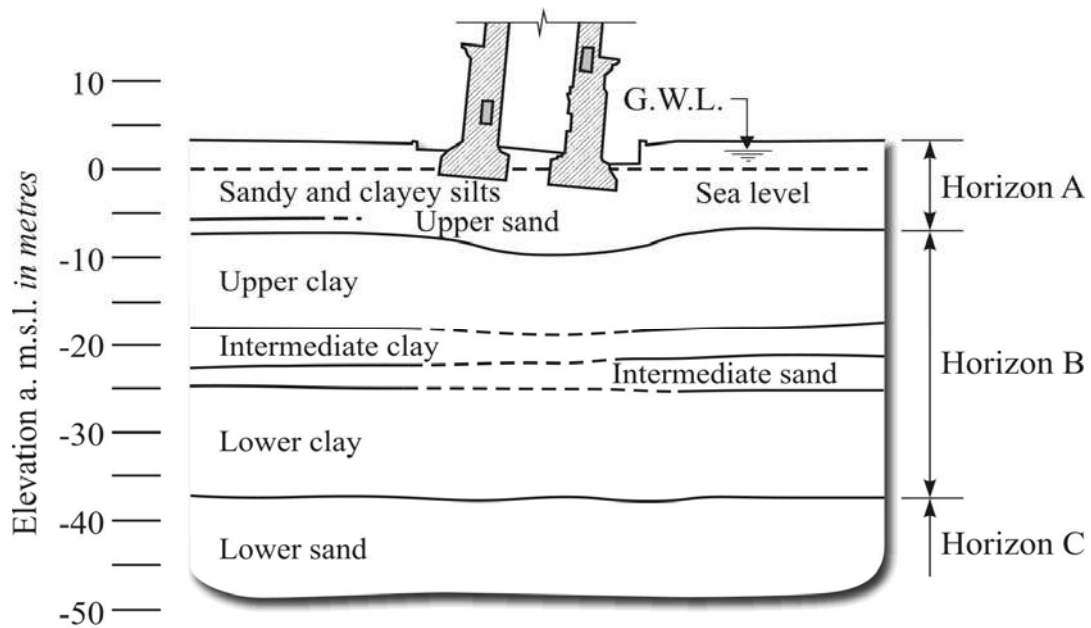
Figure 4. Soil profile.

The ground underlying the Pisa Tower consists of three formations as shown in Fig. 4. Horizon A, about 10m thick, is composed of soft estuarine deposits of sandy and clayey silts laid down under tidal conditions. Horizon B consists of soft sensitive normally consolidated marine clay extending to a depth of about 40m. Because it is very sensitive, this material loses much of its strength if disturbed. Horizon C is dense marine sand extending to a depth of about 60m. An upper perched water table in Horizon A is encountered between 1m and 2m below the level of Piazza dei Miracoli corresponding to elev. +3.0 above m.s.l. The contact between Horizon A and the marine clay of Horizon B is dished beneath the Tower, indicating that it experienced average settlements of between 3.0m and 3.5m.

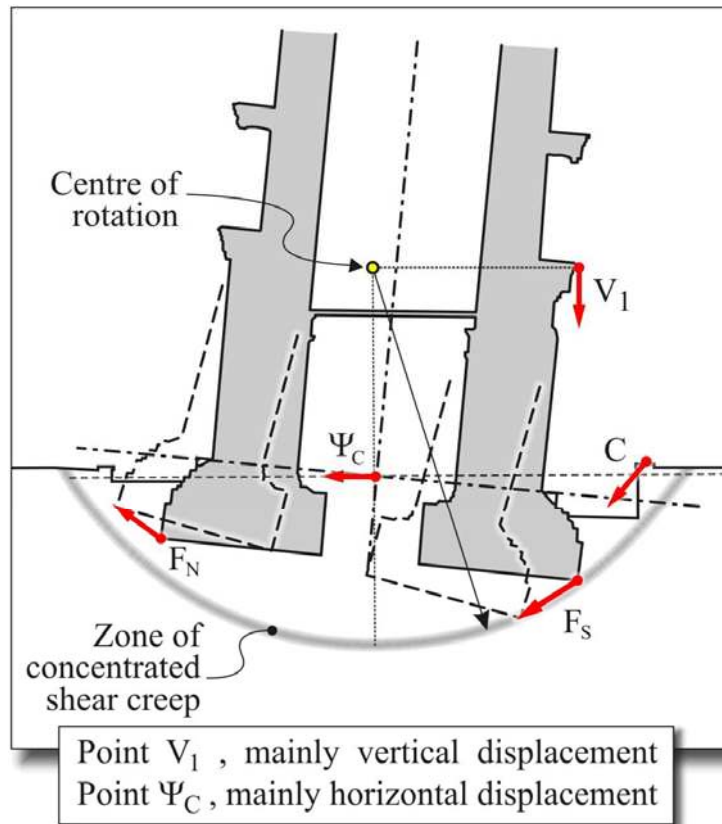
Figure 5. Motion of Tower foundation during steady creep (gradually accelerates) - Burland, Viggiani (1994).

Precise measurements begun in 1911 and show that during the twentieth century the inclination of the Tower has been increasing inexorably each year and the rate of tilt has doubled since the 1930's. In 1990 the increase of tilt was about 6 arc seconds per year which is equivalent to a horizontal movement at the top of about 1.5mm per year (Jamiolkowski, 2001). There has been much debate about the cause of this progressive increase in inclination. It has usually been attributed to creep in the underlying soft marine clay, the assumption being made that the south side was settling more than the north side. A careful study of the geodetic survey measurements going back to 1911 revealed a most surprising form of motion of the foundations which was radically different to previously held ideas. The theodolite measurements showed that the first cornice had not moved horizontally – apart from two occasions in 1934 and the early 1970s when man had intervened. Also, precision level measurements which commenced in 1928 showed that the centre of the foundation plinth had not displaced vertically relative to the surrounding ground. Therefore, the rigid body motion of the Tower could only be as shown in Fig. 5, with an instantaneous centre of rotation at the level of the first cornice vertically above the centre of the foundation. The direction of motion of points FN and FS are shown by vectors and it is clear that the foundation has been moving northwards with FN rising and FS sinking (Burland and Viggiani, 1994).

3. The pattern of ground movements depicted in Fig. 5 led to the important conclusion that the seat of the continuing long-term rotation of the Tower lies in Horizon A and not within the underlying marine clay as had been widely assumed in the past. It can therefore be concluded that the latter stratum must have undergone a considerable period of ageing since the end of construction. The ageing resulted in an increased resistance to yield – a conclusion that proved to be of great importance in the successful computer modeling of the application of the temporary counterweight (Burland and Potts, 1994).

Kinematically admissible mechanism of ground movement, curvilinear concentrated shear creep zone passing through more plastic layer of horizon A

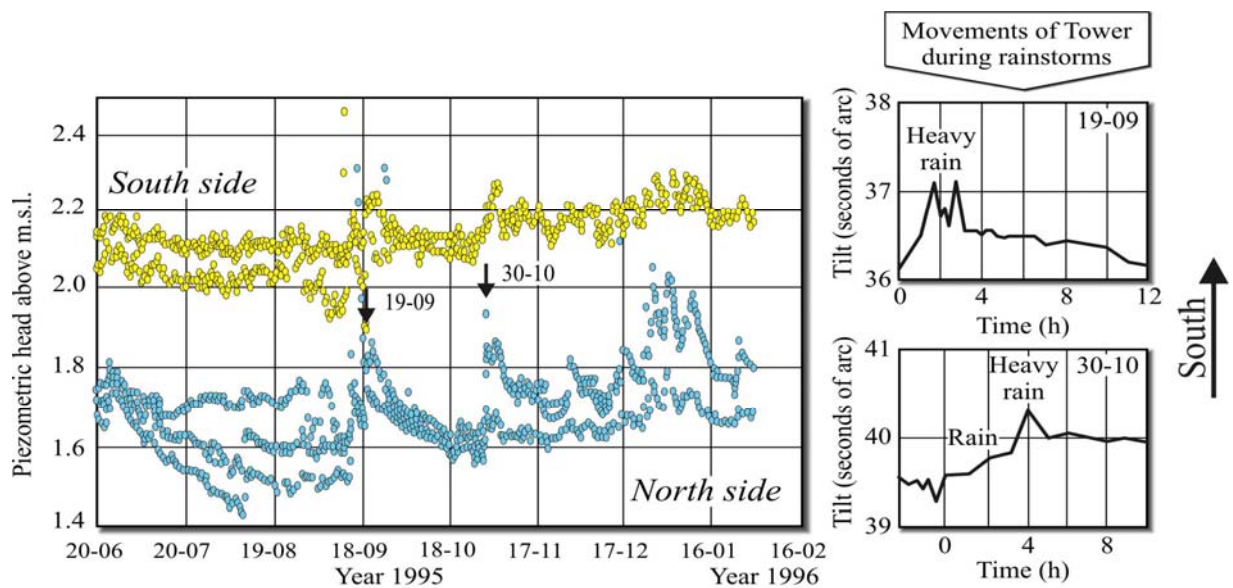
Figure 6. Ground water level fluctuation in horizon A.

4. In the light of the measured motion of the Tower foundation, and consistent with the seat of the movement lying within Horizon A, it was concluded that, in addition to creep, the most likely cause of the progressive seasonal rotation was a fluctuating ground-water level due to seasonal heavy rainstorms that occur between September and December every year. Accordingly a number of stand-pipes were installed in Horizon A around the Tower. Measurements made over a number of years have confirmed this hypothesis. Commencement of rotation each year coincides with very sharp rises in the ground water level in the Horizon A following each heavy rainstorm (Burland et al, 2003). Fig.6 shows the ground water level fluctuations for a selected period of time in the piezometers located to the North and to the South in the vicinity of the Tower. The insert figures to the right show the changes in inclination of the Tower in arc seconds as a result of two heavy rainstorms that occurred in September and October of 1995. Each of these events caused a larger rise in piezometric head on the North side than the South side of the Tower. This resulted in a southward rotation of about one arc second in each case which was only partly reversible.

As mentioned previously, the deduced motion of the Tower foundation shown in Fig. 5 led to the conclusion that the seasonal fluctuating water table in Horizon A during intense periods of rain was the main factor responsible for this continuing movement, see Fig. 6. It is also of significance that, apart from these intense periods of rain, the average ground water levels close to the South side of the Tower in Horizon A are 200mm to 300mm higher than those to the North, as shown in Fig. 6. This difference generates a small, but not negligible stabilising moment for the Monument which is so close to falling over. In the autumn and winter, when rainfall events are more intense, the water table rises sharply, reduces the difference in piezometric level and thereby produces southward rotations of the Tower which are not fully recoverable. To minimise this effect it was necessary to eliminate the fluctuations of the water table and, with this objective, a drainage system was installed consisting of three wells sunk on the north side with radial sub-horizontal drains running into them from beneath the north side of the catino, (Fig. 13). The water levels in the wells are controlled by the level of the outlet pipes. The drainage system was implemented in April and May 2002 and led to a decrease in the pore water pressure as well as a significant reduction in its seasonal fluctuations, as shown in Fig. 14. The installation of this drainage system induced a further northward rotation of the Tower as can be seen in Fig. 15.

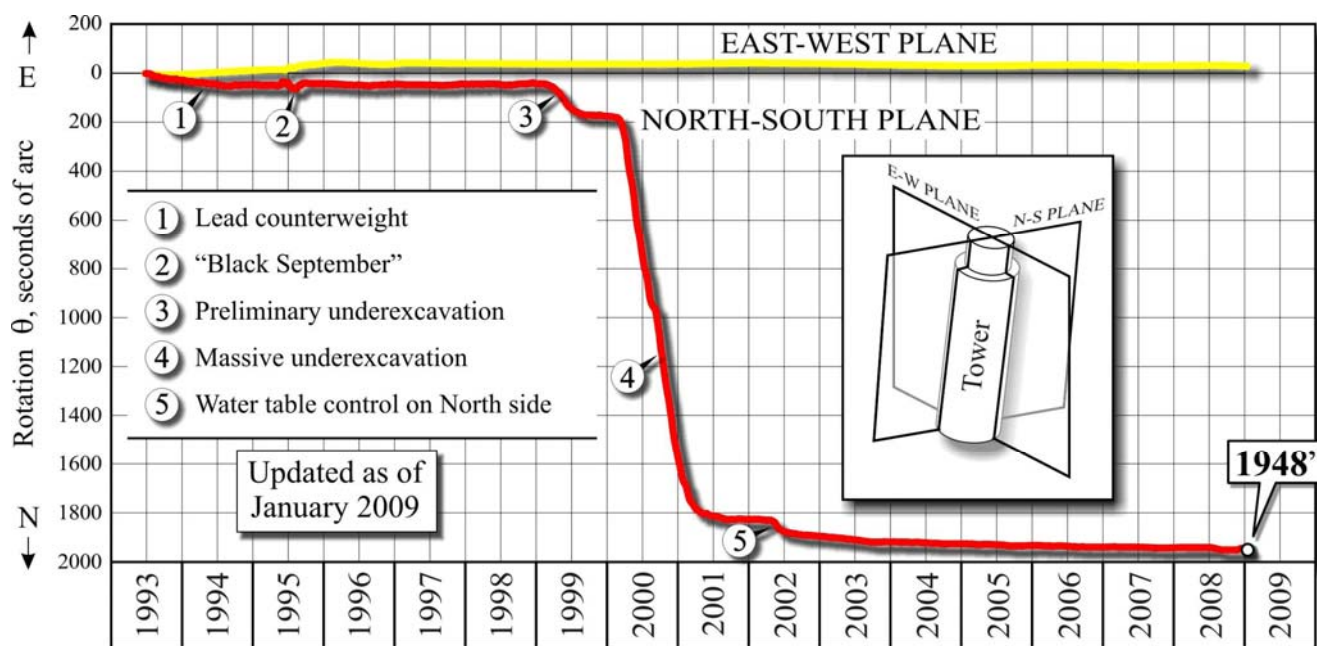
Figure 16. Rotation of Tower foundation as result of stabilization works.

As a result of the full underexcavation and of the implementation of the ground water control in Horizon A, the Tower foundation in mid 2002 had reduced its tilt by 1880 arc seconds - about 10% of the maximum value reached in 1993. In the succeeding six years the Tower has continued rotating northwards at a reducing rate, so that by September 2008 the

accumulated reduction of the foundation tilt reached 1948 arc seconds, see Fig.16. In the two years from September 2006 to September 2008 the residual rate of rotation northwards has reduced to less than 0.2 arc second per year.

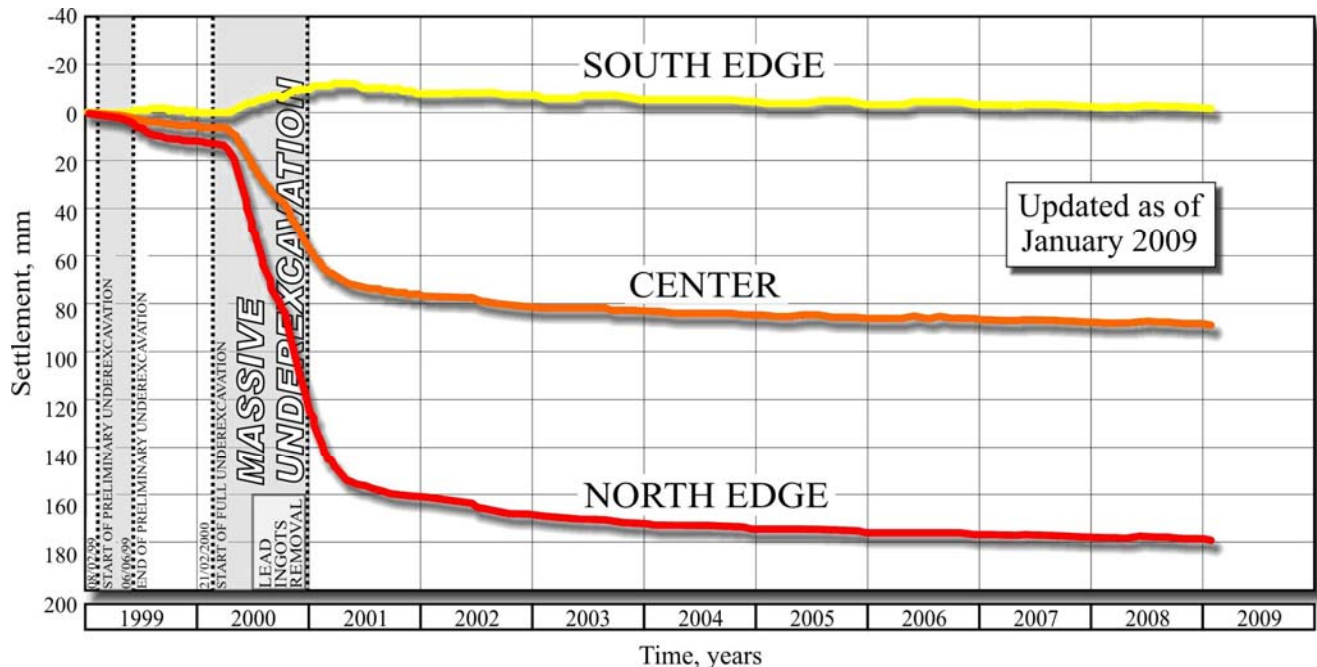
Figure 17. Settlement of Tower foundation as result of stabilization works.

The settlements of the south edge, centre and north edge of the foundation generated by the stabilisation operations, mainly by full underexcavation, are shown in Fig.17. In September 2008 the centre of the foundation had settled around 90mm and is continuing to settle at a rate that, over the last two years, is less than 1.0 mm/year. This is approaching the background rate of settlement of the Piazza due to the general subsidence of the Pisa plain. As regards the South edge of the foundation, it rose by about 15 mm during the underexcavation and has since settled around 12mm. This behaviour indicates that during underexcavation, the axis of rotation was located under the imprint of the plinth and that the pressures due to the Tower weight at the south edge had reduced.

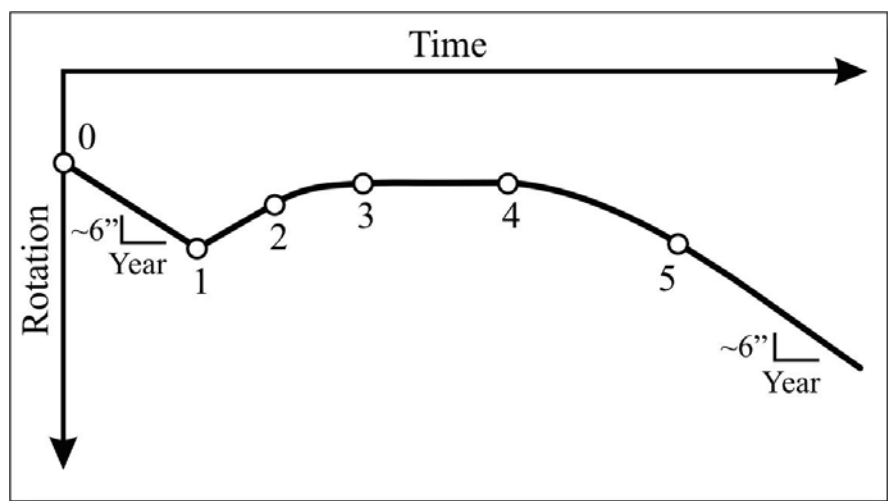
Figure 18. Expected future behaviour of the Leaning Tower of Pisa.

- **Pessimistic Scenario.** As illustrated in Fig. 18, after the completion of time effects of the underexcavation (period 2-3), the Tower will remain motionless for a period estimated as a few decades (period 3-4), followed by a possible resumption of the southward rotation. Initially this southward rate of rotation will be very much less than the 6 arc second per year that existed before the stabilisation works. However the rotation rate will gradually increase (period 4-5) and may approach again, after a very long time, a value close to 6 arc seconds. In what period of time this will occur is difficult to estimate. However, considering that the stabilisation works brought the Tower inclination back to the situation that existed at the beginning of the XIX century, the authors believe that the period of time for the Tower to return to its 1993 inclination will be at least 200 years.
