Reconstruction of Konstantinovsky Palace in a Suburb of Saint Petersburg

ABSTRACT: *This article describes a complex approach to the condition survey and design executed as part of the remedial works on Konstantinovsky palace in the suburb of Strelna (Saint Petersburg)--one of the most beautiful historic monuments of 18th century Russia. The palace was almost completely destroyed in the 1940s. In 2000 the decision was made to reconstruct the palace, and the project for palace reconstruction was developed. The project was completed in 2003. The following important stages of the project are discussed in this paper: palace condition survey and site investigations, analyses of the palace retaining structures, design project of palace reconstruction, and phases of the remedial works.*

PALACE CONDITION SURVEY AND SITE INVESTIGATION

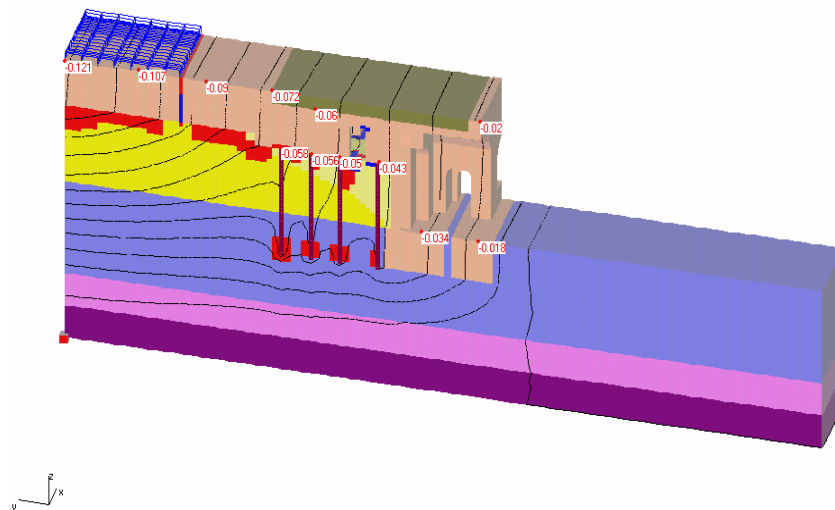
1. Provided that the piled foundation is kept intact underneath the cellar walls (Fig. 11, 12) and the loggia structures remain in stable condition, with settlement of exterior loggia structures not exceeding 3.4 cm, and the settlement of the cellar walls not exceeding 5.8 cm, the building would be stable.
2. In the case of the decomposed timber piles, if the cellar wall settlement reached 7.7 cm it would cause the transverse wall's dilapidation. Due to decomposition, the piles were considered inadequate to support the required loads and thus were not included in the analyses.
3. In the case of ground piping and foundation brickwork loosening, if the settlement reached 8.3 cm and the deformation profile resembled that shown in Fig. 13, then the brickwork material would be dilapidated. Observed brickwork dilapidation suggested that this mechanism was actually occurring at the site.

Figure 12. Contours of settlements of the cellars and loggias (m) with account of intact timber piles. Dark red color denotes soil regions reaching the limit state by Mohr-Coulomb criteria.

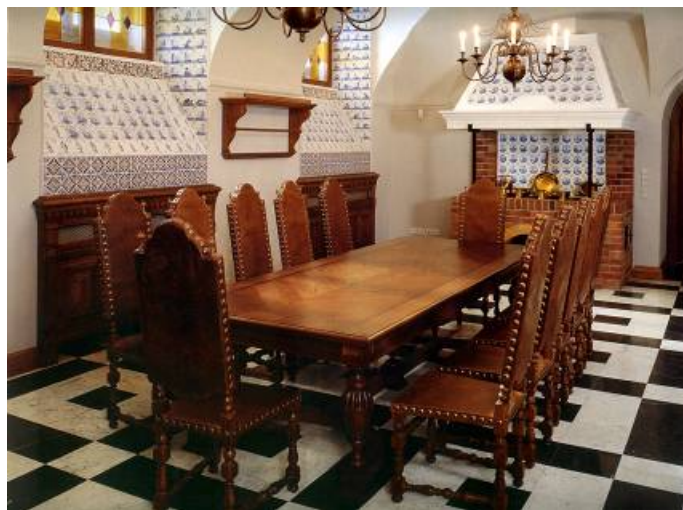
Figure 20. Cellars of Konstantinovsky Palace, 2004 (at the location of reconstructed retaining cellar wall, see Fig. 10).
