Reconstruction of Konstantinovsky Palace in a Suburb of Saint Petersburg

ABSTRACT: *This article describes a complex approach to the condition survey and design executed as part of the remedial works on Konstantinovsky palace in the suburb of Strelna (Saint Petersburg)--one of the most beautiful historic monuments of 18th century Russia. The palace was almost completely destroyed in the 1940s. In 2000 the decision was made to reconstruct the palace, and the project for palace reconstruction was developed. The project was completed in 2003. The following important stages of the project are discussed in this paper: palace condition survey and site investigations, analyses of the palace retaining structures, design project of palace reconstruction, and phases of the remedial works.*

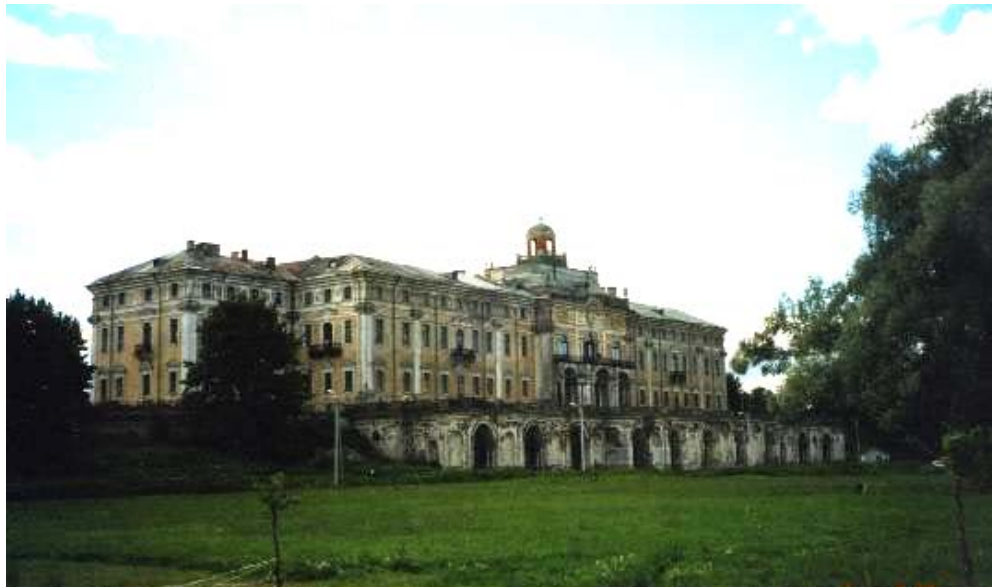
Figure 6. A photograph of Konstantinovsky Palace taken in 2000 before reconstruction.

The condition survey results were as follows (see Fig. 6, 7, 9, 10):

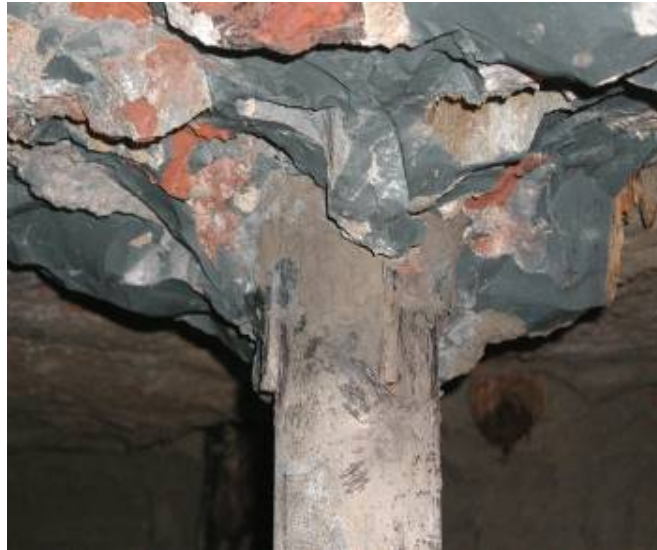
Figure 18. Bored pile with tube reinforcement viewed from underneath foundation.
