Rockfall and Subsidence on Mumbai-Pune Expressway

ABSTRACT: Mumbai-Pune, India's first expressway, which crosses the mountainous and rugged Deccan Trap Province, suffered from a large amount of rockfall and major landslides in 2003 and 2004. A significant number of accidents and fatalities have occurred on the expressway as a result of such events. On the basis of frequency and magnitude of the recorded incidences of rockfall, seventeen critical areas of the road have been deemed in need of investigations and mitigation. One of the problematic areas that suffered from rockfall and subsidence is at km 41 on the expressway, adjacent to a tunnel (Adoshi). This location has been chosen for detailed study. This area extends for 500 m along the expressway, and the embankment has subsided by 2 to 3 m along the entire length. Based on the geological, geomorphologic and geotechnical investigations, causative factors for rockfall and subsidence at this location have been established. This paper presents the field investigations, probable causes, stability analysis and remedial measures for controlling the subsidence and rock fall.

Reference: Kumar, K., Prasad, P.S., Mathur, S., Kimothi, S.

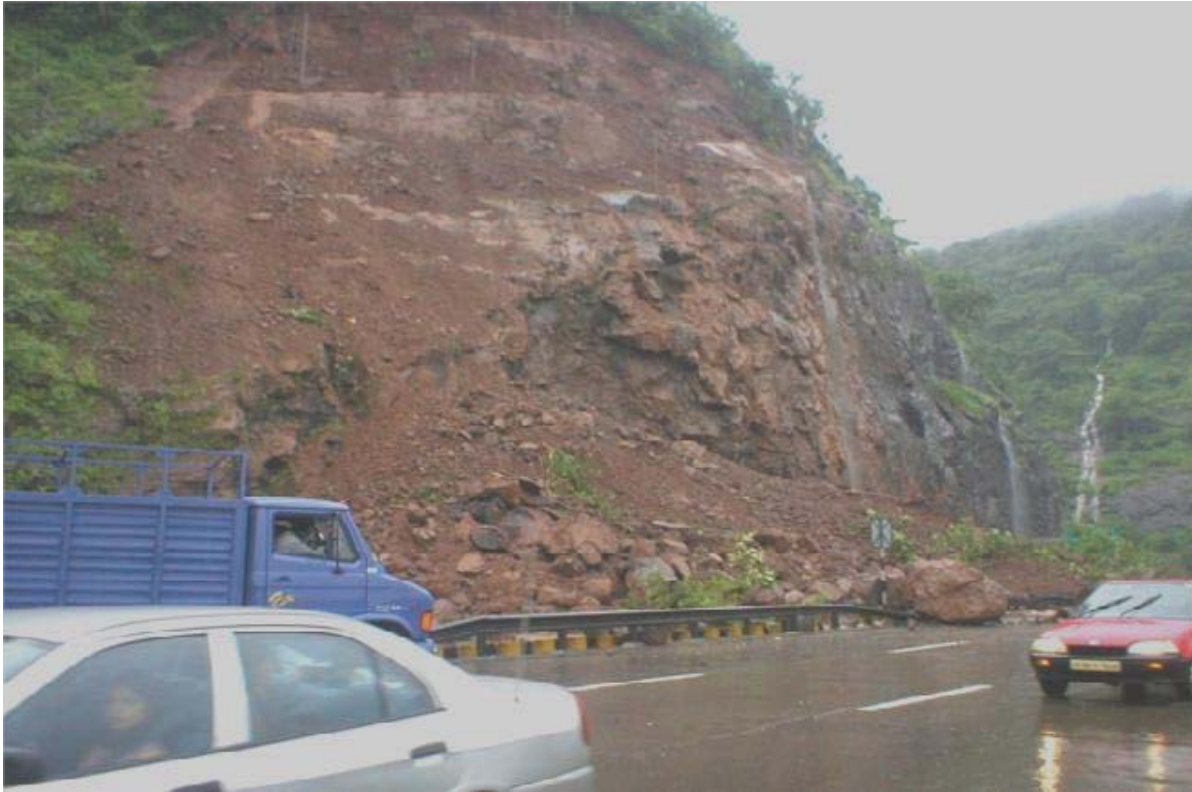
Figure 3. Rockfall and debris in 2004.

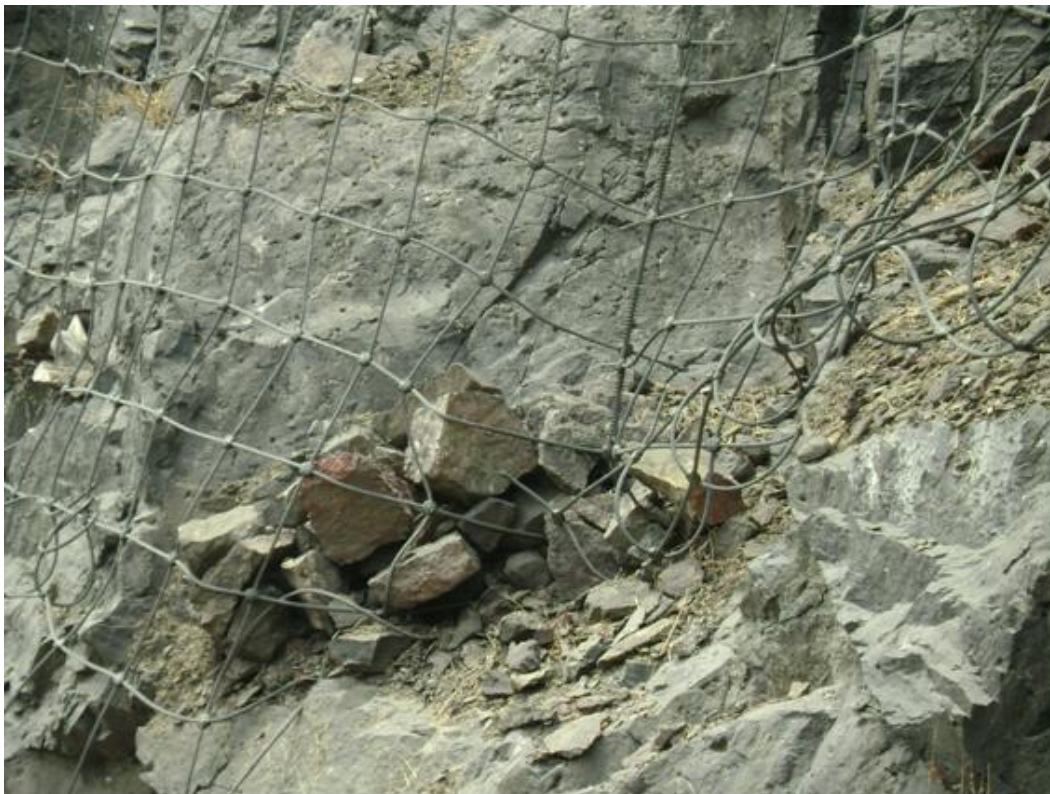
The remedial measures suggested were implemented in 2006 on some of the highway's stretches. In a few locations, the slopes were stabilized with SFERS and steel cable net; at others, the slopes were treated only with steel cable net. The slopes are being physically monitored by the Central Road Research Institute (CRRI) till September 2010. Figures 8 and 9 show the remedial measures that were implemented on the rock slope. The rocks were detached from the sloping surface where the slope is treated with steel cable net. Some rocks are trapped in the net and some were falling at the toe of the slope.

Figure 9. Trapped rock blocks at the toe of the slope.

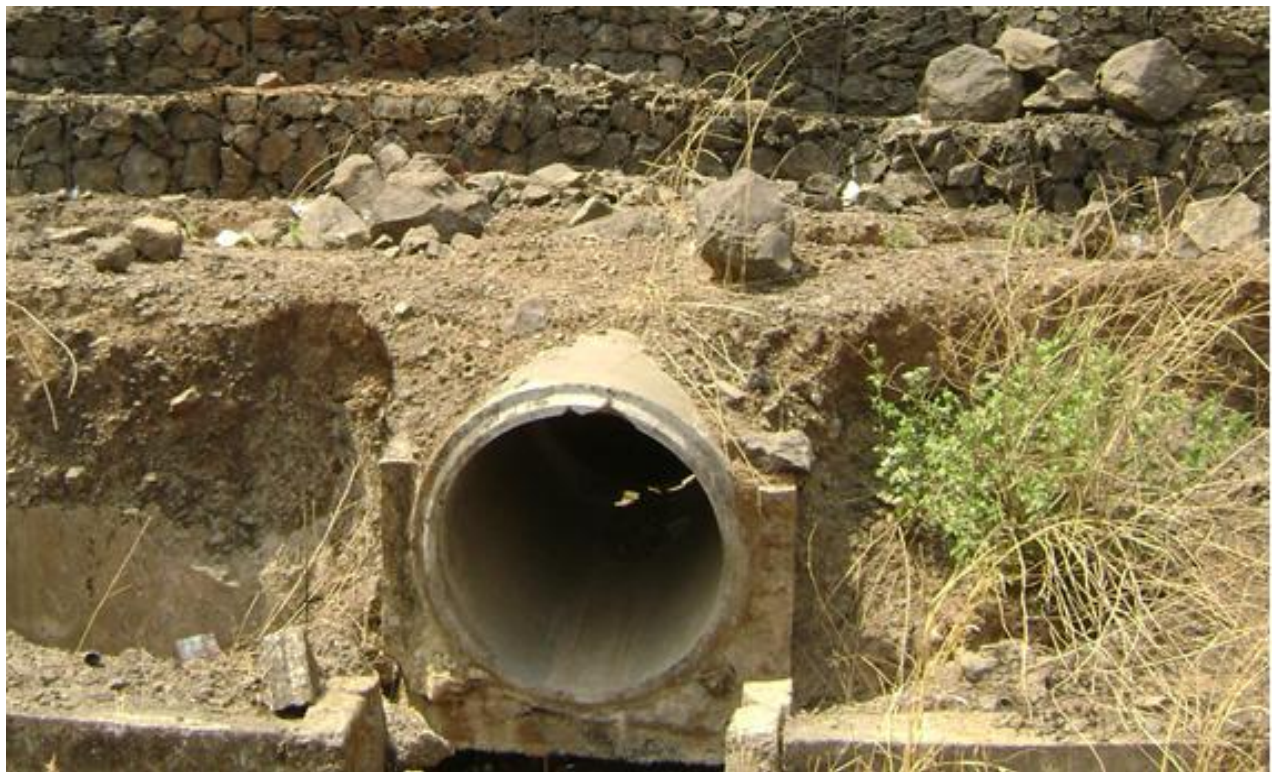
Figure 12. Pipe culvert without stepped chute.
