Rockfall and Subsidence on Mumbai-Pune Expressway

ABSTRACT: *Mumbai-Pune, India's first expressway, which crosses the mountainous and rugged Deccan Trap Province, suffered from a large amount of rockfall and major landslides in 2003 and 2004. A significant number of accidents and fatalities have occurred on the expressway as a result of such events. On the basis of frequency and magnitude of the recorded incidences of rockfall, seventeen critical areas of the road have been deemed in need of investigations and mitigation. One of the problematic areas that suffered from rockfall and subsidence is at km 41 on the expressway, adjacent to a tunnel (Adoshi). This location has been chosen for detailed study. This area extends for 500 m along the expressway, and the embankment has subsided by 2 to 3 m along the entire length. Based on the geological, geomorphologic and geotechnical investigations, causative factors for rockfall and subsidence at this location have been established. This paper presents the field investigations, probable causes, stability analysis and remedial measures for controlling the subsidence and rock fall.*

investigations carried out to assess the probable causes

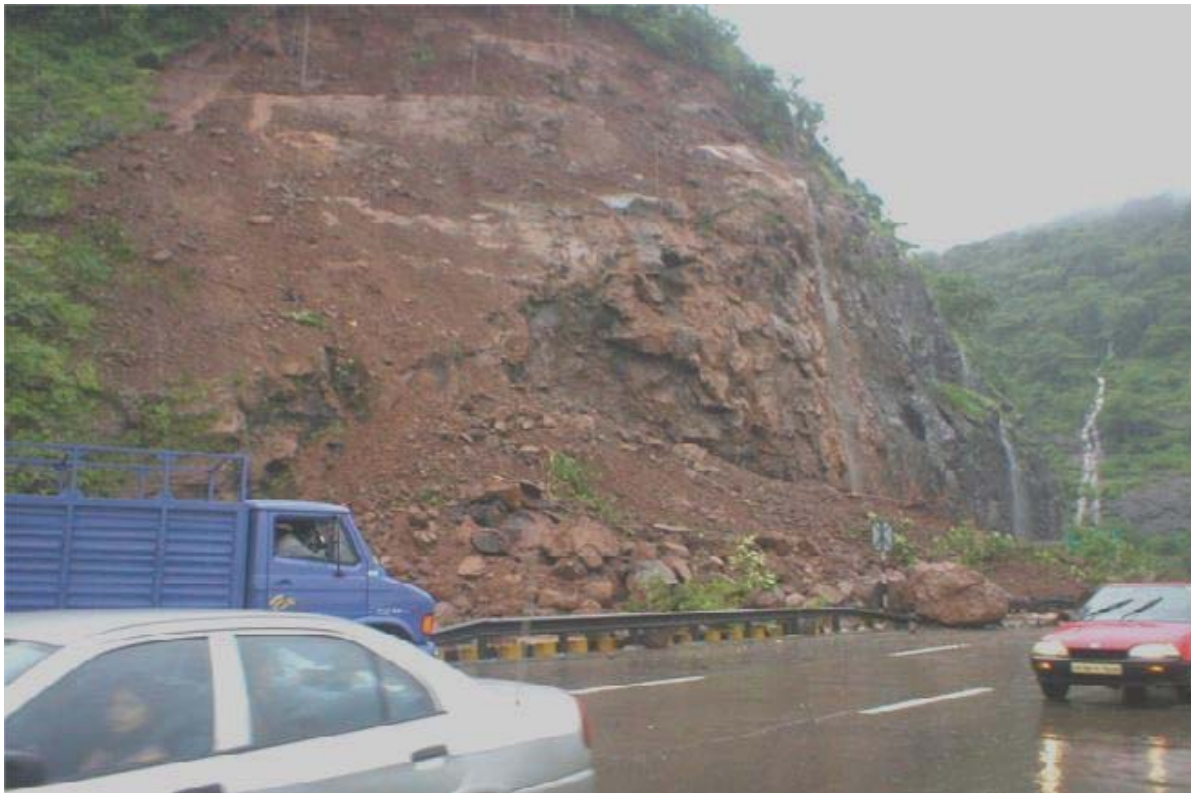
Figure 3. Rockfall and debris in 2004.

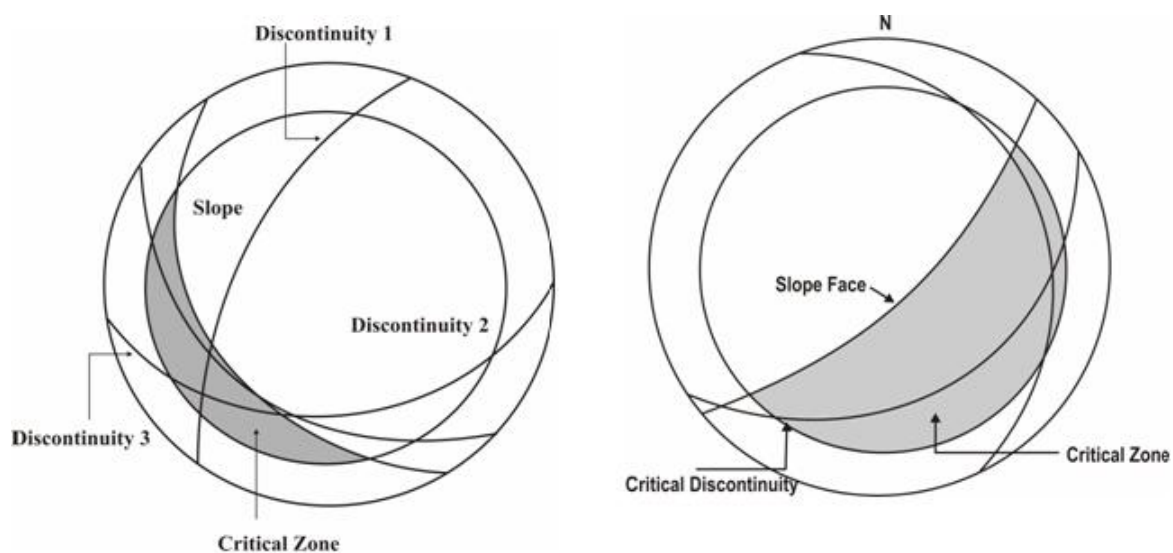
Figure 4. Markland test for planar failure on two sites showing critical zone for potential failure.

planes. The fractures on the rocks, which are normally confused with joints, have prominent attitudes. There are mainly three major joints, but one of the most prominent planes of weakness is the vertical joint (typical of basaltic layer, i.e. columnar joint). This prominent joint is repeated at regular intervals. The stereographic projection diagram, using the field data of joints, revealed the formation of a prominent wedge at the slope face. The vertical joints intersect to form wedges on the slope independently as well as when they intersect other steeply dipping fractures and other horizontal and subhorizontal fractures, as shown in Figure 4. In most cases, the plunge of the intersection of these two joint sets lies toward NNW in the direction of the slope. Additionally, the plunge of the intersection of the joints is more than the angle of the slope most of the time. The Markland Test was used to define the critical zone of planar and wedge failure in the stereographic projection. In the case of planar failure, the dip of the discontinuity exceeds the angle of friction of the rock; the discontinuity daylight in the slope face and dips less than the slope. In the case of wedge failure, the plunge of the line of intersection of two joints is considered (Figure 4) (Markland, 1972).

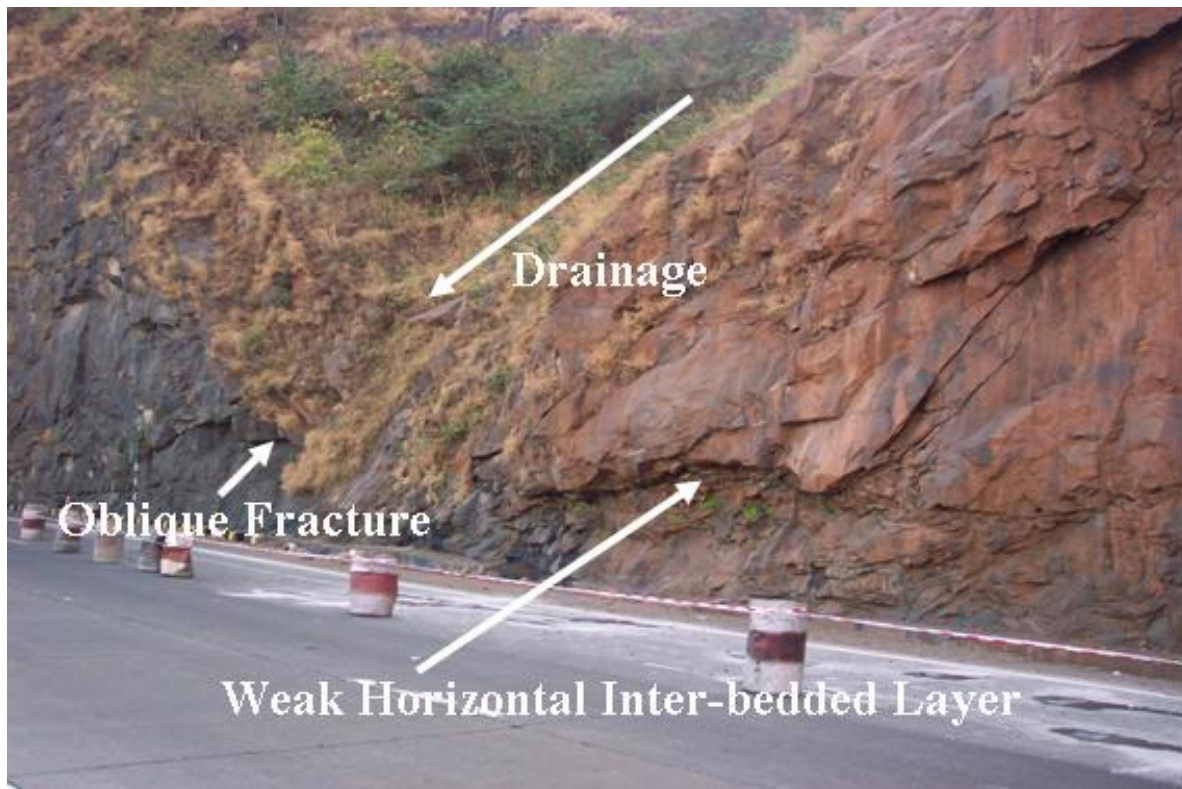
Figure 6. Intersection of oblique and sub-horizontal fractures.

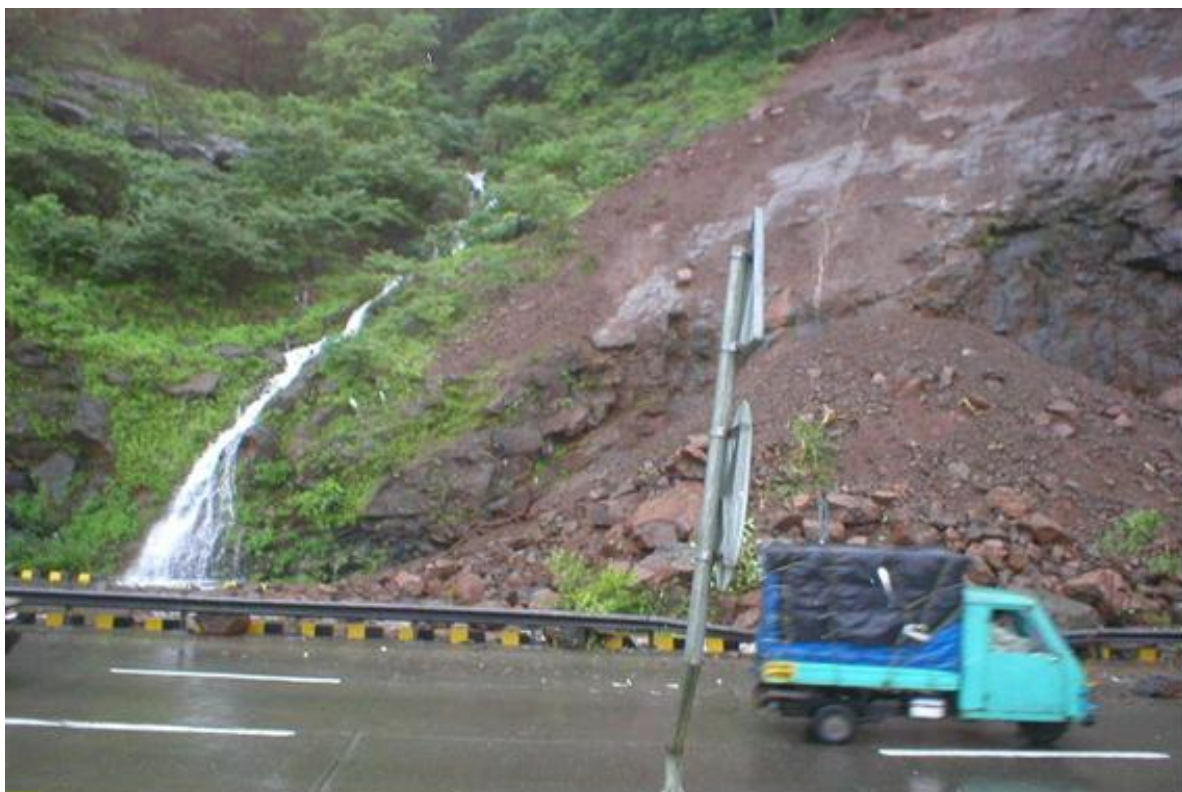
The slope is well covered by trees. The uphill slope has good catchment, and the rainwater generally drains out through the natural streams on both flanks of the slide. A considerable quantity of water also flows down the middle of the slope, above the affected portion. Near the crown there are a number of loose stone blocks, which rest on the slope. These may facilitate blocking and infiltration of more water into the slope during rains. The crown consists of a thin soil cover of a few centimeters to about one-third of a meter in thickness, below which lies 1–2-meter thick weathered and jointed basalt. This layer of weathered and jointed basalt, along with the thin overburden, fails along a smooth sheet joint surface and falls on the expressway through the adjoining vertical cut slope (Figure 2). This vertical cut of about 40 m in height has many joint intersections separating the blocks of the basaltic layer (Figure 5). A stream, guided by the intersection of one of the oblique and sub-horizontal fractures (Figure 6), remains dry except during the monsoon months when it serves as one of the main draining streams (Figure 7). A significant amount of water drains from the above catchment area.

Figure 7. Significant water drainage during a monsoon.

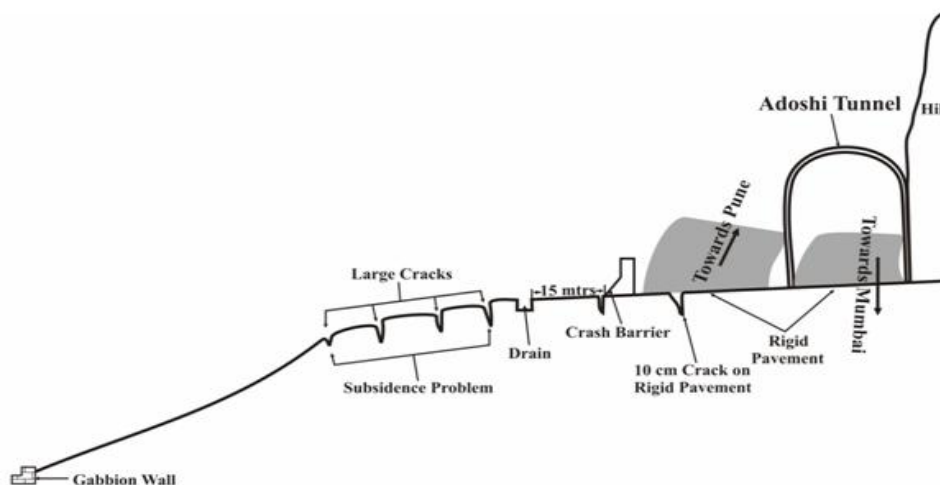
The subsidence portion (Figure 1) is located at km 41 on the downhill side of the expressway, adjacent to Adoshi tunnel (which extends for 500 m along the expressway). Figure 10 shows the schematic diagram of the subsidence problem on the expressway. The annual rainfall in this area is 200–300 cm, and the present drainage measures are not sufficient to drain this amount of water effectively. During the rainy season, water causes significant damage to this road at four locations in the form of a waterfall. One is in the curved portion, the second one is in between the curve and entrance of the tunnel, the third one is above the tunnel and the fourth one is after the tunnel exit. Pipe culverts were provided to help drain out the water on this stretch of the road, but the gradient of these culverts is not proper. However, it was observed that the internal diameter of the pipes varies from 1 to 1.2 m. In the pipe culvert, two pipe sections 1.0 m in internal diameter are provided, and the remaining pipes are 1.20 m in internal diameter. Two 1.0 m diameter pipe sections are installed in between the 1.20 m pipe sections. The joint between the 1.0 m diameter pipe and the 1.2 m diameter pipe is not proper, and the gap between the two pipes is 30 cm (Figure 11). Remaining pipes are also not joined properly. During periods of heavy rain, water seeps through the joints and saturates the surrounding soil mass, thereby causing cracking between lanes (i.e., flexible and rigid pavement). The runoff from the pipe culvert and cross drains is draining directly onto the embankment surface (Figure 12). The rainwater scours the embankment soil, thereby causing the instability of the embankment. After the exit of the Adoshi tunnel, the gradient of the drain is not proper. As a result, water may stagnate and seep into the pavement through the existing weep holes. The rigid pavement (on the outermost side lane) subsided by 5 to 6 cm, and subsidence also has occurred in between the joint of fast track lane (middle lane) and the truck lane. The average width of a crack is 5 cm and the average length of a crack is 85 m (Figure 13). The surface between the crash barrier and the rigid portion has been paved with bitumen. The flexible portion or shoulder (bituminous surface) has separated from the rigid pavement; the depth of the crack is 50 cm (Figure 14).

Figure 10. Schematic diagram showing subsidence problem on the Mumbai-Pune expressway.

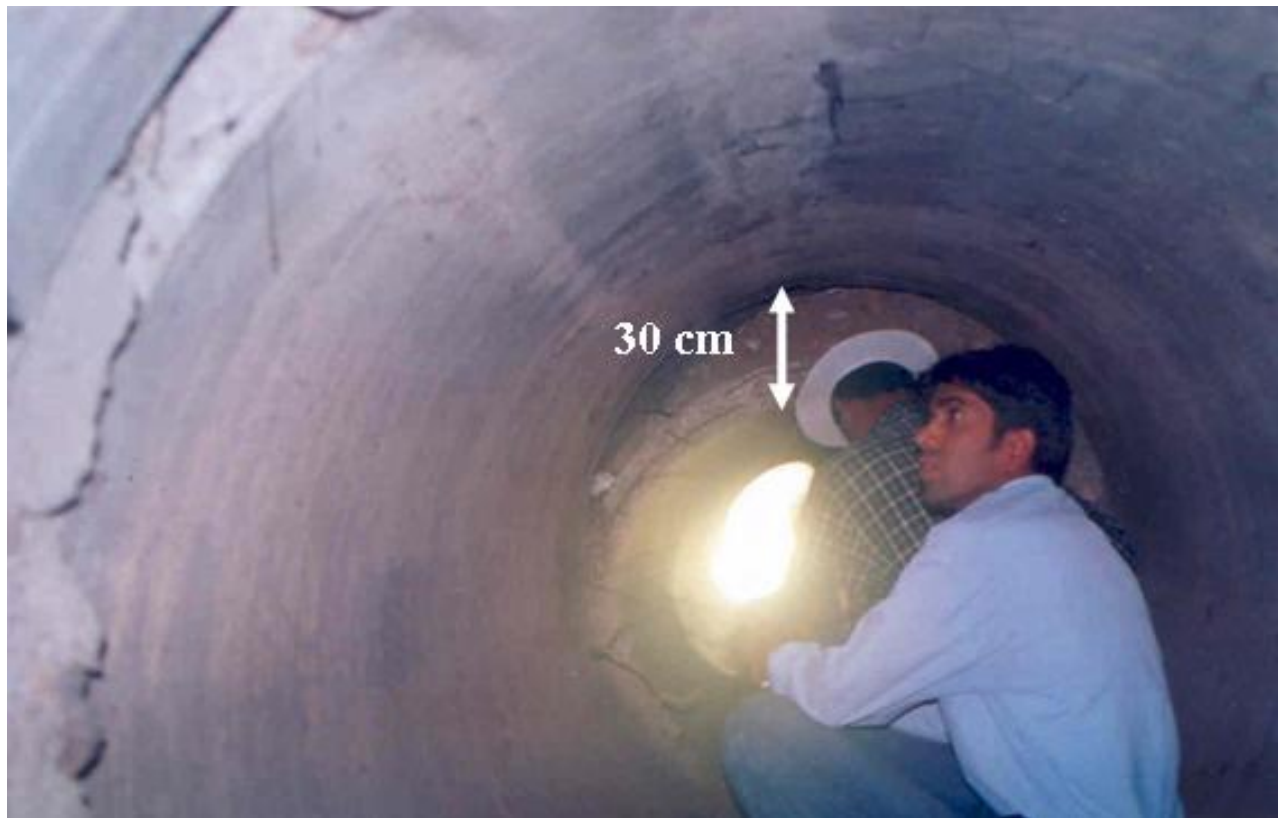
Figure 11. Dislodged pipe culvert.

- The broken culvert was repaired by providing uniform-sized pipe sections, and the joints were properly sealed.
- On the shoulder portion and below the crash barrier, the cracks were sealed with cement grouting and monitored for three years. The portion stabilized and no further cracks were observed in this area.
- After the crash barrier, the embankment was excavated up to 3 m and recompacted to 95% of maximum dry density and moisture content.
- Longitudinal and transverse drains were provided at frequent intervals.
- To prevent erosion and to stabilize the embankment, the slope has been protected with stone pitching/turfing.

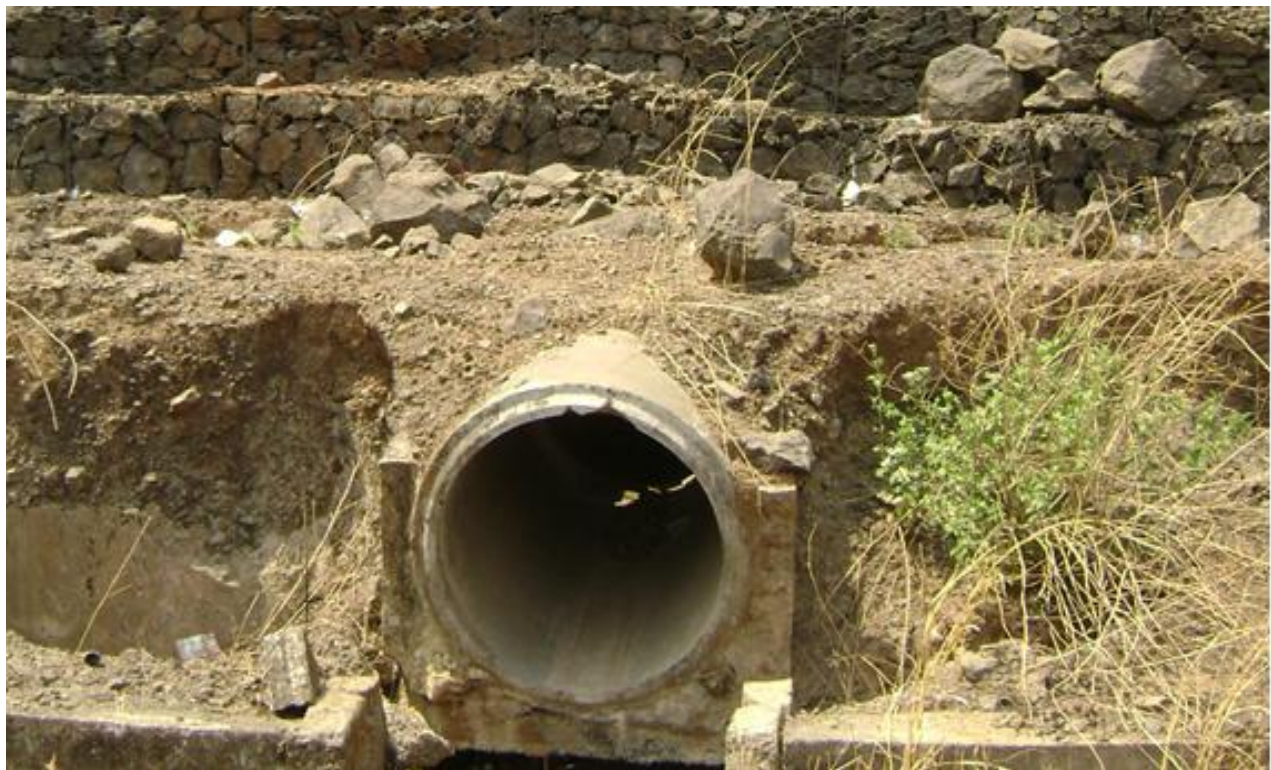
Figure 12. Pipe culvert without stepped chute.

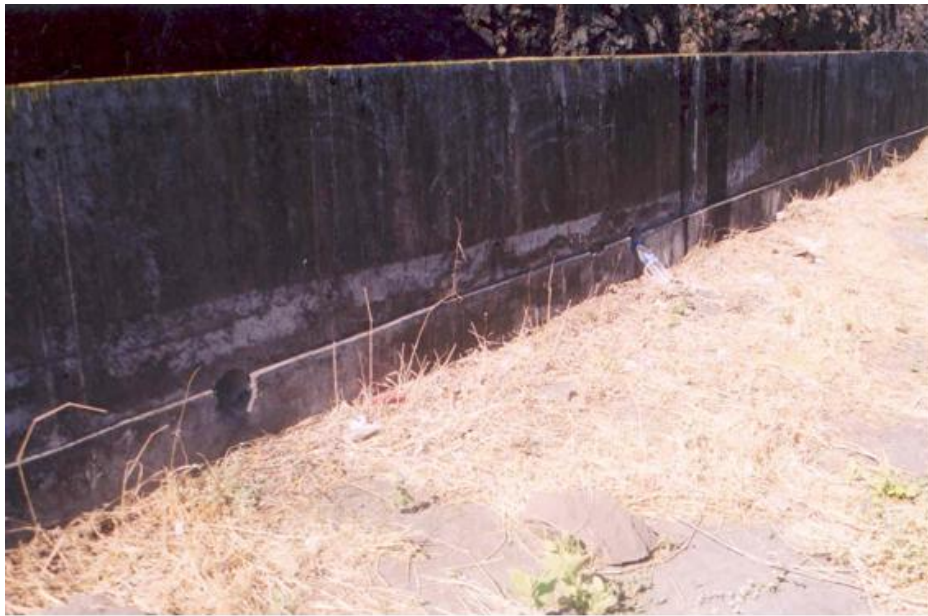
A crash barrier has been provided along the slope. Beyond the crash barrier, the average width of the embankment on the downhill extends downhill another 12 m. Drainage holes (Figure 15) are provided in the crash barrier at frequent intervals, but the holes are left open directly on the embankment surface. The considerable quantity of water passing through these drainage holes is causing saturation of the embankment fill beyond the parapet and is weakening the foundation of the crash barrier as well as the scouring below the crash barrier and pavement (Figure 16). A longitudinal drain is provided after a certain distance from the crash barrier on the embankment. From the crash barrier to the longitudinal drain, the surface is not lined and scouring was observed below the crash barrier. The crash barrier is also tilted, and below the crash barrier, the embankment slope has experienced scouring up to a depth of 1 m. The embankment has subsided by 2 to 3 m in steps, and each step has an average height of 1 m (Figure 17).

Figure 15. Drainage holes left open on embankment surface.

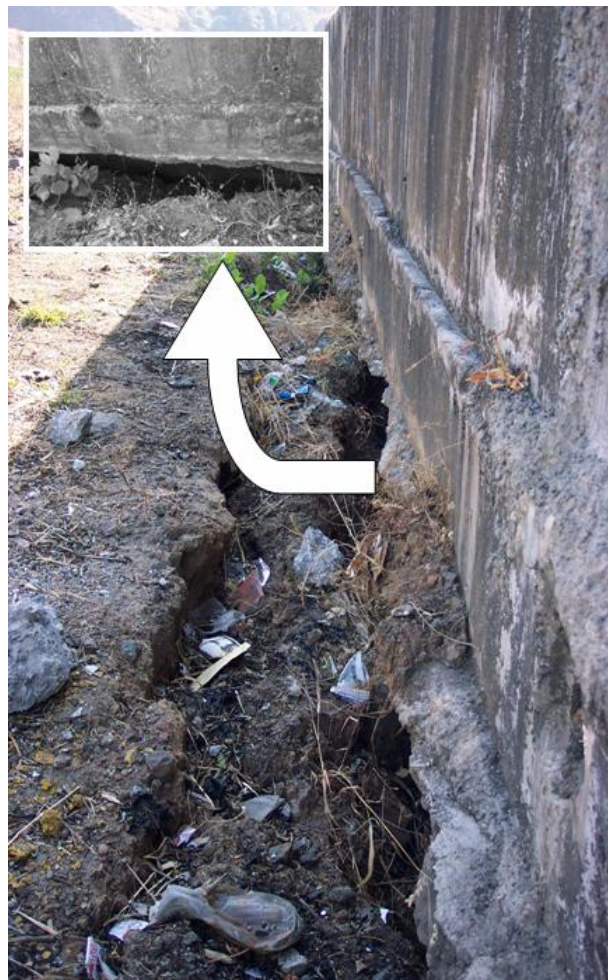
Figure 16. Embankment scoured below the crash barrier.
