## Rockfall and Subsidence on Mumbai-Pune Expressway

**ABSTRACT:** Mumbai-Pune, India's first expressway, which crosses the mountainous and rugged Deccan Trap Province, suffered from a large amount of rockfall and major landslides in 2003 and 2004. A significant number of accidents and fatalities have occurred on the expressway as a result of such events. On the basis of frequency and magnitude of the recorded incidences of rockfall, seventeen critical areas of the road have been deemed in need of investigations and mitigation. One of the problematic areas that suffered from rockfall and subsidence is at km 41 on the expressway, adjacent to a tunnel (Adoshi). This location has been chosen for detailed study. This area extends for 500 m along the expressway, and the embankment has subsided by 2 to 3 m along the entire length. Based on the geological, geomorphologic and geotechnical investigations, causative factors for rockfall and subsidence at this location have been established. This paper presents the field investigations, probable causes, stability analysis and remedial measures for controlling the subsidence and rock fall.

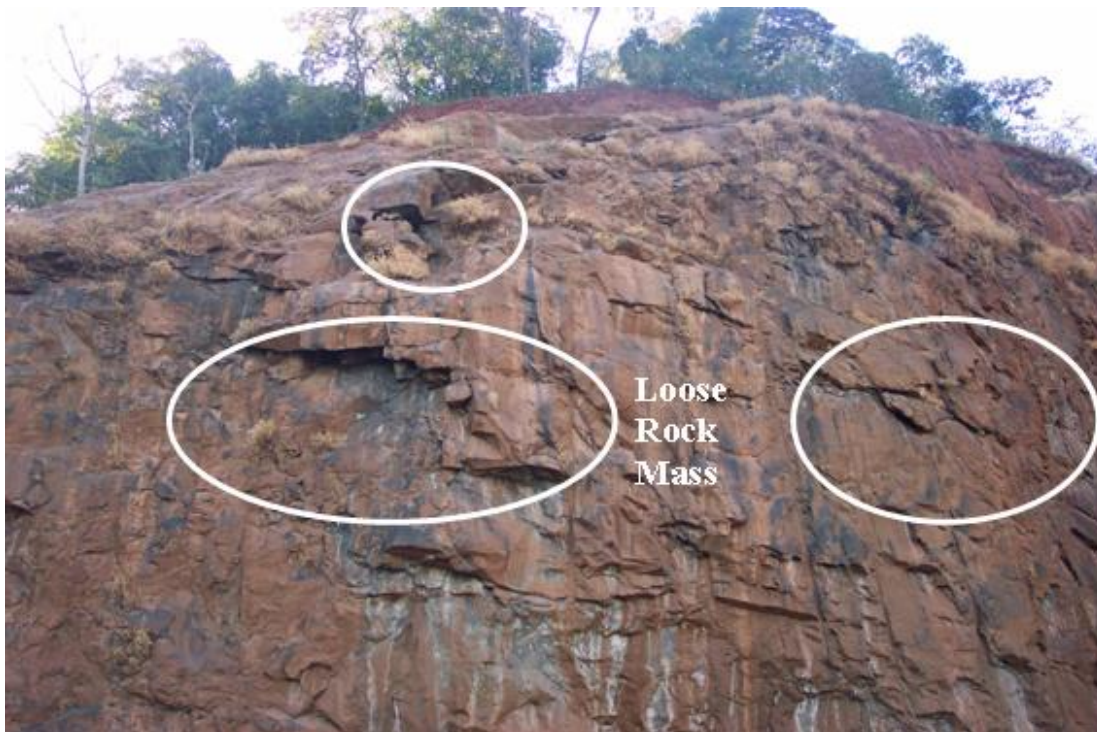
Figure 5. Vertical joints and formation of wedge along slope face.

The vertical face, which is vulnerable to sudden detachment of rocks, was mitigated to prevent dislodged rock from falling off the vertical cliff. The steep vertical cuts with loose overhanging blocks were leveled and the loose rock was removed. Since the rocks have multiple open joints and are likely to widen over time, the application of steel fiber reinforced shotcrete (SFRS) of 70 mm thickness was suggested along with covering the entire sledge with a steel cable net of aperture size (300 mm x 300 mm) in order to stabilize the rock slopes. Steel fibers are very efficient compared to other material fibers such as asbestos, nylon or polypropylene and glass due to their high tensile strength and adherence to concrete. The SFRS provides measures to prevent the rock blocks from moving off the slope and also will prevent the weathering of the rock slope. This kind of stabilization is not intended to prevent the movement of blocks but rather to control rockfall from bouncing onto or blocking the expressway. For installing the steel cable net on the slope, a trench of 30 cm x 50 cm at a distance of 1.5 m from the top of the cliff was excavated. Iron rods were inserted 0.5 m from the bed of the trench. After inserting the rods, the holes were grouted with cement concrete. Subsequently, the steel rope net was laid and the trench was filled with cement concrete for anchorage. The steel cable was spread across the vertical face of the slope up to the toe. The cable net was anchored on the surface of the slope with expansion bolts/grouted bolts of 0.50 m length.

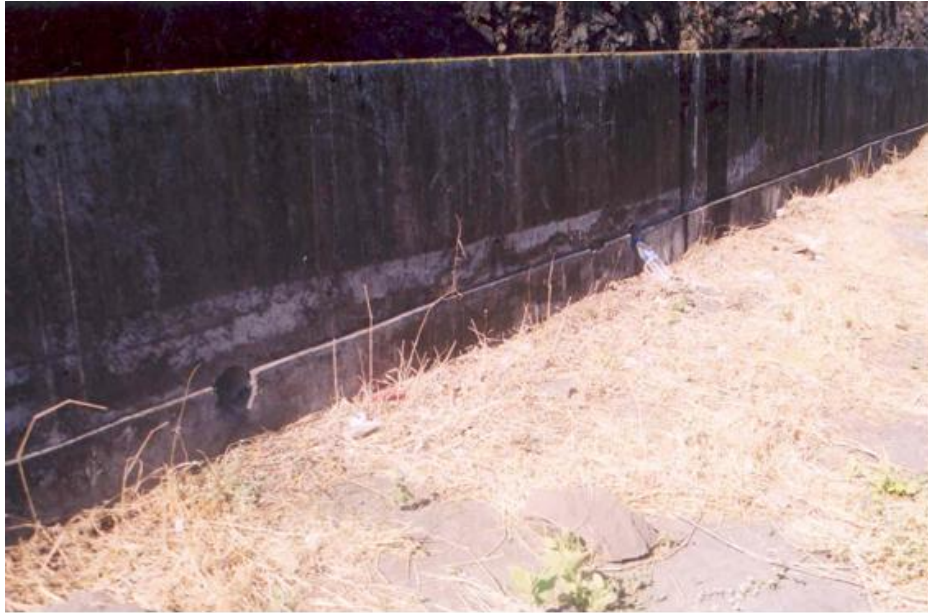
A crash barrier has been provided along the slope. Beyond the crash barrier, the average width of the embankment on the downhill extends downhill another 12 m. Drainage holes (Figure 15) are provided in the crash barrier at frequent intervals, but the holes are left open directly on the embankment surface. The considerable quantity of water passing through these drainage holes is causing saturation of the embankment fill beyond the parapet and is weakening the foundation of the crash barrier as well as the scouring below the crash barrier and pavement (Figure 16). A longitudinal drain is provided after a certain distance from the crash barrier on the embankment. From the crash barrier to the longitudinal drain, the surface is not lined and scouring was observed below the crash barrier. The crash barrier is also tilted, and below the crash barrier, the embankment slope has experienced scouring up to a depth of 1 m. The embankment has subsided by 2 to 3 m in steps, and each step has an average height of 1 m (Figure 17).

*Figure 15. Drainage holes left open on embankment surface.*
