Rockfall and Subsidence on Mumbai-Pune Expressway

ABSTRACT: Mumbai-Pune, India's first expressway, which crosses the mountainous and rugged Deccan Trap Province, suffered from a large amount of rockfall and major landslides in 2003 and 2004. A significant number of accidents and fatalities have occurred on the expressway as a result of such events. On the basis of frequency and magnitude of the recorded incidences of rockfall, seventeen critical areas of the road have been deemed in need of investigations and mitigation. One of the problematic areas that suffered from rockfall and subsidence is at km 41 on the expressway, adjacent to a tunnel (Adoshi). This location has been chosen for detailed study. This area extends for 500 m along the expressway, and the embankment has subsided by 2 to 3 m along the entire length. Based on the geological, geomorphologic and geotechnical investigations, causative factors for rockfall and subsidence at this location have been established. This paper presents the field investigations, probable causes, stability analysis and remedial measures for controlling the subsidence and rock fall.

Reference: Kumar, K., Prasad, P.S., Mathur, S., Kimothi, S.

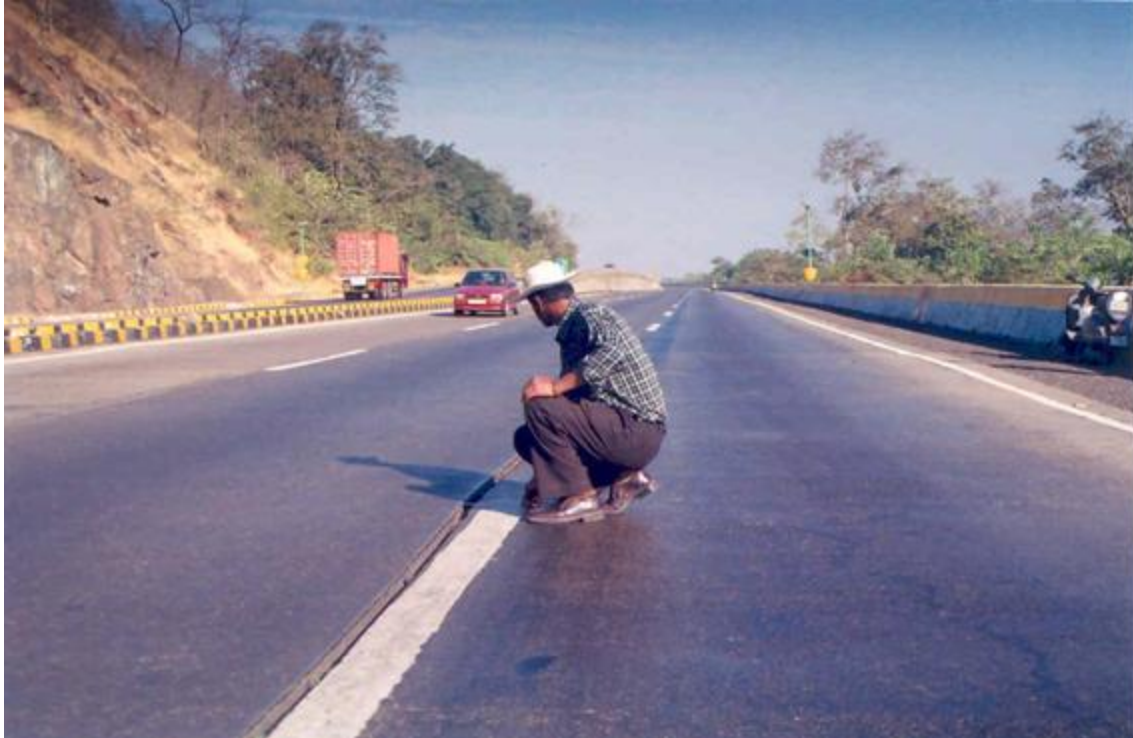
Figure 13. Dislodged rigid pavement.

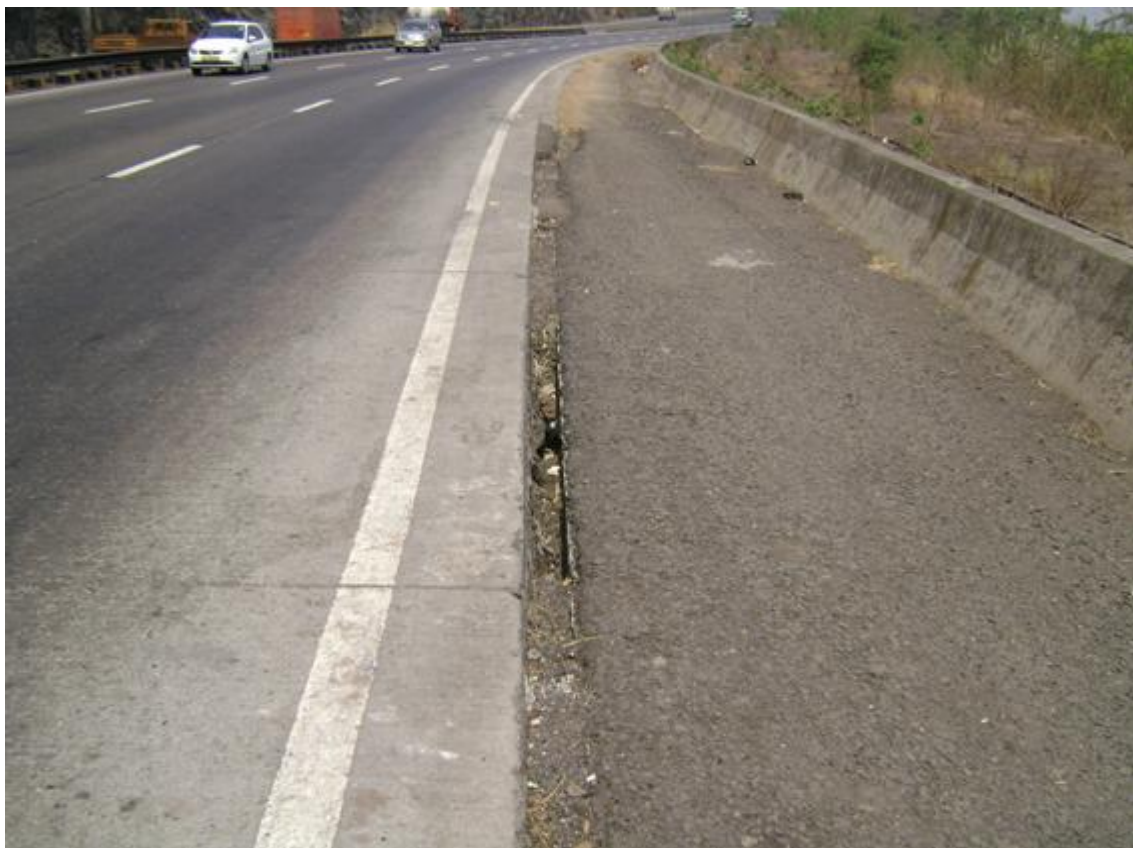
The subsidence portion (Figure 1) is located at km 41 on the downhill side of the expressway, adjacent to Adoshi tunnel (which extends for 500 m along the expressway). Figure 10 shows the schematic diagram of the subsidence problem on the expressway. The annual rainfall in this area is 200–300 cm, and the present drainage measures are not sufficient to drain this amount of water effectively. During the rainy season, water causes significant damage to this road at four locations in the form of a waterfall. One is in the curved portion, the second one is in between the curve and entrance of the tunnel, the third one is above the tunnel and the fourth one is after the tunnel exit. Pipe culverts were provided to help drain out the water on this stretch of the road, but the gradient of these culverts is not proper. However, it was observed that the internal diameter of the pipes varies from 1 to 1.2 m. In the pipe culvert, two pipe sections 1.0 m in internal diameter are provided, and the remaining pipes are 1.20 m in internal diameter. Two 1.0 m diameter pipe sections are installed in between the 1.20 m pipe sections. The joint between the 1.0 m diameter pipe and the 1.2 m diameter pipe is not proper, and the gap between the two pipes is 30 cm (Figure 11). Remaining pipes are also not joined properly. During periods of heavy rain, water seeps through the joints and saturates the surrounding soil mass, thereby causing cracking between lanes (i.e., flexible and rigid pavement). The runoff from the pipe culvert and cross drains is draining directly onto the embankment surface (Figure 12). The rainwater scours the embankment soil, thereby causing the instability of the embankment. After the exit of the Adoshi tunnel, the gradient of the drain is not proper. As a result, water may stagnate and seep into the pavement through the existing weep holes. The rigid pavement (on the outermost side lane) subsided by 5 to 6 cm, and subsidence also has occurred in between the joint of fast track lane (middle lane) and the truck lane. The average width of a crack is 5 cm and the average length of a crack is 85 m (Figure 13). The surface between the crash barrier and the rigid portion has been paved with bitumen. The flexible portion or shoulder (bituminous surface) has separated from the rigid pavement; the depth of the crack is 50 cm (Figure 14).

Figure 14. Crack between rigid and bituminous pavement.
