Mississippi River Levee Failures: June 2008 Flood

ABSTRACT: *During the spring and summer of 2008, record rainfall in the Midwest United States led to severe flooding as water overtopped the levees bordering the Mississippi River and its tributaries. The erosion associated with the overtopping resulted in levee breaches in many places. After the flooding, a field reconnaissance team was sent to collect time-sensitive data and provide a comprehensive overview of the performance of the levees during the flooding.*

Reference: Bernhardt, M., Briaud, J.L., Kim, D., Leclair, M., Storesund, R., Lim, S.G., Bea, R.G., Rogers, J.D., (2011). *Mississippi River Levee Failures: June 2008 Flood*. International Journal of Geoengineering Case Histories, <http://casehistories.geoengineer.org>, Vol.2, Issue 3, p. 127-162. doi: 10.4417/IJGCH-02-02-03.

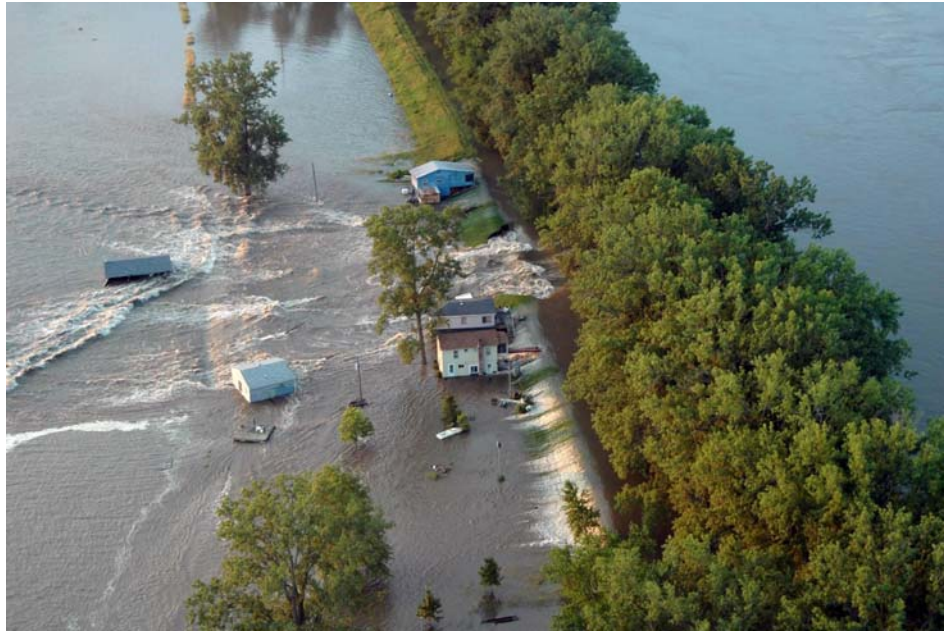
The first site visited during the 2008 Midwest Levee reconnaissance was the Winfield-Pin Oak site near Winfield, Missouri. The levee breached on June 18, 2008. A gap approximately 150 m long was created in the levee by the overtopping waters. Figure 12 is a photo taken by the St. Louis District USACE showing an aerial view as two homes were knocked off their foundations by the force of the water. Figure 13 shows the same site on September 29, 2008 during the Midwest Levee reconnaissance. It should be noted that the breach shown in Figure 13 was contained between the blue and white houses shown in Figure 12 even though overtopping was also occurring further down the levee.

Figure 12. Winfield-Pin Oak breach (USACE St. Louis District 2008).

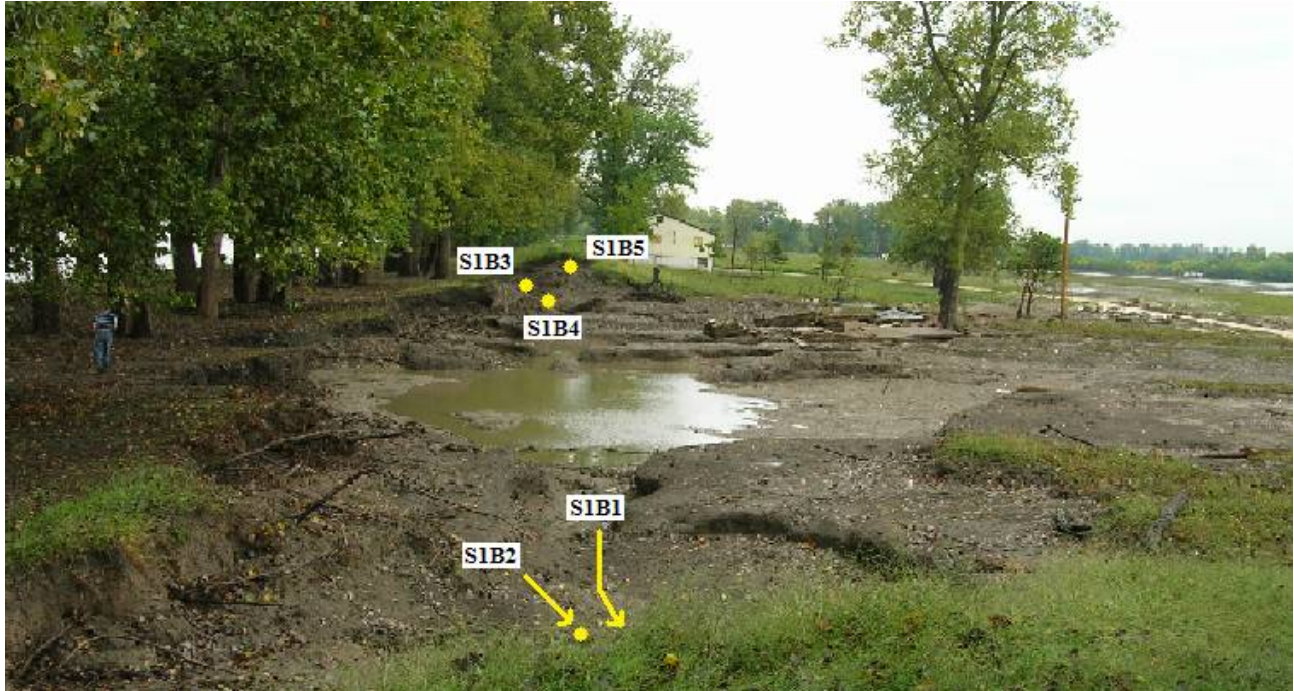
Five samples were taken from various locations within the breach (15). Table 3 provides a summary of the sample locations as well as Torvane and Pocket Penetrometer readings. Note that the Pocket Penetrometer gives an estimate of the unconfined compression strength while the Torvane estimate the undrained shear strength directly. Common practice is to take the undrained shear strength equal to 0.3 times the Pocket Penetrometer readings.

Figure 15. Boring locations Winfield – Pin Oak breach looking south.

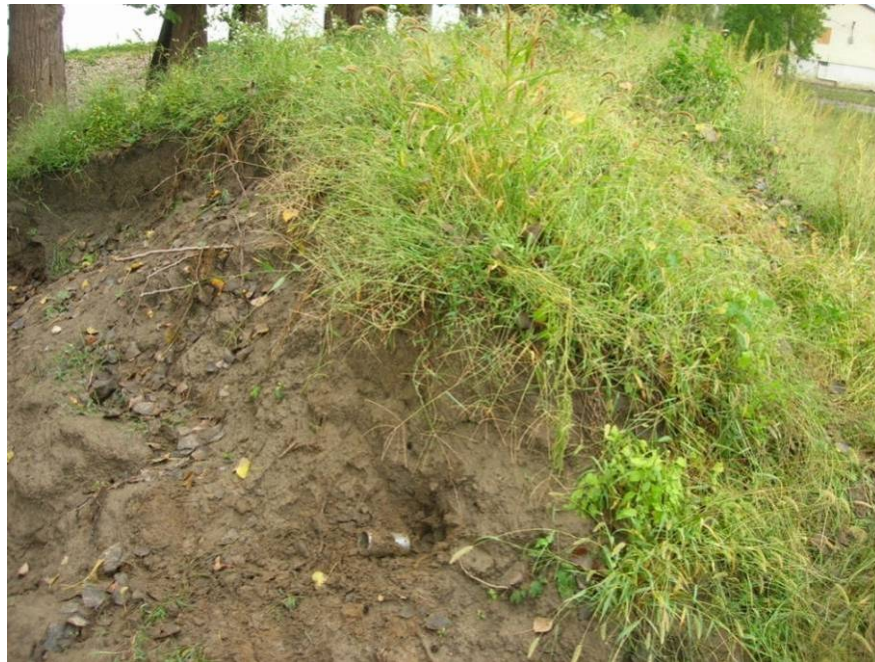
The vegetative cover at the Winfield site (Figure 18) was low to moderate density comprised and mostly of crabgrass and foxtail. While the ground cover looks somewhat established in the Figure, most of the grasses present were annual weeds rather than sod forming grasses. Such weeds are only present for a portion of the year and tend to clump leaving spaces where the soil surface is bare. In several areas there was little or no coverage.

Figure 18. Winfield – Pin Oak vegetative cover.

Foxtail is a “weed-like” summer annual plant which forms in tuft-like groupings and often develops in areas of less dense turf grass (American Lawns 2009). The ground coverage at the site must not have been dense because of the ability of the foxtail to intrude. Crabgrass is an annual grass generally found in the warmer climates. This “weed” is very invasive and can take over an area, but because it is an annual plant it will die out during a freeze. None of the grasses identified at this site are what would be considered “good” protective armoring. These vegetative conditions, however, are based on post flood observations and may not reflect the actual conditions at the time of overtopping.
