Mississippi River Levee Failures: June 2008 Flood

ABSTRACT: *During the spring and summer of 2008, record rainfall in the Midwest United States led to severe flooding as water overtopped the levees bordering the Mississippi River and its tributaries. The erosion associated with the overtopping resulted in levee breaches in many places. After the flooding, a field reconnaissance team was sent to collect time-sensitive data and provide a comprehensive overview of the performance of the levees during the flooding.*

Reference: Bernhardt, M., Briaud, J.L., Kim, D., Leclair, M., Storesund, R., Lim, S.G., Bea, R.G., Rogers, J.D., (2011). *Mississippi River Levee Failures: June 2008 Flood*. International Journal of Geoengineering Case Histories, <http://casehistories.geoengineer.org>, Vol.2, Issue 3, p. 127-162. doi: 10.4417/IJGCH-02-02-03.

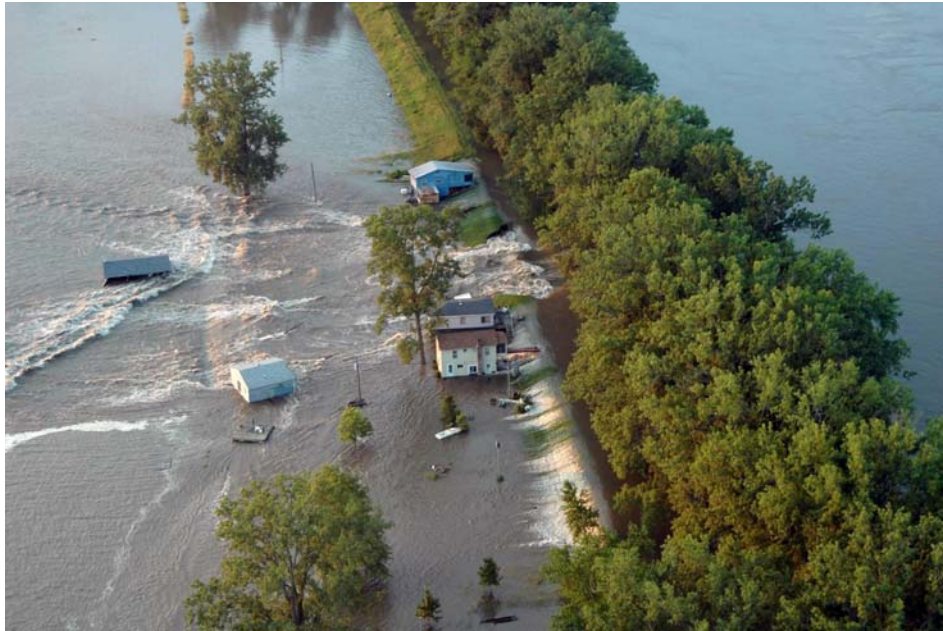
The first site visited during the 2008 Midwest Levee reconnaissance was the Winfield-Pin Oak site near Winfield, Missouri. The levee breached on June 18, 2008. A gap approximately 150 m long was created in the levee by the overtopping waters. Figure 12 is a photo taken by the St. Louis District USACE showing an aerial view as two homes were knocked off their foundations by the force of the water. Figure 13 shows the same site on September 29, 2008 during the Midwest Levee reconnaissance. It should be noted that the breach shown in Figure 13 was contained between the blue and white houses shown in Figure 12 even though overtopping was also occurring further down the levee.

Figure 12. Winfield-Pin Oak breach (USACE St. Louis District 2008).

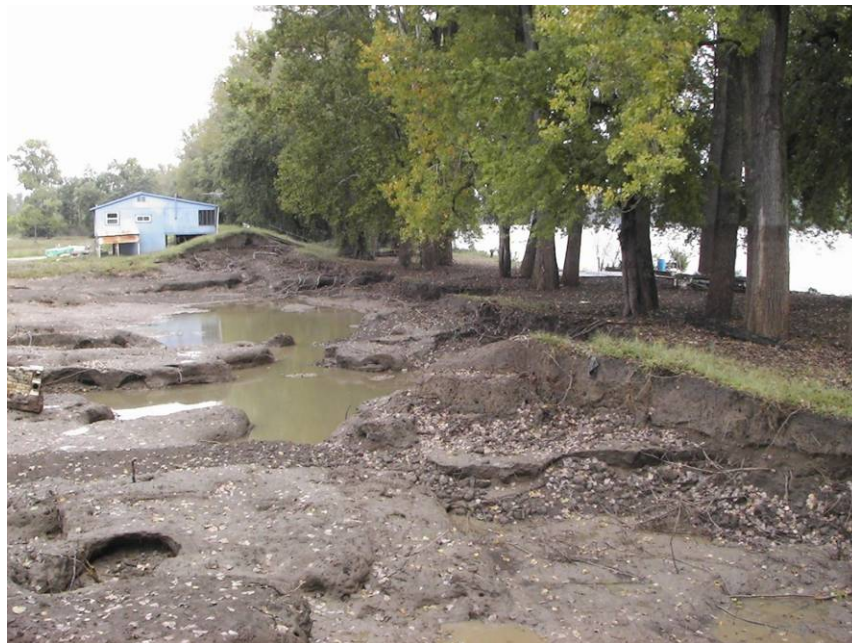
Figure13. Winfield-Pin Oak site, Missouri.

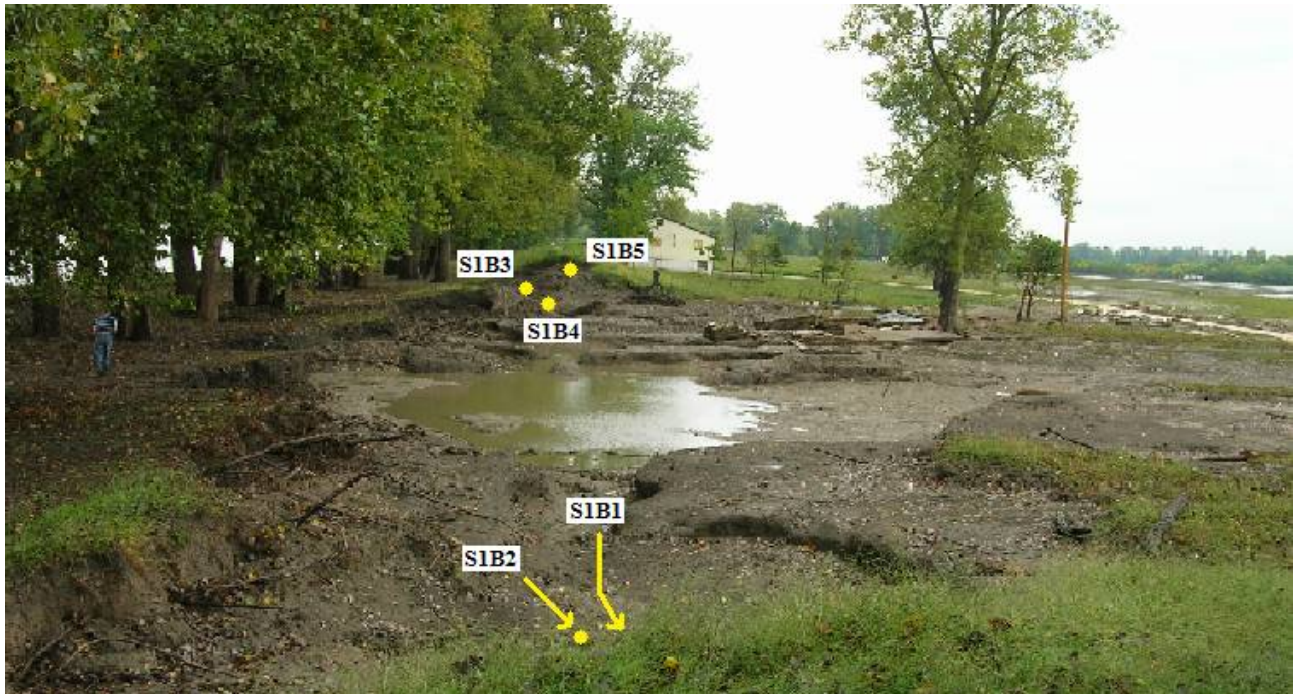
Five samples were taken from various locations within the breach (15). Table 3 provides a summary of the sample locations as well as Torvane and Pocket Penetrometer readings. Note that the Pocket Penetrometer gives an estimate of the unconfined compression strength while the Torvane estimate the undrained shear strength directly. Common practice is to take the undrained shear strength equal to 0.3 times the Pocket Penetrometer readings.

Figure 15. Boring locations Winfield – Pin Oak breach looking south.

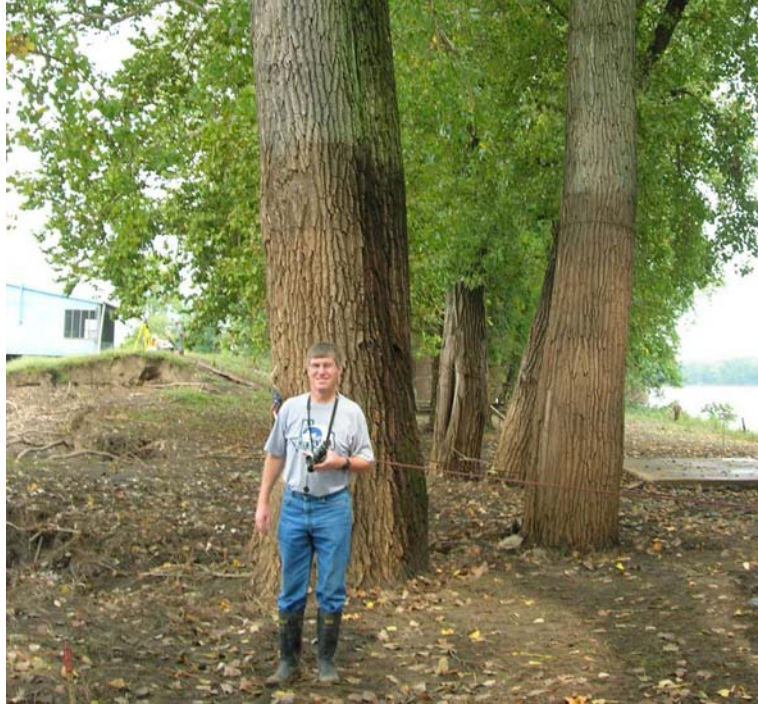
The Mississippi River runs North to South at this location. The levee borders the West river bank while the East bank is bordered by natural cliffs which provide a barrier for the flood waters and force the rising water into the levees. The water line on the trees that border the river side of the levee (Figure 16) was about 1 m higher than the existing levee crests indicating that during peak flow the water was overtopping the levee by almost 1 m. It also shows that the overtopping duration was long enough to leave a water mark or mud line on the trees.

Figure 16. High water marks on trees bordering levees.

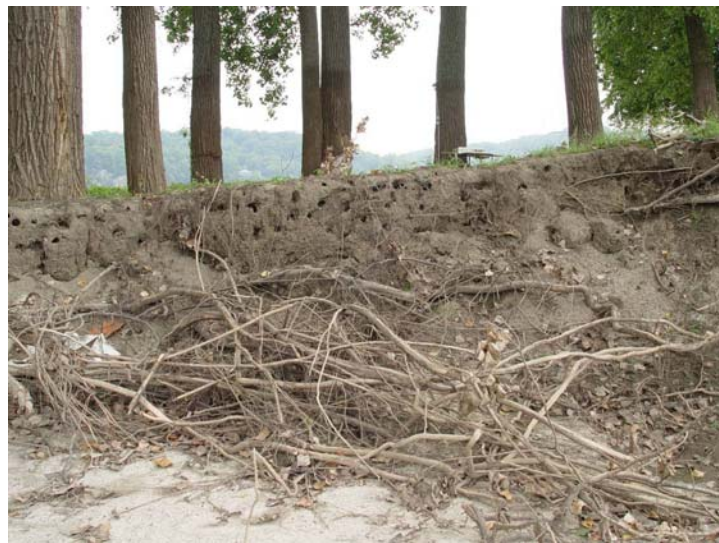
Extensive root networks and crayfish tunnels were present throughout the existing levee and breached area (Figure 17). These encroachments often encourage the formation of seepage paths through embankments.

Figure 17. Root networks and crayfish tunnels throughout the levee.

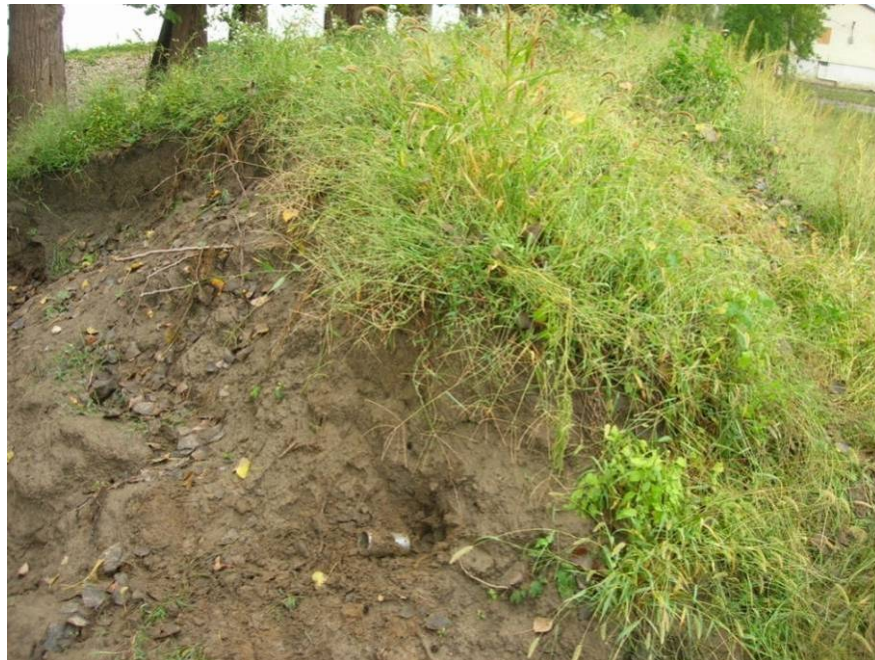
The vegetative cover at the Winfield site (Figure 18) was low to moderate density comprised and mostly of crabgrass and foxtail. While the ground cover looks somewhat established in the Figure, most of the grasses present were annual weeds rather than sod forming grasses. Such weeds are only present for a portion of the year and tend to clump leaving spaces where the soil surface is bare. In several areas there was little or no coverage.

Figure 18. Winfield – Pin Oak vegetative cover.

Foxtail is a “weed-like” summer annual plant which forms in tuft-like groupings and often develops in areas of less dense turf grass (American Lawns 2009). The ground coverage at the site must not have been dense because of the ability of the foxtail to intrude. Crabgrass is an annual grass generally found in the warmer climates. This “weed” is very invasive and can take over an area, but because it is an annual plant it will die out during a freeze. None of the grasses identified at this site are what would be considered “good” protective armoring. These vegetative conditions, however, are based on post flood observations and may not reflect the actual conditions at the time of overtopping.

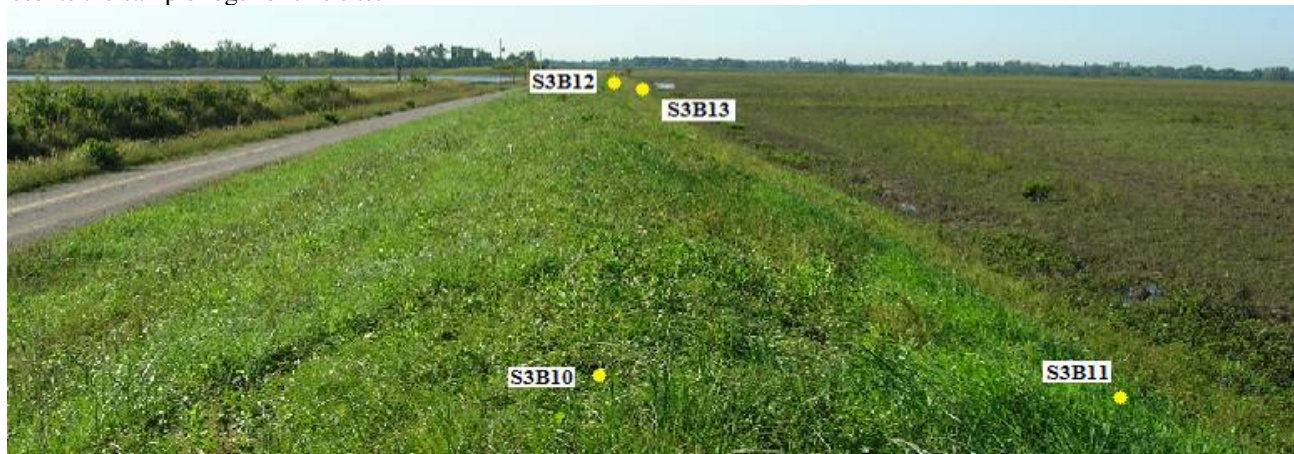
This site was unique in the fact that there was no breach in 2008. The only sign of erosion was at a box culvert that was cracked allowing water and soil to seep through. A local resident (Mr. James Pieper) informed the team that the levee was overtopped by nearly 1 m of water for three days and never failed. Four samples were collected from various locations along the levee. Because there was no actual breach, only surficial samples were taken. These samples were much harder to obtain and the soil seemed to be much stiffer than at the previous sites as can be seen by the higher Pocket Penetrometer values (Table 6) obtained at this site compared to the Winfield site. Figure 20 shows the boring locations and Table 6 presents the sample logs for this site.

Figure 20. Brevator boring locations.

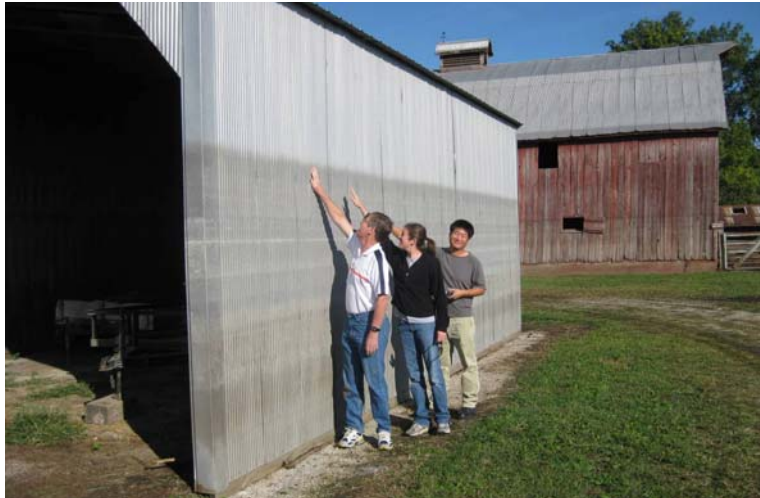
While the levees did not breach, there was still a large amount of damage to homes and equipment on the dry side of the levee due to the overtopping waters. The area enclosed by the levees at this site was much smaller compared to the other sites, so the overtopping water began to fill the internal area like a swimming pool. Figure 21 shows the high water marks on a barn located within the area surrounded by the levees. As the water on the dry side of the levee rose, the difference in elevation between the two sides decreased thereby decreasing the erosion potential. Substantial damage occurred within the internal area even though the levee performed well.

Figure 21. High water marks on barn within the Brevator levee system.

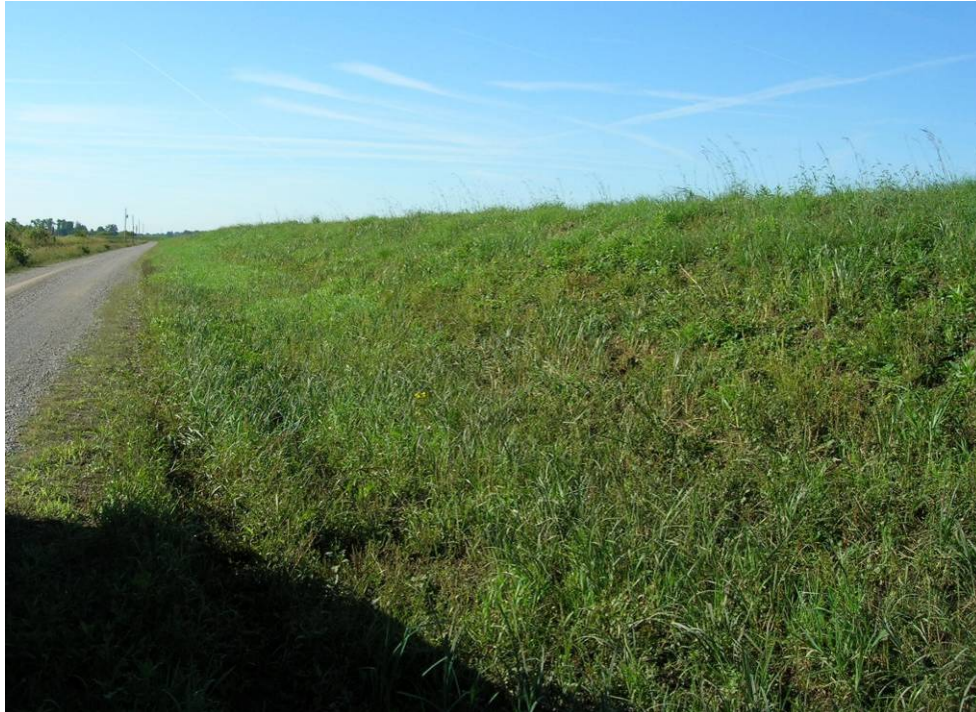
At the time of overtopping, there was substantial vegetative cover. Figure 22 shows the vegetative cover present on the levee 3 months after the flooding. It was noted that the grass was Reed Canary grass approximately 1 m tall at the time of flooding. This type of grass survived the continuous flow of water and had a positive impact on preventing erosion. The overtopping waters forced the grass to lay down essentially creating a protective cover or barrier on top of the soil surface and preventing erosion.

Further examination of the grass cover indicated that additional varieties of plants were present at the site including: Switchgrass, Smooth Brome, Reed Canarygrass, and Foxtail. The consistency of the coverage and the root density were much higher at this site than any of the other sites.

Figure 22. Brevator vegetative cover on September 30, 2008.

The grasses found at the Brevator site seemed to satisfy all of these criteria. The recommended grasses for the Midwest include: Switchgrass, Tall Fescue, Smooth Brome and Reed Canarygrass. A percent coverage of at least 90 percent is desirable. It is also recommended that the grasses on the levee be allowed to grow to taller heights during the flood season (0.5 to 1 m). While most of the erosion prevention depends on the root system, it is not always adequate for the magnitude and duration of flows experienced during overtopping flood events.
