Quarry-Induced Slope Instability at a Broadcasting Transmission Plant near Valcava, Lombardia, Italy

Monica Barbero, Assistant professor, Politecnico di Torino (Torino, Italy); email: monica.barbero@polito.it
Fabrizio Barpi, Assistant professor, Politecnico di Torino (Torino, Italy); email: fabrizio.barpi@polito.it

ABSTRACT: *Since 2006, a broadcasting tower and ancillary buildings on the top of a hill adjacent to a large, active limestone quarry, in northern Italy near the village of Valcava, has been heavily damaged by ground deformation due to slope instability. In 2005, the quarry began to work the slope toward the broadcasting plant, releasing bedding planes that affected the tower site: a number of fractures occurred in the warehouse and in the ground around it, that grew particularly during significant rainfalls. In October 2006 a landslide occurred in the quarry area, close to the broadcasting site. In order to understand what induced the fracture process in the buildings and define a support system to stabilize the broadcasting site, a detailed geotechnical survey and a number of numerical slope stability analyses were carried out. One of the main goals of the paper is t

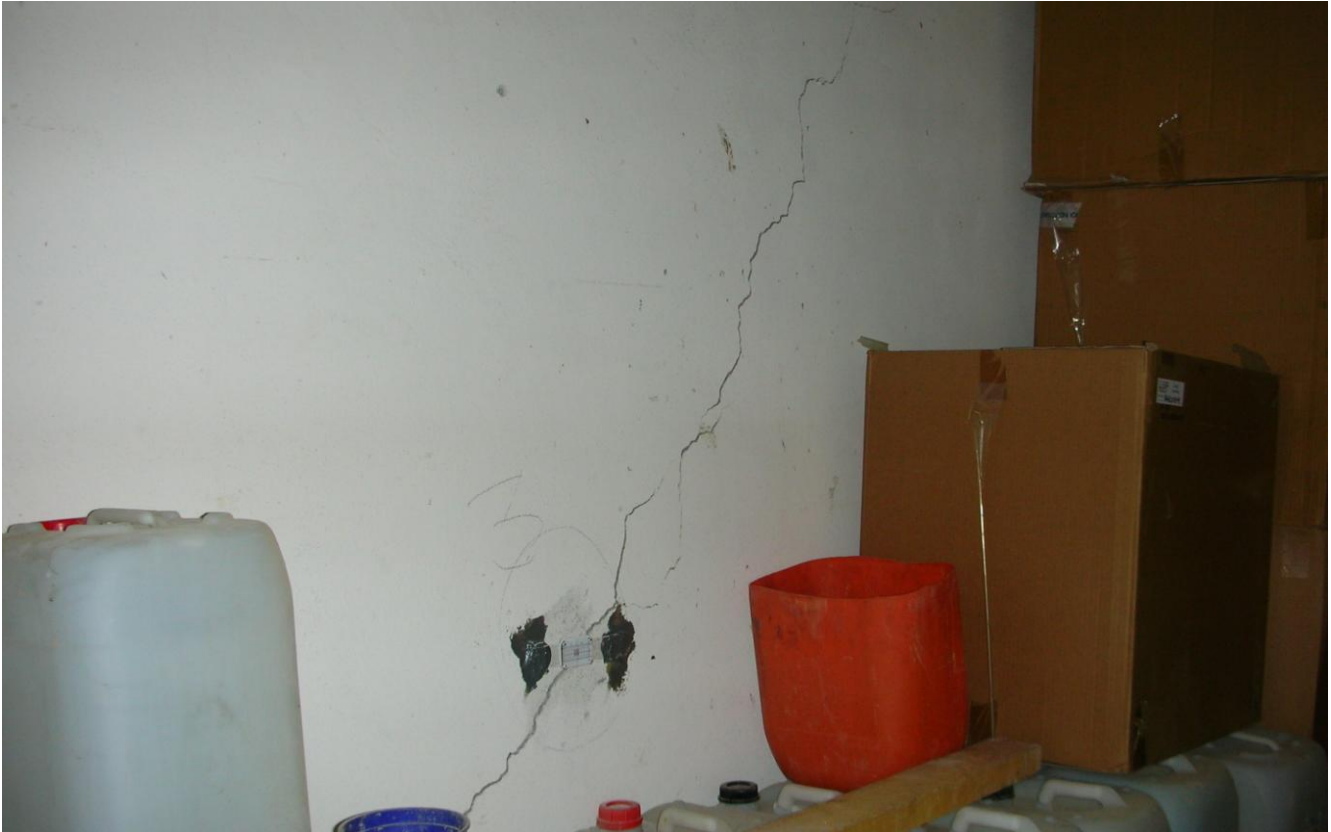
In 2005, quarry operations initiated at the slope toward the broadcasting tower. In May 2006, tension cracks developed in the ground at the top of the hill and many cracks appeared in the walls and floor of the building (Figures 2 and 3). The cracks were parallel to the slope face, suggesting a downward movement of the slope. In October 2006, after two days of medium-high intensity rains, a landslide with a volume of about 27000 m³ occurred in the pit (Figure 4 and 5) at a distance of about 45 m below the warehouse area (Figure 6) and the cracks in the warehouse and in the ground increased, the latter reaching openings of some centimeters. The intense rains of the winter 2006 quickened instability phenomena (Barbero et al., 2008).

Figure 2. Wall damage inside the warehouse.

As crack opening and spreading are important signs of the instability evolution, crack gauges were placed across the larger cracks observed in the warehouse and a continuous monitoring of lengths and openings was performed. Unfortunately, no measurements are available for the cracks that appeared outside the warehouse (tension cracks in Figure 6). The cracks in the warehouse appeared to become more frequent toward the slope in the landslide direction, suggesting that the down slope movement of the rock mass affects the foundation of the warehouse.

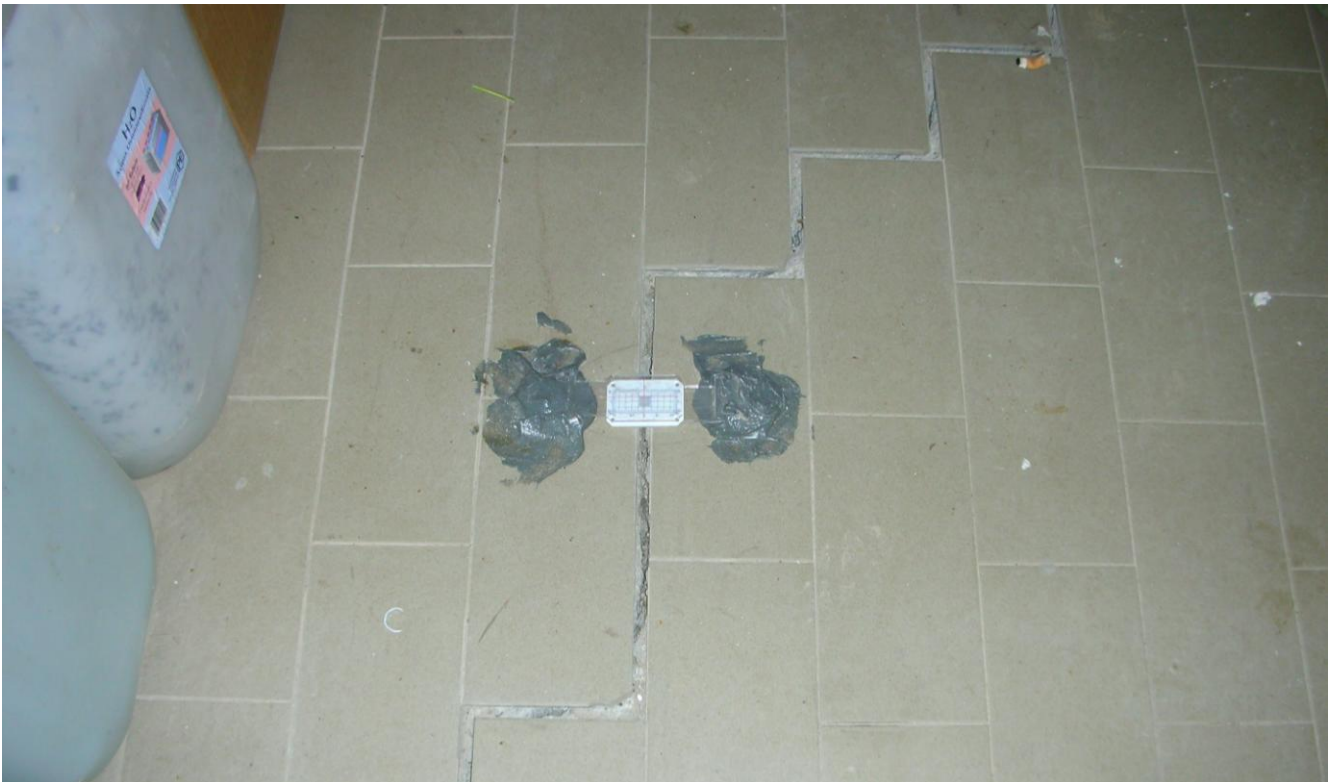
Figure 3. Floor damage inside the warehouse.

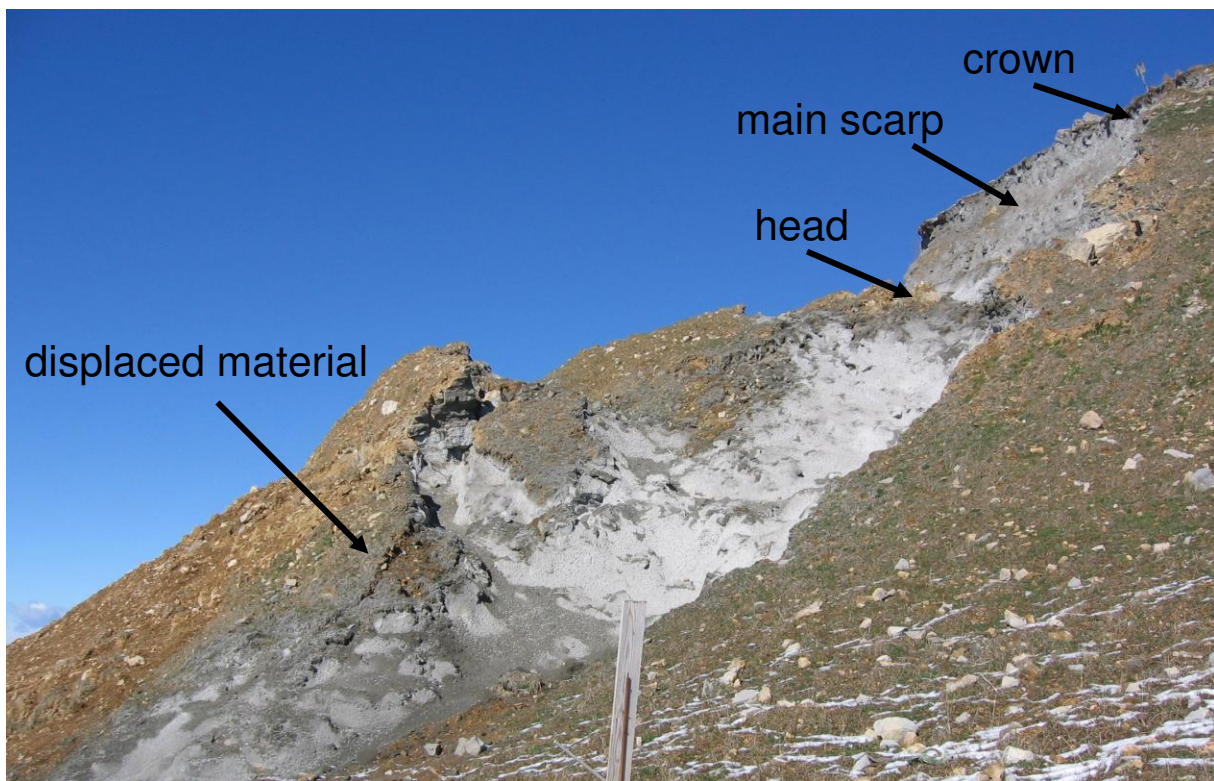
Figure 5. Top of the landslide.

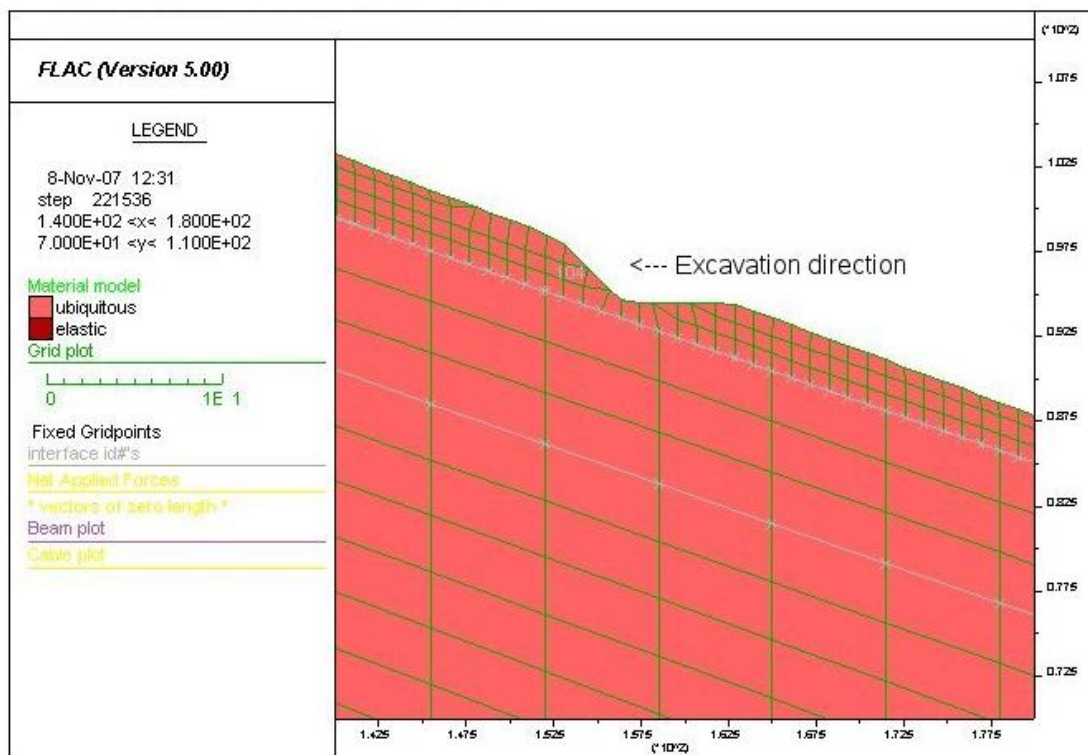
The obtained results pointed out that, with the extension of the pit area, the displacements in the upper part of the slope increase. Close to the warehouse they become in the order of a few centimeters. In particular, the displacements become considerable when the excavation involves the deformable layer.

The results allow to assert that a progression of the mining activity toward the broadcasting plant would induce its instability. For this reason, it can be considered as a triggering cause of the slope movement. As such, it should not to be authorized.

Figure 14. Model for the progression of the mining activities analysis.
