Quarry-Induced Slope Instability at a Broadcasting Transmission Plant near Valcava, Lombardia, Italy

Monica Barbero, Assistant professor, Politecnico di Torino (Torino, Italy); email: monica.barbero@polito.it
Fabrizio Barpi, Assistant professor, Politecnico di Torino (Torino, Italy); email: fabrizio.barpi@polito.it

ABSTRACT: *Since 2006, a broadcasting tower and ancillary buildings on the top of a hill adjacent to a large, active limestone quarry, in northern Italy near the village of Valcava, has been heavily damaged by ground deformation due to slope instability. In 2005, the quarry began to work the slope toward the broadcasting plant, releasing bedding planes that affected the tower site: a number of fractures occurred in the warehouse and in the ground around it, that grew particularly during significant rainfalls. In October 2006 a landslide occurred in the quarry area, close to the broadcasting site. In order to understand what induced the fracture process in the buildings and define a support system to stabilize the broadcasting site, a detailed geotechnical survey and a number of numerical slope stability analyses were carried out. One of the main goals of the paper is t

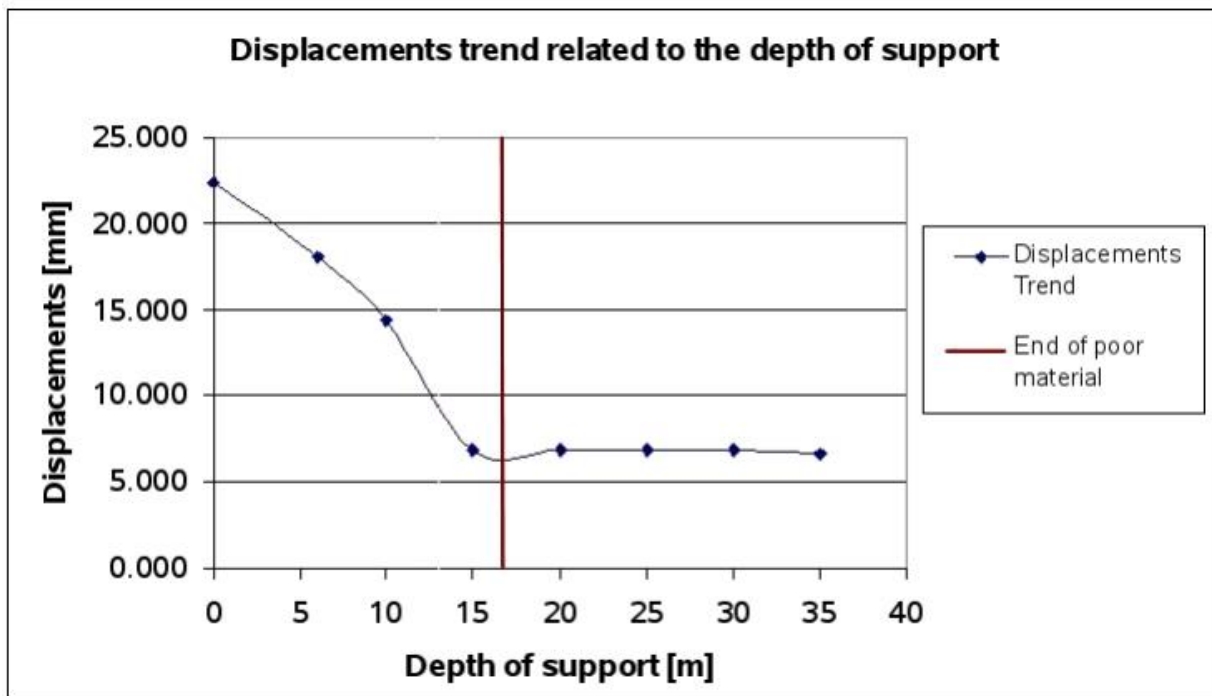
The results (Figure 16) confirm that the minimum length for the micropiles is about 16 m (the depth at which the boundary between the weaker layer and the undisturbed rock mass is located). On the other hand micropile lengths greater than 20 m don't provide further benefit to the plant stability. It is possible to conclude that 27 m is a good estimate of the length for the micropiles.

Figure 16. Model displacements in the area upstream the bulkhead, related to the length of the micropiles (assuming that in-situ bedrock is at 16 m depth).
