Quarry-Induced Slope Instability at a Broadcasting Transmission Plant near Valcava, Lombardia, Italy

ABSTRACT: *Since 2006, a broadcasting tower and ancillary buildings on the top of a hill adjacent to a large, active limestone quarry, in northern Italy near the village of Valcava, has been heavily damaged by ground deformation due to slope instability. In 2005, the quarry began to work the slope toward the broadcasting plant, releasing bedding planes that affected the tower site: a number of fractures occurred in the warehouse and in the ground around it, that grew particularly during significant rainfalls. In October 2006 a landslide occurred in the quarry area, close to the broadcasting site. In order to understand what induced the fracture process in the buildings and define a support system to stabilize the broadcasting site, a detailed geotechnical survey and a number of numerical slope stability analyses were carried out. One of the main goals of the paper is to underline the effectiveness of the numerical analyses to understand the instability phenomena when they are particularly complex. Furthermore, by using a reliable numerical model with a good understanding of site ge

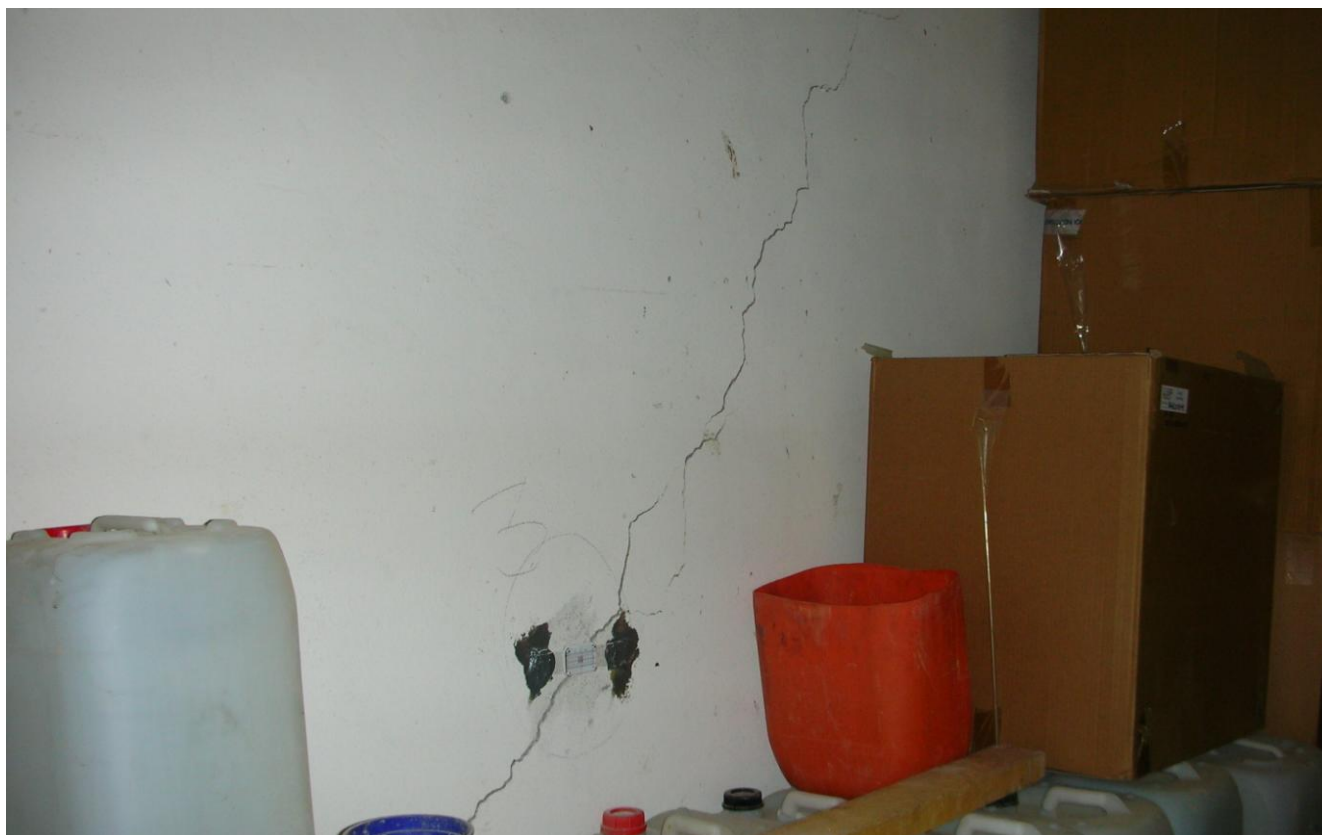
Figure 2. Wall damage inside the warehouse.

As crack opening and spreading are important signs of the instability evolution, crack gauges were placed across the larger cracks observed in the warehouse and a continuous monitoring of lengths and openings was performed. Unfortunately, no measurements are available for the cracks that appeared outside the warehouse (tension cracks in Figure 6). The cracks in the warehouse appeared to become more frequent toward the slope in the landslide direction, suggesting that the down slope movement of the rock mass affects the foundation of the warehouse.

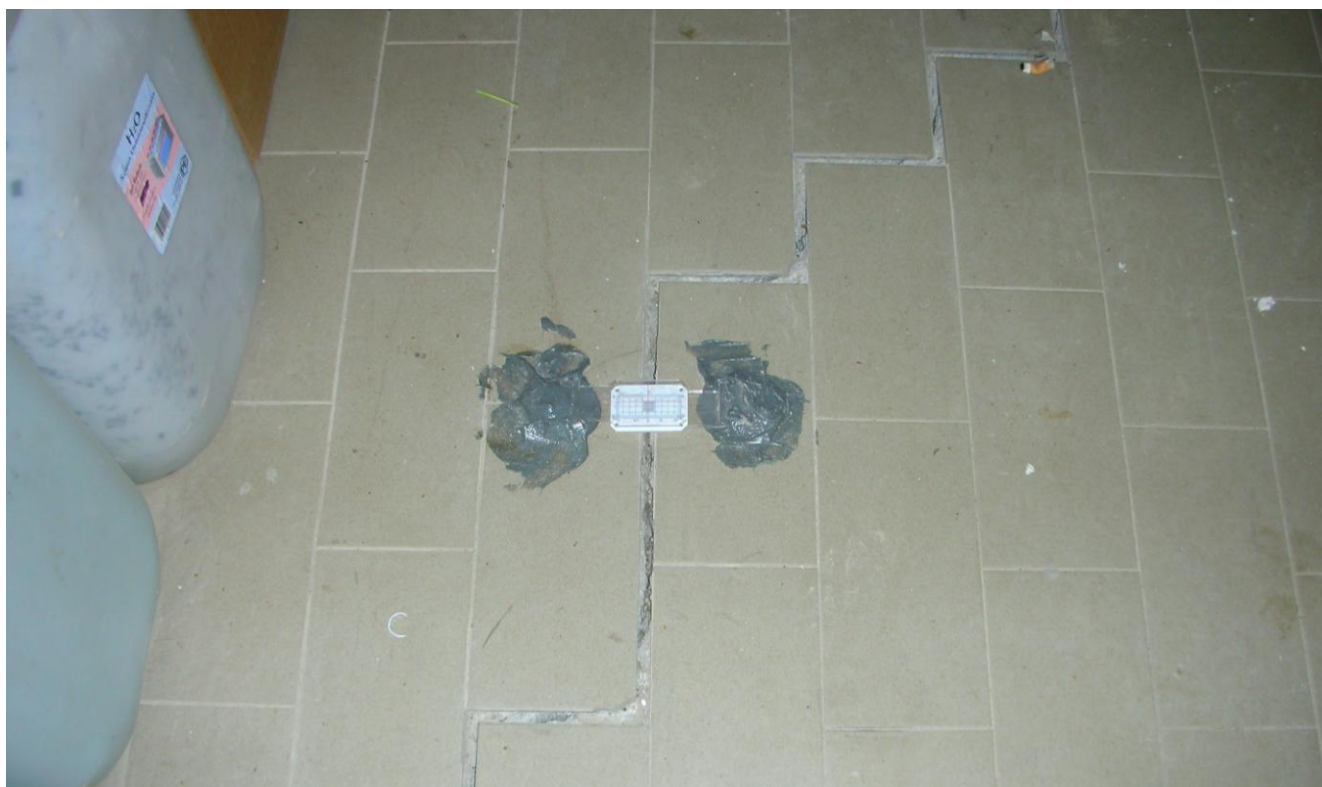
Figure 3. Floor damage inside the warehouse.

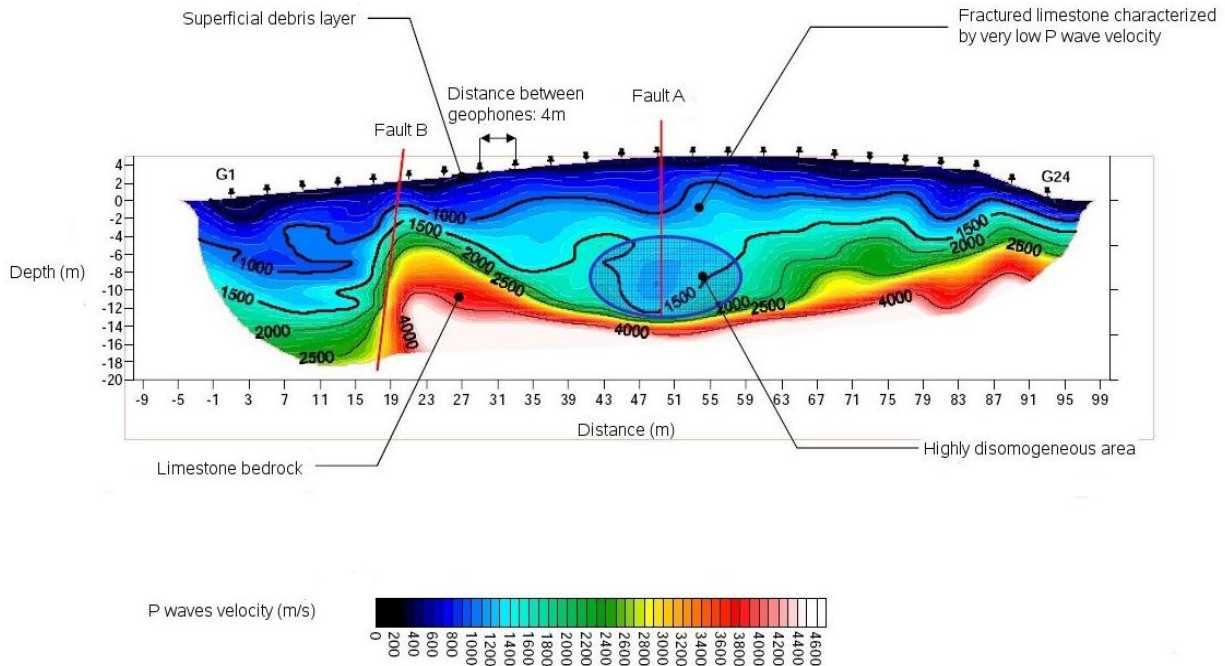
The data were processed with tomographic technique (Hampson & Russel, 1984; Olsen, 1989) and then interpreted considering the conventional exploration with core-drilling data. Similar results were generated in the slope and in the tower area. Upslope of the warehouse, in the tower area, there is a superficial layer of fill about 3 m deep, underlain by a layer of fractured limestone overlying apparently intact bedrock at a depth of about 16 m, as shown in Figure 8. Near the warehouse, upslope from the landslide, a pit showed the same stratigraphic sequence is observed in the tower area, as well as evidence of the two main faults A and B (Figure 9). Because of fault B, the apparently intact limestone is found at a depth of more than 20 m. The seismic survey thus confirmed the likelihood that the sliding surface was located above a depth of 20 m.

Figure 9. Seismic refraction survey results: P waves velocity trend inside the rock mass, below the warehouse area.

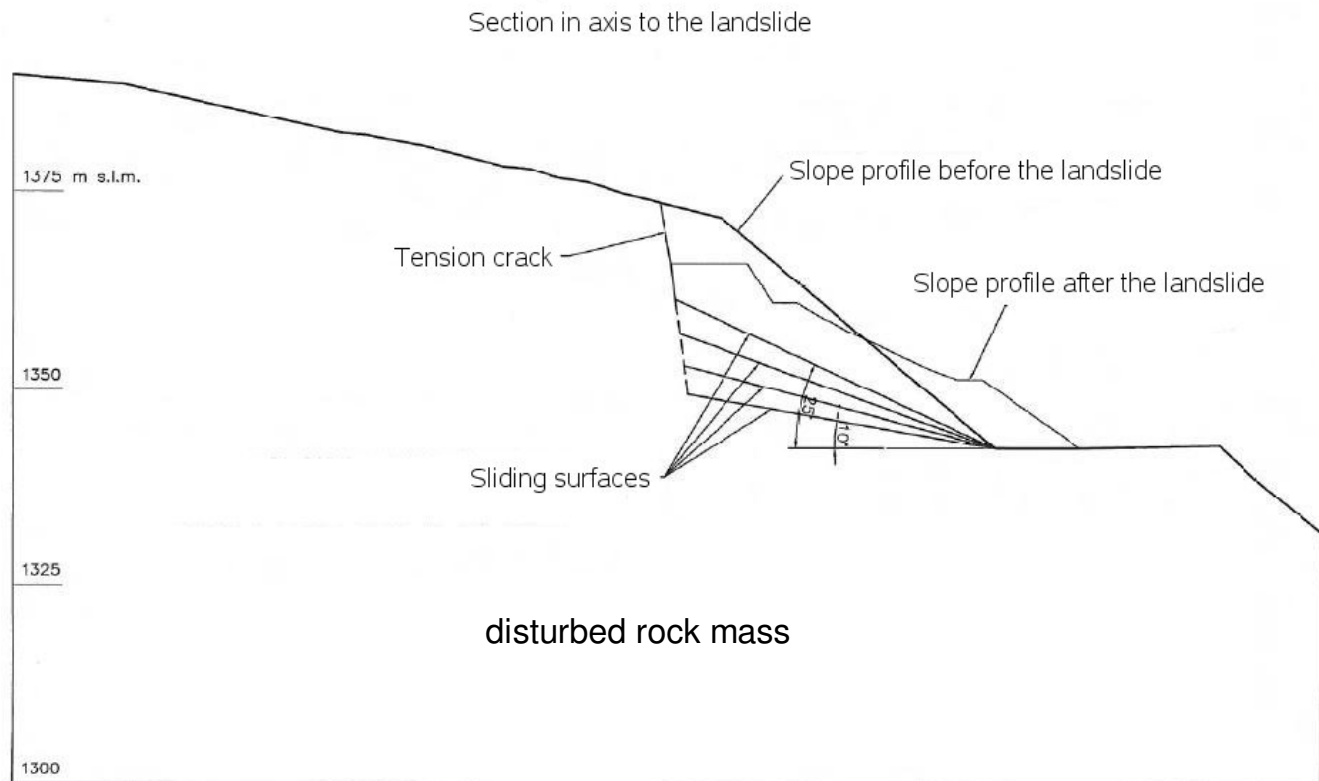
Figure 10. Slope section used for the limit equilibrium analyses (Slope-W).

In the cases of 20° to 25° sliding surface dips, limit equilibrium (i.e., safety factor $F = 1$) is reached for a water level in the tension crack of about 40% to 60% of its height and strength parameters very close to that obtained from the geotechnical characterization: 0 kPa/32°, 4 kPa/30° and 9 kPa/28° (cohesion/friction angle). According to the geotechnical characterization results and in situ observations, the last set of parameters was chosen as residual characteristics for the bedding planes.

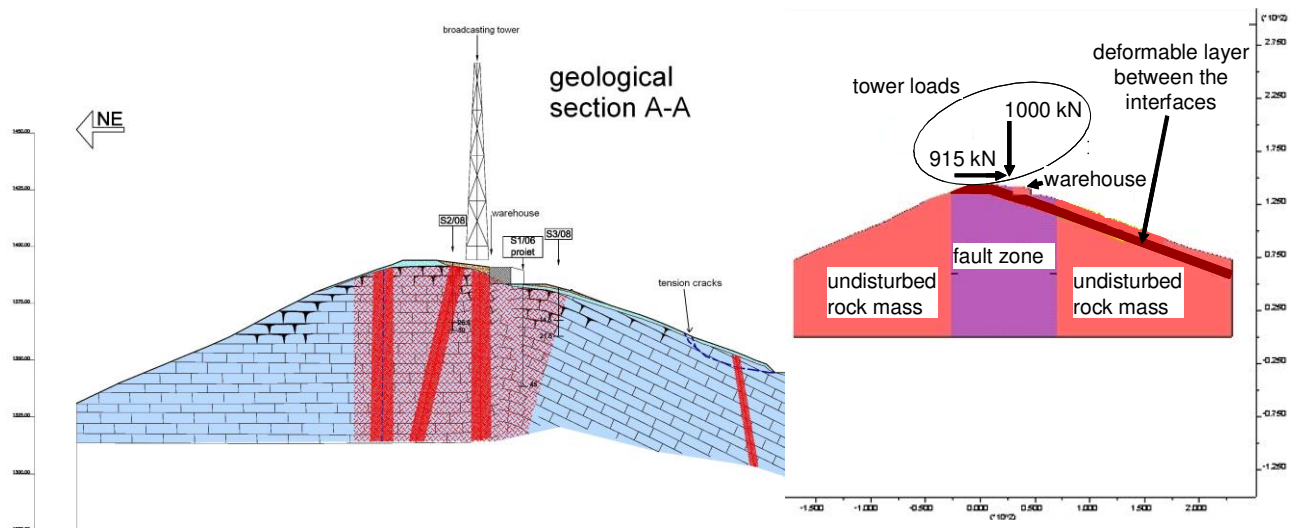
The analyses results show a global factor of safety varying between 2.1 (scenario 3) and 2.8 (scenario 1), confirming the stability of the slope in the past.

The results also show the development of a shear band parallel to the slope profile, at a depth of about 15-20 m for scenario 3 and 5-10 m for scenario 2. This confirms that the transversal isotropy induced by the bedding planes is a predisposing cause of sliding. The presence of water in the rock mass also reduces the stability of the slope.

Figure 11. Geological section A-A (left) and model for numerical analyses (right).

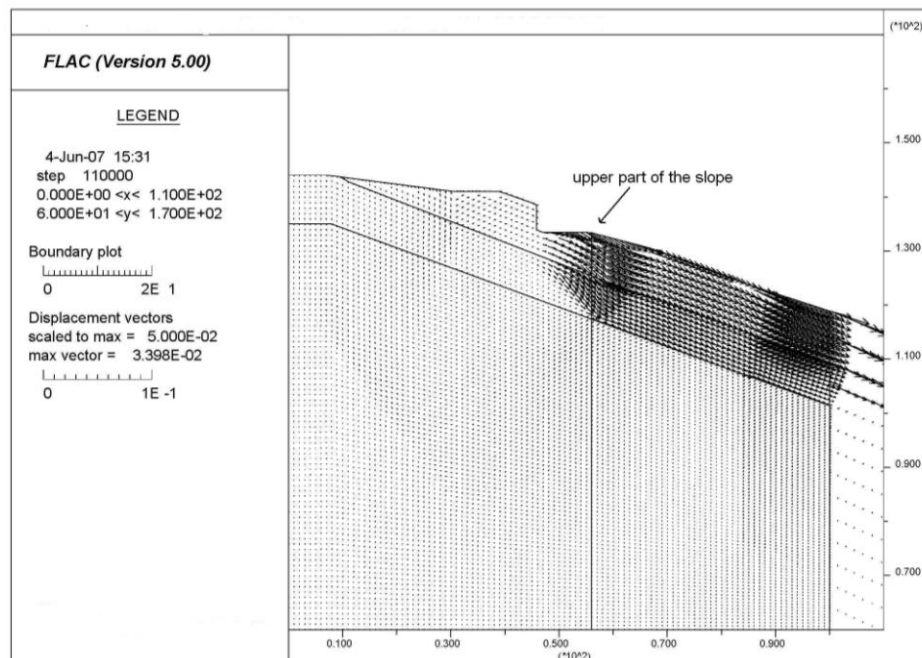
The results show an important displacement increase in the upper part of the slope. The displacements in the warehouse area are appreciable only in the case of water table at 5 m from the level of site (Figure 13). A wide area in the disturbed rock mass reaches the plastic boundary for every hydraulic scenarios. From this, it is possible to reconstruct the slope's stress-strain history. The cuts in the pit area induced a progressive instability in the area immediately below the broadcasting plant, with downwards displacements that started in the pit cut and spread towards the warehouse. The landslide in the pit area quickened the instability phenomenon that worsened with heavy rain falls, leading to considerable displacements in the warehouse area.

Figure 13. Numerical results: displacements in the upper part of the slope.

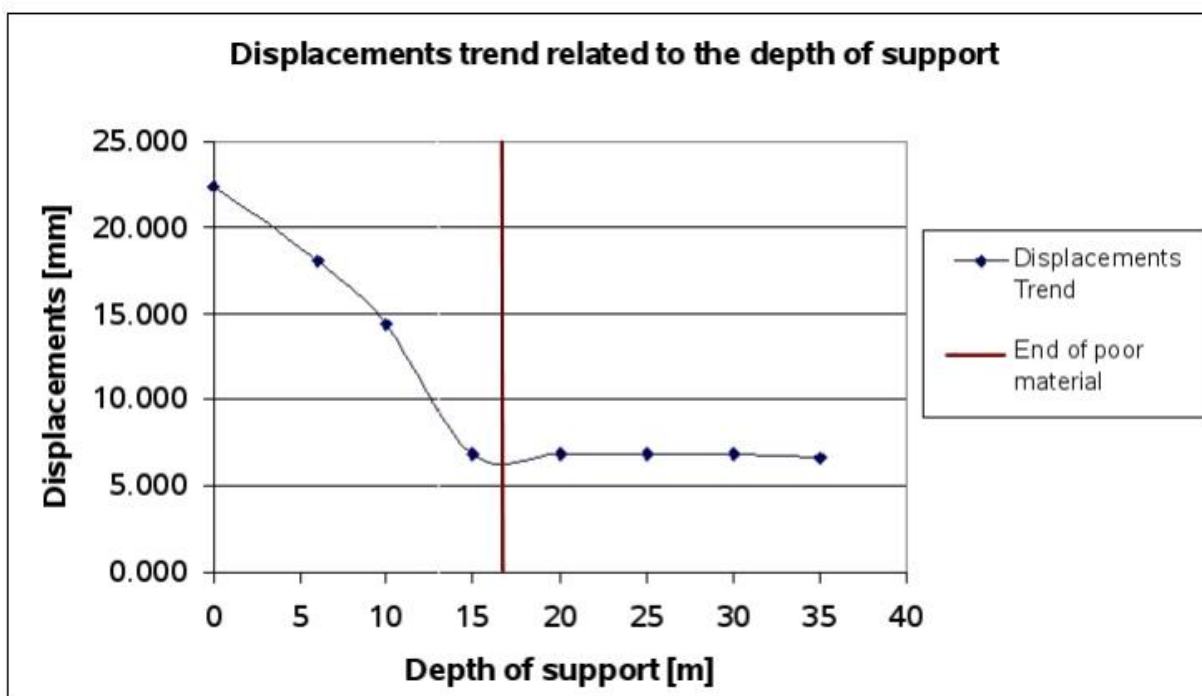
The results (Figure 16) confirm that the minimum length for the micropiles is about 16 m (the depth at which the boundary between the weaker layer and the undisturbed rock mass is located). On the other hand micropile lengths greater than 20 m don't provide further benefit to the plant stability. It is possible to conclude that 27 m is a good estimate of the length for the micropiles.

Figure 16. Model displacements in the area upstream the bulkhead, related to the length of the micropiles (assuming that in-situ bedrock is at 16 m depth).

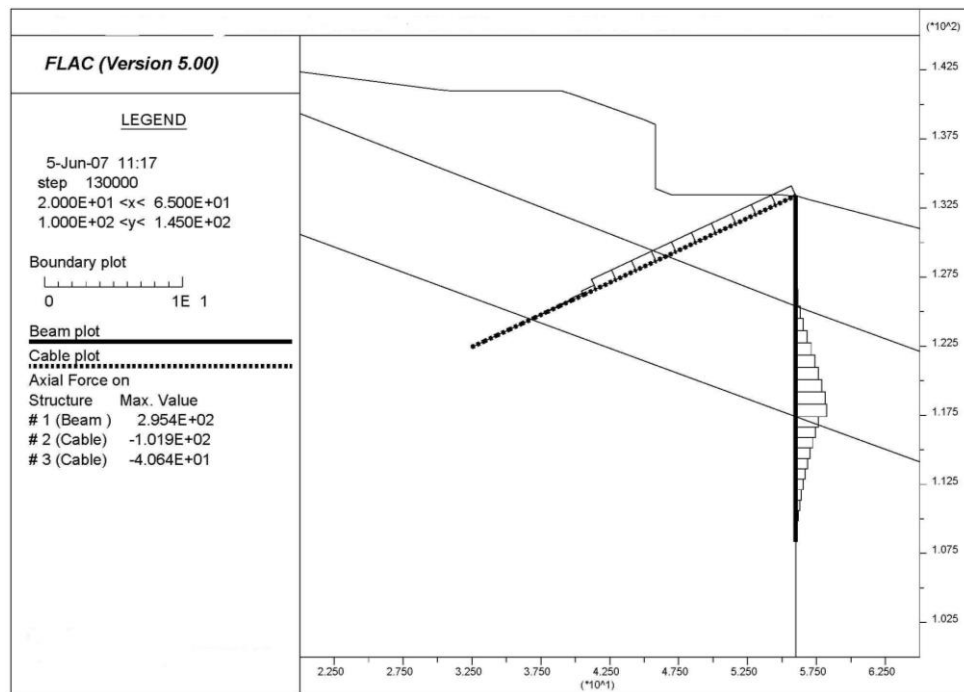
Figure 17. Axial forces acting on micropiles and anchors.

numerical analyses provided the normal force, bending moment and shear force acting on the micropiles and the axial forces acting on the anchors (Figures 17, 18 and 19). These results were used to design the steel elements.

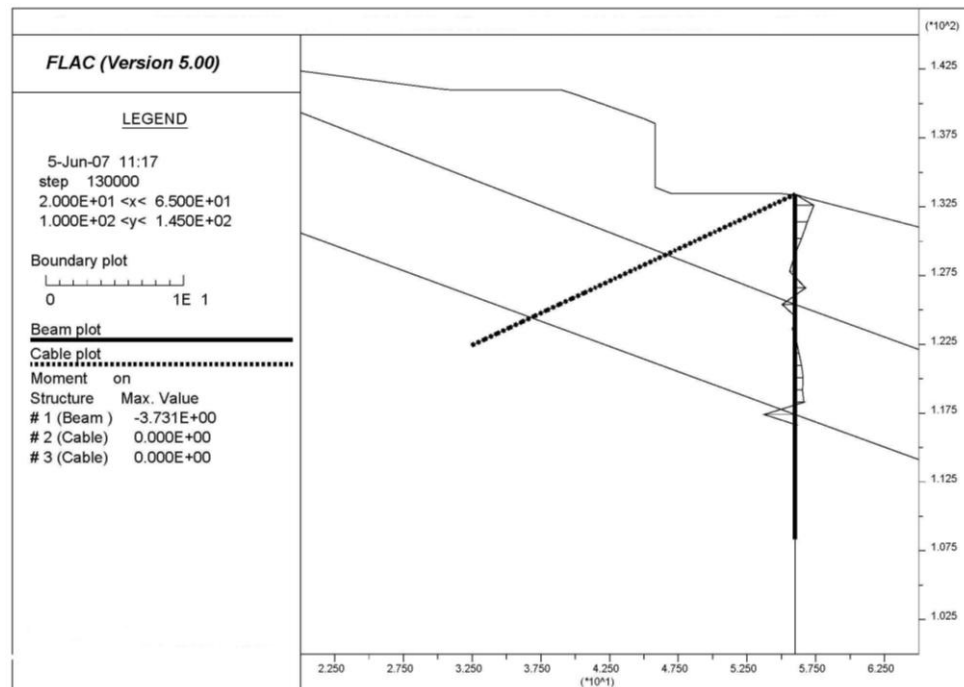
Figure 18. Bending moment acting on micropiles.

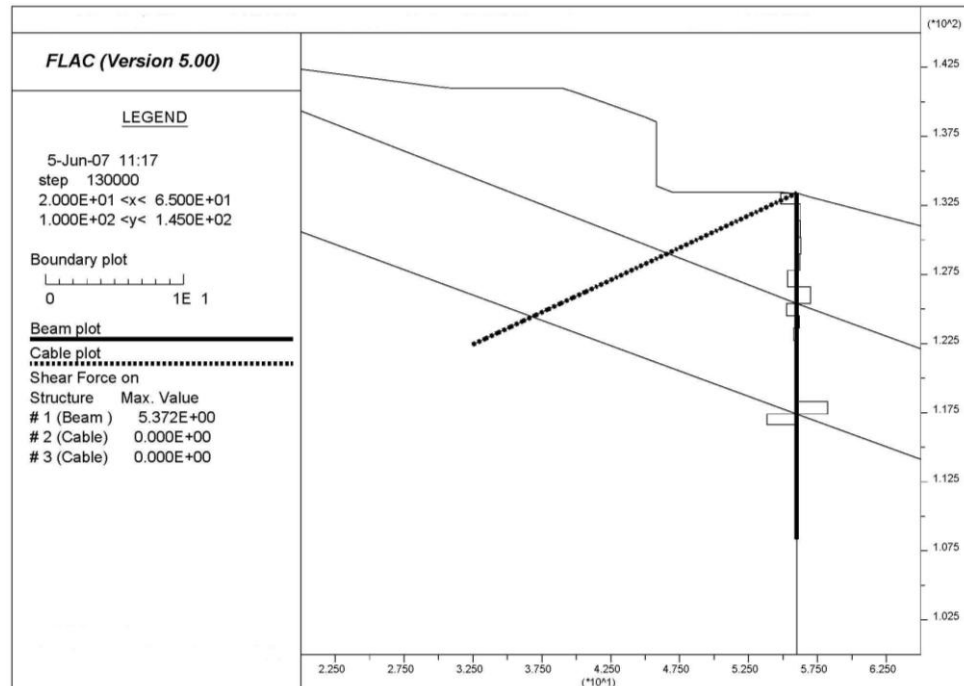
Figure 19. Shear force acting on micropiles.
