## Embankment Failure in Residual Soils at Nivsar, Ratnagiri

**ABSTRACT:** *The Nivsar Yard embankment was constructed by the Konkan Railways in 1994. Near the station building, the 22m high embankment runs parallel to the Kajali River for a stretch of about 100m. This stretch has experienced failure and settlement related problems since the record-breaking July 2005 rainfall. Corrective ground improvement measures were implemented immediately after the monsoon. However, these measures were inadequate because the failure surface reappeared during the following monsoon. The failure surface mirrored the shape and size of the failure observed in 2005. Since then after nearly every monsoon, the embankment has moved despite precautionary measures taken by the railway to arrest the movement. The hydrogeological and geotechnical properties which affect slope stability are first discussed. The stability of the embankment is then evaluated at 5 sections drawn along the slope. Two cases are considered. In the first case, the stability of the unreinforced slope is calculated. In the second case, calculations are done using the slope reinforced with soil nails and micropiles installed in 2005

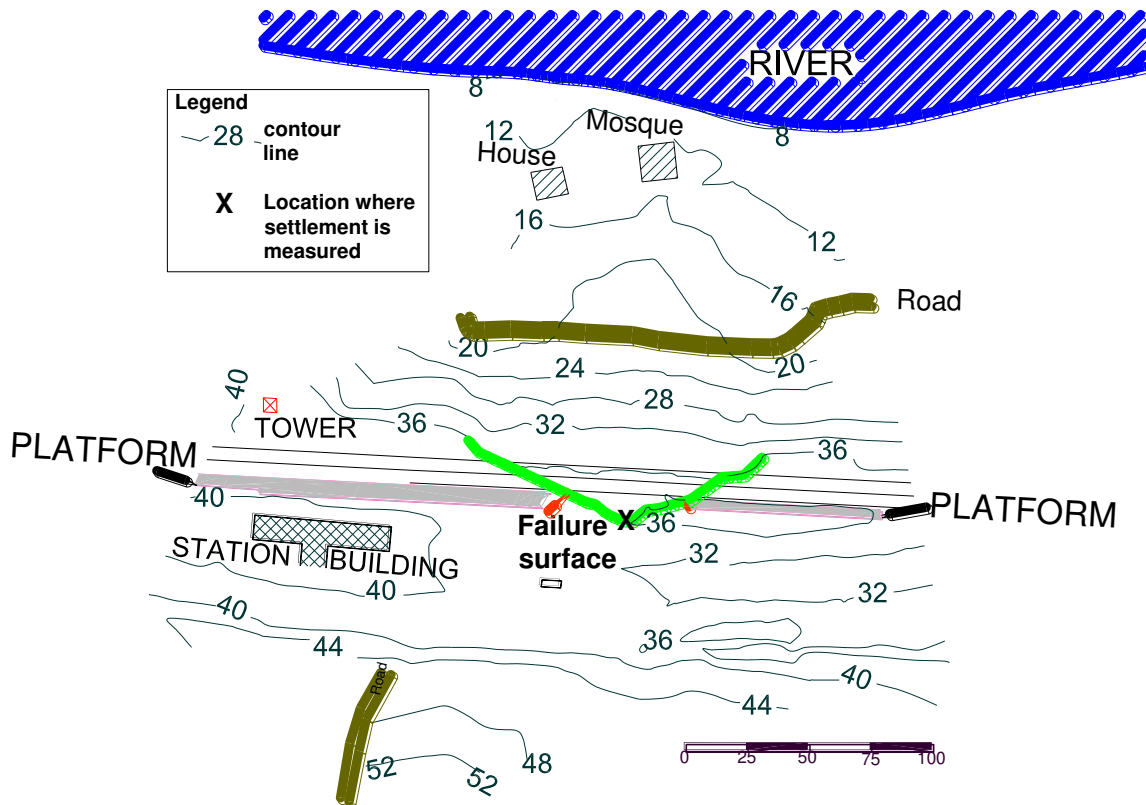
site until the year 2005. In that year, cracks in the embankment developed between chainage km 218.8 and 218.9 following record-breaking rainfall. Heavy rain occurred for 3 days between July 24<sup>th</sup> and 26<sup>th</sup>. Cracks opened up to 20mm width over a period of 15 to 20 days. During the same time, the slope settled by more than 150mm. The total settlement was about 550mm towards the end of the 2005 monsoon. At the end of this period, the cracks took shape of a parabola with its vertex close to the station platform. The parabola sloped downhill for about 100 to 120m towards the river. Figure 2 shows the extent of the slope failure observed in 2005.

Figure 2. Failure at Nivsar Yard Embankment

Soon after the observed failure, and when the 2005 monsoon was over, soil nails and micro-piles were installed to prevent further damage to the embankment. Table 1 shows details of the ground improvement works undertaken at the site in 2005. However, the 100mm wide and 130m long crack reappeared during the 2006 monsoon. As in the previous year, the crack encompassed all 3 railway lines, including the main line. The shape and size of the crack mirrored the shape and size observed following the 2005 monsoon. The embankment settled throughout the 2006 monsoon reaching a high value of 2930mm at the station platform.

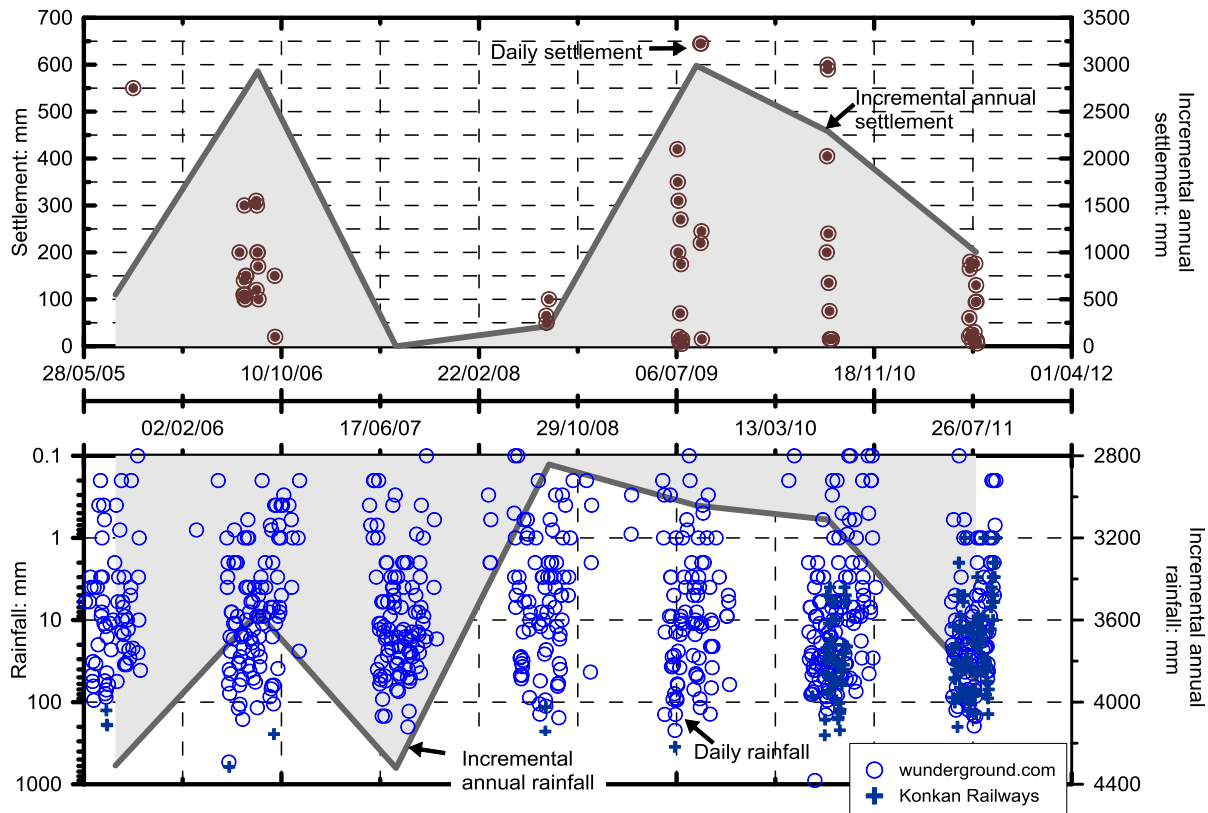
Figure 3 shows the recorded settlement of the embankment from the year 2005. The settlement was measured at top of the embankment near the station platform and its location is shown in Figure 2. Figure 3 also shows the record of rainfall in this region. The rainfall record was obtained from the web pages of <http://www.wunderground.com/> and from the data maintained by Konkan Railways. A clear trend between the magnitude of rainfall and slope movement can be observed in Figure 3. For instance, rainfall of over 200mm per day was invariably followed by more than 100mm settlement every year except during the 2007 and 2008 monsoons. The embankment did not move during the 2007 monsoon. Movement occurred only after more than half of the 2008 monsoon was complete. It appears that the stabilisation work completed before the onset of the 2007 monsoon was insufficient and effective only for a year, before losing effectiveness during the 2008 monsoon. It is likely that the slip planes redeveloped along the original failure surface during the 2008 ground failure. All effects of the soil improvement vanished before the onset of the 2009 monsoon, resulting in rapid movement of the embankment towards the river. The failure cracks that developed in 2009 are shown in Figures 4a-c. Figures 4a and b show the top few meters of the micro-piles that were exposed because of the steady soil-flow down the hill, and Figure 4c shows the transverse cracks observed along the road.

Figure 3. Settlement and rainfall record at Nivsar Yard Embankment.

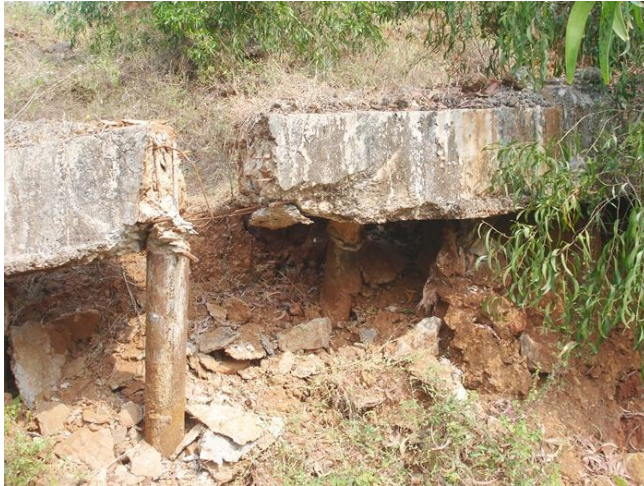
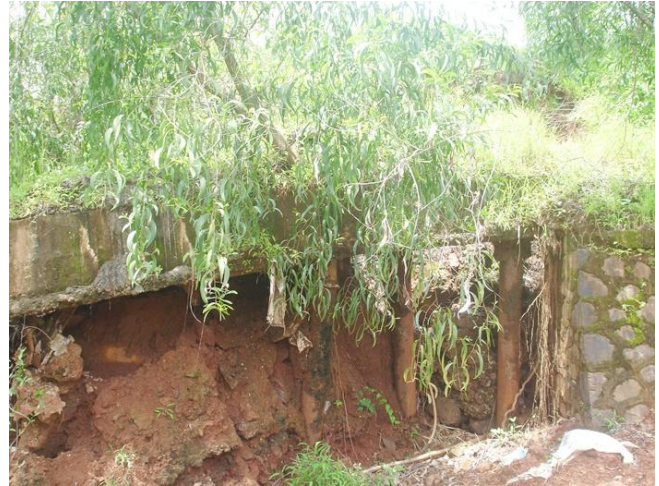
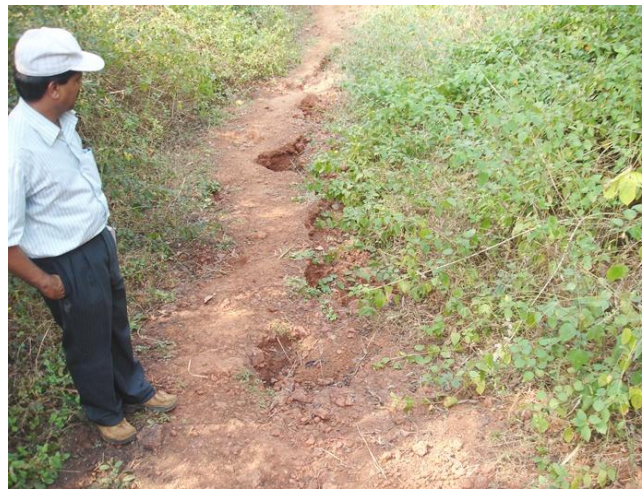
*Figures 4a-c. Failure of micropiles and curtain grouting: (a) and (b) Exposed pile foundation; and (c) Location of transverse cracks along the road (curtain grouting was conducted around this location).*

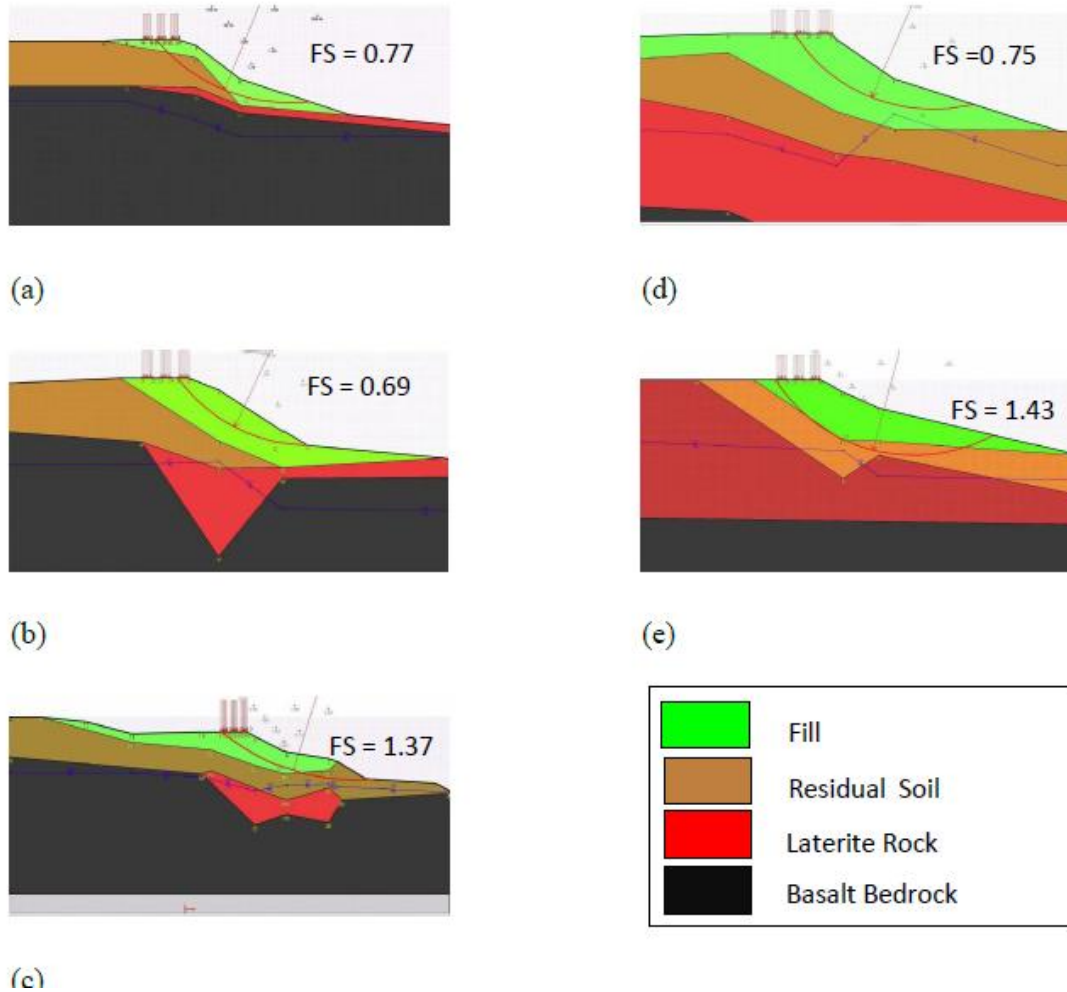
Figures 11a-e show the minimum safety factor and the location of the critical circle in sections A-A to E-E for the dry season. It is surprising to note that the minimum safety factor in 3 out of 4 sections is less than one, despite the fact that the slope was known to be stable and did not show any distress during the dry season. These sections are A-A, B-B and D-D in the figures. Figures 11a to 11e also show that the ground water level is below the critical failure circle in all 4 cases. Therefore, even if it is argued that the hydrological conditions which led to the 2005 failure and those measured in 2010 and 2011 may not be the same, it is unlikely that the position of the water table could influence the stability of the slope during the dry season.

Figures 11a-e. Safety factor during dry season with original parameters for section: (a) A-A; (b) B-B; (c) C-C; (d) D-D; and (e) E-E.

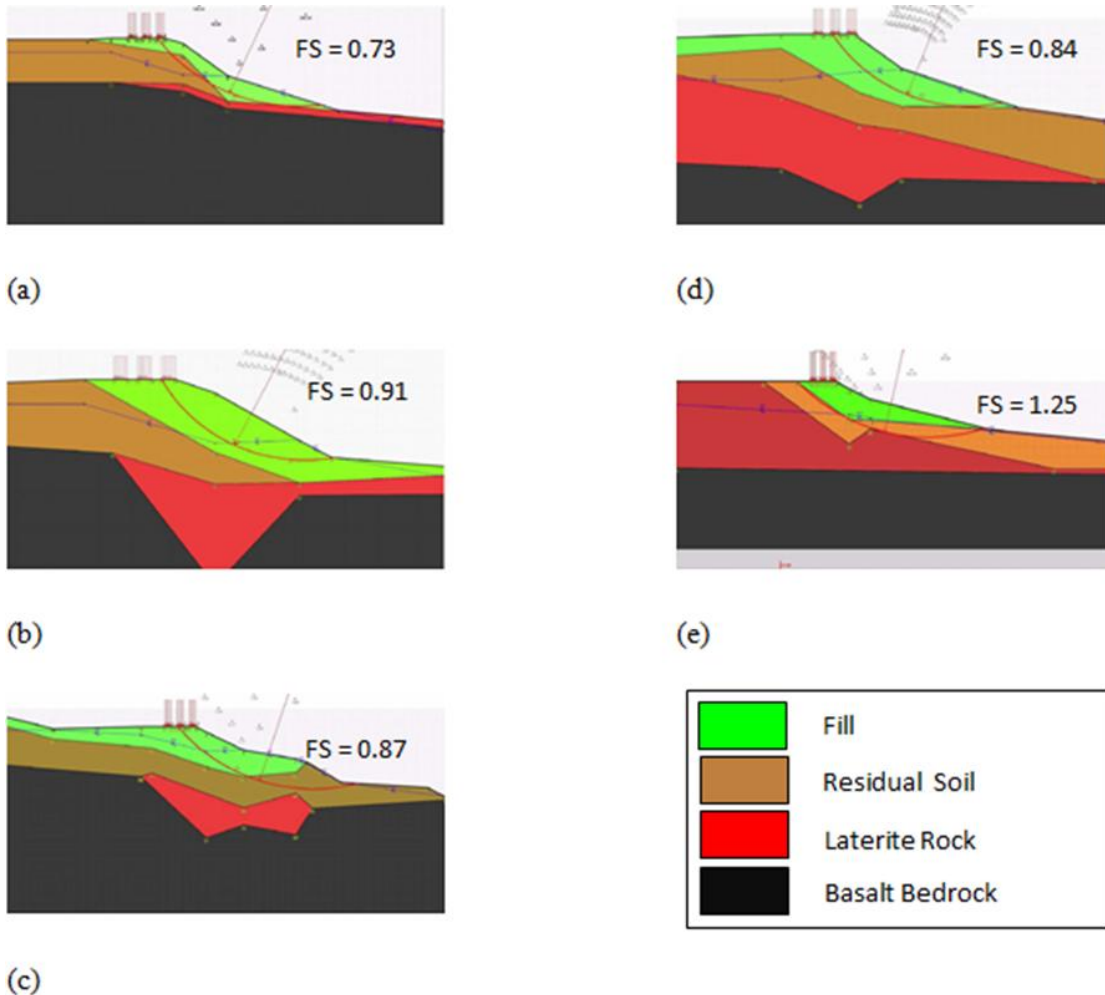
Figures 12a-e. Safety factor during wet season with modified parameters for section: (a) A-A; (b) B-B; (c) C-C; (d) D-D; and (e) E-E.

Figures 12a to 12e show the minimum safety factor and the location of critical circles in sections A-A to E-E for the wet (monsoon) season. In all the figures, the critical slip circle passes through the toe of the embankment, which is similar to the observations made at the site (see Figure 5). Similarly, the top of the circle in Figure 12c intersects the rail tracks and lie close to point X in Figure 2. The safety factor of all the 5 sections for the dry and the wet seasons are compared in Table 8. As can be seen, the safety factor reduced to less than one with the rise in ground water table in all sections, except in section EE. Figure 12e shows that only section E-E was stable during the wet season. This section was far beyond the failure zone shown in Figure 7. Regardless of the above observation, it is plausible that factors such as deep-rooted trees present at the site may have affected the safety factor. All the same, the effect of vegetation on the slope stability cannot readily be incorporated within this simplistic framework (Bernhardt et al. 2011).

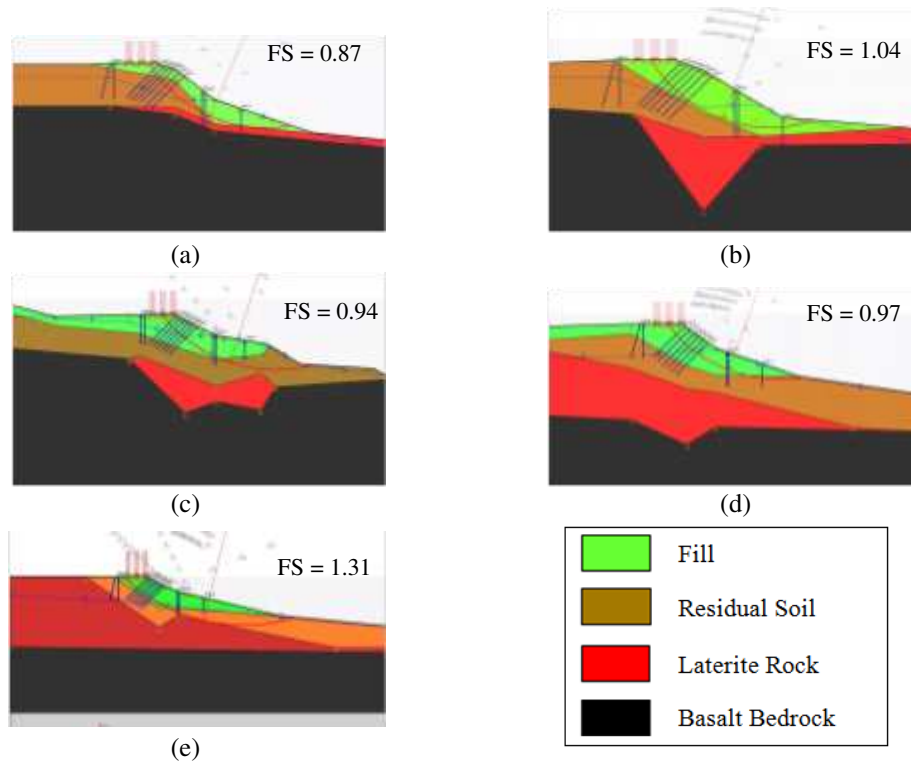
Soil nails and micropiles were installed in November 2005. These reinforcements failed and could not arrest the slope movement during the 2006 monsoon. Subsequently, two new rows of micropiles installed in January 2007 also failed during the 2008 monsoon. It was therefore appropriate to also study the stability of the 2006 and 2008 reinforced slope failures. In this analysis, the location, diameter and spacing of the reinforcement elements were taken from Table 1. Ground conditions and the slope geometry were identical to those used in the previous case. Figures 14a-e and 15a-e show the minimum safety factors and the location of critical circles in sections A-A to E-E for the 2006 and 2008 wet (monsoon) season, respectively. As can be seen, the safety factor is less than one in sections A-A, C-C and D-D for both years, indicating that the soil nails and micropiles installed in November 2005 and January 2007 were indeed inadequate to resist the slope movement. It is also interesting to note from Figures 12a-e and 14a-e to 15a-e that the reinforcement has little influence on the shape and size of the critical slip circle.

Figures 14a-e. Safety factor and critical slip circle during wet season with November 2005 ground improvement scheme for section: (a) A-A; (b) B-B; (c) C-C; (d) D-D; and (e) E-E.

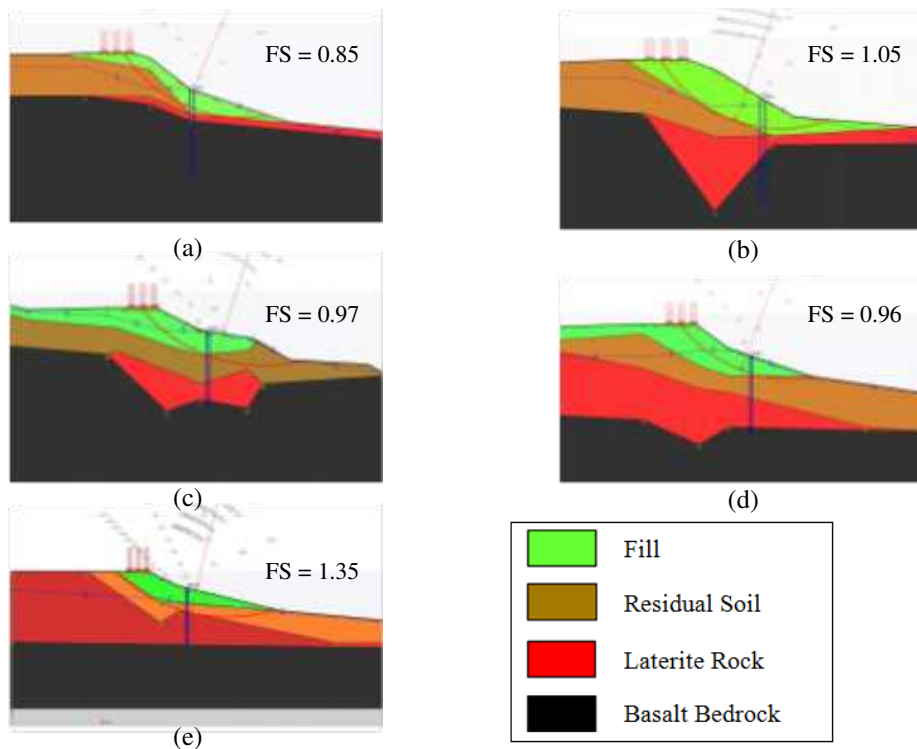
Figures 15a-e. Safety factor and critical slip circle during wet season with January 2007 ground improvement scheme for section: (a) A-A; (b) B-B; (c) C-C; (d) D-D; and (e) E-E.

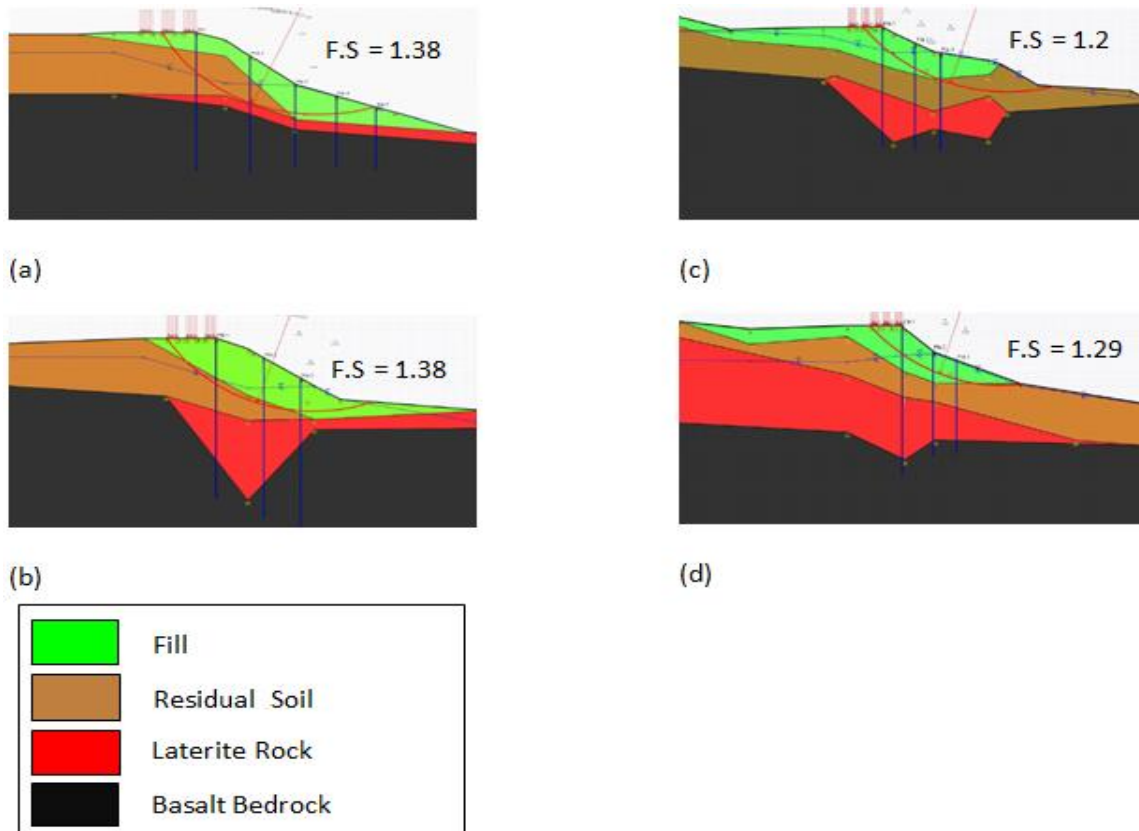
Figures 17a-d. Safety factor during wet season with proposed contiguous bored pile for section: (a) A-A; (b) B-B; (c) C-C; and (d) D-D.

One possible solution to enhance the stability of the slope was with the use of large diameter piles to retain the (failed) soil mass. In this case, safety factors of sections A-A to E-E were also deduced by assuming that the slope was reinforced with single or multiple rows of contiguous bored pile wall constructed parallel to the platform. Figure 16 shows the schematic layout of the proposed bored pile wall. The 1.2m diameter piles terminated below the slightly-to-moderately weathered basalt rock because of which sections B-B and C-C had long piles to provide adequate anchorage (Table 3). Table 9 shows the location and length of the piles used in the analysis. Figures 17a-d show the minimum safety factor and the location of critical circles in sections A-A to D-D for the wet season when the slope is reinforced with contiguous bored pile wall. As can be seen, the minimum safety factor increased up to 1.2 and 1.38 with the use of contiguous bored pile wall.

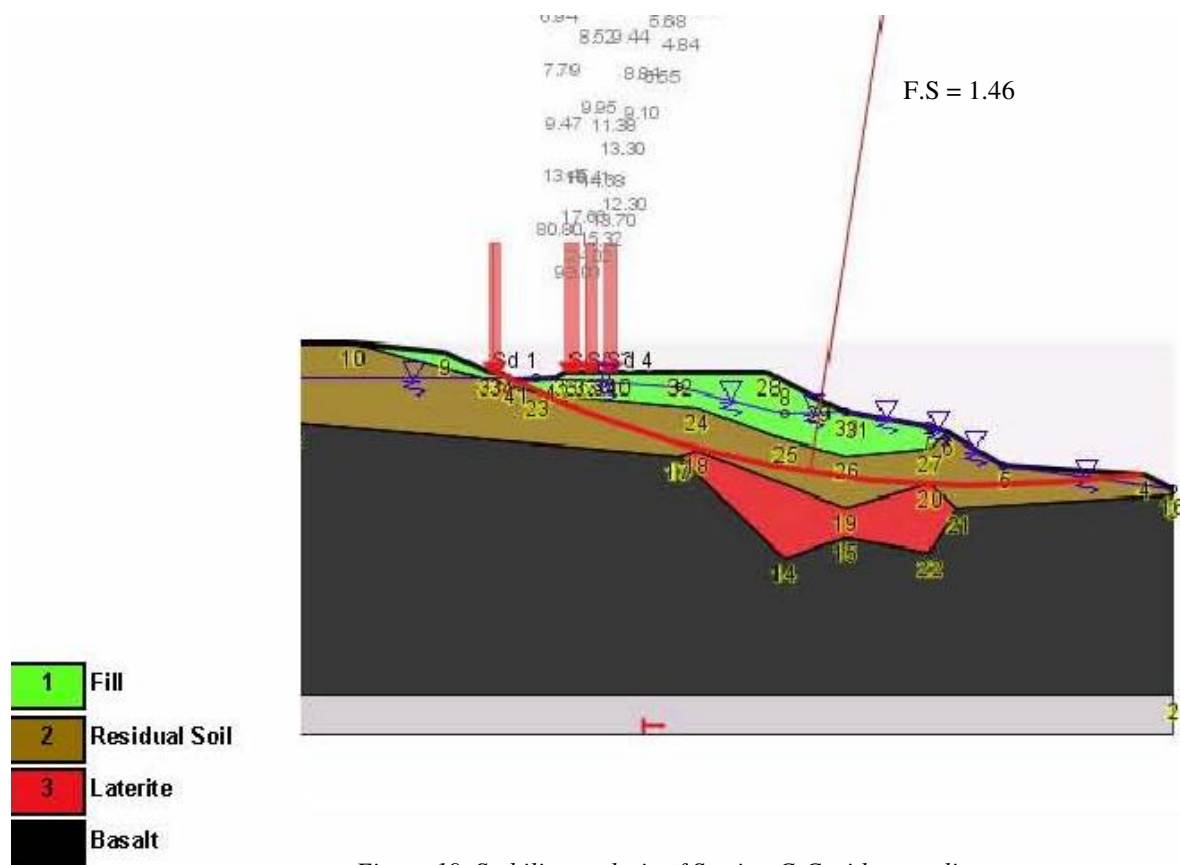
Figure 19. Stability analysis of Section C-C with new alignment.

The cost to use the bored pile wall was over 200 million Indian Rupees (US\$ 3.6 million) and appeared to be prohibitive. As an alternative to this design, the old rail alignment was removed and replaced by a new alignment. The new alignment consisted of 3 loop-lines and 1 main-line. Figure 18 shows section C-C along with the location of the new alignment. In this section, the top left side of the hill was slightly levelled to accommodate the main line and the loop lines. Section C-C was chosen because the new alignment was closest to the failure surface at this section. The horizontal distance from the vertex of the failure surface and the 4 lines was 16m, 21.3m, 26.2m and 46.4m, respectively. The stability of the slope was then reinvestigated using the computer program Talren-4 (Terrasol 2005). As in the previous case, all the lines were loaded by 125 kN/m<sup>2</sup>. This assumption was unduly conservative in absence of strict guidelines (RDSO 2003b). Nonetheless, it permitted trains with more overtaking opportunities on the passing-loops. The ground water level was modeled using the highest RL recorded in Table 5. The failure circles are shown in Figure 19. As can be seen, the minimum safety factor is

more than 1.4. The slope was therefore considered to be safe and unlikely to fail under the new loads. This new alignment has been implemented since 2011. It has been constructed at less than 20 percent of the cost incurred to improve the ground. The railways have also removed the speed restriction at Nivsar which has resulted in additional savings during the monsoon.
