Embankment Failure in Residual Soils at Nivsar, Ratnagiri

ABSTRACT: *The Nivsar Yard embankment was constructed by the Konkan Railways in 1994. Near the station building, the 22m high embankment runs parallel to the Kajali River for a stretch of about 100m. This stretch has experienced failure and settlement related problems since the record-breaking July 2005 rainfall. Corrective ground improvement measures were implemented immediately after the monsoon. However, these measures were inadequate because the failure surface reappeared during the following monsoon. The failure surface mirrored the shape and size of the failure observed in 2005. Since then after nearly every monsoon, the embankment has moved despite precautionary measures taken by the railway to arrest the movement. The hydrogeological and geotechnical properties which affect slope stability are first discussed. The stability of the embankment is then evaluated at 5 sections drawn along the slope. Two cases are considered. In the first case, the stability of the unreinforced slope is calculated. In the second case, calculations are done using the slope reinforced with soil nails and micropiles installed in 2005 and 20

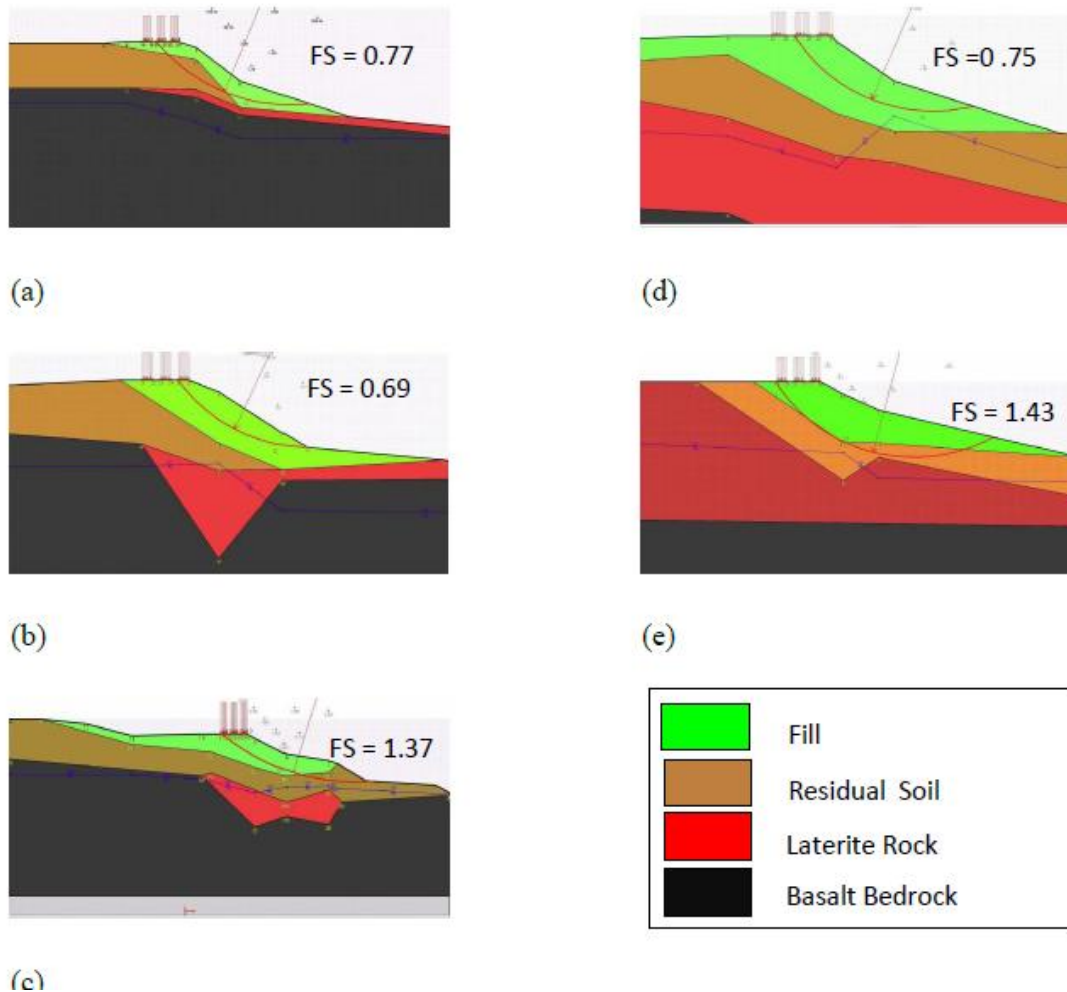
Figures 11a-e show the minimum safety factor and the location of the critical circle in sections A-A to E-E for the dry season. It is surprising to note that the minimum safety factor in 3 out of 4 sections is less than one, despite the fact that the slope was known to be stable and did not show any distress during the dry season. These sections are A-A, B-B and D-D in the figures. Figures 11a to 11e also show that the ground water level is below the critical failure circle in all 4 cases. Therefore, even if it is argued that the hydrological conditions which led to the 2005 failure and those measured in 2010 and 2011 may not be the same, it is unlikely that the position of the water table could influence the stability of the slope during the dry season.

Figures 11a-e. Safety factor during dry season with original parameters for section: (a) A-A; (b) B-B; (c) C-C; (d) D-D; and (e) E-E.

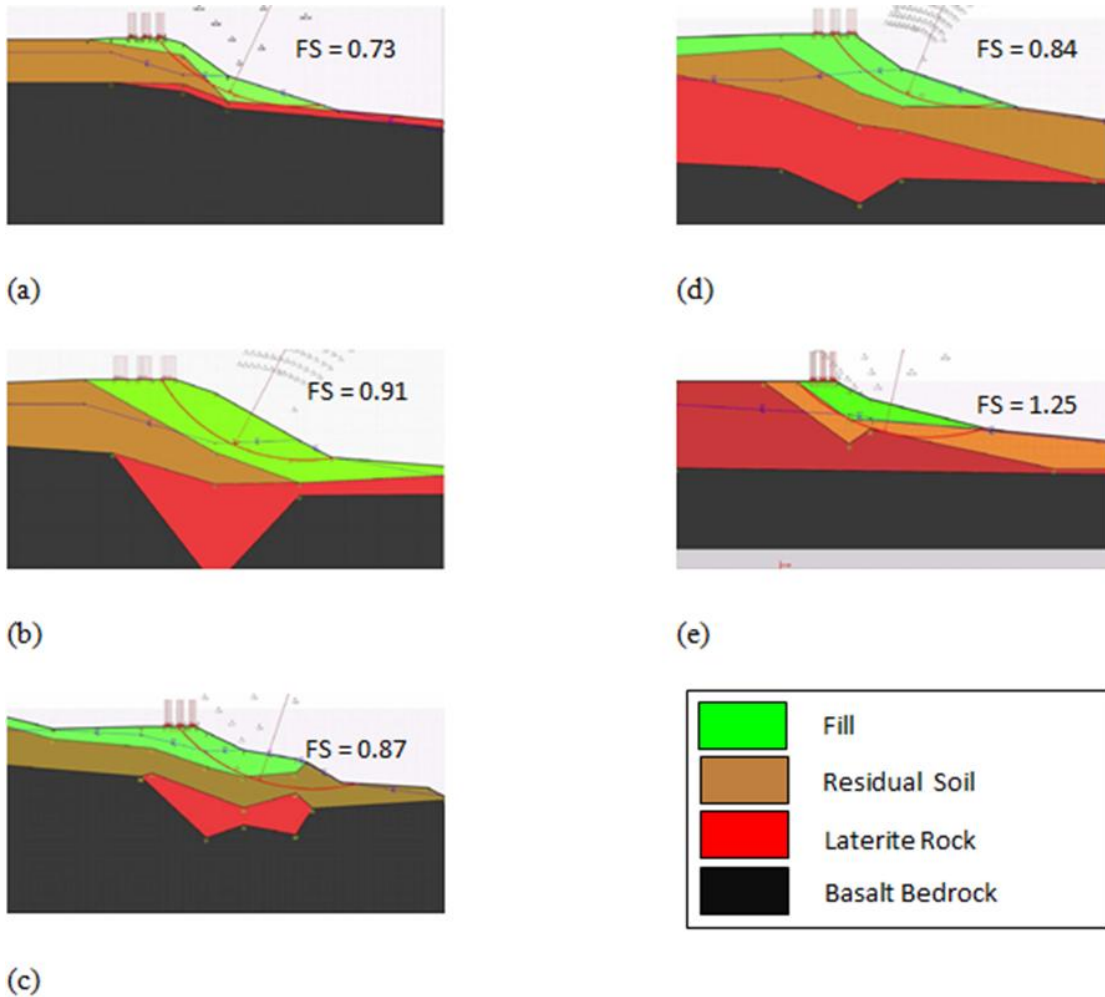
Figures 12a-e. Safety factor during wet season with modified parameters for section: (a) A-A; (b) B-B; (c) C-C; (d) D-D; and (e) E-E.

Figures 12a to 12e show the minimum safety factor and the location of critical circles in sections A-A to E-E for the wet (monsoon) season. In all the figures, the critical slip circle passes through the toe of the embankment, which is similar to the observations made at the site (see Figure 5). Similarly, the top of the circle in Figure 12c intersects the rail tracks and lie close to point X in Figure 2. The safety factor of all the 5 sections for the dry and the wet seasons are compared in Table 8. As can be seen, the safety factor reduced to less than one with the rise in ground water table in all sections, except in section EE. Figure 12e shows that only section E-E was stable during the wet season. This section was far beyond the failure zone shown in Figure 7. Regardless of the above observation, it is plausible that factors such as deep-rooted trees present at the site may have affected the safety factor. All the same, the effect of vegetation on the slope stability cannot readily be incorporated within this simplistic framework (Bernhardt et al. 2011).

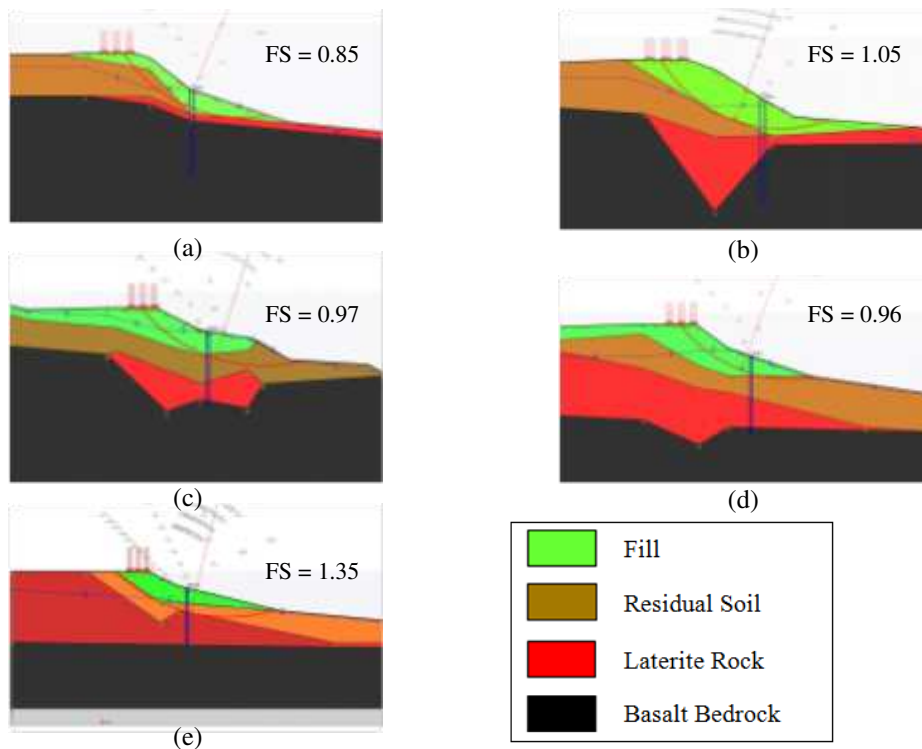
Soil nails and micropiles were installed in November 2005. These reinforcements failed and could not arrest the slope movement during the 2006 monsoon. Subsequently, two new rows of micropiles installed in January 2007 also failed during the 2008 monsoon. It was therefore appropriate to also study the stability of the 2006 and 2008 reinforced slope failures. In this analysis, the location, diameter and spacing of the reinforcement elements were taken from Table 1. Ground conditions and the slope geometry were identical to those used in the previous case. Figures 14a-e and 15a-e show the minimum safety factors and the location of critical circles in sections A-A to E-E for the 2006 and 2008 wet (monsoon) season, respectively. As can be seen, the safety factor is less than one in sections A-A, C-C and D-D for both years, indicating that the soil nails and micropiles installed in November 2005 and January 2007 were indeed inadequate to resist the slope movement. It is also interesting to note from Figures 12a-e and 14a-e to 15a-e that the reinforcement has little influence on the shape and size of the critical slip circle.

Figures 15a-e. Safety factor and critical slip circle during wet season with January 2007 ground improvement scheme for section: (a) A-A; (b) B-B; (c) C-C; (d) D-D; and (e) E-E.

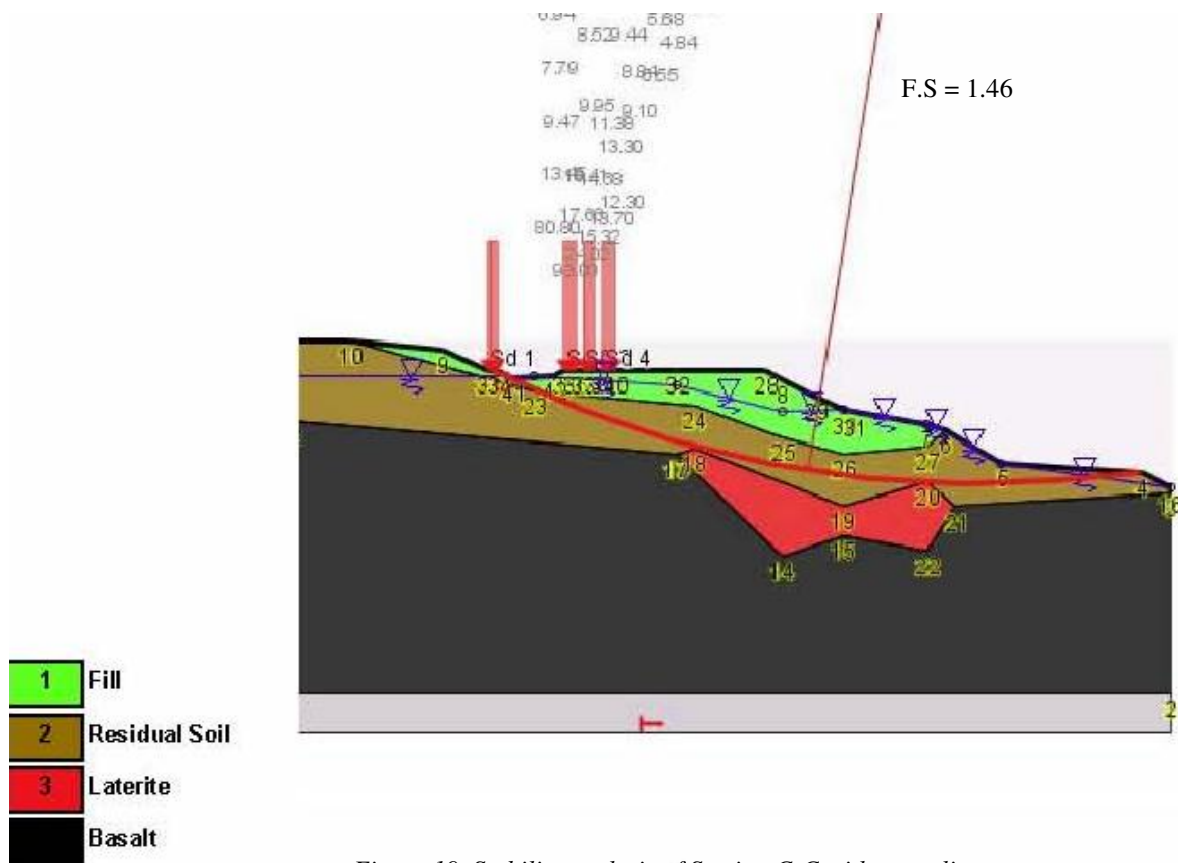
Figure 19. Stability analysis of Section C-C with new alignment.

The cost to use the bored pile wall was over 200 million Indian Rupees (US\$ 3.6 million) and appeared to be prohibitive. As an alternative to this design, the old rail alignment was removed and replaced by a new alignment. The new alignment consisted of 3 loop-lines and 1 main-line. Figure 18 shows section C-C along with the location of the new alignment. In this section, the top left side of the hill was slightly levelled to accommodate the main line and the loop lines. Section C-C was chosen because the new alignment was closest to the failure surface at this section. The horizontal distance from the vertex of the failure surface and the 4 lines was 16m, 21.3m, 26.2m and 46.4m, respectively. The stability of the slope was then reinvestigated using the computer program Talren-4 (Terrasol 2005). As in the previous case, all the lines were loaded by 125 kN/m². This assumption was unduly conservative in absence of strict guidelines (RDSO 2003b). Nonetheless, it permitted trains with more overtaking opportunities on the passing-loops. The ground water level was modeled using the highest RL recorded in Table 5. The failure circles are shown in Figure 19. As can be seen, the minimum safety factor is

more than 1.4. The slope was therefore considered to be safe and unlikely to fail under the new loads. This new alignment has been implemented since 2011. It has been constructed at less than 20 percent of the cost incurred to improve the ground. The railways have also removed the speed restriction at Nivsar which has resulted in additional savings during the monsoon.
