Embankment Failure in Residual Soils at Nivsar, Ratnagiri

ABSTRACT: *The Nivsar Yard embankment was constructed by the Konkan Railways in 1994. Near the station building, the 22m high embankment runs parallel to the Kajali River for a stretch of about 100m. This stretch has experienced failure and settlement related problems since the record-breaking July 2005 rainfall. Corrective ground improvement measures were implemented immediately after the monsoon. However, these measures were inadequate because the failure surface reappeared during the following monsoon. The failure surface mirrored the shape and size of the failure observed in 2005. Since then after nearly every monsoon, the embankment has moved despite precautionary measures taken by the railway to arrest the movement. The hydrogeological and geotechnical properties which affect slope stability are first discussed. The stability of the embankment is then evaluated at 5 sections drawn along the slope. Two cases are considered. In the first case, the stability of the unreinforced slope is calculated. In the second case, calculations are done using the slope reinforced with soil nails and micropiles installed in 2005 and 20

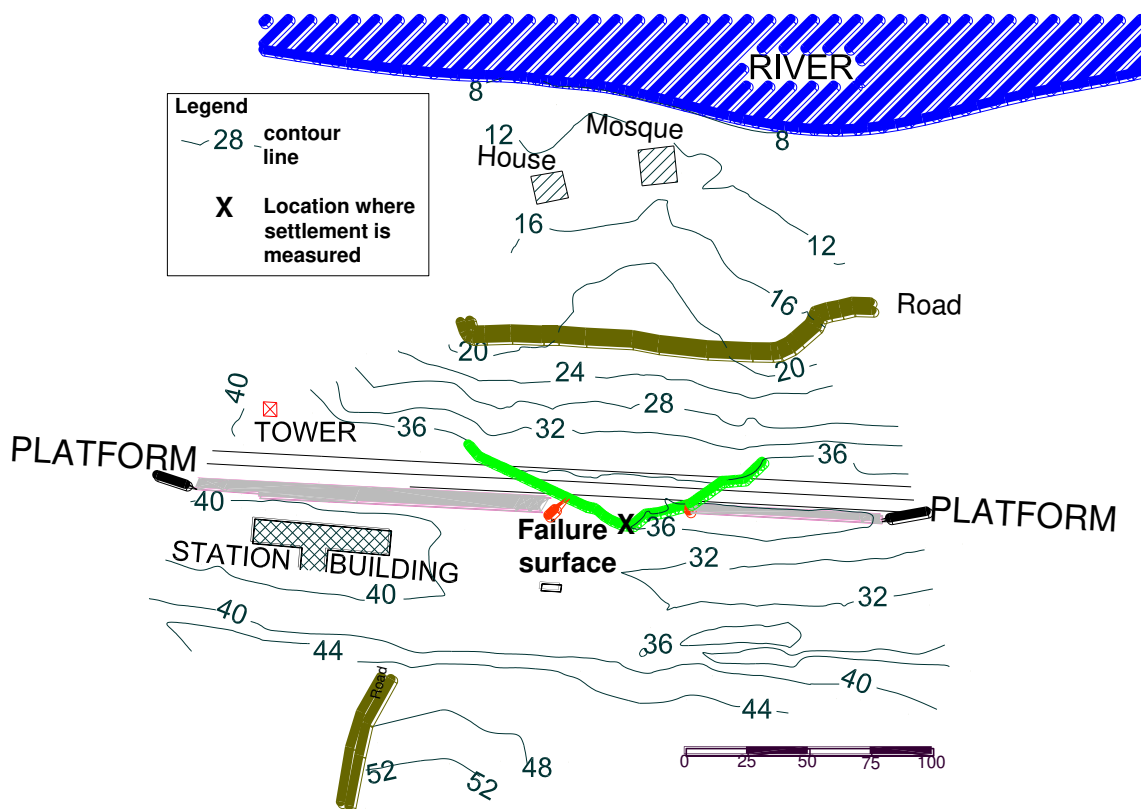
site until the year 2005. In that year, cracks in the embankment developed between chainage km 218.8 and 218.9 following record-breaking rainfall. Heavy rain occurred for 3 days between July 24th and 26th. Cracks opened up to 20mm width over a period of 15 to 20 days. During the same time, the slope settled by more than 150mm. The total settlement was about 550mm towards the end of the 2005 monsoon. At the end of this period, the cracks took shape of a parabola with its vertex close to the station platform. The parabola sloped downhill for about 100 to 120m towards the river. Figure 2 shows the extent of the slope failure observed in 2005.

Figure 2. Failure at Nivsar Yard Embankment

Soon after the observed failure, and when the 2005 monsoon was over, soil nails and micro-piles were installed to prevent further damage to the embankment. Table 1 shows details of the ground improvement works undertaken at the site in 2005. However, the 100mm wide and 130m long crack reappeared during the 2006 monsoon. As in the previous year, the crack encompassed all 3 railway lines, including the main line. The shape and size of the crack mirrored the shape and size observed following the 2005 monsoon. The embankment settled throughout the 2006 monsoon reaching a high value of 2930mm at the station platform.
