Embankment Failure in Residual Soils at Nivsar, Ratnagiri

ABSTRACT: The Nivsar Yard embankment was constructed by the Konkan Railways in 1994. Near the station building, the 22m high embankment runs parallel to the Kajali River for a stretch of about 100m. This stretch has experienced failure and settlement related problems since the record-breaking July 2005 rainfall. Corrective ground improvement measures were implemented immediately after the monsoon. However, these measures were inadequate because the failure surface reappeared during the following monsoon. The failure surface mirrored the shape and size of the failure observed in 2005. Since then after nearly every monsoon, the embankment has moved despite precautionary measures taken by the railway to arrest the movement. The hydrogeological and geotechnical properties which affect slope stability are first discussed. The stability of the embankment is then evaluated at 5 sections drawn along the slope. Two cases are considered. In the first case, the stability of the unreinforced slope is calculated. In the second case, calculations are done using the slope reinforced with soil nails and micropiles installed in 2005 and 200

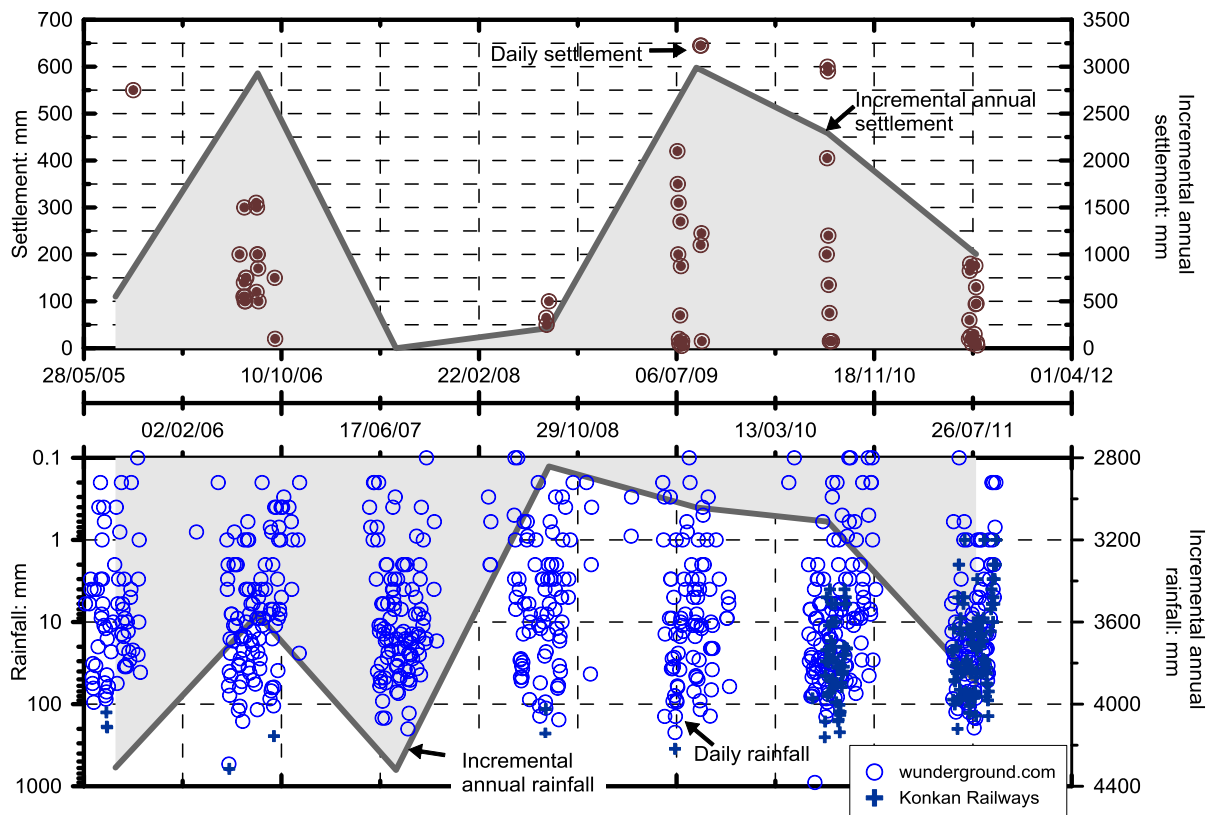
Figure 3 shows the recorded settlement of the embankment from the year 2005. The settlement was measured at top of the embankment near the station platform and its location is shown in Figure 2. Figure 3 also shows the record of rainfall in this region. The rainfall record was obtained from the web pages of <http://www.wunderground.com/> and from the data maintained by Konkan Railways. A clear trend between the magnitude of rainfall and slope movement can be observed in Figure 3. For instance, rainfall of over 200mm per day was invariably followed by more than 100mm settlement every year except during the 2007 and 2008 monsoons. The embankment did not move during the 2007 monsoon. Movement occurred only after more than half of the 2008 monsoon was complete. It appears that the stabilisation work completed before the onset of the 2007 monsoon was insufficient and effective only for a year, before losing effectiveness during the 2008 monsoon. It is likely that the slip planes redeveloped along the original failure surface during the 2008 ground failure. All effects of the soil improvement vanished before the onset of the 2009 monsoon, resulting in rapid movement of the embankment towards the river. The failure cracks that developed in 2009 are shown in Figures 4a-c. Figures 4a and b show the top few meters of the micro-piles that were exposed because of the steady soil-flow down the hill, and Figure 4c shows the transverse cracks observed along the road.

Figure 3. Settlement and rainfall record at Nivsar Yard Embankment.

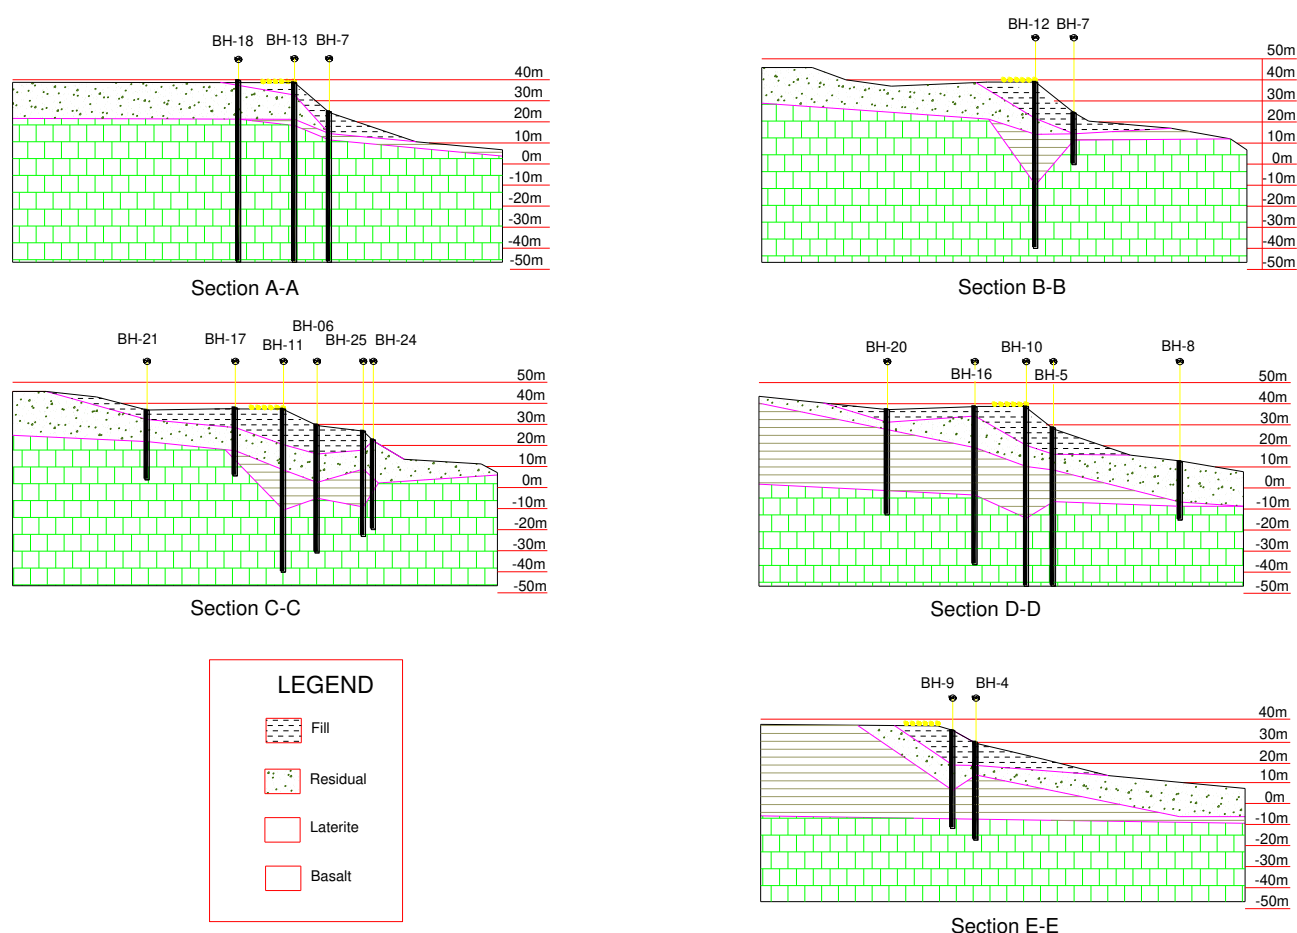
Using the borehole data, five cross-sections were drawn to interpret the subsurface profile of the site. The five sections are marked as A-A to E-E in Figure 7 and are shown in Figure 9. Sections B-B to D-D were chosen to represent the edges and centre of the failure zone. Laterites were nearly absent in section A-A and had the maximum presence in section D-D. The average geotechnical properties at each section are shown in Table 4. The material properties in Table 4 were obtained from the field and laboratory testing programme monitored jointly by Konkan Railways and IIT Bombay. Direct shear tests were conducted to obtain c' and ϕ' . Unconsolidated undrained (UU) triaxial tests were conducted to obtain c_u . The secant Young's modulus, E , of selected samples was obtained from stress-strain curves on UU samples confined with 50 to 200 kN/m² mean stress. Unconfined compression tests were conducted to obtain the c_u of laterites and basalt.

Figure 9. Subsurface profile at the site. Location of sections A-A to E-E are as per Figure 7.

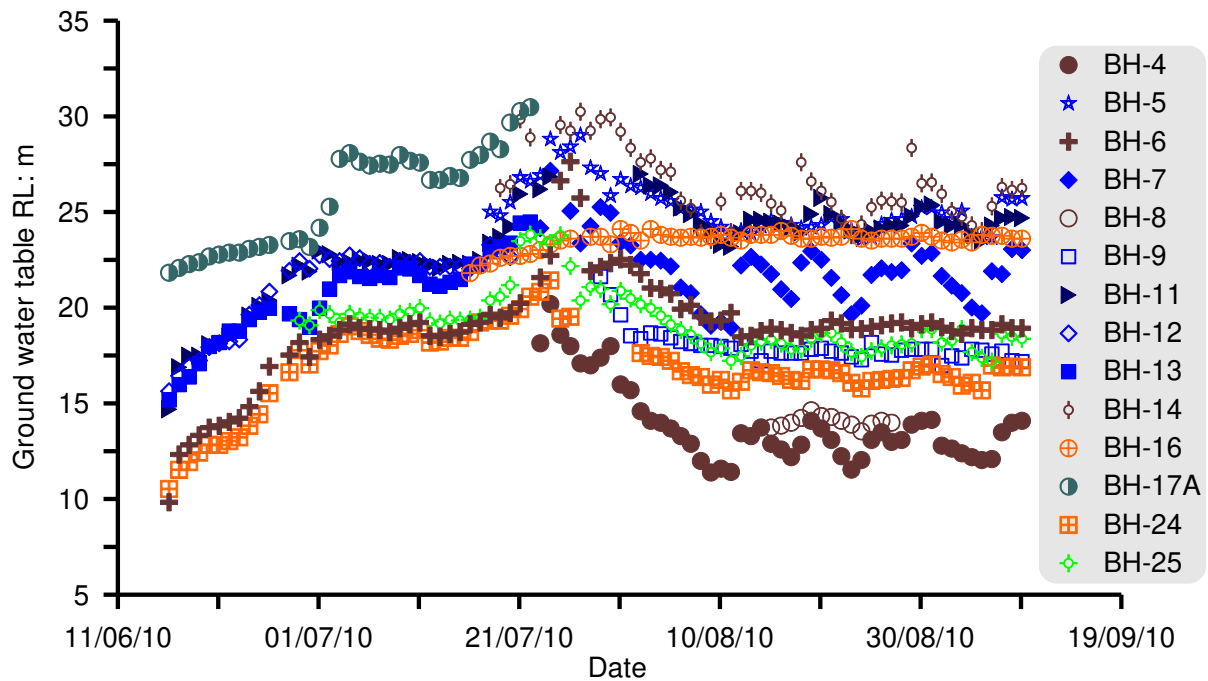
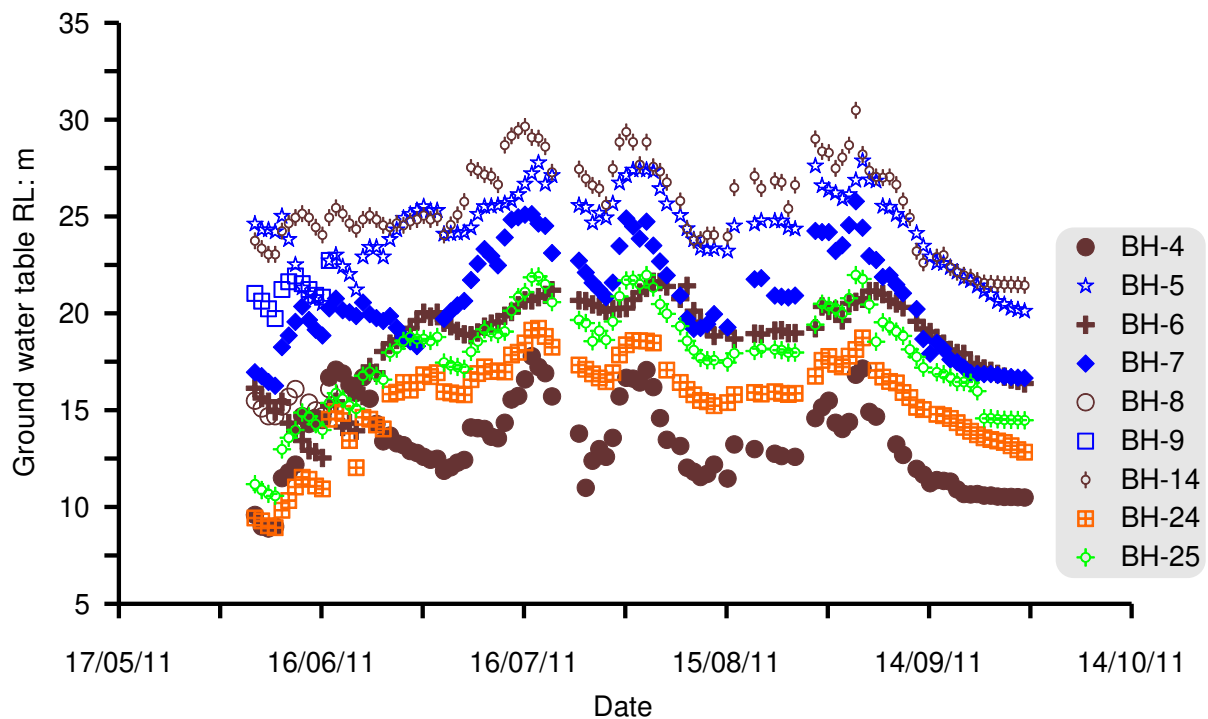
Standpipes were installed in the boreholes after the completion of the drilling. Ground water depths were occasionally recorded in these standpipes for about two years. Figures 10a and 10b show the water table recorded in 2010 and 2011, respectively. The slope movement during the 2010 and 2011 monsoons, sheared-off some of the standpipes. As a result a complete record of ground water data is not available over the monitoring period at these locations. The maximum and minimum water table depths are summarised in Table 5. A few observations may be made from Figures 10a-b and Table 5. First, the water table changed from 12.5m to 20m over the monitoring period in boreholes which were drilled along the centre-line of the failure surface. This variation in the water level possibly created a large pressure gradient. Second, the seasonal variation in the water level was more than 9m in boreholes drilled within the failure zone. There was significant variation in the water level even outside the failure surface. For example, the pressure head difference between boreholes BH-7 and BH-12 was more than 17m although the boreholes were only about 35m apart. Inevitably, these large pressure head difference caused large groundwater flow and significant seepage forces.

Figures 10a-b. Water table in standpipes: (a) In 2010; and (b) In 2011.

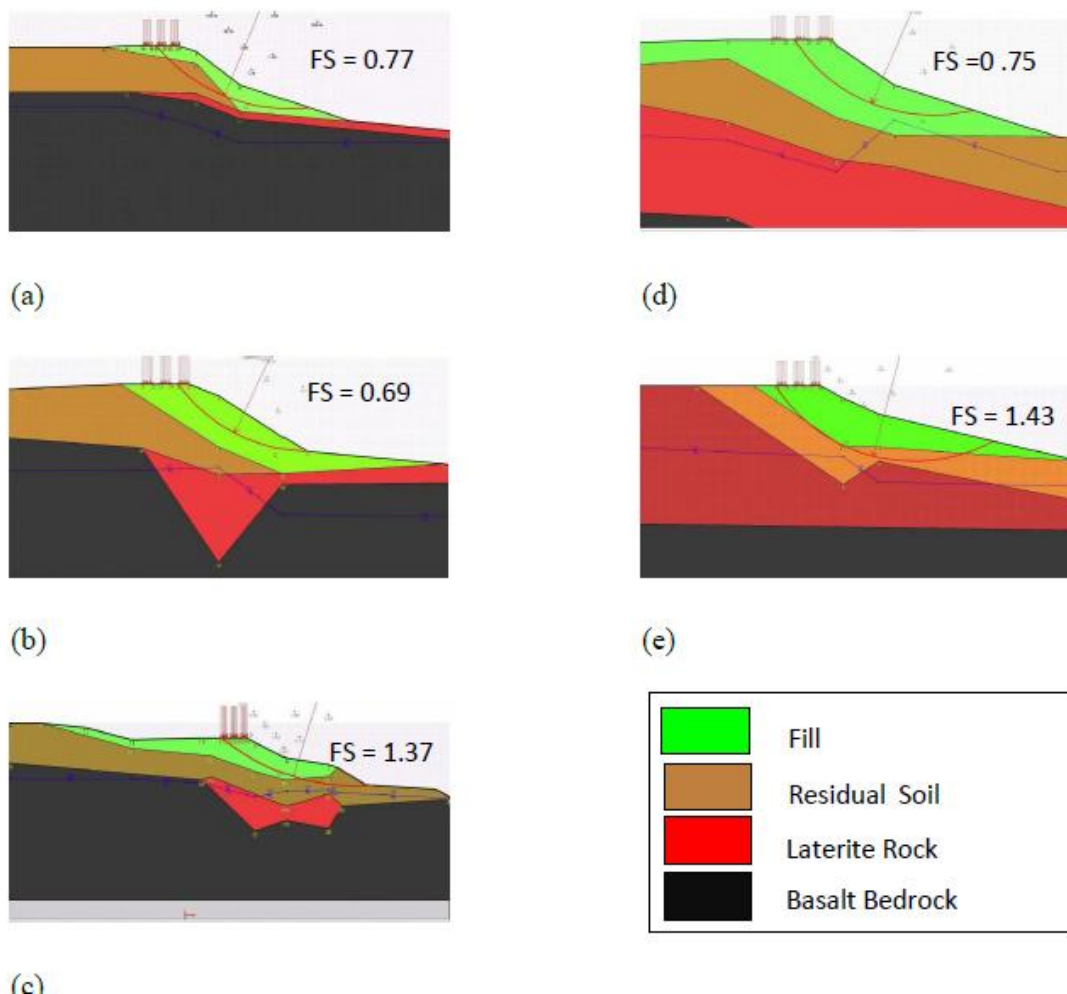
Figures 11a-e show the minimum safety factor and the location of the critical circle in sections A-A to E-E for the dry season. It is surprising to note that the minimum safety factor in 3 out of 4 sections is less than one, despite the fact that the slope was known to be stable and did not show any distress during the dry season. These sections are A-A, B-B and D-D in the figures. Figures 11a to 11e also show that the ground water level is below the critical failure circle in all 4 cases. Therefore, even if it is argued that the hydrological conditions which led to the 2005 failure and those measured in 2010 and 2011 may not be the same, it is unlikely that the position of the water table could influence the stability of the slope during the dry season.

Figures 11a-e. Safety factor during dry season with original parameters for section: (a) A-A; (b) B-B; (c) C-C; (d) D-D; and (e) E-E.

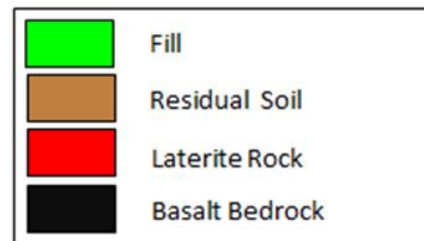
Figures 12a-e. Safety factor during wet season with modified parameters for section: (a) A-A; (b) B-B; (c) C-C; (d) D-D; and (e) E-E.

Figures 12a to 12e show the minimum safety factor and the location of critical circles in sections A-A to E-E for the wet (monsoon) season. In all the figures, the critical slip circle passes through the toe of the embankment, which is similar to the observations made at the site (see Figure 5). Similarly, the top of the circle in Figure 12c intersects the rail tracks and lie close to point X in Figure 2. The safety factor of all the 5 sections for the dry and the wet seasons are compared in Table 8. As can be seen, the safety factor reduced to less than one with the rise in ground water table in all sections, except in section EE. Figure 12e shows that only section E-E was stable during the wet season. This section was far beyond the failure zone shown in Figure 7. Regardless of the above observation, it is plausible that factors such as deep-rooted trees present at the site may have affected the safety factor. All the same, the effect of vegetation on the slope stability cannot readily be incorporated within this simplistic framework (Bernhardt et al. 2011).

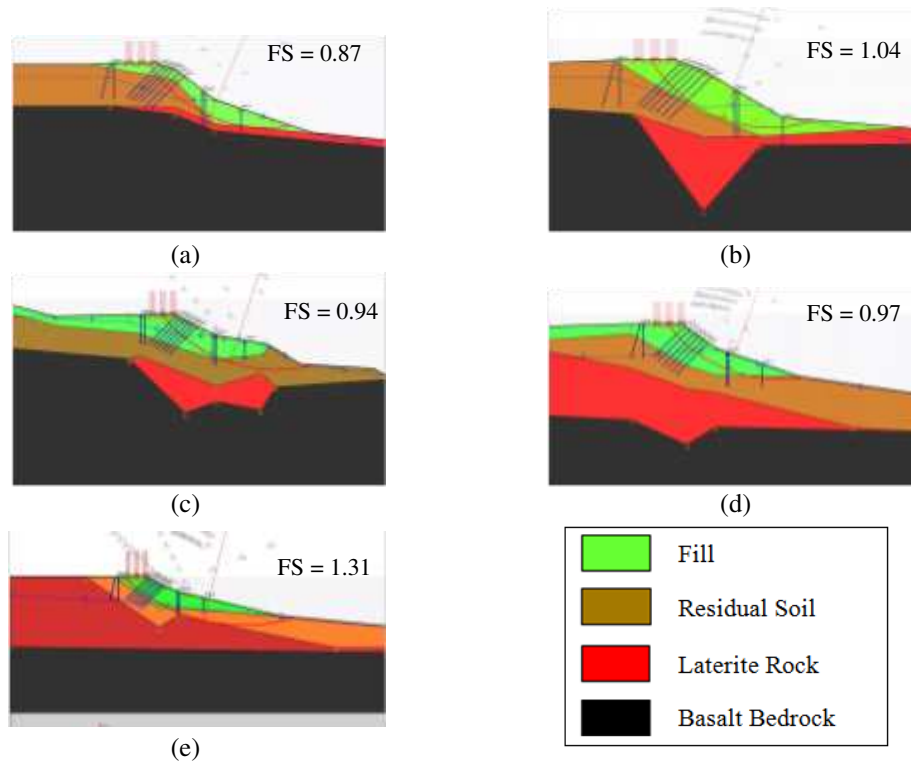
Soil nails and micropiles were installed in November 2005. These reinforcements failed and could not arrest the slope movement during the 2006 monsoon. Subsequently, two new rows of micropiles installed in January 2007 also failed during the 2008 monsoon. It was therefore appropriate to also study the stability of the 2006 and 2008 reinforced slope failures. In this analysis, the location, diameter and spacing of the reinforcement elements were taken from Table 1. Ground conditions and the slope geometry were identical to those used in the previous case. Figures 14a-e and 15a-e show the minimum safety factors and the location of critical circles in sections A-A to E-E for the 2006 and 2008 wet (monsoon) season, respectively. As can be seen, the safety factor is less than one in sections A-A, C-C and D-D for both years, indicating that the soil nails and micropiles installed in November 2005 and January 2007 were indeed inadequate to resist the slope movement. It is also interesting to note from Figures 12a-e and 14a-e to 15a-e that the reinforcement has little influence on the shape and size of the critical slip circle.

Figures 14a-e. Safety factor and critical slip circle during wet season with November 2005 ground improvement scheme for section: (a) A-A; (b) B-B; (c) C-C; (d) D-D; and (e) E-E.

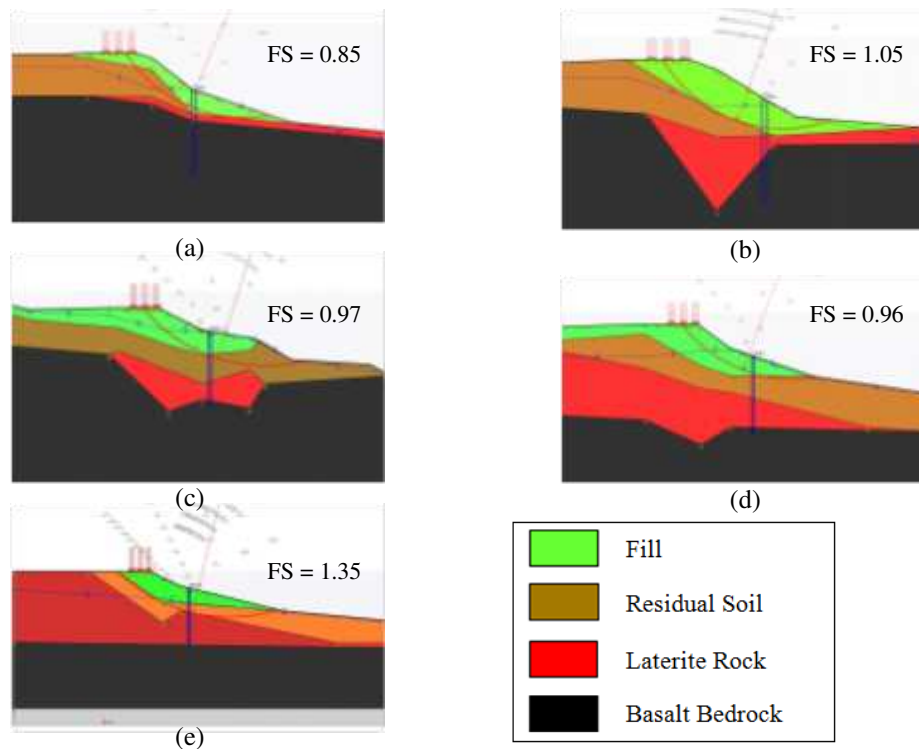
Figures 15a-e. Safety factor and critical slip circle during wet season with January 2007 ground improvement scheme for section: (a) A-A; (b) B-B; (c) C-C; (d) D-D; and (e) E-E.

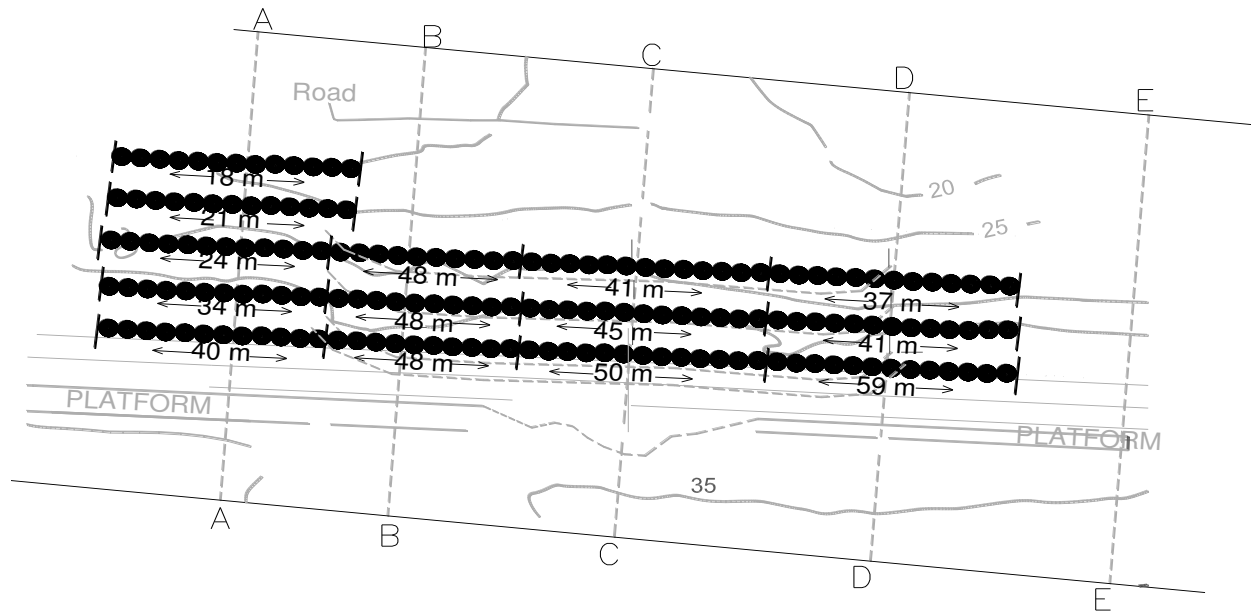
Figure 16. Schematic layout of the proposed 1.2m diameter bored pile wall at 1.2m c/c (contiguous bored pile wall). Note: Numbers below the piles indicate length of the piles.

One possible solution to enhance the stability of the slope was with the use of large diameter piles to retain the (failed) soil mass. In this case, safety factors of sections A-A to E-E were also deduced by assuming that the slope was reinforced with single or multiple rows of contiguous bored pile wall constructed parallel to the platform. Figure 16 shows the schematic layout of the proposed bored pile wall. The 1.2m diameter piles terminated below the slightly-to-moderately weathered basalt rock because of which sections B-B and C-C had long piles to provide adequate anchorage (Table 3). Table 9 shows the location and length of the piles used in the analysis. Figures 17a-d show the minimum safety factor and the location of critical circles in sections A-A to D-D for the wet season when the slope is reinforced with contiguous bored pile wall. As can be seen, the minimum safety factor increased up to 1.2 and 1.38 with the use of contiguous bored pile wall.

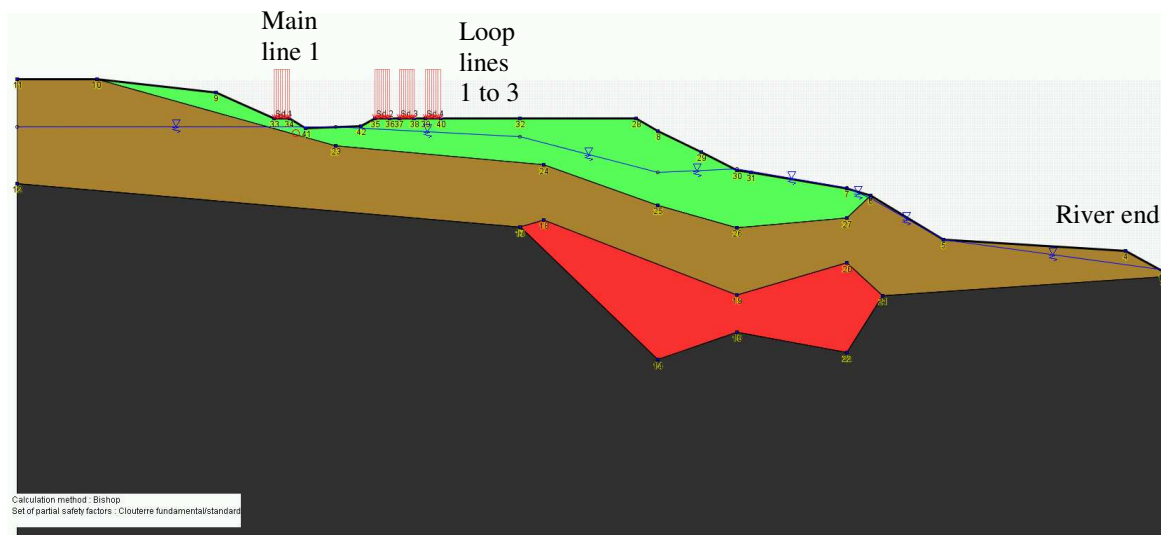
Figure 18. Section C-C with new rail alignment. The main alignment consists of 3 loop lines and 1 main line.

The cost to use the bored pile wall was over 200 million Indian Rupees (US\$ 3.6 million) and appeared to be prohibitive. As an alternative to this design, the old rail alignment was removed and replaced by a new alignment. The new alignment consisted of 3 loop-lines and 1 main-line. Figure 18 shows section C-C along with the location of the new alignment. In this section, the top left side of the hill was slightly levelled to accommodate the main line and the loop lines. Section C-C was chosen because the new alignment was closest to the failure surface at this section. The horizontal distance from the vertex of the failure surface and the 4 lines was 16m, 21.3m, 26.2m and 46.4m, respectively. The stability of the slope was then reinvestigated using the computer program Talren-4 (Terrasol 2005). As in the previous case, all the lines were loaded by 125 kN/m². This assumption was unduly conservative in absence of strict guidelines (RDSO 2003b). Nonetheless, it permitted trains with more overtaking opportunities on the passing-loops. The ground water level was modeled using the highest RL recorded in Table 5. The failure circles are shown in Figure 19. As can be seen, the minimum safety factor is
