The July 10 2000 Payatas Landfill Slope Failure

ABSTRACT: *This paper presents an investigation of the slope failure in the Payatas landfill in Quezon City, Philippines. This failure, which killed at least 330 persons, occurred July 10th 2000 after two weeks of heavy rain from two typhoons. Slope stability analyses indicate that the raised leachate level, existence of landfill gas created by natural aerobic and anaerobic degradation, and a significantly over-steepened slope contributed to the slope failure. The Hydrologic Evaluation of Landfill Performance (HELP) model was used to predict the location of the leachate level in the waste at the time of the slope failure for analysis purposes. This paper presents a description of the geological and environmental conditions, identification of the critical failure surface, and slope stability analyses to better understand the failure and present recommendations for other landfills in tropical areas. In addition, this case history is used to evaluate uncertainty in parameters used in back-analysis of a landfill slope failure.*

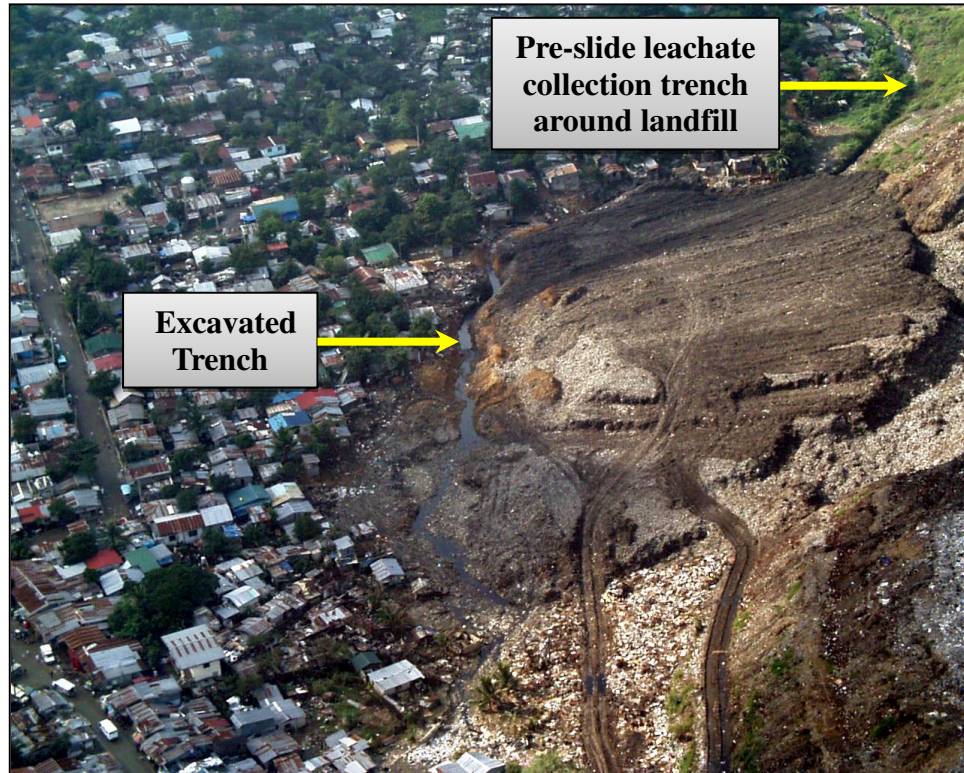
Figure 5 shows a close-up of the slope failure area and scarp in Payatas Landfill. Regrading of the slide mass had started shortly after the failure, which is shown in Figure 5. A leachate collection trench was excavated along the toe of the slide mass and is highlighted by the arrow and text box in Figure 5. The native brown soil underlying the waste and residential area is visible along the toe and sides of this excavated leachate collection trench. Leachate seepage existed prior to and shortly after the slope failure; however, the exact leachate level in the landfill just prior to failure is not known. A smaller landfill leachate collection trench was present along the slope toe prior to the slide and was similar to the trench shown in Figure 4. The leachate collection trench as it existed prior to the slide was covered by the slide mass and hence, is not visible (see the central portion of Figure 5). However, it was visible along the toe of the north-facing slope of the landfill east of the slide mass (see the top of Figure 5 where a small trench separates homes from the landfill toe and is highlighted by an arrow and text box). In summary, Figure 5 indicates that the leachate trench in front of the slide mass was constructed after the slide to collect leachate exiting the slide mass and a considerable volume of leachate existed in the landfill prior to failure but the exact leachate level at failure is not known.

Figure 5. Slope failure showing new and existing leachate trenches along slope toe (photo by S.M. Merry).

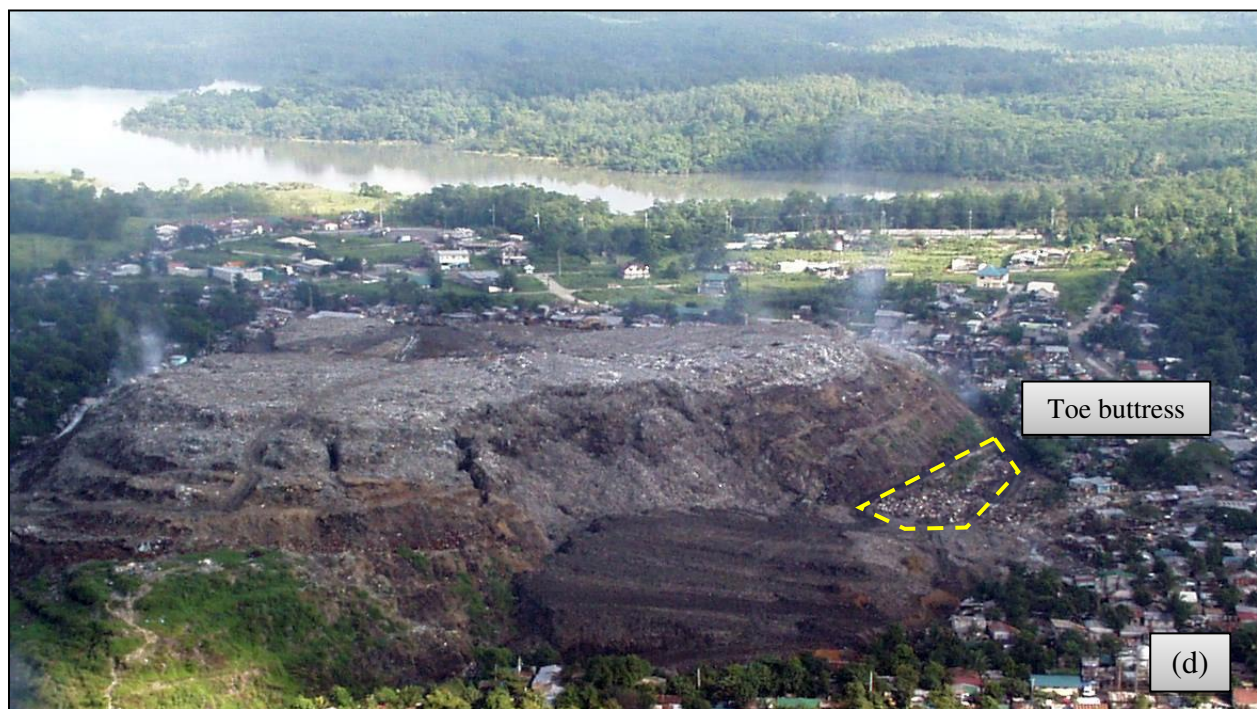
Figure 6 shows a series of aerial views of the waste slide area that were used to understand the failure surface for use in the stability analyses. Figures 6(a) and 6(b) provide side views from the southeast and northwest direction, respectively, of the waste slide. Figure 6(c) highlights benches in the landfill slope, and Figure 6(d) delineates a mildly sloped toe buttress. Digital measurements from these photographs were used to create the cross-section shown in Figure 7. These measurements indicate toe buttress slope angles in the slide area of 1.4H:1V (~35°) to 0.84H:1V (~50°) and steeper side slopes above the buttress that range from 60° to 70° (Bautista, 2007; UNFCCC, 2007). Additionally, site reconnaissance and pictures both indicate that leachate was seeping from this toe buttress.

Figure 6. Slope geometry and failure surface after failure (a) evidence of seeping leachate, (b) representative slope inclination, (c) location of slope benches, (d) toe buttress (photos by S.M. Merry).
