The July 10 2000 Payatas Landfill Slope Failure

ABSTRACT: *This paper presents an investigation of the slope failure in the Payatas landfill in Quezon City, Philippines. This failure, which killed at least 330 persons, occurred July 10th 2000 after two weeks of heavy rain from two typhoons. Slope stability analyses indicate that the raised leachate level, existence of landfill gas created by natural aerobic and anaerobic degradation, and a significantly over-steepened slope contributed to the slope failure. The Hydrologic Evaluation of Landfill Performance (HELP) model was used to predict the location of the leachate level in the waste at the time of the slope failure for analysis purposes. This paper presents a description of the geological and environmental conditions, identification of the critical failure surface, and slope stability analyses to better understand the failure and present recommendations for other landfills in tropical areas. In addition, this case history is used to evaluate uncertainty in parameters used in back-analysis of a landfill slope failure.*

Reference: Jafari, N. H., Stark, T. D., and Merry, S. (2013). *The July 10 2000 Payatas Landfill Slope Failure

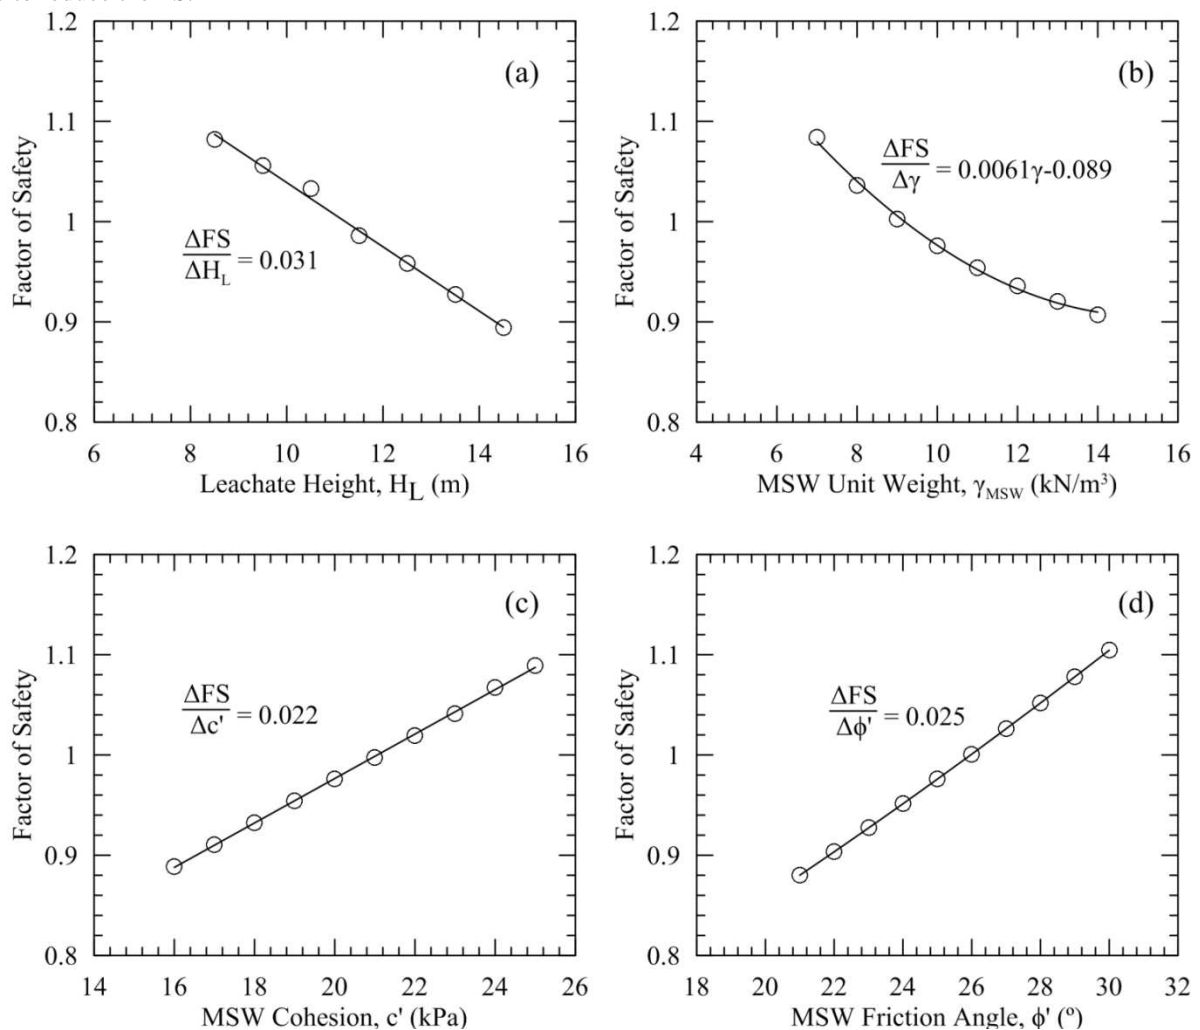
Using site reconnaissance information, pictures, and reports of the wasteslide, an inverse analysis was conducted to estimate the piezometric level at the time of failure. Figures 14(a), 14(b), 14(c), and 14(d) show the sensitivity of the factor of safety for a range of MSW shear strength parameters, MSW unit weight, and leachate level. For each sensitivity parameter, the factor of safety was computed using the circular failure surface in Figure 11(a). In Figure 14, the trend line slope is used to capture the sensitivity of FS to each parameter. For example, Figure 14(a) shows that FS decreases by 0.031 for a 1 m increase in leachate level. Using the trend line slopes for each parameter, the contributing factors leading to failure can be compared. MSW unit weight can increase when rain infiltrates into the waste mass and increases moisture content. The sensitivity of MSW unit weight is a nonlinear relationship shown in Figure 14(b). Figures 14(c) and 14(d) indicate that reducing MSW cohesion and friction, i.e., slopes equal to 0.022 and 0.025, respectively, contributes less to failure than increasing the leachate height (slope=0.031). Thus, Figure 14 suggests that leachate height has the greatest influence to reduce the FS.

Figure 14. Sensitivity of Inverse analysis to MSW input parameters for FS of unity.
