The July 10 2000 Payatas Landfill Slope Failure

ABSTRACT: *This paper presents an investigation of the slope failure in the Payatas landfill in Quezon City, Philippines. This failure, which killed at least 330 persons, occurred July 10th 2000 after two weeks of heavy rain from two typhoons. Slope stability analyses indicate that the raised leachate level, existence of landfill gas created by natural aerobic and anaerobic degradation, and a significantly over-steepened slope contributed to the slope failure. The Hydrologic Evaluation of Landfill Performance (HELP) model was used to predict the location of the leachate level in the waste at the time of the slope failure for analysis purposes. This paper presents a description of the geological and environmental conditions, identification of the critical failure surface, and slope stability analyses to better understand the failure and present recommendations for other landfills in tropical areas. In addition, this case history is used to evaluate uncertainty in parameters used in back-analysis of a landfill slope failure.*

Reference: Jafari, N. H., Stark, T. D., and Merry, S. (2013). *The July 10 2000 Payatas Landfill Slope Failure

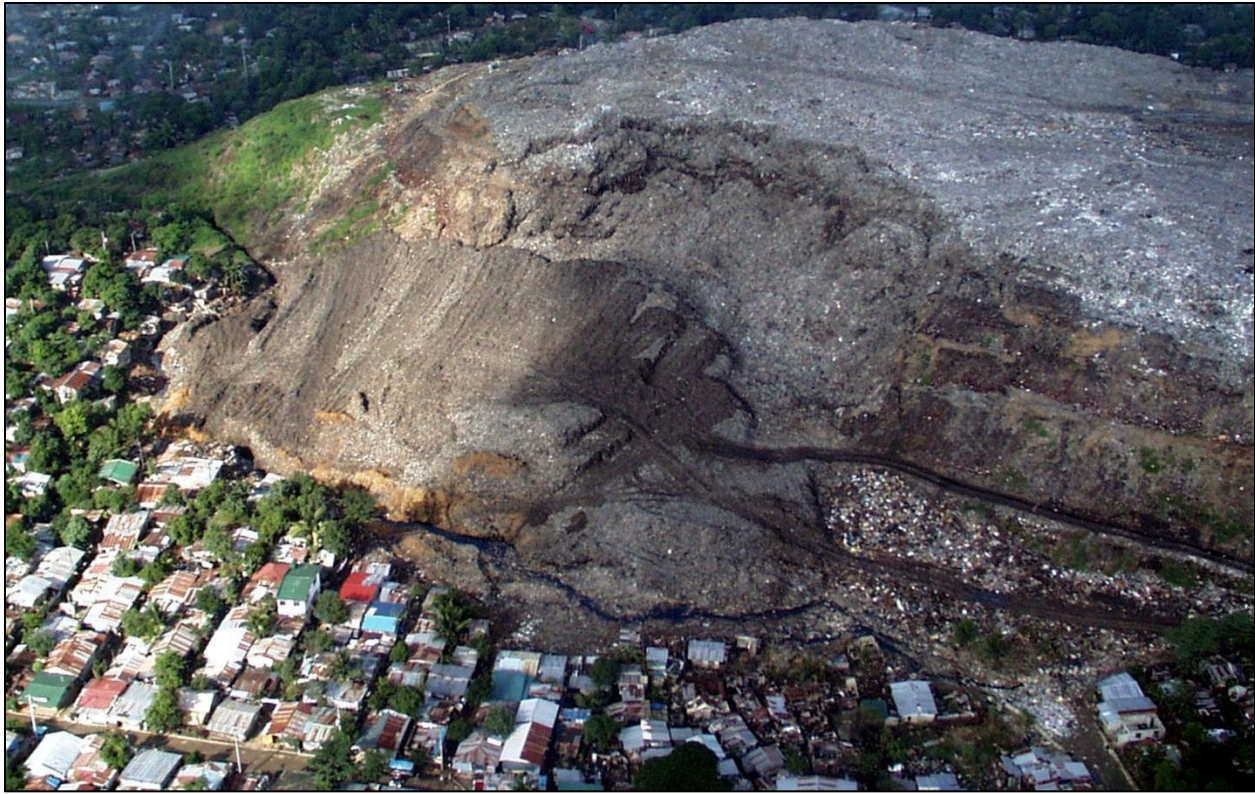
Figure 2. Aerial view of 12.7-hectare Payatas Landfill with slope failure and homes visible in foreground (photo by S.M. Merry).

Each of the above-referenced shear strength recommendations were developed for MSW below its field capacity. When fine-grained materials are intermixed with partially saturated MSW, negative pore pressures may exist in the partially saturated media. If the negative pore pressures are ignored, the total and effective stresses are equal and the shear strength envelopes may be directly compared. The MSW strength envelopes have generally resulted in progressively higher shear strengths, although recent work (e.g., Stark et al., 2009 and Bray et al., 2009) tends to reduce the shear strength at higher normal stresses due to the stress dependent nature of MSW. MSW strengths for effective normal stresses of 500 kPa or less are considered herein because of the shallow nature of the Payatas slope failure suggested by Figure 2.

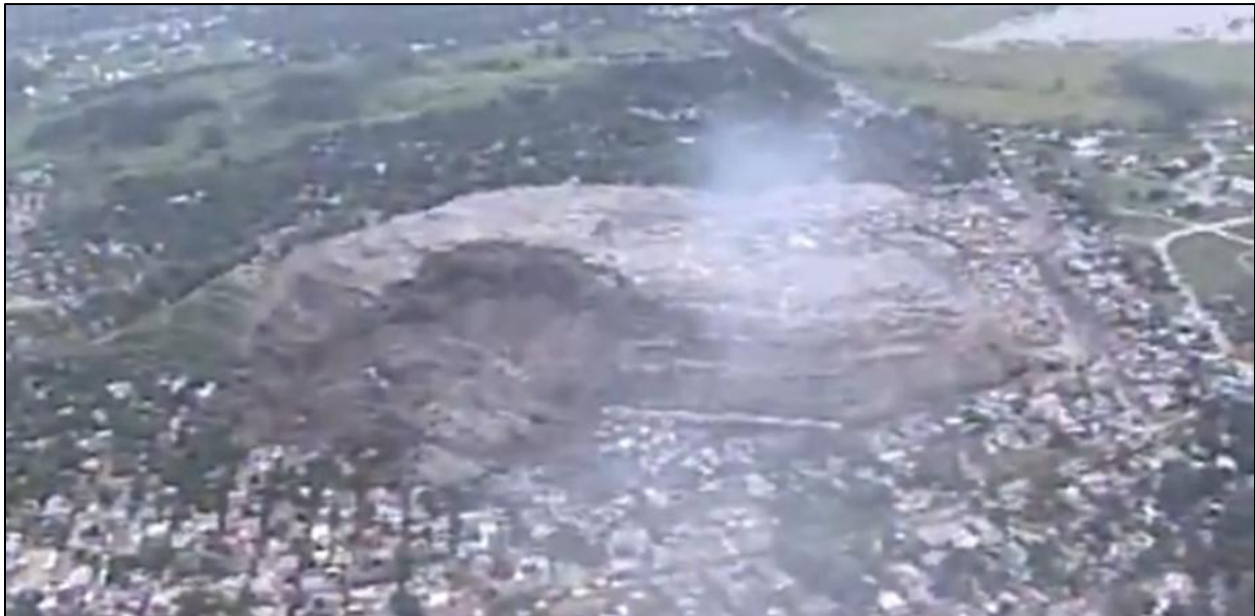
Figure. 3 Aerial view of waste slide from news video before regrading of slide mass (Baua, 2011).

The failure surfaces shown in Figure 11 were estimated from photographs in Figures 2, 3, 5, and 6 and consist of a shallow circular and shallow planar failure surface through only the MSW. From Figure 3, the authors surmise that the failure surface is shallow in nature, and the waste mass slid down the side slope as a mass, i.e., a slab or sliver slide. Subsequently, ledges developed along the main scarp formed from vertical blocks toppling over or sliding down (see Figure 3). Therefore, it was concluded that the failure surface passed from the crest of the slope through the MSW, and exited at the slope toe without entering the underlying brown native clayey silt.

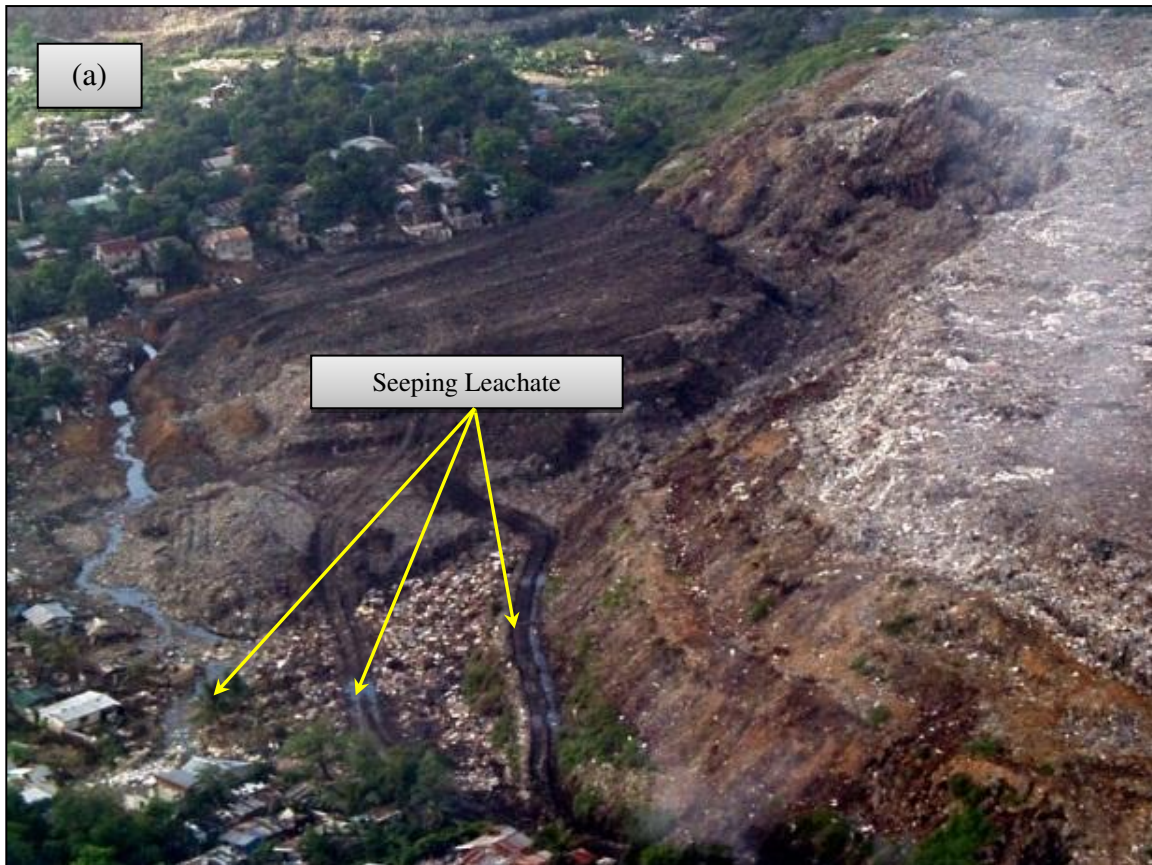
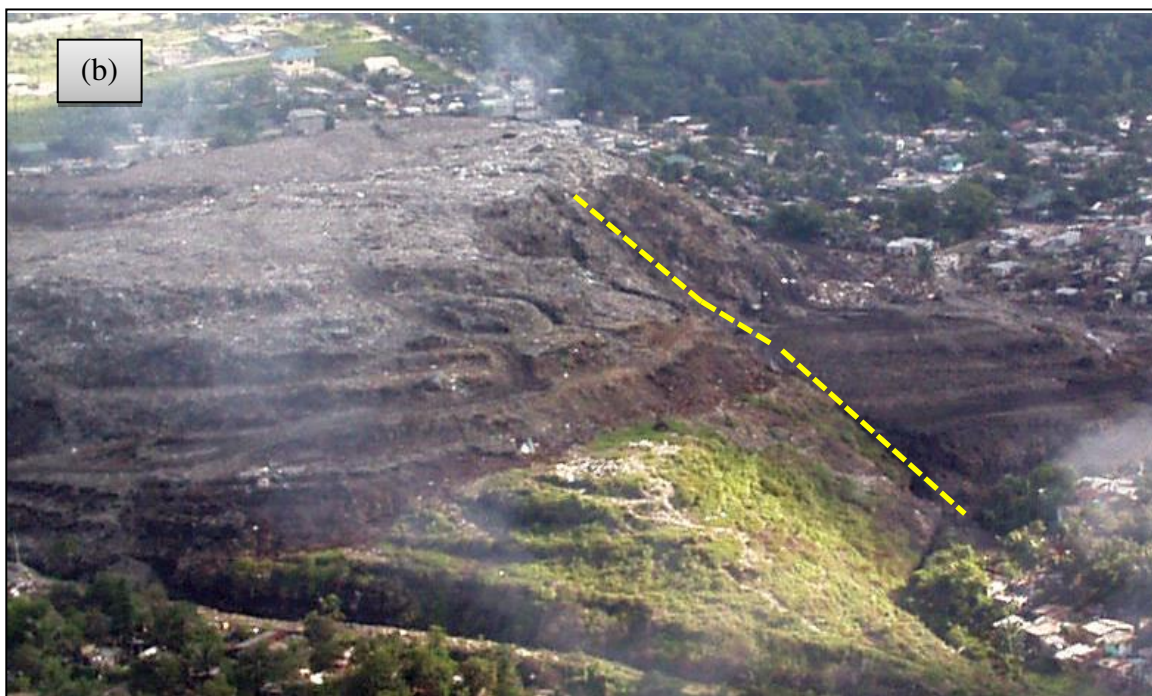
Figure 6 shows a series of aerial views of the waste slide area that were used to understand the failure surface for use in the stability analyses. Figures 6(a) and 6(b) provide side views from the southeast and northwest direction, respectively, of the waste slide. Figure 6(c) highlights benches in the landfill slope, and Figure 6(d) delineates a mildly sloped toe buttress. Digital measurements from these photographs were used to create the cross-section shown in Figure 7. These measurements indicate toe buttress slope angles in the slide area of 1.4H:1V ($\sim 35^\circ$) to 0.84H:1V ($\sim 50^\circ$) and steeper side slopes above the buttress that range from 60° to 70° (Bautista, 2007; UNFCCC, 2007). Additionally, site reconnaissance and pictures both indicate that leachate was seeping from this toe buttress.

Figure 6. Slope geometry and failure surface after failure (a) evidence of seeping leachate, (b) representative slope inclination, (c) location of slope benches, (d) toe buttress (photos by S.M. Merry).
